**ARBORICULTURAL SURVEY  
to BS 5837:2005  
at  
Site at Rabbit Ings  
Lund Hill Lane  
Royston  
Barnsley  
South Yorkshire**

White Young Green, Edinburgh

8460/AB

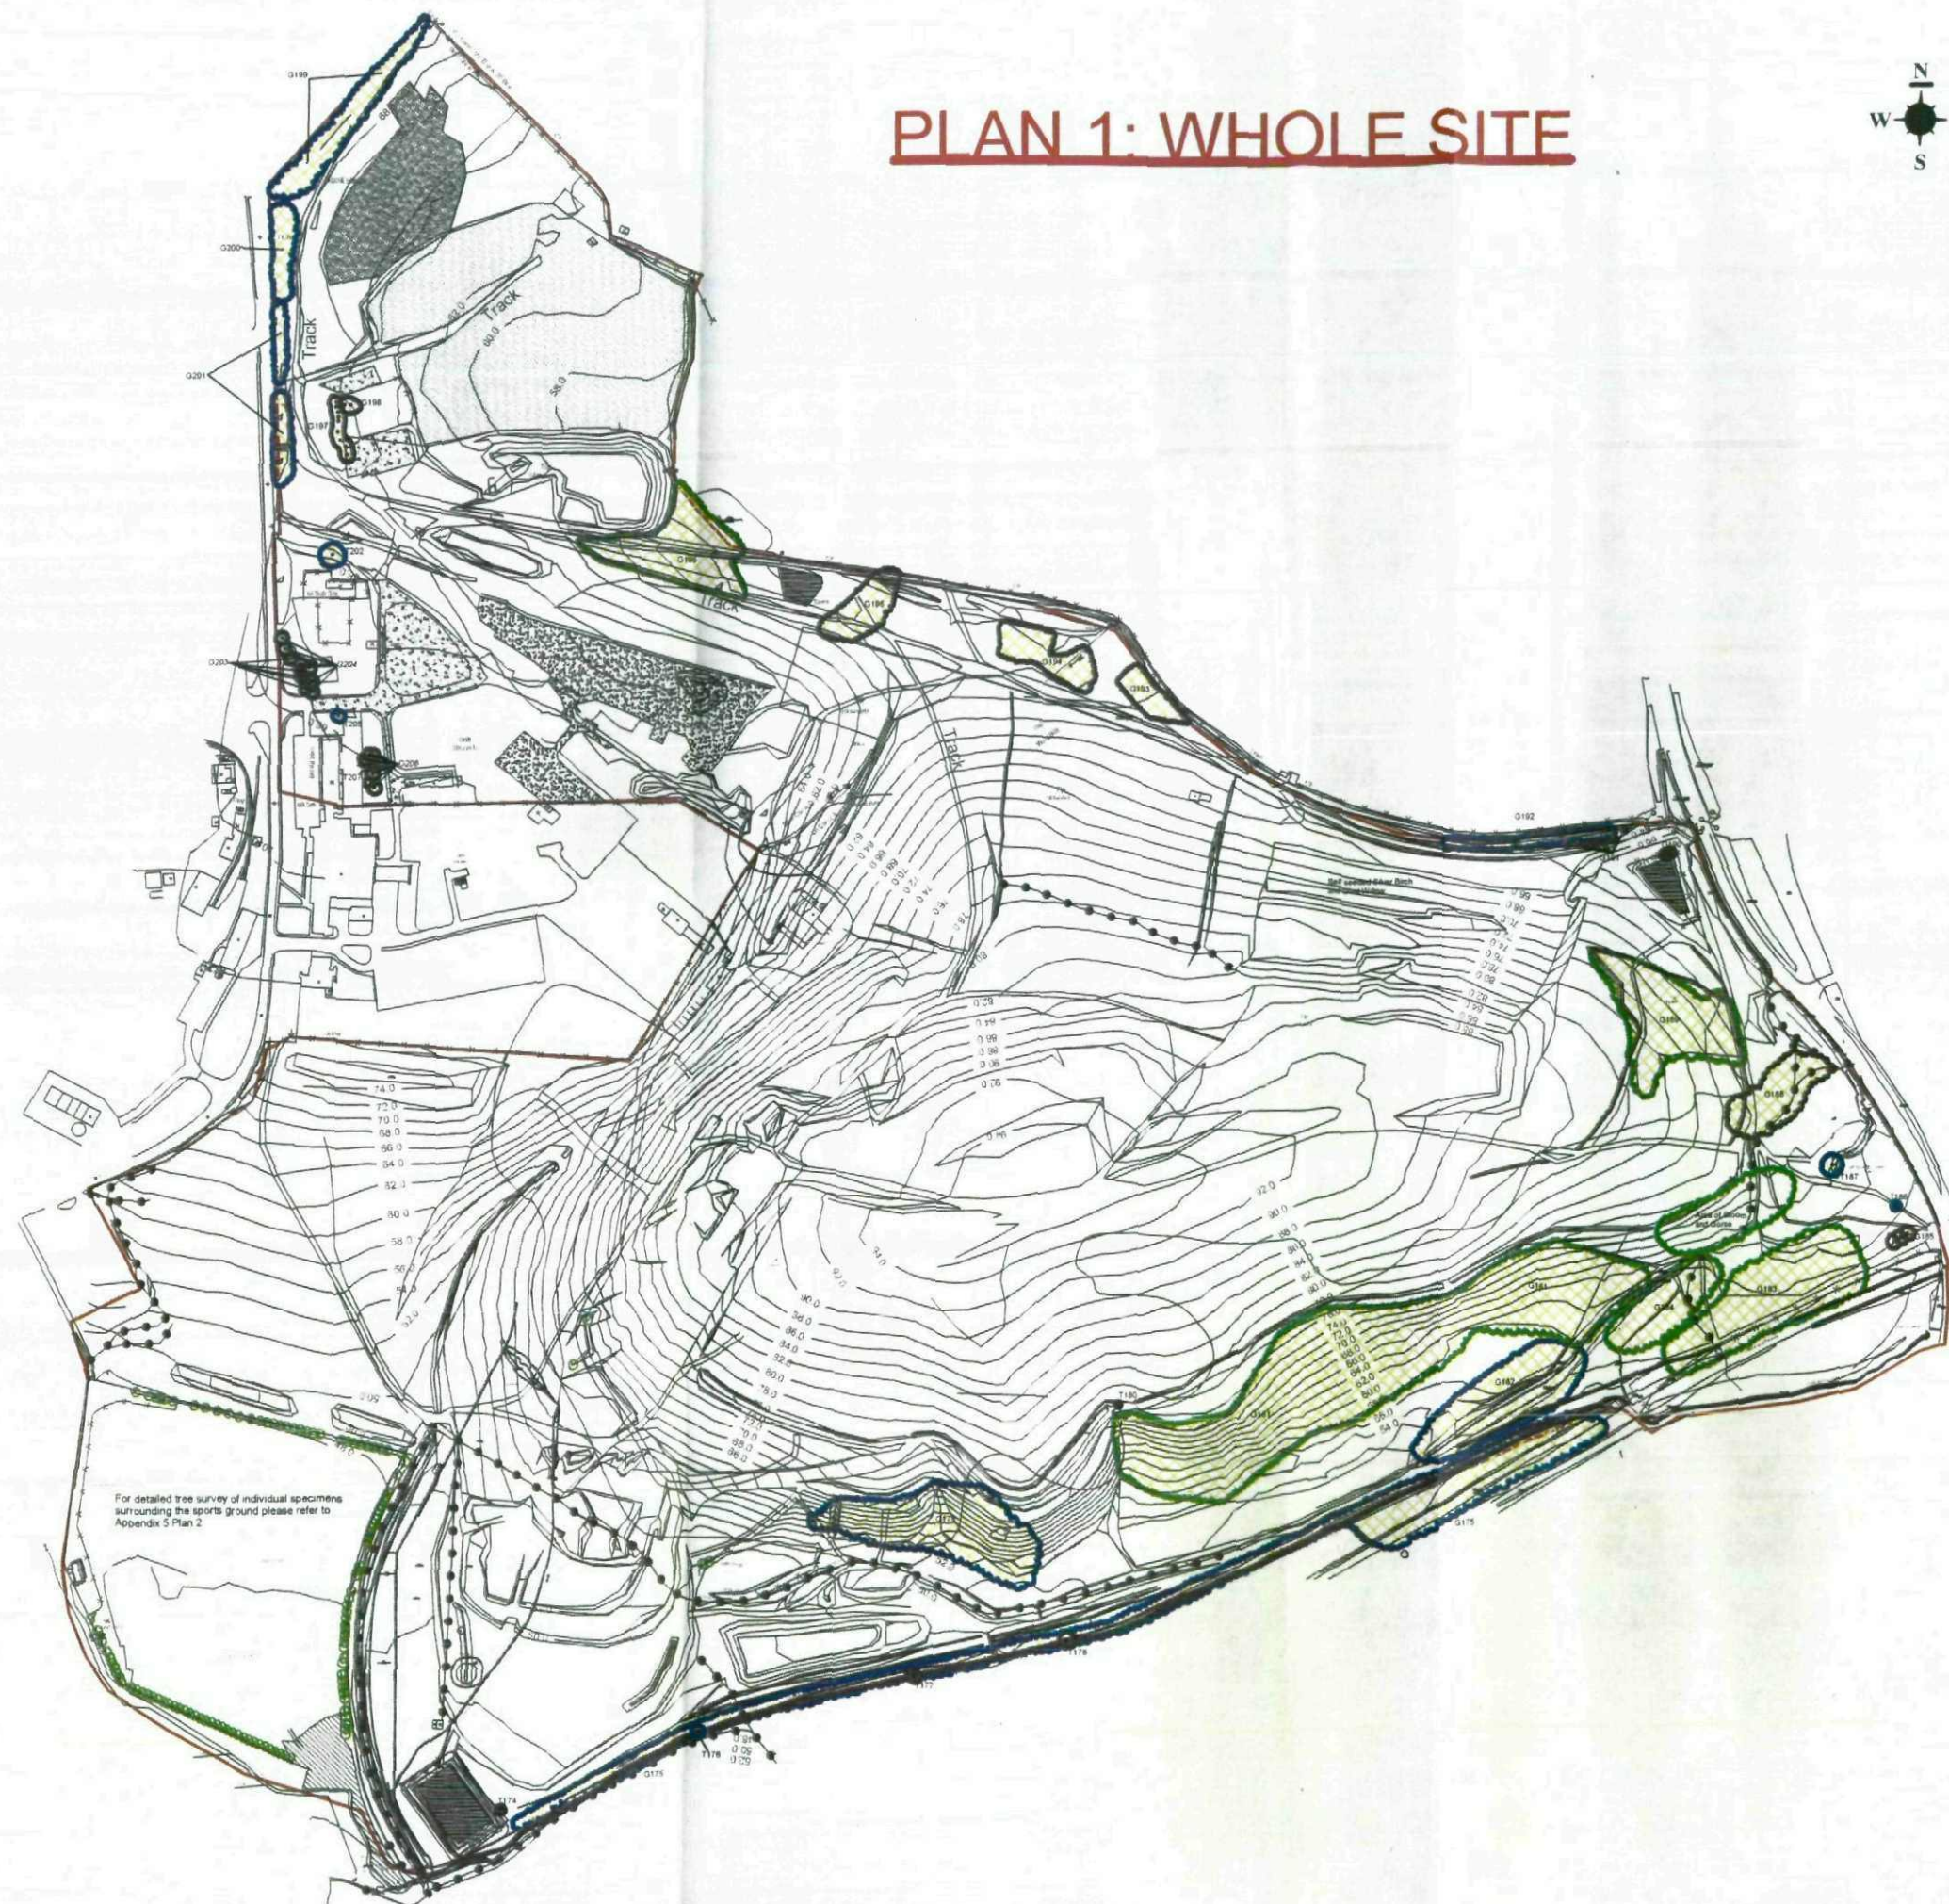
# PLAN 1: WHOLE SITE

TITLE: Site at Rabbit Ings (Whole Site),  
Lund Hill Lane, Royston,  
Barnsley, Job No: 8460VB.

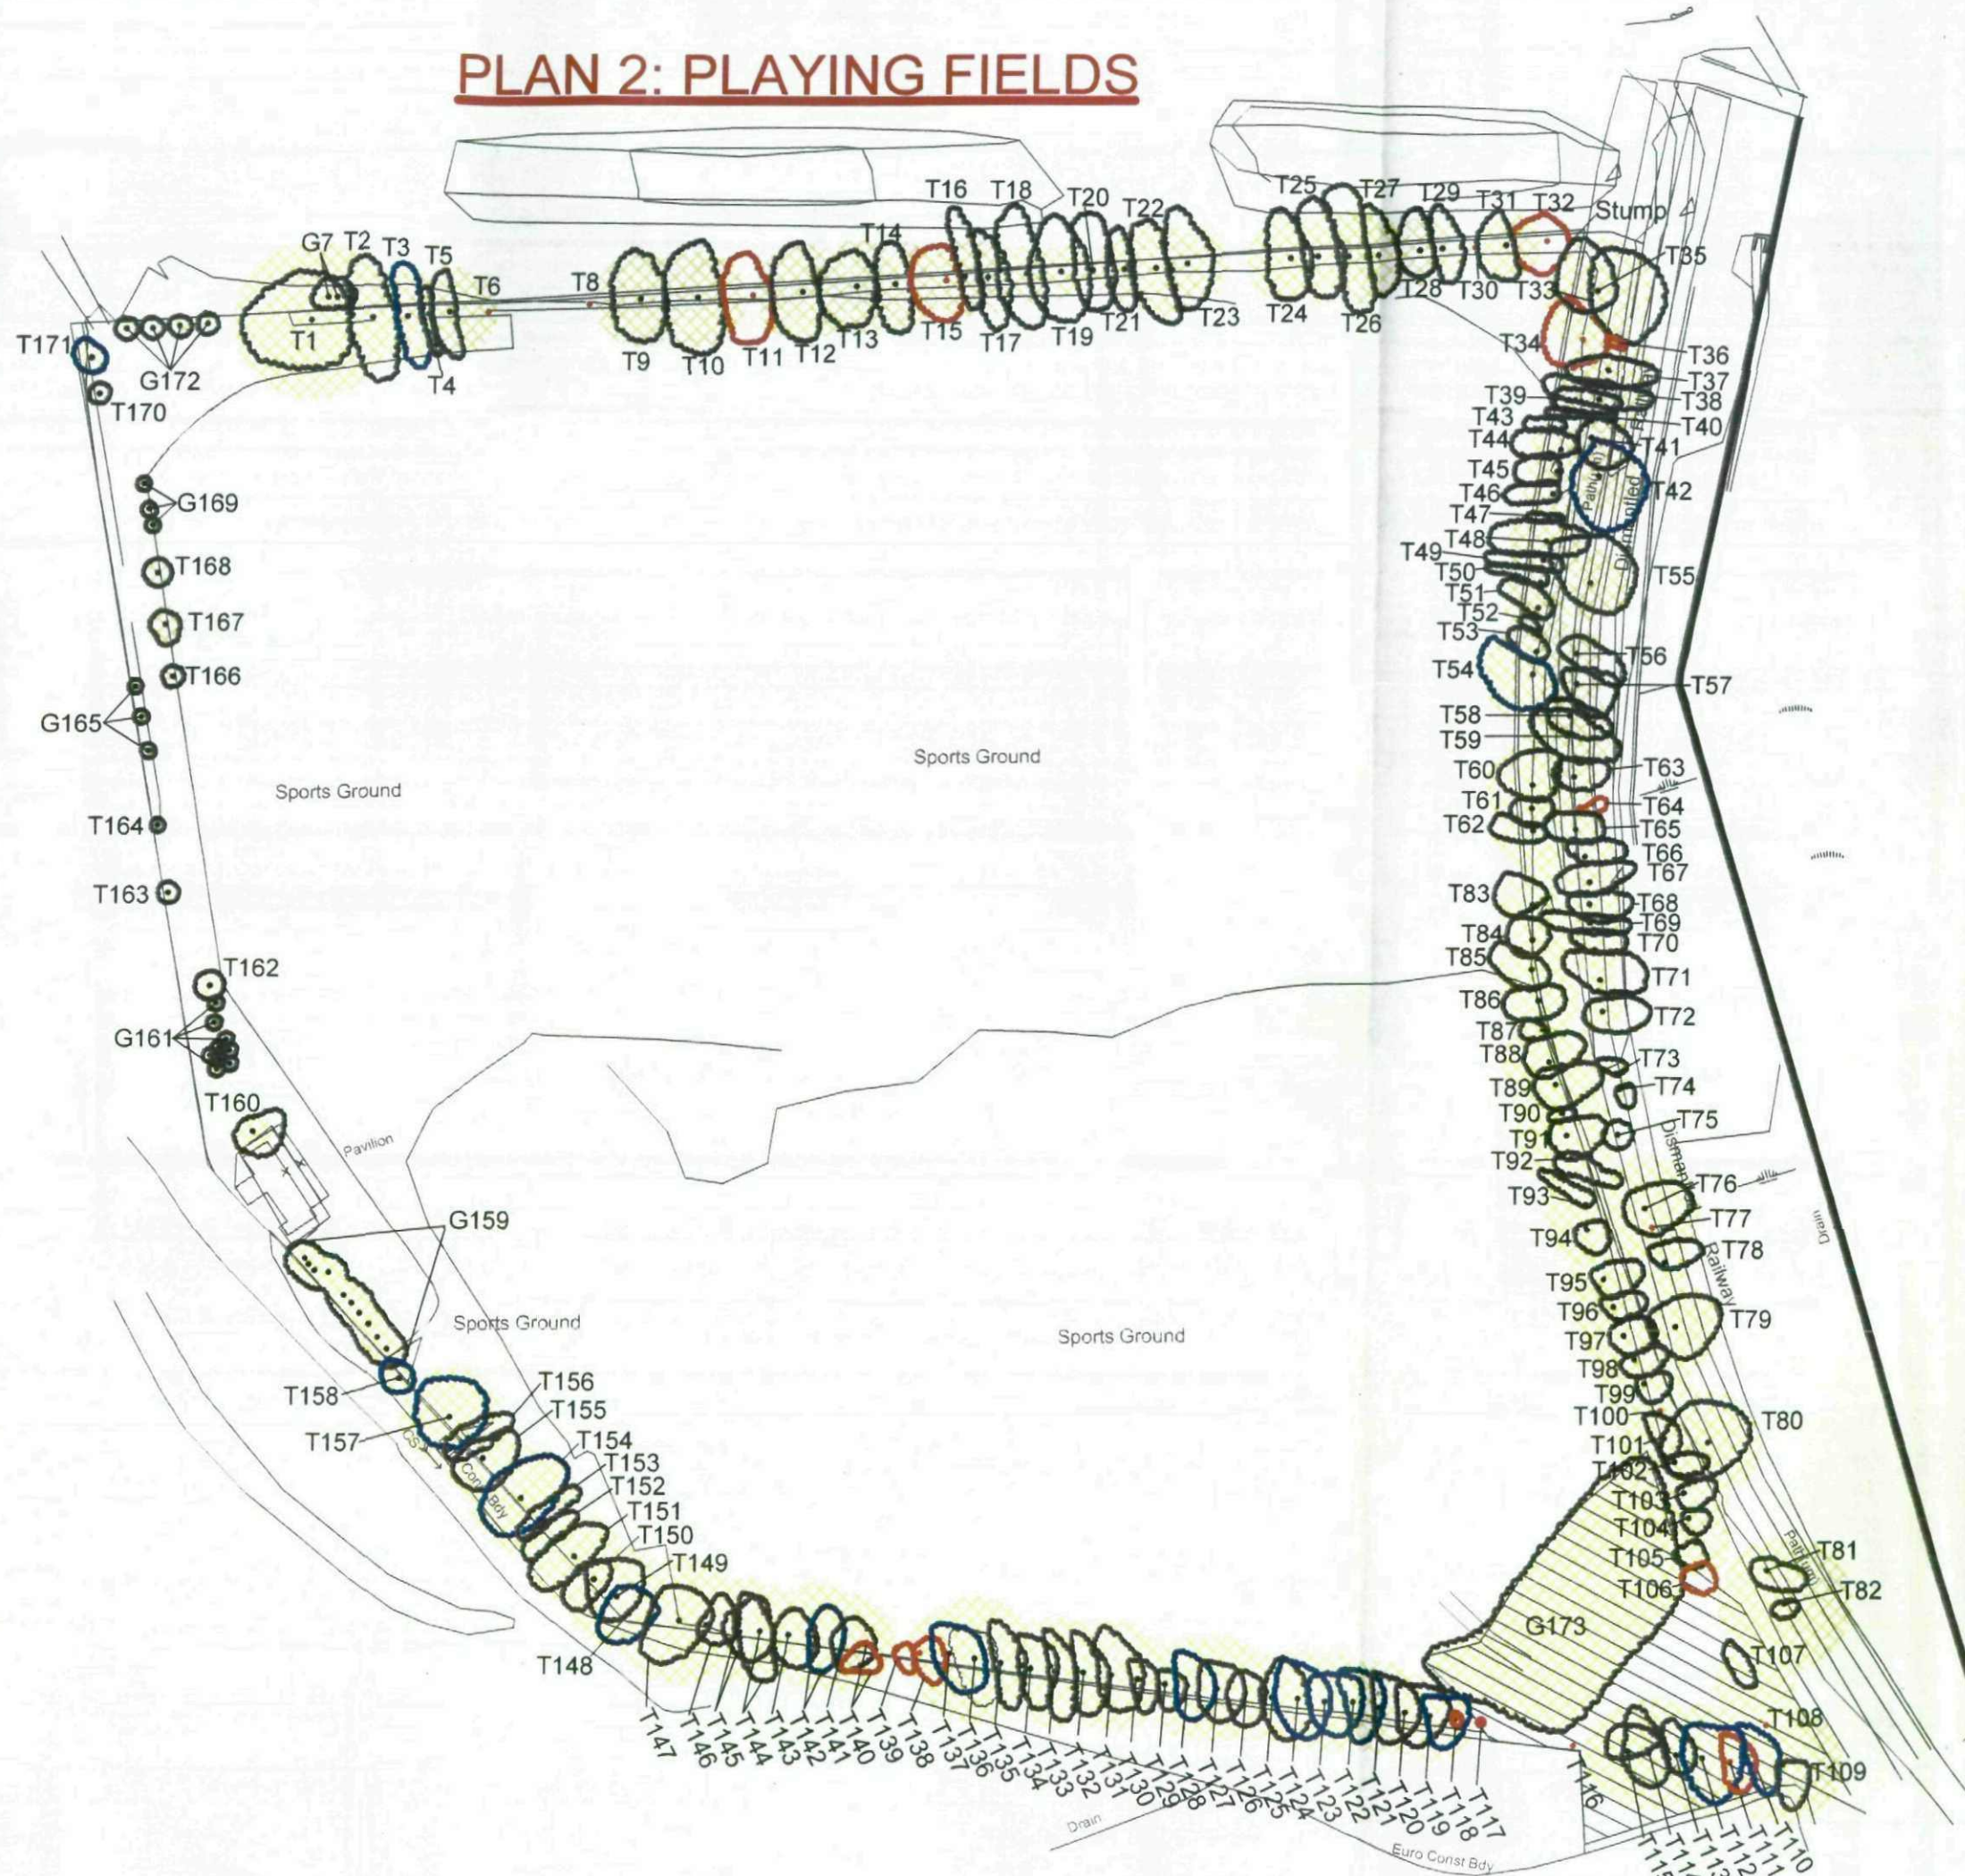
# PLAN 2: PLAYING FIELDS

THE ROOT PROTECTION AREA (RPA) IS THE MINIMUM AREA AROUND A TREE WHICH SHOULD BE LEFT UNDISTURBED, IN ORDER TO AVOID DAMAGE TO THE ROOTS OR THE ROOTING ENVIRONMENT.

IF WORK NEEDS TO BE CARRIED OUT WITHIN THE RPA THEN SPECIALIST SURFACES OR SPECIALIST CONSTRUCTION TECHNIQUES MUST BE CONSIDERED. CARE MUST ALSO BE TAKEN TO AVOID GROUND COMPACTION WITHIN THE RPA AND THE STORAGE OF MATERIALS IS NOT PERMITTED. ANY EXCAVATIONS WHICH ARE REQUIRED WITHIN THE RPA MUST ONLY BE CARRIED OUT BY HAND.
