## Bat Survey

Cliffe Farm

Cubley

March 2011

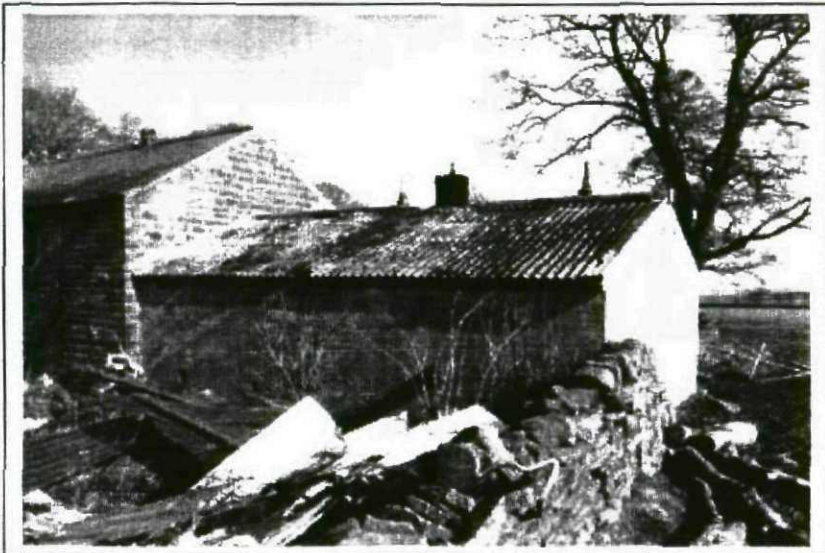
**FIG 7**

| Ref | Description |
|---|---|
| G | <p>Single-storey barn with blockwork walls and corrugated sheet roof. The gable was plain with a tight fascia. The eaves fairly low. Generally unsuitable for bats.</p> <p>Internally the ridge and gables were exceptionally cobwebby indicating that bats were very unlikely.</p> |

**Barn G**

| G- Concrete Block Barn | Building unsuitable –No suitable roost sites. |

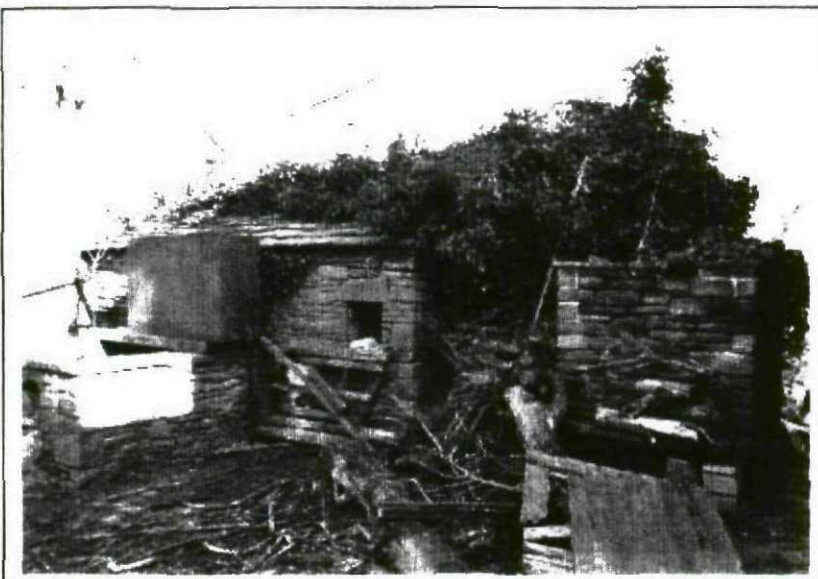
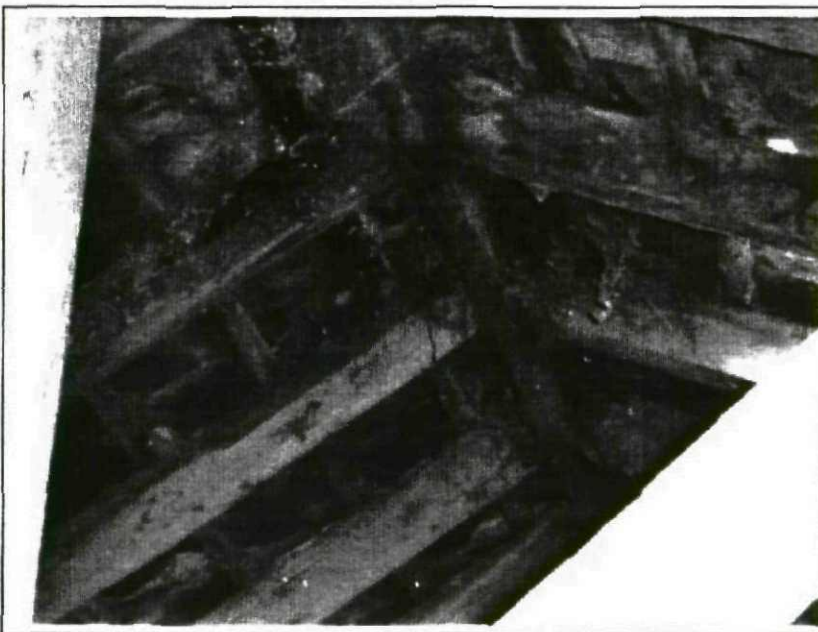
**FIG 5**

| Ref | Description |
|---|---|
| D | <p>Pig sty and outside toilet built as a lean-to against the outside wall. Small stone structure substantially covered with thick ivy, particularly the toilet. No potential for bats. (Fig 5)</p> |

**Barn D**

| D – Pig Sty | Building unsuitable – too small & low |

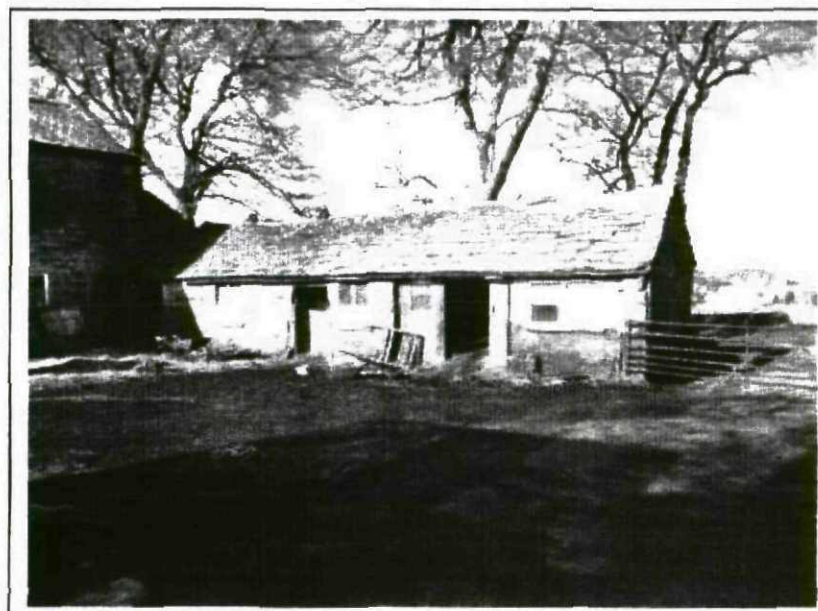
**Barn E**

| Ref | Description |
|---|---|
| E | <p>Single-storey stables with stone and brick walls and stone slate roof. There were some gaps in the gable verge pointing. The front (east) wall was plain and the yard wall contained three stable doors. The building was quite low and unlikely to be attractive to bats.</p> <p>Internally the roof was supported on sawn timber trusses containing no suitable sockets or joints which could provide suitable roosting crevices. The ridge and apexes of internal gable walls were cobwebby suggesting bats were unlikely. (Fig 5).</p> |

| E - Stables | Roost unlikely-external walls quite low. Internal roof very cobwebby. |
