**Hirst Cottage
Chapel Lane
Billingley**

**Pre-Development Arboricultural Report
And
Method Statement**

10 December 2024

**By
Ian Kennedy
Wharnccliffe Trees and Woodland Consultancy**

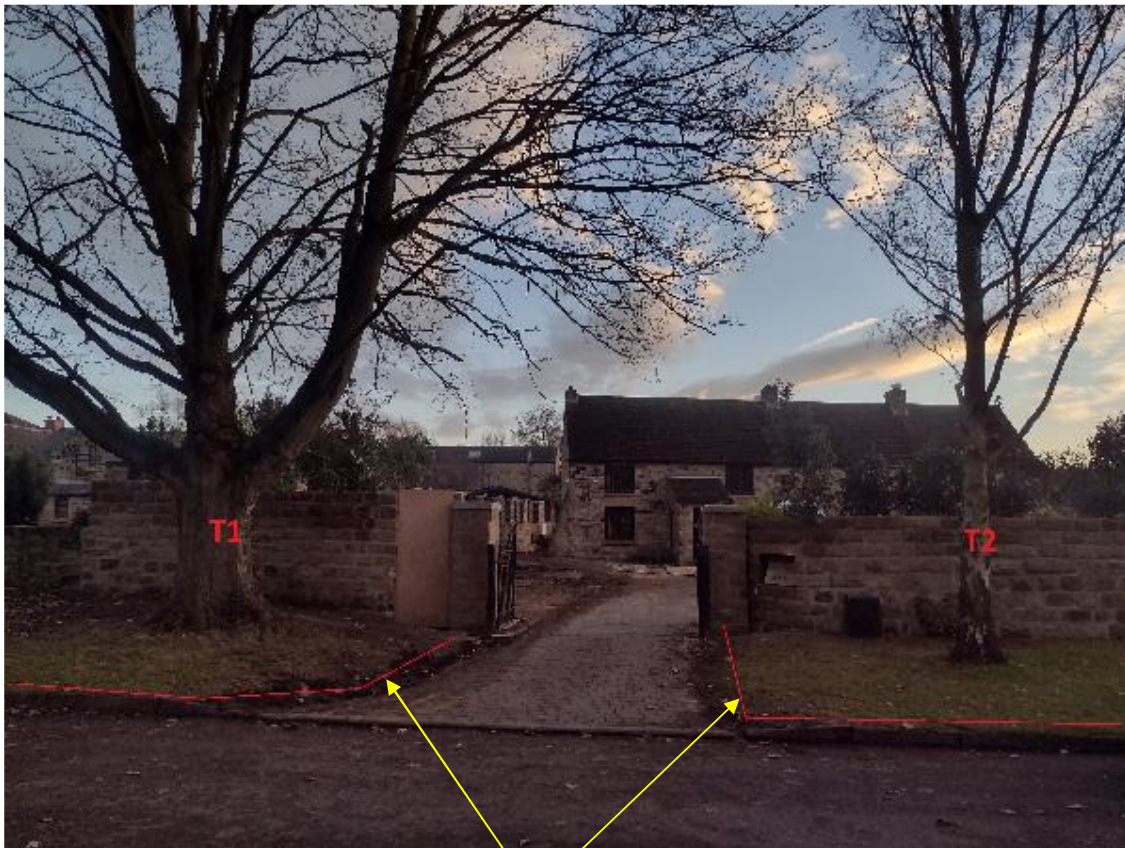
Photograph 1.

Position of temporary timber post and rail tree protective fencing.

Protective fencing around the edge of the grass verge will be necessary to protect Trees 1 and 2 from vehicles accessing the property. Roots of these trees will be growing throughout the verge and vehicles running on the verge would cause soil compaction and root damage.

1. Erect tree protective fencing around the edge of the grass verge to protect Trees 1 and 2 at the positions shown of Photograph 1 and Plan 3 below.
2. Erect tree protective fencing around the RPAs of Trees 4 and 5 as shown on Plan 3.
3. Prune the trees in Group 1 back to the boundary.
4. Complete the development.
5. Remove temporary tree protective fencing,

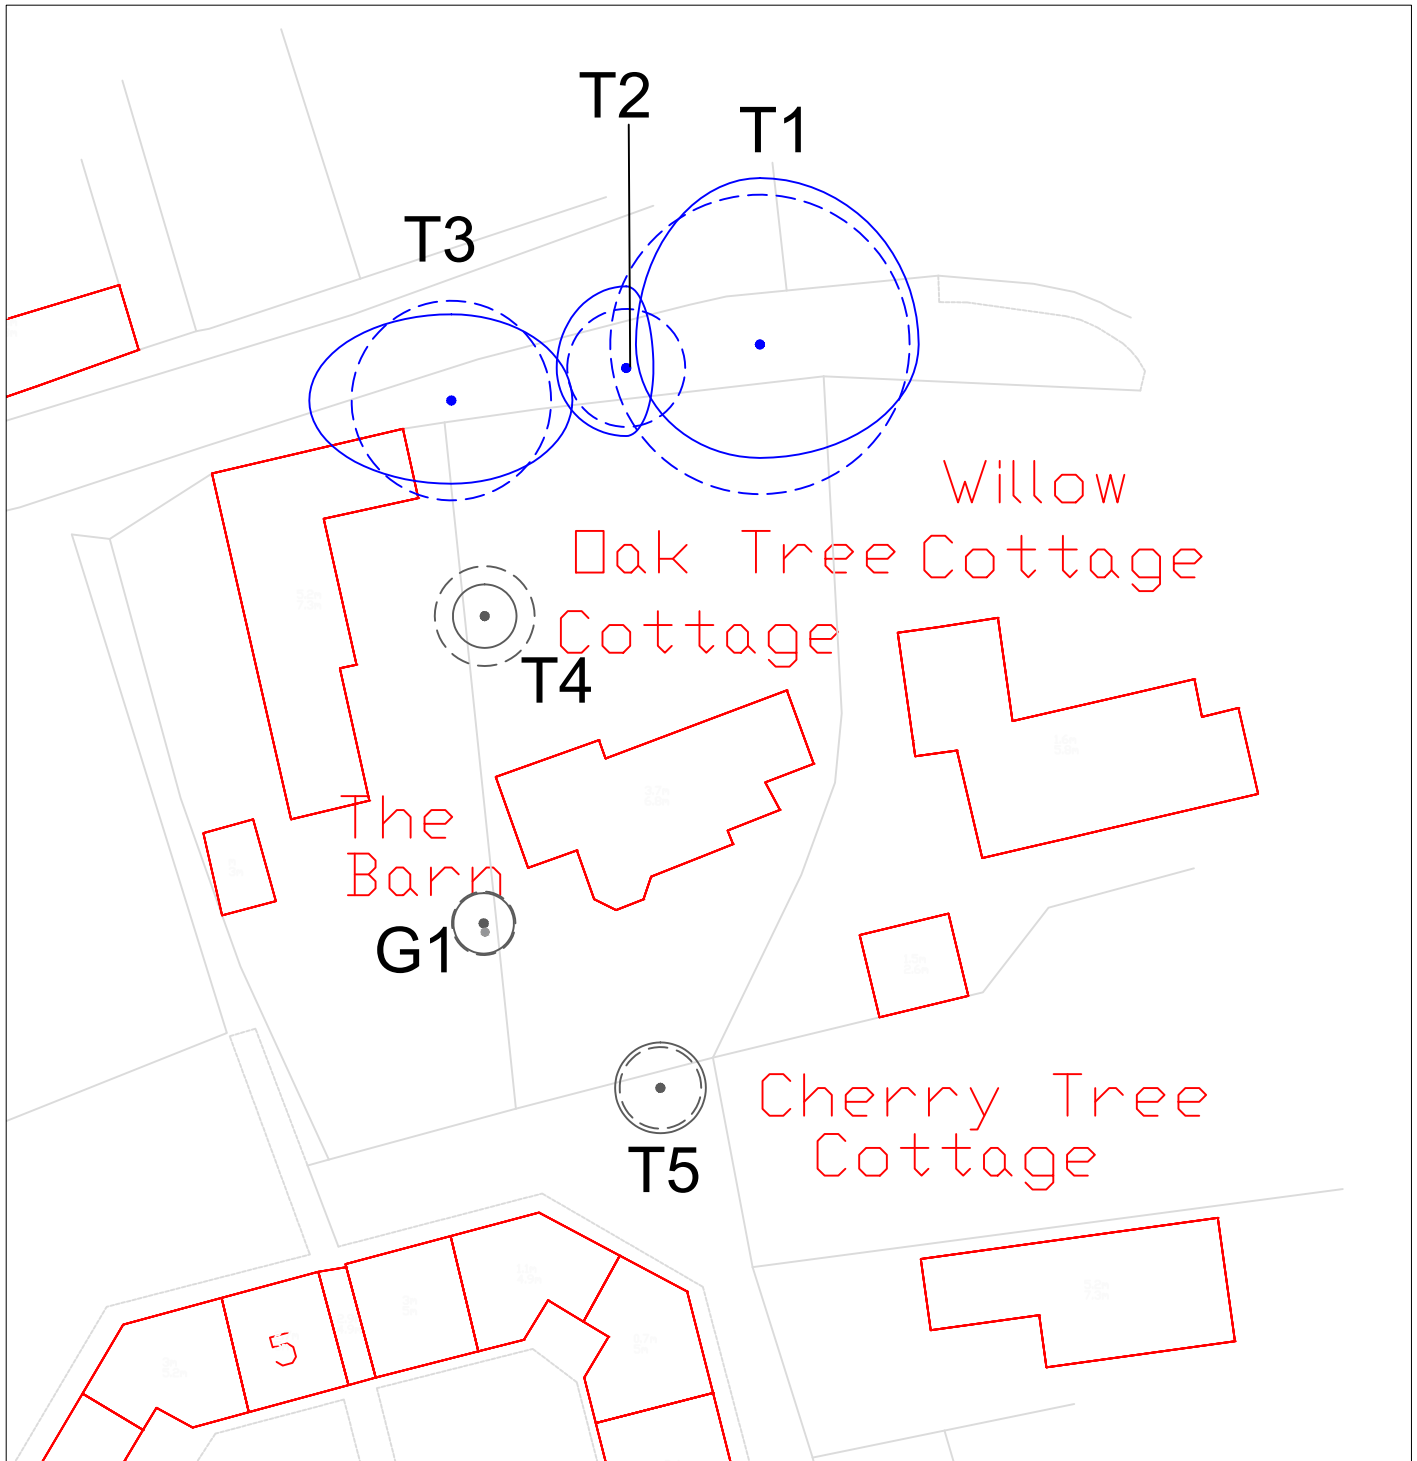
Plan 1 Tree Constraints Plan showing the existing layout

Scale 1:500 @ A4

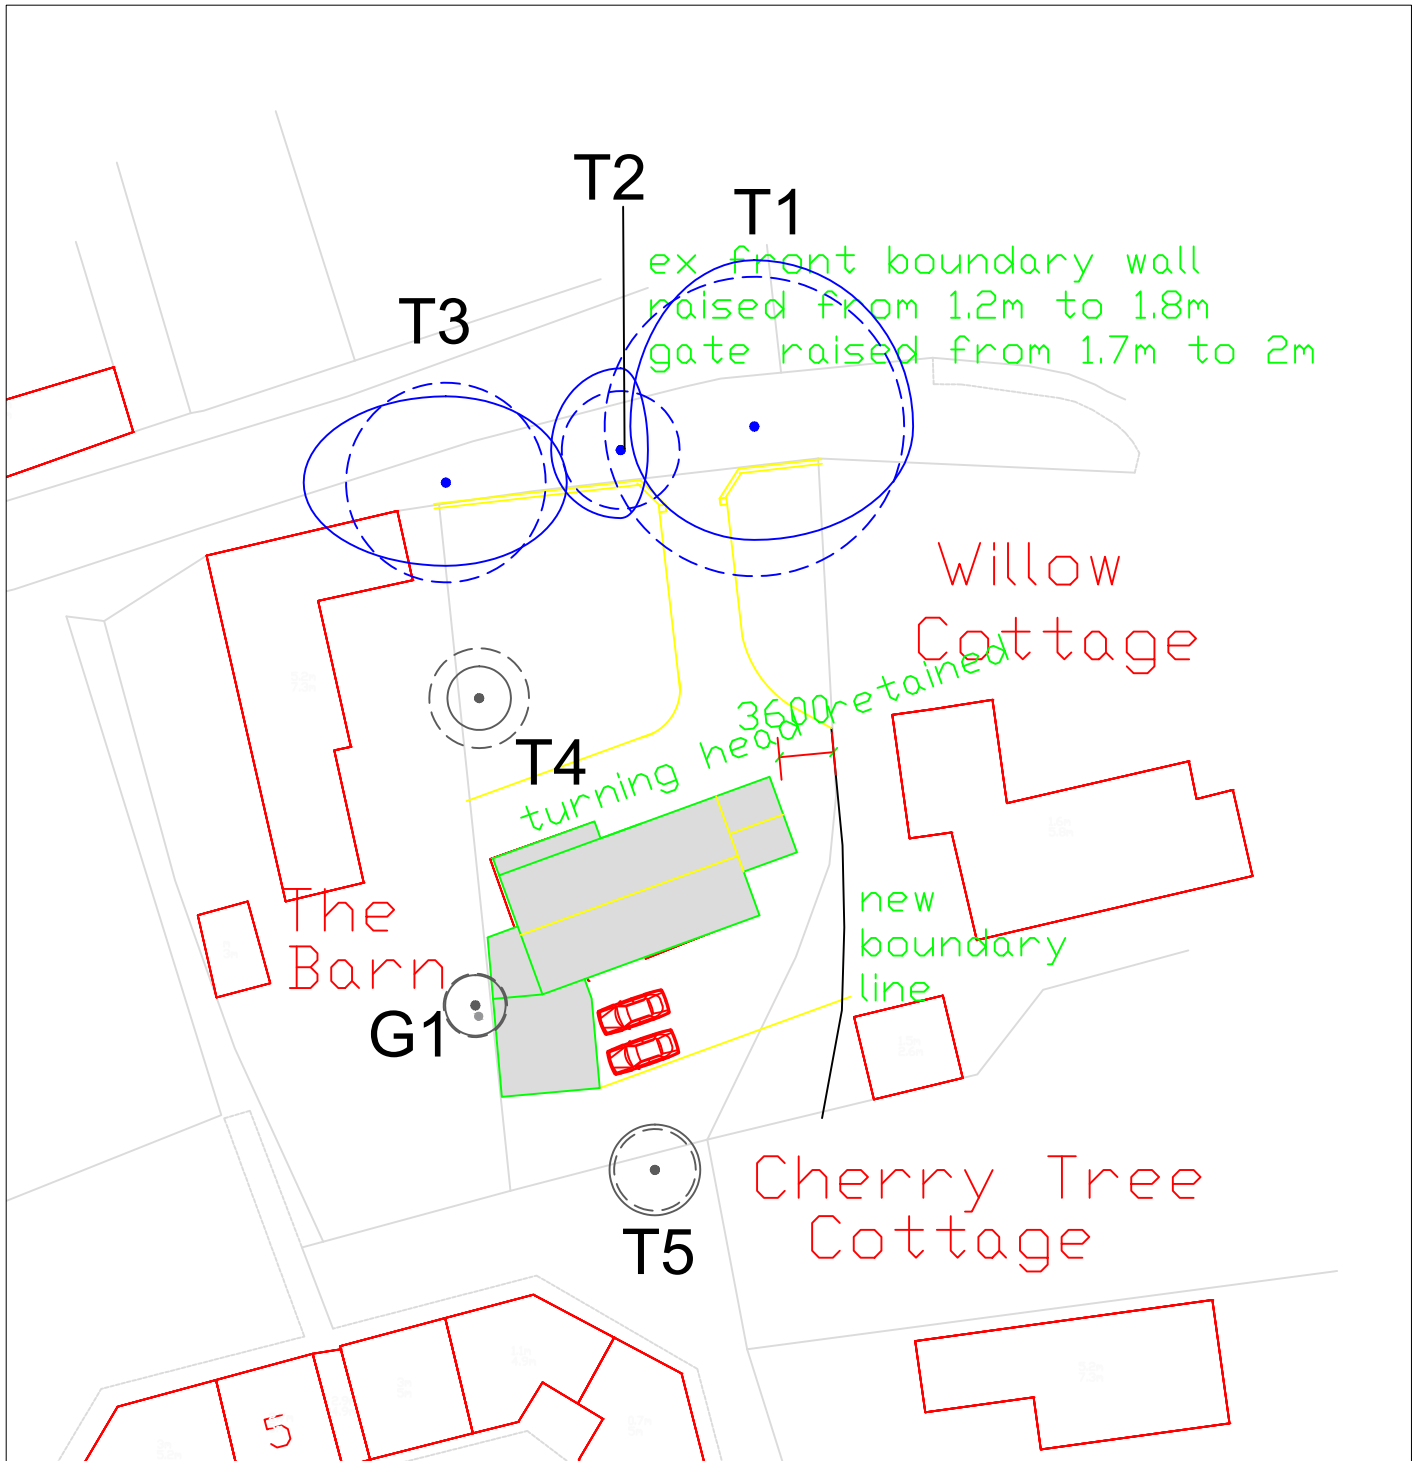
Plan 2 Tree Constraints Plan showing the proposed layout

Scale 1:500 @ A4

The footprint of the rear extension encroaches into the crown spreads and root protection areas (RPAs) of the two small trees in Group 1. The crowns of the trees slightly overhang the boundary into the application property. The crowns would need to be pruned back to the boundary. This is minor work that the trees would cope with because they are relatively young. The rear extension would also encroach into the RPA of the trees but because of the relatively young age and small size of the trees they should cope with this.
