Birkwood Primary School, Barnsley

Bat Survey Report

ER-6406-01 Bat Survey

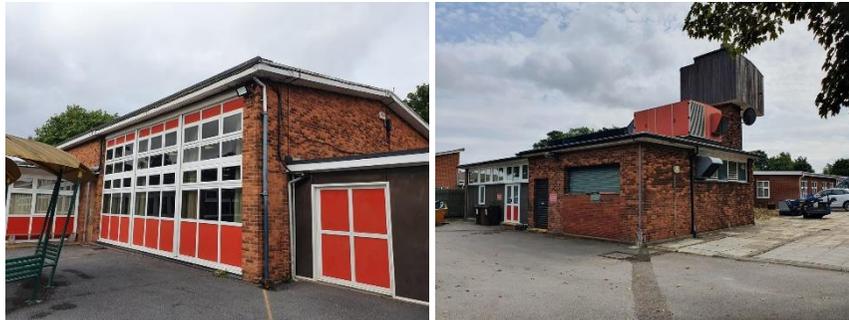
14. The school consists of a series of single storey redbrick buildings of slightly varying heights, adjacent one another or linked via connecting corridors and surrounding a central playground.

Figure 3 Typical view of surveyed building.

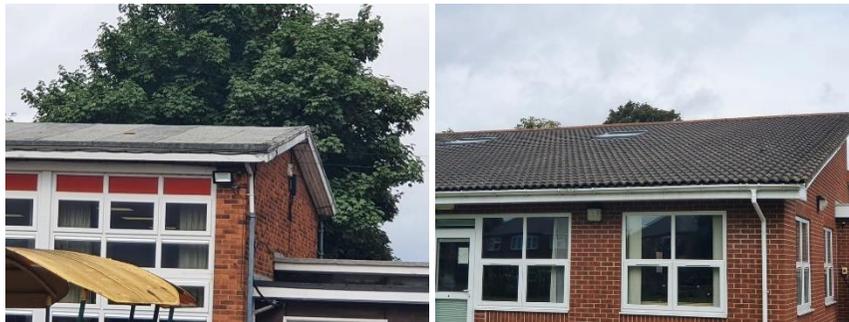
15. Roofs across the survey area are either flat or have a very shallow pitch. The majority are roofed with roofing felt which appears well sealed along its edges. A more recent extension is found to the south with an interlocking tile roof, in good condition throughout.

Figure 4 Showing typical felt roof (left) and tile roof of more recent extension (right).

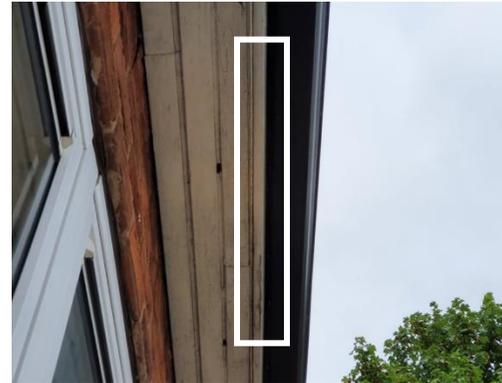
16. Plastic guttering rests directly below the eaves and adjacent the wooden/ plastic soffit box partway along some of the roofs. In certain locations to the north, a gap is noted where the guttering sits away from the soffit, presenting a potential roost feature (PRF) suitable for a small number of crevice-dwelling bats.

Figure 5 Showing gap behind guttering.

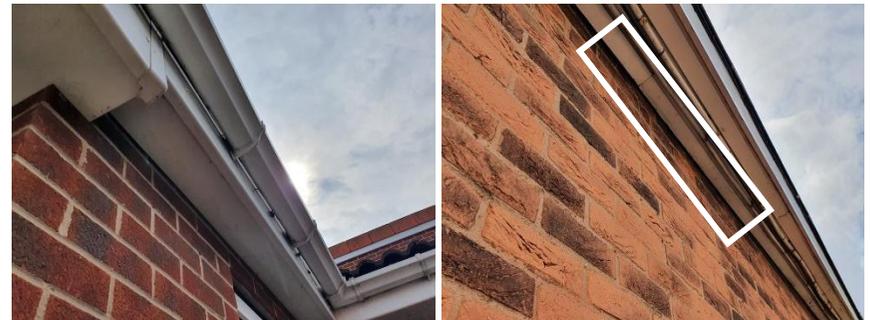
17. Wooden and plastic soffits run the perimeter of the school. For the most part these are in good condition, resting flat against adjacent brickwork. A single exception is noted close to the linking corridor at school's centre. A small gap in evident suitable for roosting.

Figure 6 Showing typical sealed plastic soffit (left) and gap to wooden soffit (right).

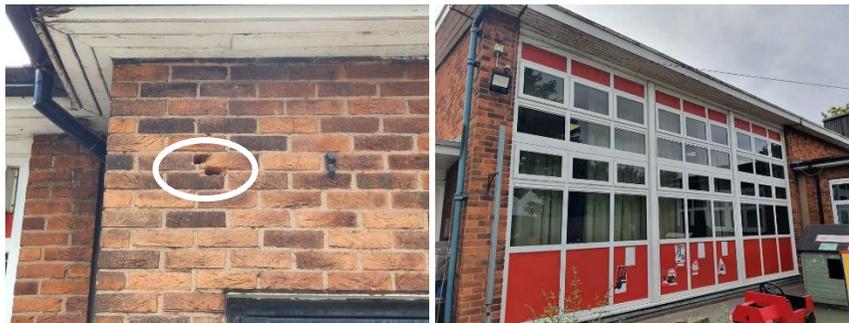
18. Two holes are noted in the brickwork of the boiler room to the Site's north. These could not be examined closely and could lead to wall cavities beyond, presenting a PRF. The brickwork across the rest of the survey area is in good condition, with minimal signs of weathering and mortar intact.
19. Windows and doors are mostly uPVC framed with some wooden in older parts of the school. All are in fine condition and rest flush with surrounding brickwork.

Figure 7 Showing hole in wall of boiler room (left) and typical view of uPVC windows (right).

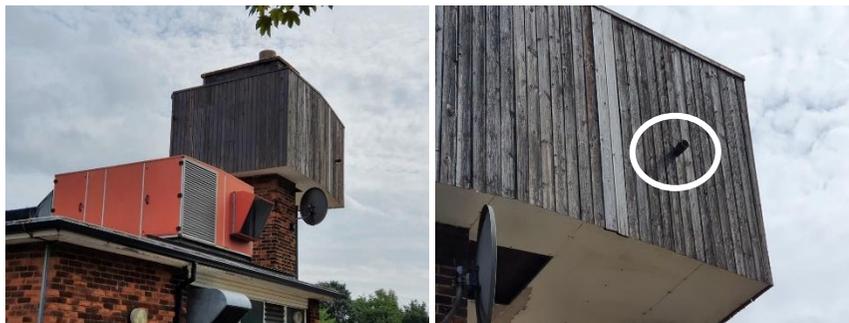
20. A metal air conditioning unit sits atop the boiler room. The unit has no PRFs and the thermal properties of the metal casing make it unsuitable for roosting. To its south, an unused wooden clad water tower rises above the boiler room. Cladding is well-sealed, with an outlet pipe the only possible point on ingress into the tower for bats. The potential for bats to access the water tower via this feature is very low.

Figure 8 Showing air conditioning unit atop boiler room (left) and outlet pipe to water tower (right).
