PHASE 2 GEO-ENVIRONMENTAL REPORT

Report on a Phase 2 Geo-environmental Investigation

Location: To Your Home Ltd, Century Works,
Manchester Road, Millhouse Green, Barnsley, S36 9LQ

Report No. C1675/21/E/2596

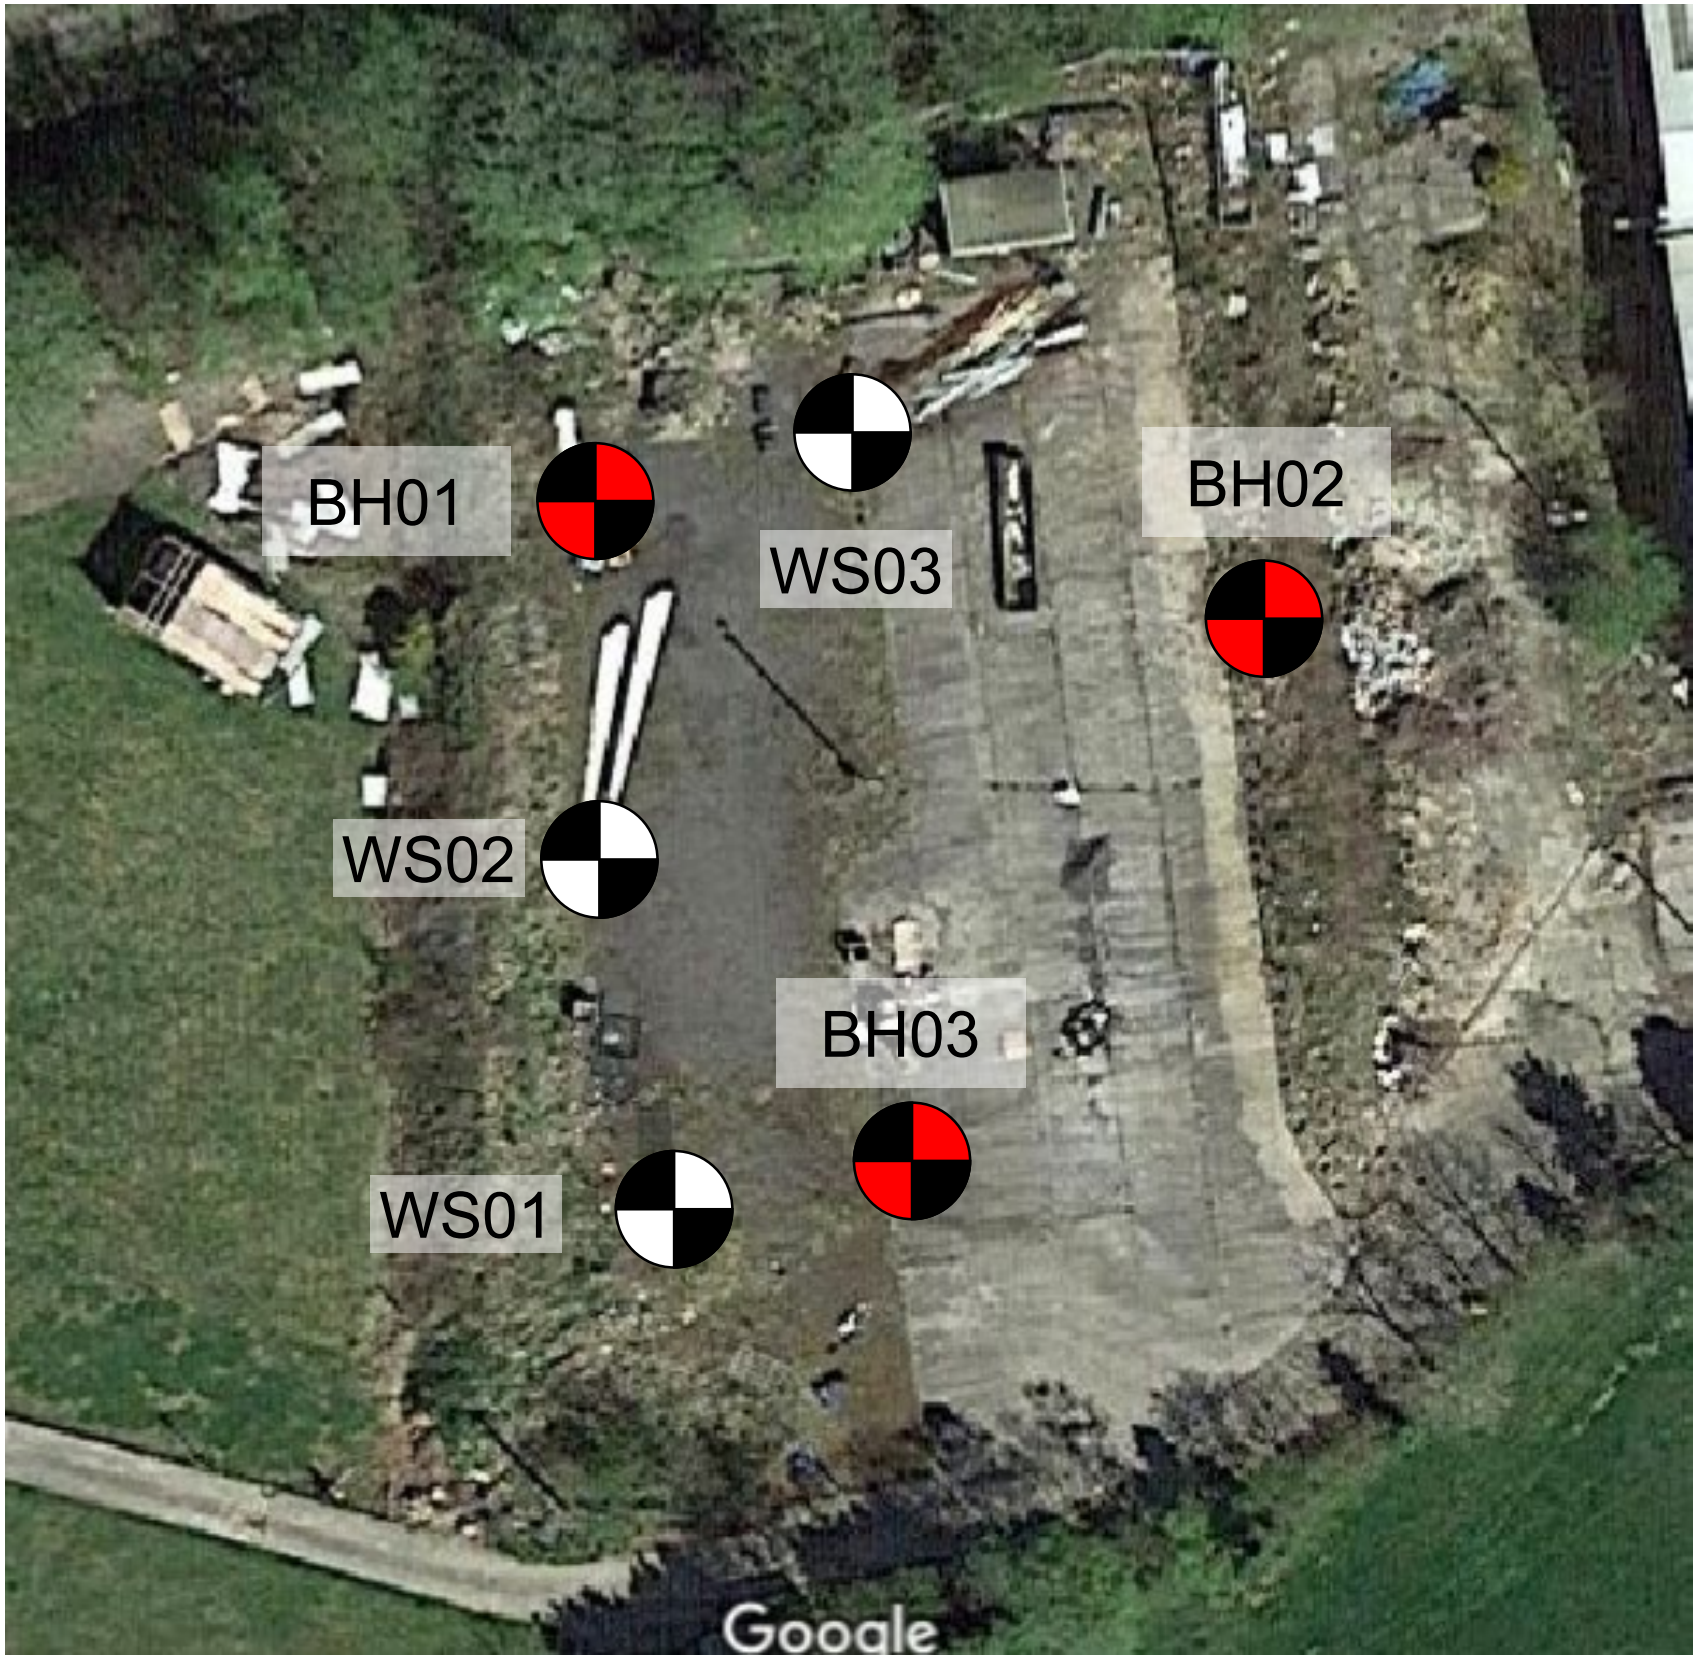
Site Plan

Investigation positions approximated from site operative's notes.

The investigatory locations are shown on the site plan which is presented in Appendix 1 to this report.

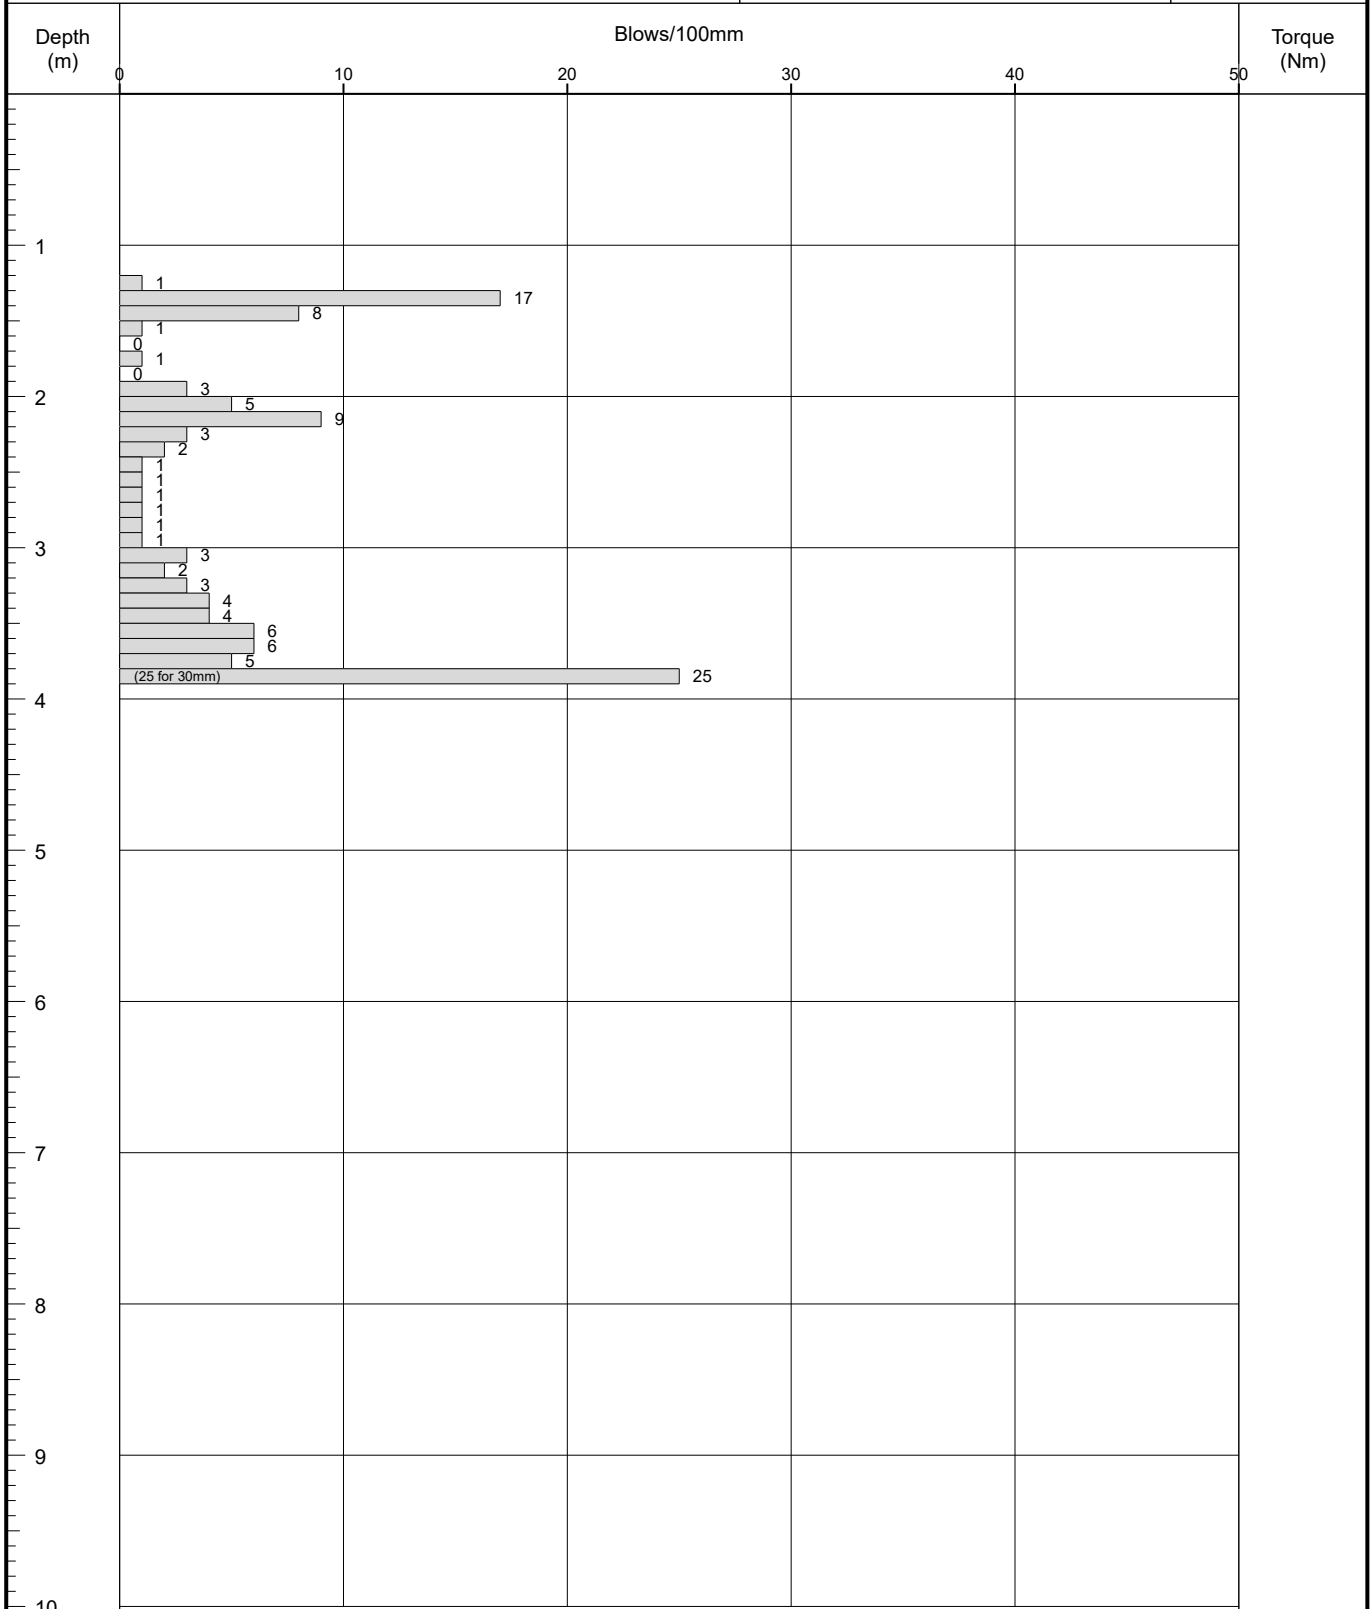
Remarks:
DP started at 1.2m due to HDSP. Abrupt refusal at 3.83m.

Fall Height 750mm

Position	Blows/100mm			Refusal type (Effective/ Abrupt*)	Comments
	0 - 2	3 - 10	10+		
	Depth to which blow count range was observed (m)				
DP01	3.0	3.8	3.83	Abrupt	Low results recorded in the made ground to 3.0m depth. Followed by consistent moderate blow counts to 3.8m within the weathered Pennine Lower Coal Measures Formation. Abrupt refusal, presumably on rock of the Pennine Lower Coal Measures Formation, at 3.83m depth.

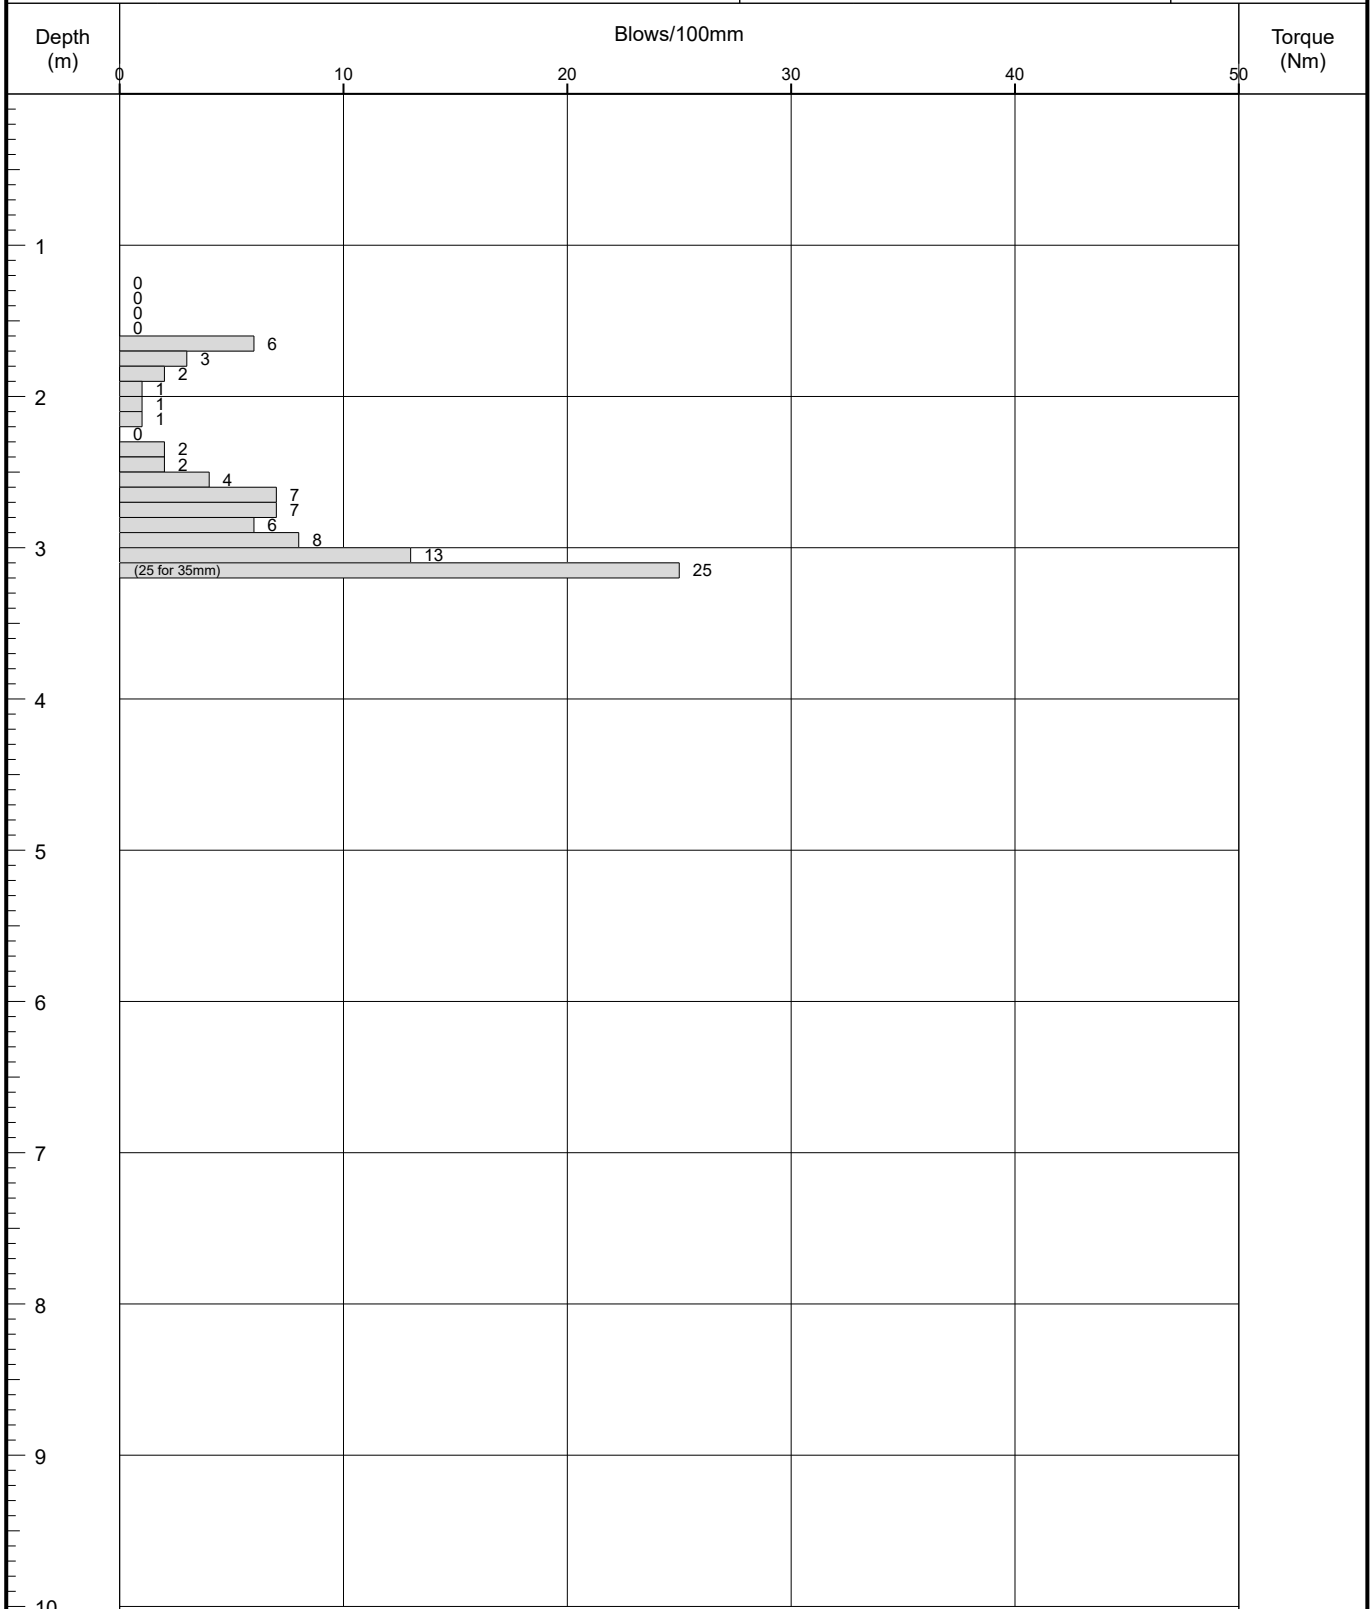
DP started at 1.2m due to HDSP. Refusal at 3.135m.

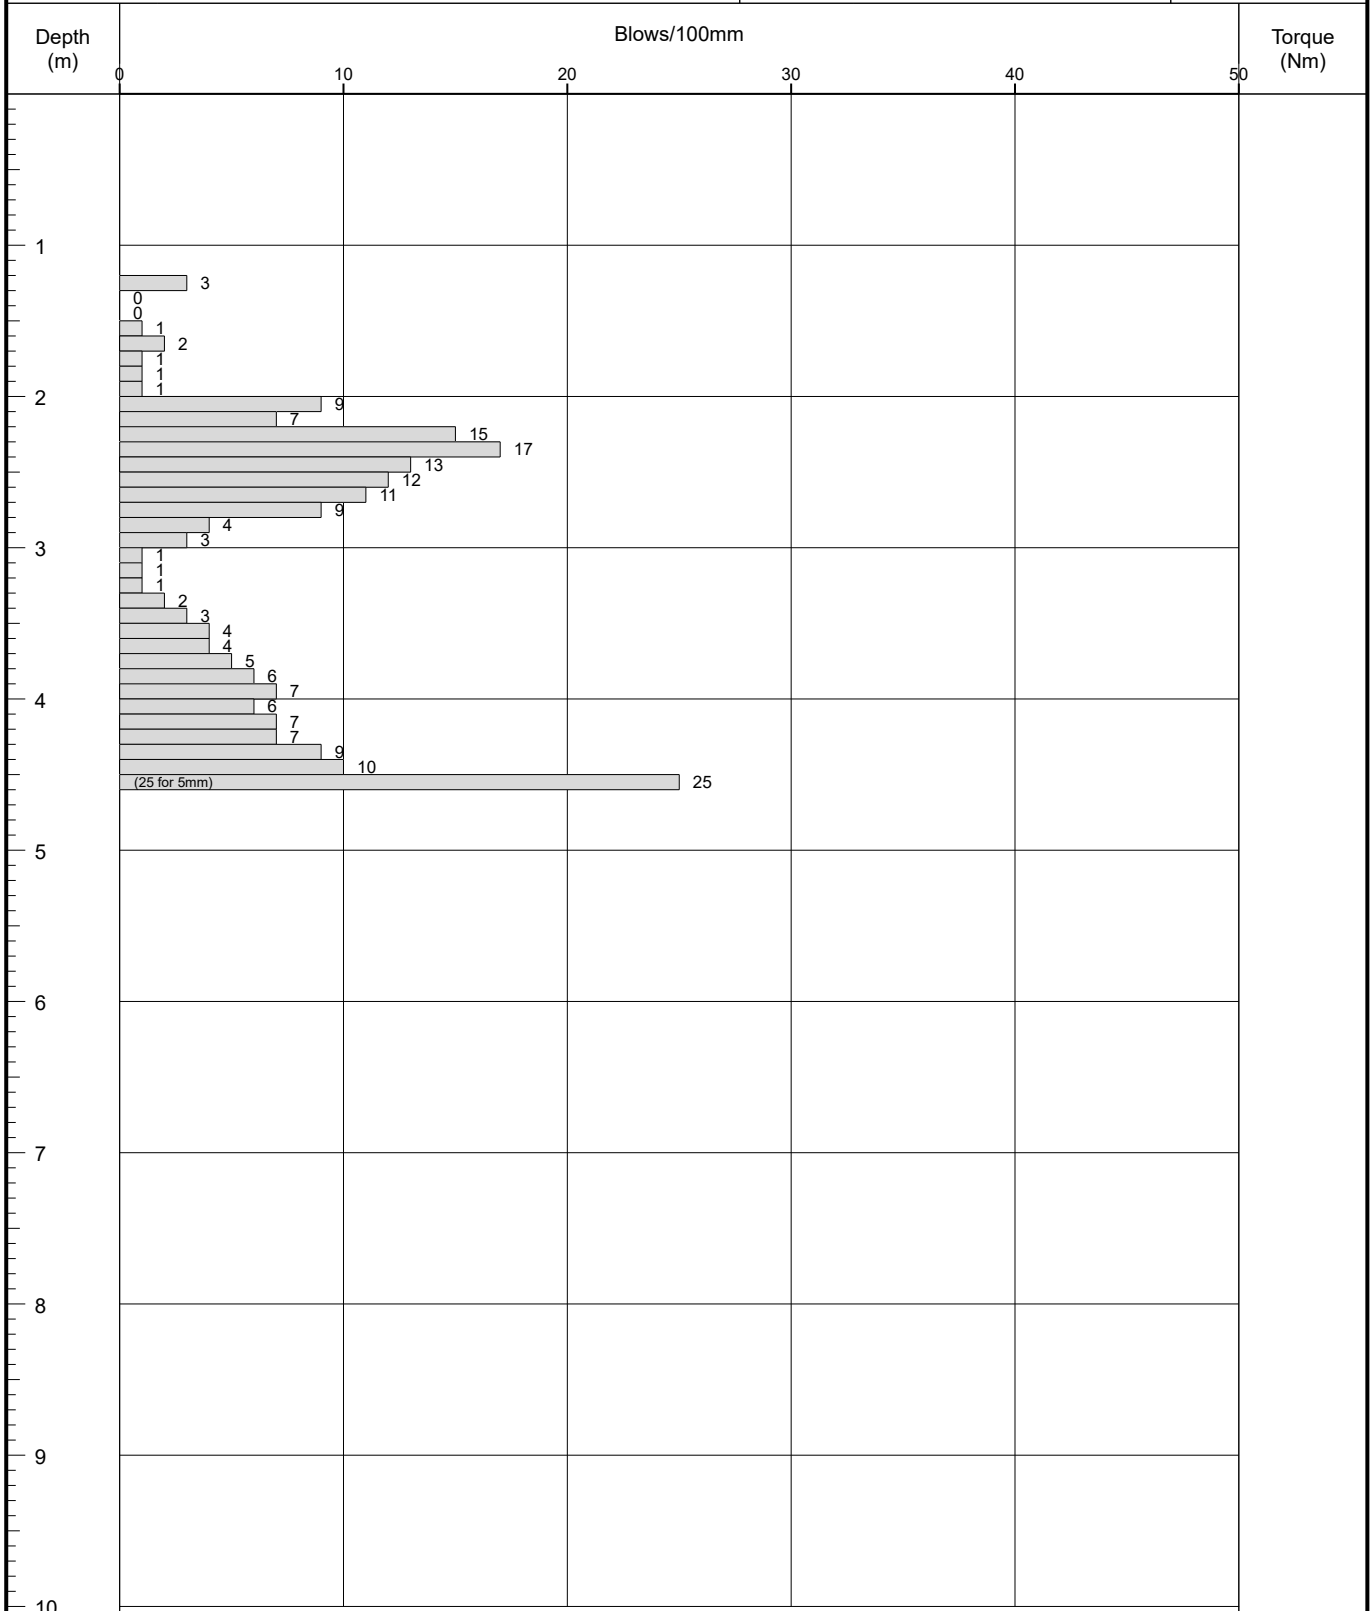
Remarks:
DP started at 1.2m due to HDSP. Refusal at 4.505m.

Fall Height 750mm

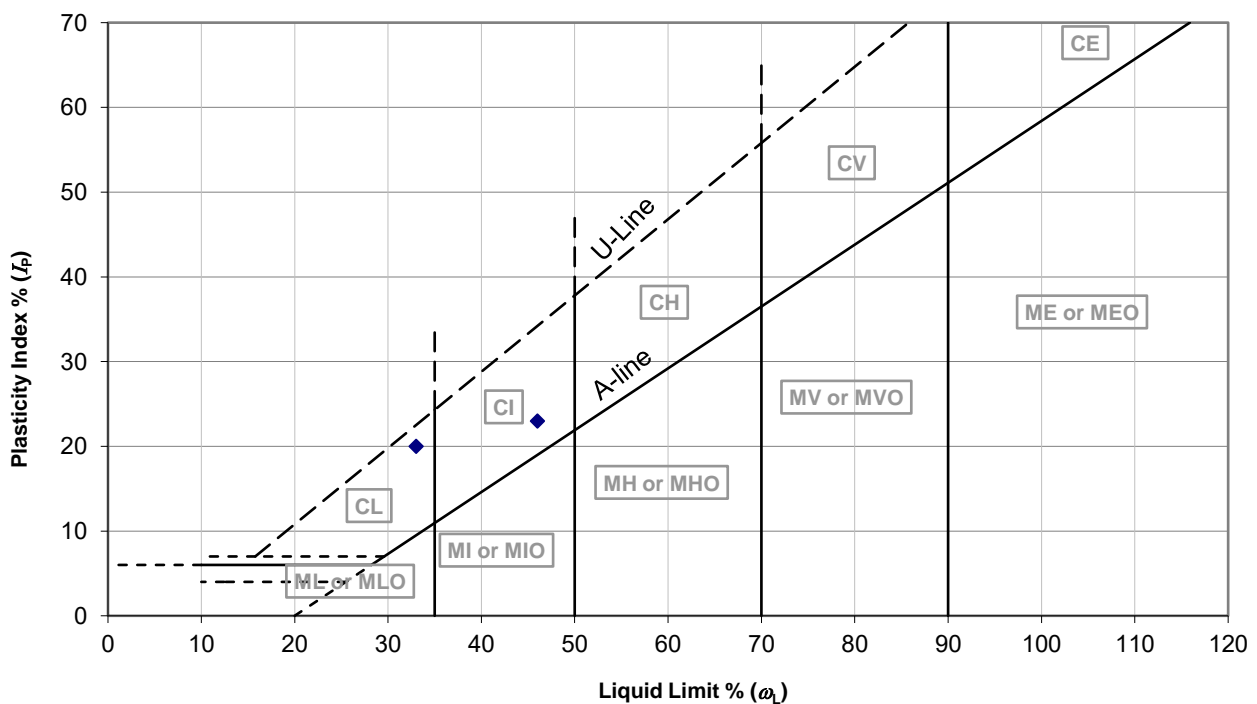
Location	Depth (m)	Moisture Content (w) (%)	Liquid Limit (wL) (%)	Plastic Limit (wP) (%)	Plasticity Index (IP) (%)	Retained by 0.425mm (%)	Modified (w) (w') (%)	Modified (IP) (IP') (%)	Liquidity/Consistency		Casagrande Class	N.H.B.C Class (%)
									(IL) (%)	(IC) (%)		
WS02	1.90	26.4	46	23	23	0	26	23	0.1	0.9	C I	MEDIUM
WS02	2.80	14.1	33	13	20	13	16	17	0.1	0.9	C L	LOW

Test type	Number of tests	Range of results	Comments
Moisture content determinations	2	14.1% to 26.4%	Slightly above plastic limit.
Index properties (1 Point)	2	LL	33 to 46%
		PL	13 to 23%
		PI	20 to 23%
		LS	08 to 11%
			Clay of low to intermediate plasticity. Consistency index 0.9 (both) Liquidity index 0.1% (both) NHBC Class – Low to Medium
