**STONE BAR FARM, BIRDWELL.**

**ECOLOGICAL IMPACT ASSESSMENT.**

**Ref No: 180266/EcIA/REV2.**

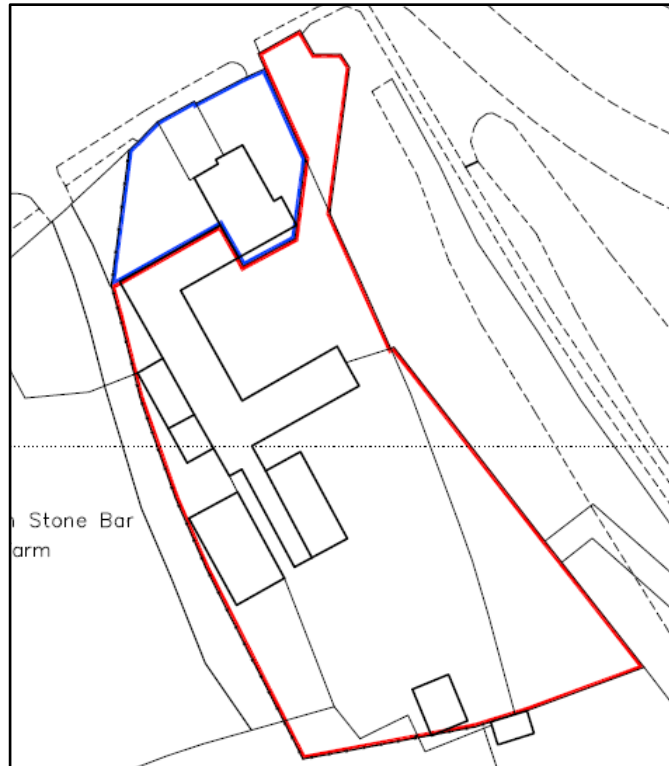
3.2.3. The survey area includes a number of buildings that are part of Stone Bar Farm, excluding the old farm house building, and some of the surrounding land. The plan below shows the limits of the survey area in red.

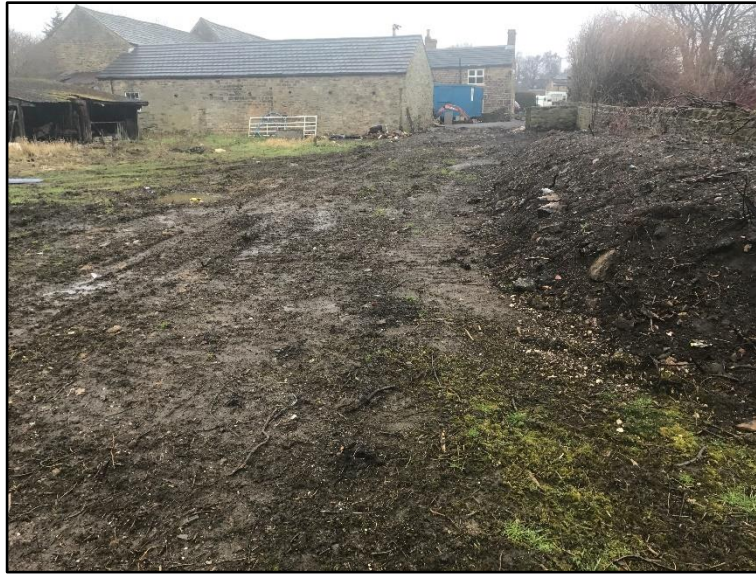
### **3.3.2. Bare Ground.**

This habitat is a result of high levels of disturbance and now comprises bare muddy ground as shown in the photograph above. There is also a small earth mound, T4, along one side.

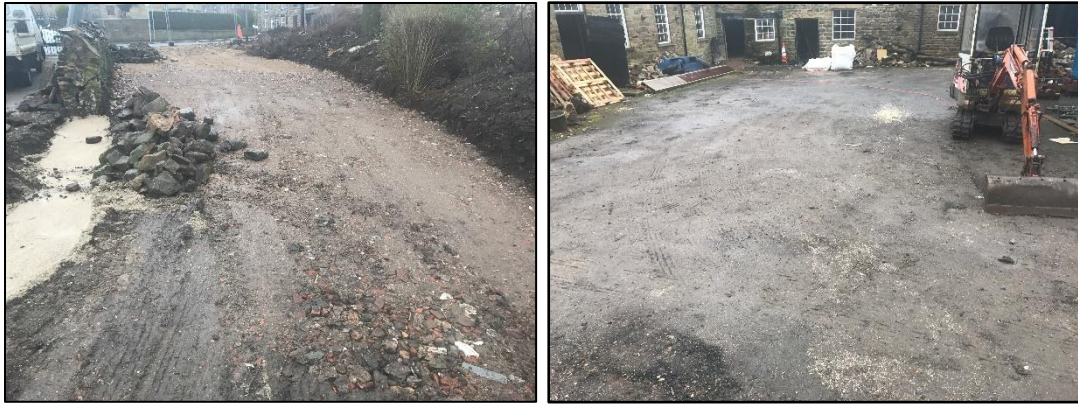
#### **3.3.4. Other Habitat (T6).**

This habitat refers to the areas of hard standing on the site. This includes the hard-standing courtyard in the middle of Buildings A to E and some hardcore that has been laid along the new access to the site.

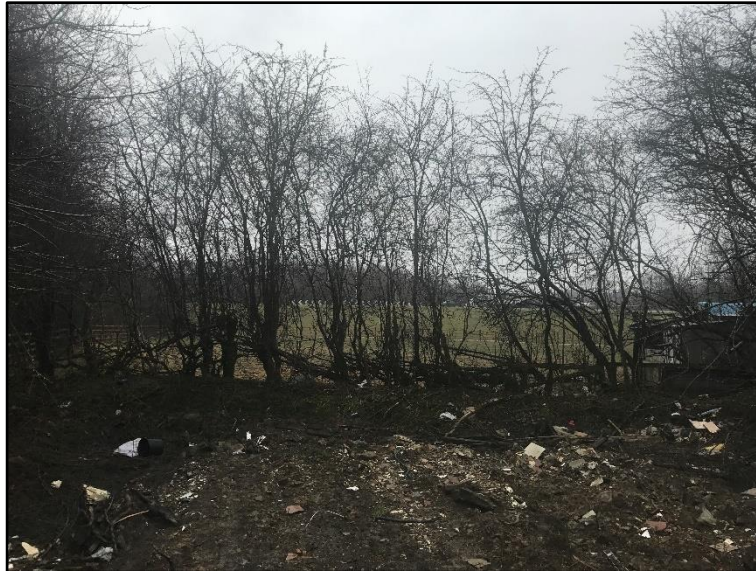
### **3.3.6. Species Poor Intact Hedgerow.**

There is a hedgerow along the most part of the southern boundary of the site. This is a thin hawthorn (*Crataegus monogyna*) hedgerow that is of very poor value. There is very little ground flora.

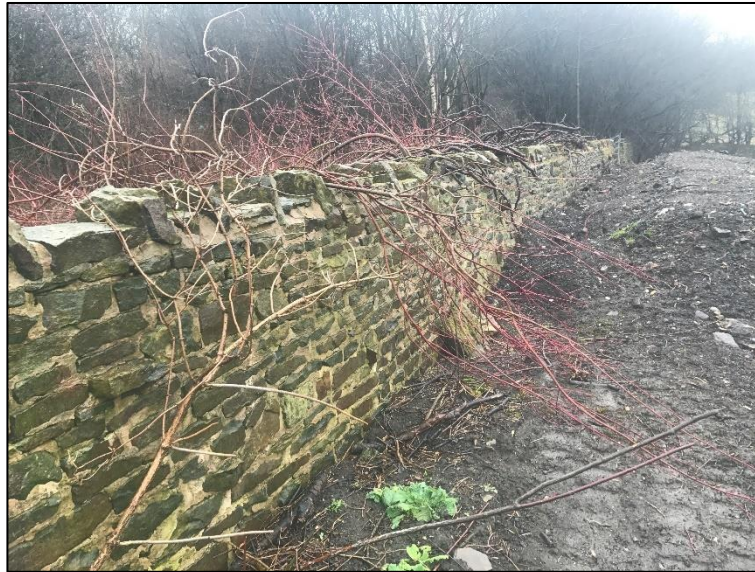
### **3.3.10. Wall.**

There is a stone wall along the eastern boundary of the site.

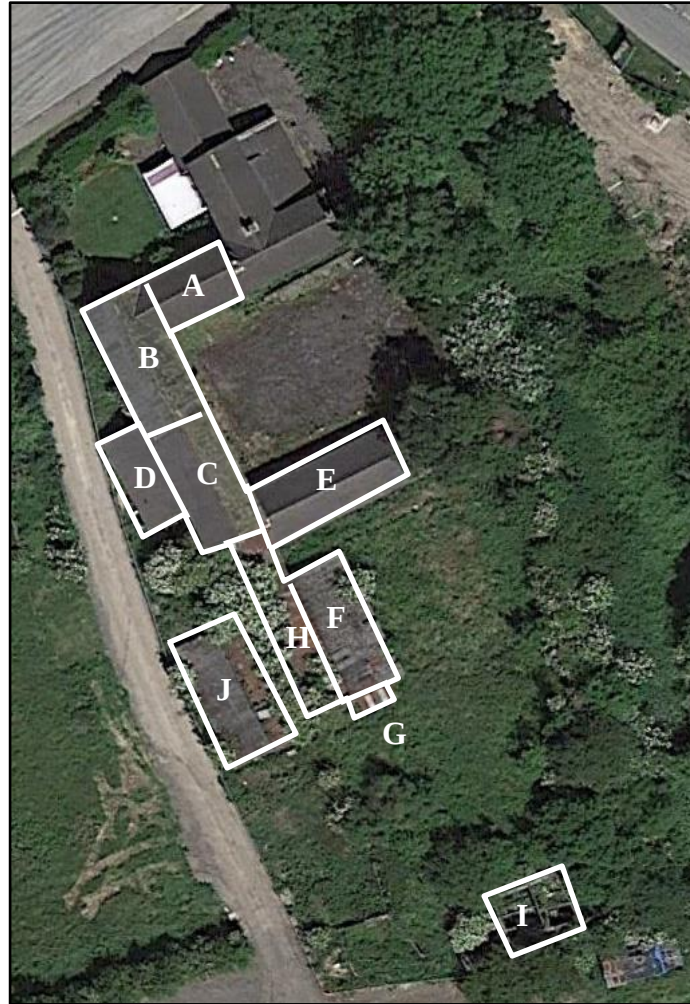
3.4.4. The buildings on the site were assessed for their potential for roosting bats. For the purpose of this report the buildings on site are referred to as ten separate buildings, referenced as Buildings A to J. These are shown on the map below.

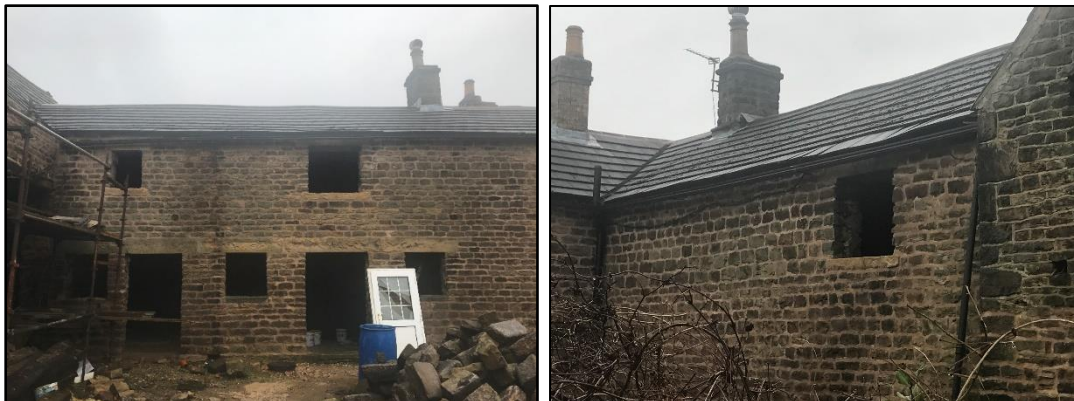
#### 3.4.4.1. Building A.

3.4.4.1.1. Building A is a two-storey barn. Some works had been carried out on the barn over the seven months prior to the preliminary appraisal of the site, although no further works have been carried out since.

3.4.4.1.2. The walls are rubble filled stone walls. The external walls have been recently pointed. The internal walls seem to have also had some pointing works carried out, but some occasional gaps between the stonework remain. The windows and doors have been removed, leaving open gaps into the wall cavity in the window openings.

3.4.4.1.3. The roof is a pitched tiled roof in fairly good condition, with just the occasional gap in the ridge and some occasional gaps under lifted tiles on the rear elevation.

3.4.4.1.4. Internally the underside of the roof tiles is lined with a breathable membrane. It is in good condition with just the occasional hole and some holes along the ridge.

3.4.4.1.5. The first floor is open to the roof space. The roof beams are of a queen post design and are in good condition with no visible cracks or gaps.

3.4.4.1.8. The current state Building A offers moderate potential for roosting bats in the low number of gaps between the internal stonework and potential along the ridge. However, it needs to be taken into consideration that a lot of pointing works were carried out over the seven months prior to the initial preliminary appraisal of the site, and it is possible that prior to that the walls provided numerous additional potential roosting opportunities for bats. For this reason, during the initial appraisal this

building was assessed as **high** potential for roosting bats. No bat field signs were identified in or around this building during the survey although any previous internal field signs may have been lost as a result of recent activity inside the building.

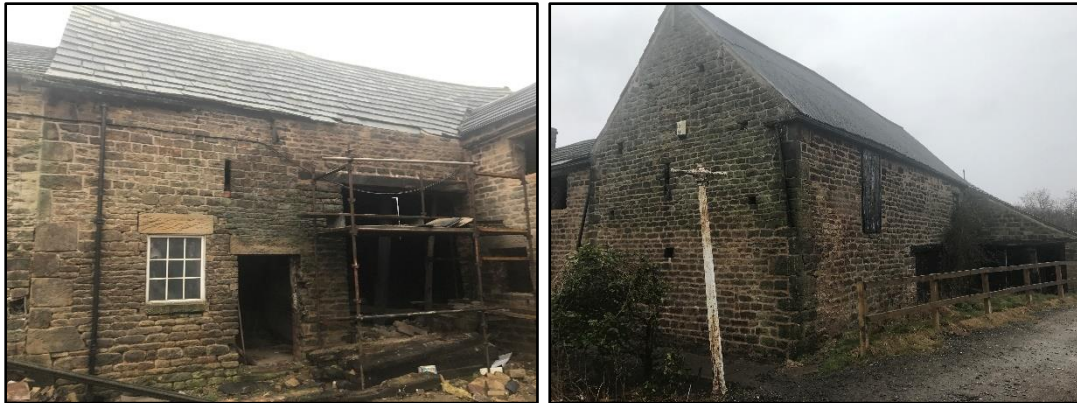
#### 3.4.4.2. Building B.

3.4.4.2.1. Building B is a two-storey barn. Some works had been carried out on the barn over the seven months prior to the preliminary appraisal of the site, although no further works have been carried out since.

3.4.4.2.2. The walls are rubble filled stone walls. The external walls have numerous gaps between the stonework. Some of the internal walls have been replaced with concrete block. The remainder of the walls display numerous gaps between leading into the cavity. There are open doorways leading into the barn and some open window slits. The windows and doorways on the rear elevation are blocked with wooden doors with gaps around.

3.4.4.2.4. Internally, the underside of the stone roof tiles on the front elevation are lined with bitumen felt that is generally in good condition. The roof beams are of a collar beam roof design. Some of the roof beams are large in size, and one in particular displayed a hole in the underside of the beam.

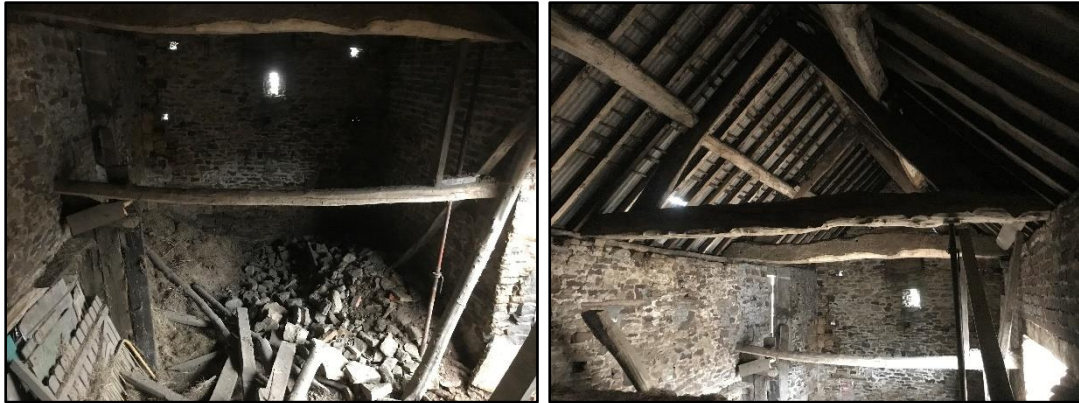
3.4.4.2.7. Photographs to show the internal of Building B.

3.4.4.2.8. Building B is assessed as **high** potential for roosting bats due to the numerous gaps between the stonework on the internal and external walls, as well as gaps under the front elevation roof tiles, along the ridge and a hole in a roof beam; all of which provide potential for roosting bats. No bat field signs were identified in or around this building during this survey although any previous internal field signs may have been lost as a result of recent activity inside the building.

4.3.1.2. The proposed works will involve the replacement of the roofs on both Buildings B and C and the pointing up of the wall on the southern gable end of Building B. In the absence of mitigation these works would result in the loss of the bat roost and there would be a **high negative impact on roosting bats at a site level.**

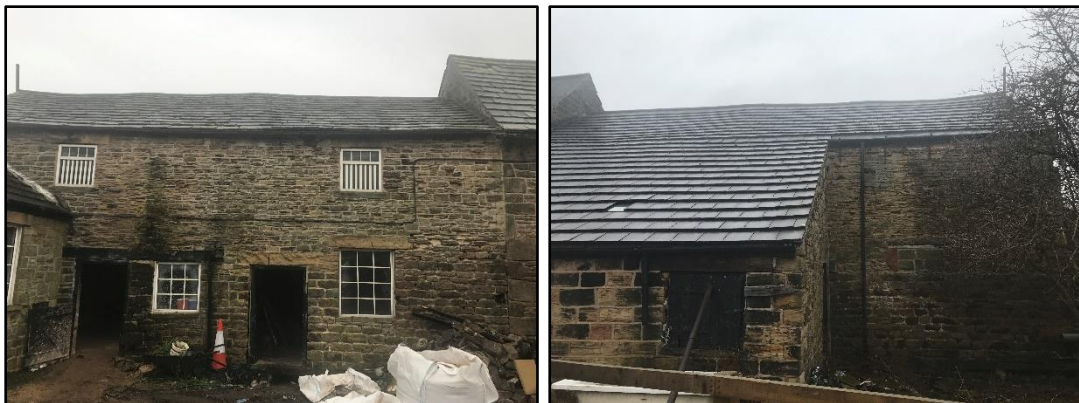
#### 3.4.4.3. Building C.

3.4.4.3.1. Building C is a two-storey barn. No works have been carried out on this building.

3.4.4.3.2. The walls are rubble filled stone walls with numerous gaps between externally and internally. The windows all remain and are generally well sealed.

3.4.4.3.3. The roof is a pitched tiled roof with numerous gaps under the tiles on the front elevation where they are lifted. The underside of the roof tiles is lined with a bitumen felt that is in good condition. The roof beams are of a queen post design.

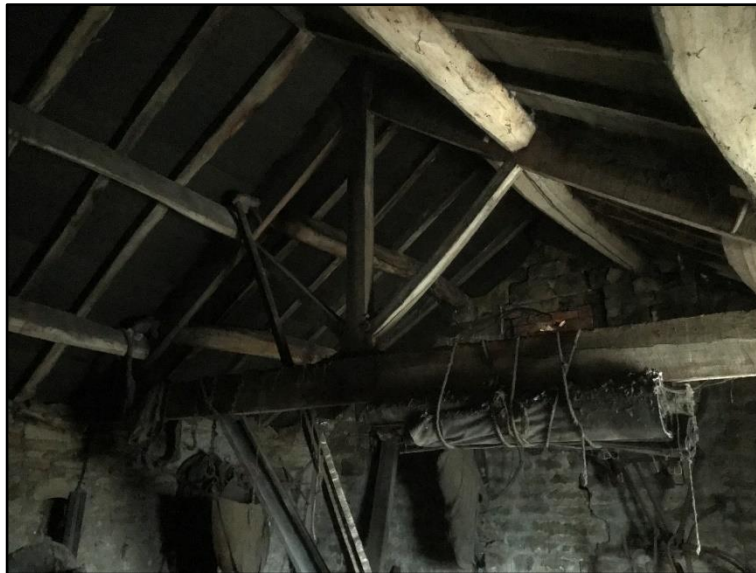
3.4.4.3.5. Photographs to show the internal of the first floor of Building C.

3.4.4.3.6. Building C is assessed as having moderate potential for roosting bats as it displays numerous gaps between the stonework and gaps under front elevation roof tiles that are suitable for roosting bats. There is potential for roosting bats inside the building, although no bat field signs were found to suggest this. As this building has remained undisturbed it is likely that any bat field signs inside the building would have been evident during this survey. No bat field signs were identified in or around this building during this survey.

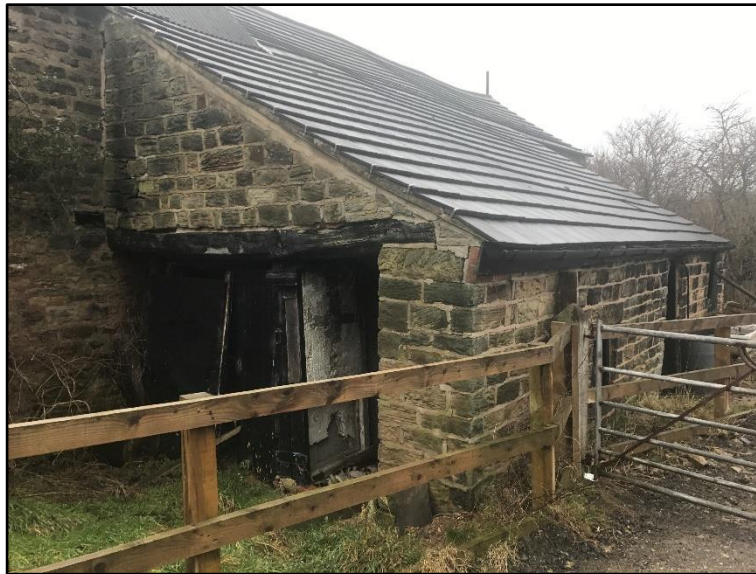
#### 3.4.4.4. Building D.

3.4.4.4.1. Building D is a single storey lean-to on the back of Buildings B and C. No works have been carried out on this building.

3.4.4.4.2. The walls are rubble filled stone walls that are generally in good condition. Internally there are some gaps between the stonework of what forms the external walls of Buildings B and C. The windows and doors all remain although are not properly closed. There is a fascia board along the front of the building.

3.4.4.4.3. The roof is a sloping roof that is a continuation of the roof of Building C. There are no obvious gaps under the roof tiles. The underside of the roof tiles is lined with a bitumen felt that is in good condition.

3.4.4.4.5. Building D is assessed as having **low** potential for roosting bats as it is generally in very good condition, with potential for roosting bats limited to some gaps in the internal walls and gaps behind the fascia, although access to these features for bats is not ideal. No bat field signs were identified in or around this building during this survey.

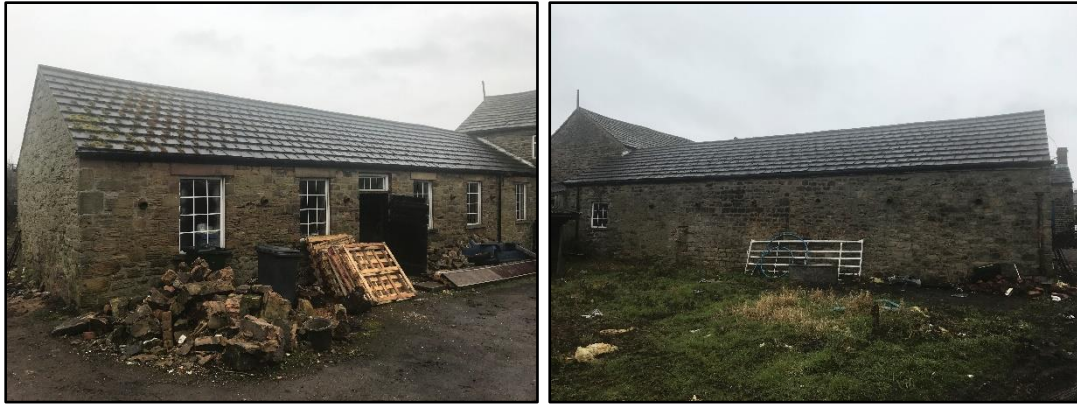
#### 3.4.4.5. Building E.

3.4.4.5.1. Building E is a single storey barn that is currently well used for storage of materials to facilitate works that are being carried out elsewhere on the site. There has therefore been a lot of disturbance inside the building.

3.4.4.5.2. The walls are cavity walls with the outer skin comprising stone and the inner skin comprising brick on the front and side elevations. The rear elevation external and gable end wall has some cracks and gaps between the stonework. The front elevation wall is in very good condition, with the exception of some holes in the wall to allow wires through. The internal walls are in good condition with no obvious cracks or gaps. The windows are all in place and well-sealed. The door was open at the time of this survey, it is unknown if it is closed each night.

3.4.4.5.3. The roof is a pitched tiled roof that is in very good condition with no obvious gaps under the tiles. There are fascia boards along the front and rear elevations with numerous gaps behind.

3.4.4.5.4. Internally, the underside of the roof tiles is lined with a bitumen felt lining that is in good condition. The roof is of a queen post design. The most part is open to the roof space, with the exception of a small enclosed loft space at the western end of the building that has no access inside it.

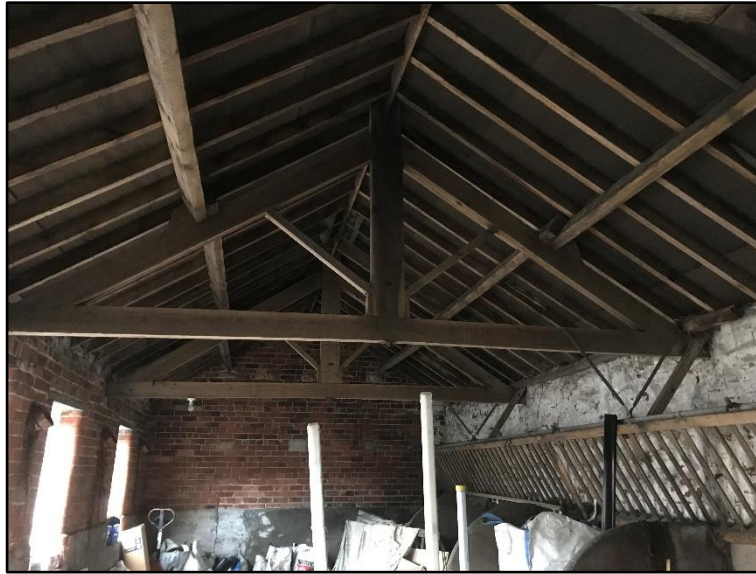
3.4.4.5.5. Photograph to show the internal of Building E.

3.4.4.5.6. Building E is assessed as having **moderate** potential for roosting bats as it provides some potential for roosting bats behind the fascia boards, in gaps between the stonework on the rear elevation and potentially inside the building although access is difficult for bats inside the building. No bat field signs were identified in or around this building during this survey.

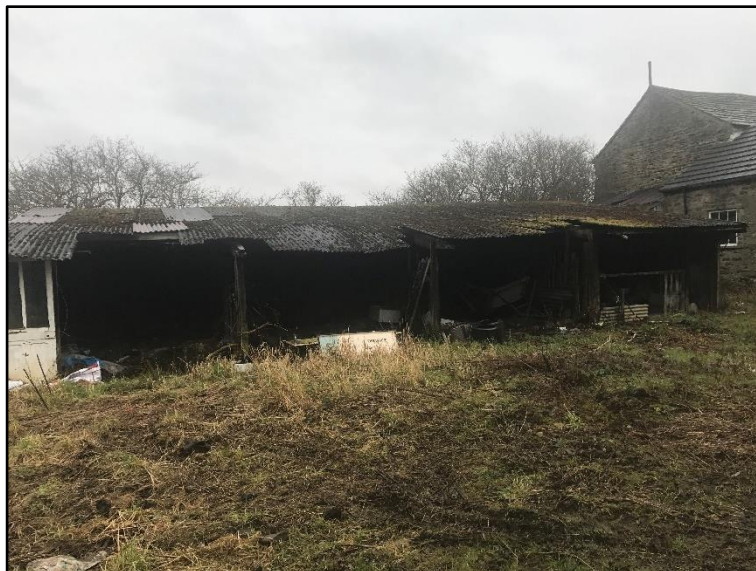
3.4.4.6. Building F.

Building F is an open fronted, single storey, dilapidated animal shed that is constructed from corrugated sheets and wood. This does not provide any features

suitable for roosting bats and therefore provides **no** potential for roosting bats. No bat field signs were identified in or around any of these buildings during this survey.

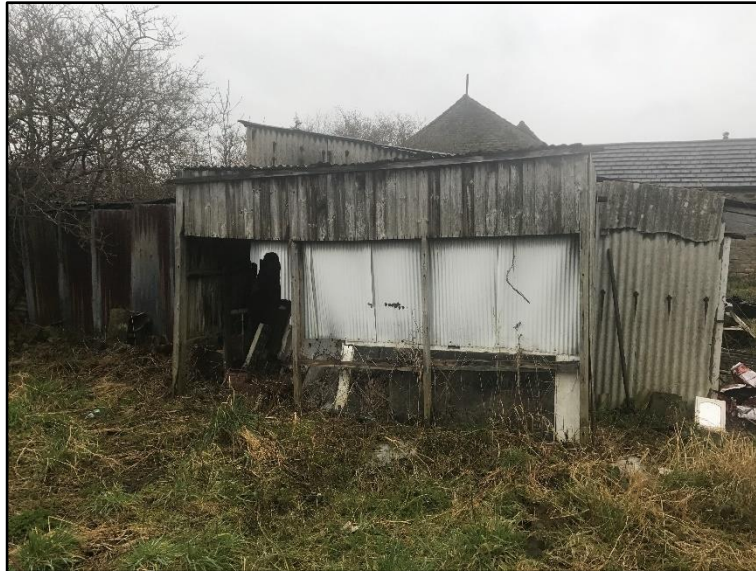
3.4.4.7. Building G.

Building G is a small, dilapidated, wooden hut on the end of Building F with some corrugated panels. This does not provide any features suitable for roosting bats and therefore provides **no** potential for roosting bats. No bat field signs were identified in or around any of these buildings during this survey.

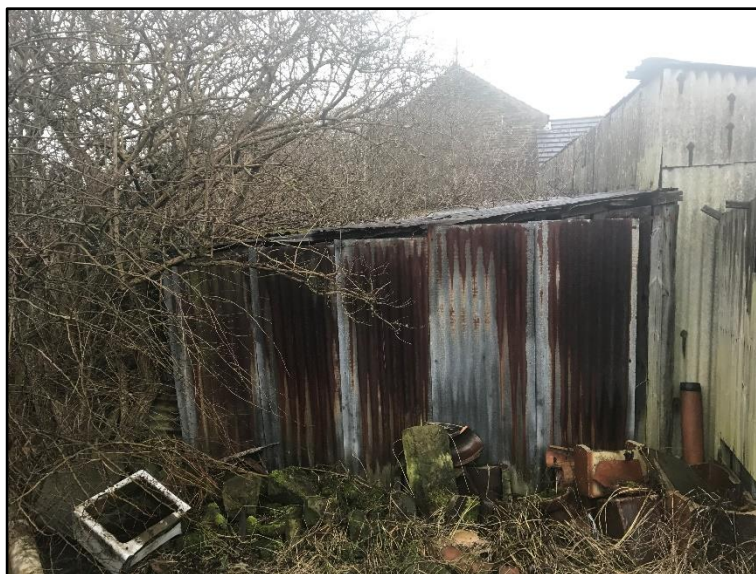
3.4.4.8. Building H.

3.4.4.8.1. Building H is an elongated corrugated shed along the rear of Building F. Access around the exterior and interior of this building was very limited due to its close proximity to other buildings and scrub growing against the building.

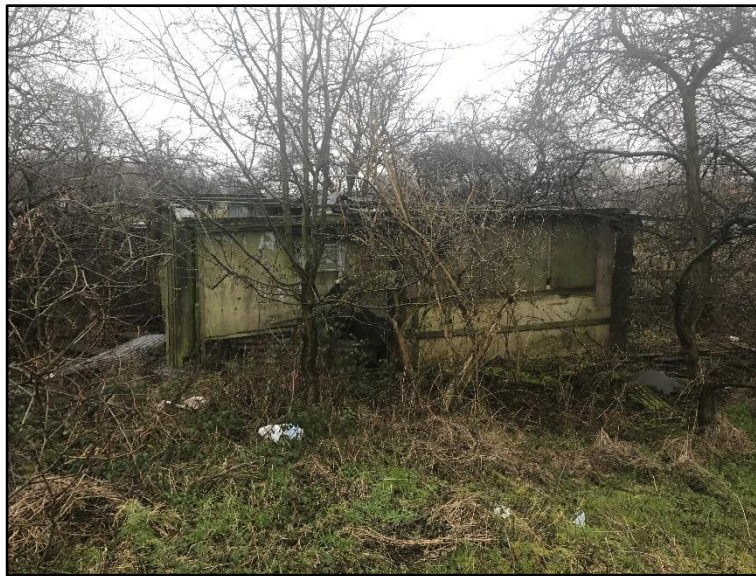
3.4.4.9. Building I.

Building I is the remains of an old wooden outbuilding that appears to have suffered some fire damage. The roof and some of the walls are collapsed and no longer intact. This does not provide any features suitable for roosting bats and therefore provides **no** potential for roosting bats. No bat field signs were identified in or around any of these buildings during this survey.

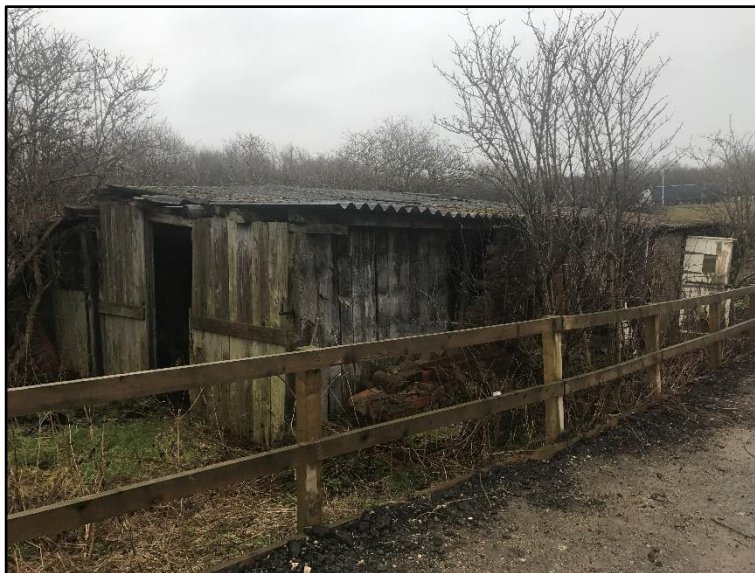
#### 3.4.4.10. Building J.

Building J is an outbuilding and stable block constructed from corrugated sheets, wood and brick. It is generally in a poor state of repair. This does not provide any features suitable for roosting bats and therefore provides **no** potential for roosting bats. No bat field signs were identified in or around any of these buildings during this survey.

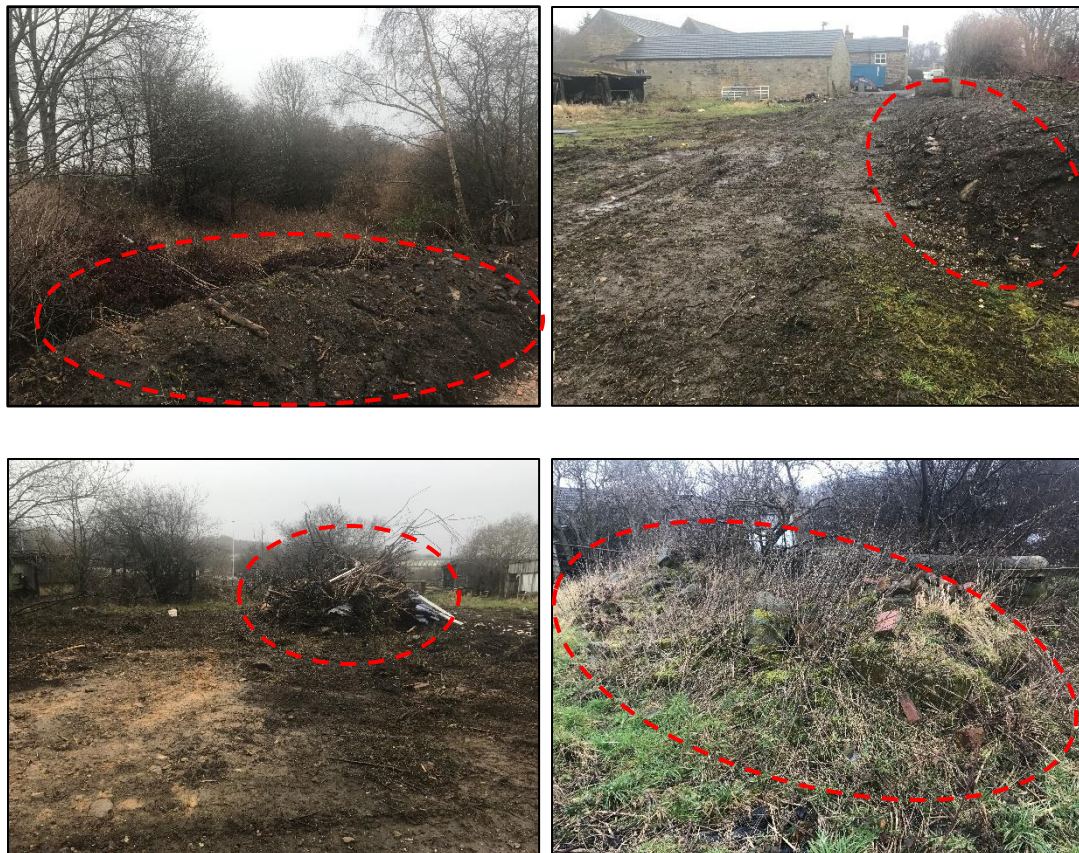
3.4.10. The site provides some potential for reptiles with some basking opportunities and refuges under piles of rubble, wood and brick. Three features in particular were identified as being of good potential refugia for reptiles. These are target noted as T1, T2, T4 and T6 in Appendix IV of this report and are shown in the photographs below.

- All personnel working on site will be briefed on the identification of reptiles in accordance with Appendix VIII of this report.
- The features identified, and target noted as T1, T2, T4 and T5 will be removed during the spring/summer months when reptiles are not in hibernation.
- All personnel will be instructed that in the event that a reptile is found during the work it should be allowed to escape the area unharmed prior to works proceeding.
- All vegetation will be cut down to a minimum of 150mm prior to site clearance to allow chance for any reptiles present to escape the area prior to site clearance.

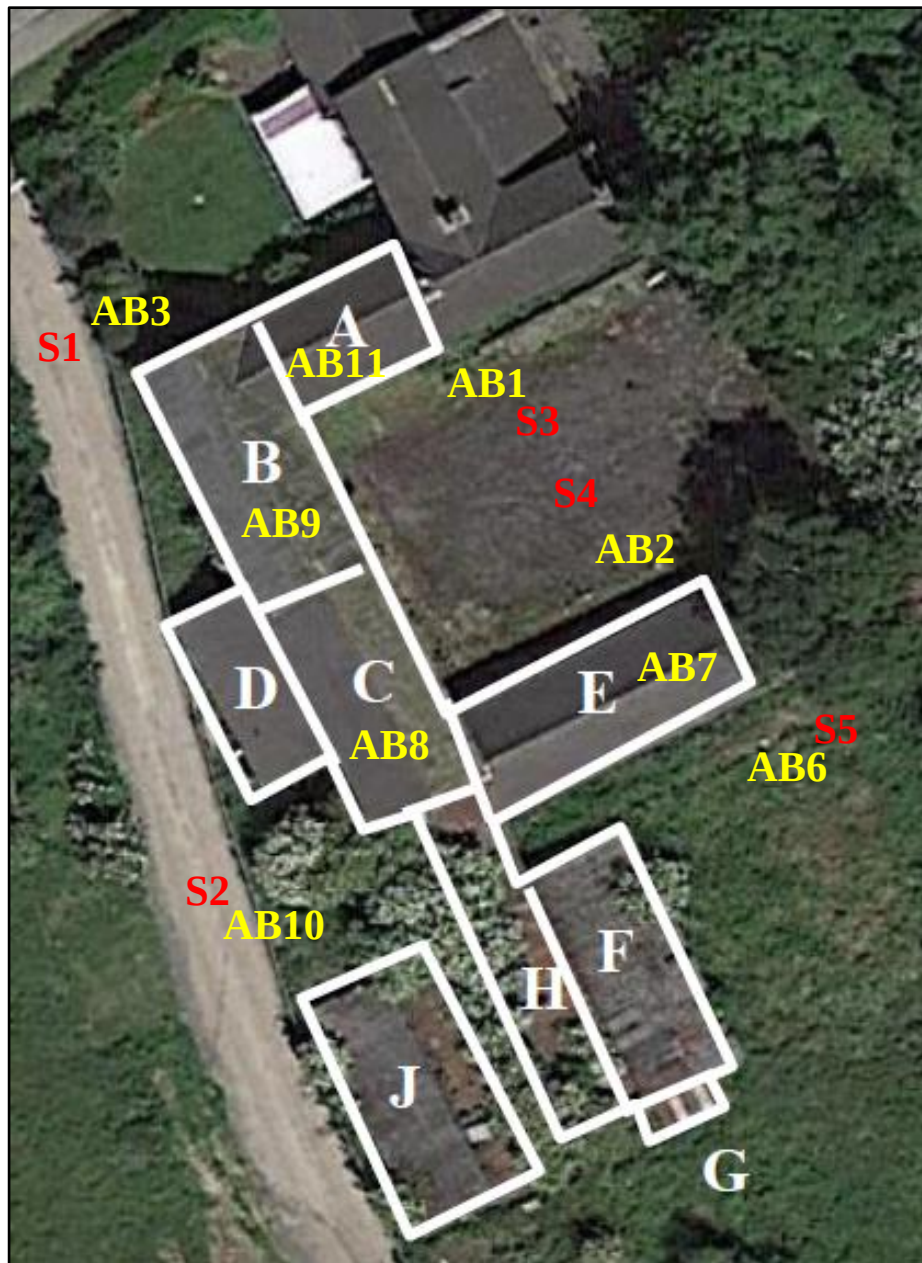
3.5.2. Five surveyors who all hold Natural England bat survey class licences were positioned around Buildings A, B, C, D and E so that all external areas of the buildings could be observed during the survey. An Anabat detector was placed next to each surveyor, as well as one Anabat detector inside each of Buildings A, B, C and E.

3.5.3. The map below shows the location of each surveyor (S) and Anabat detector (AB) during the survey.

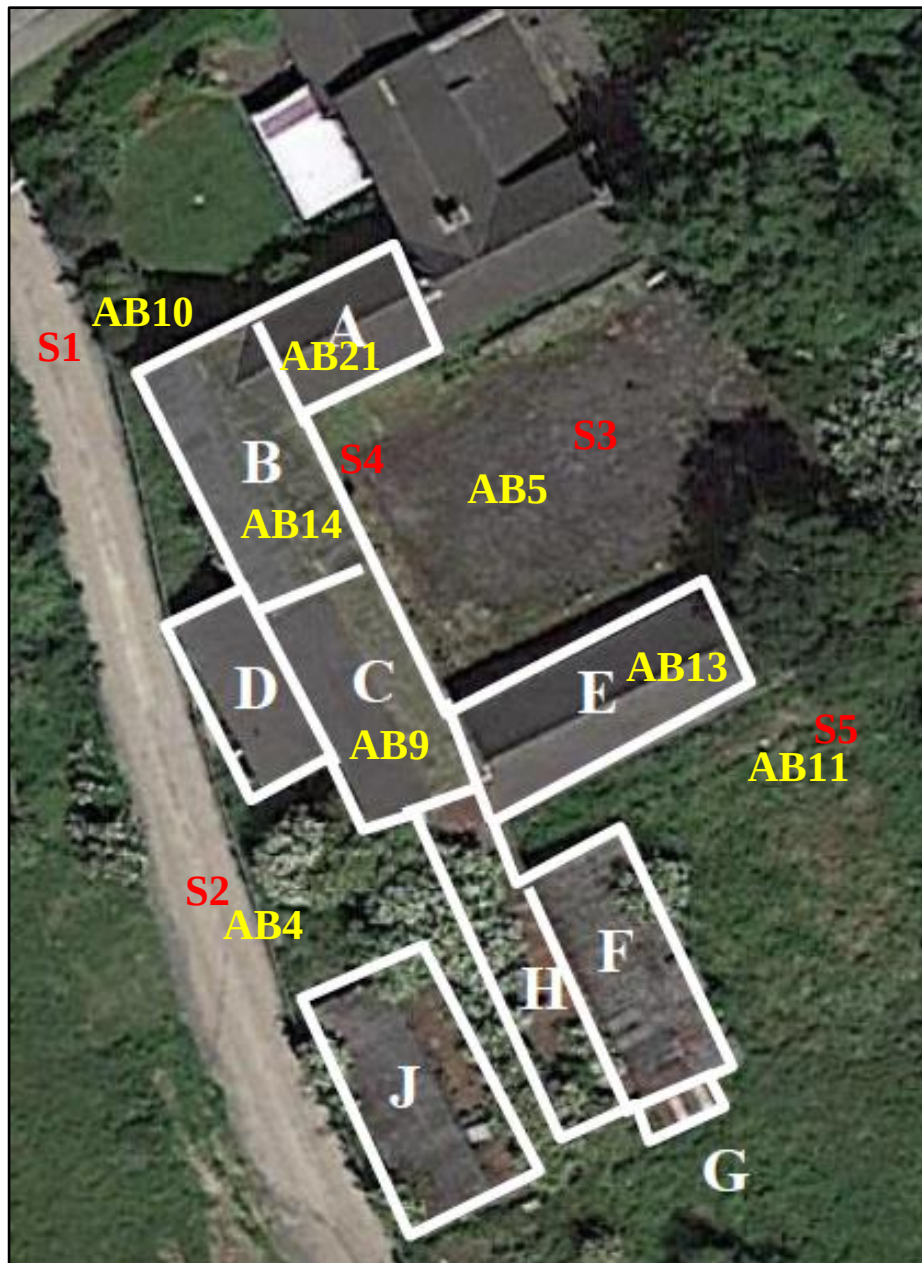
3.6.2. This survey was carried out by five surveyors, four surveyors hold Natural England class bat survey licences, and one surveyor was an experienced surveyor working as agent under other survey licences. The surveyors were positioned around Buildings A, B, C, D and E so that all external areas of the buildings could be observed during the survey. An Anabat detector was placed next to each surveyor, as well as one Anabat detectors inside each of Buildings A, B, C and E.

3.6.3. The map below shows the location of each surveyor (S) and Anabat detector (AB) during the survey.

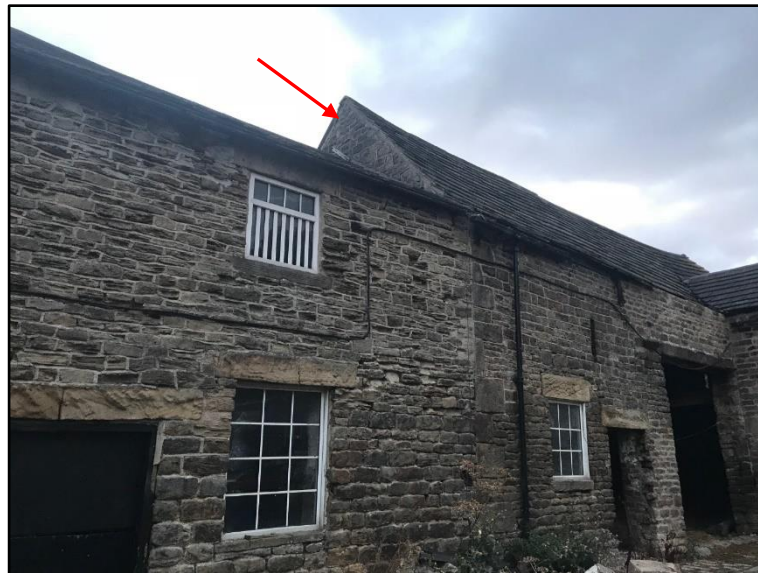
3.6.15. To summarise, one Common Pipistrelle bat was seen to enter a bat roost between the stone work on a small section of gable at the southern end of Buildings B, as shown in the photograph below.

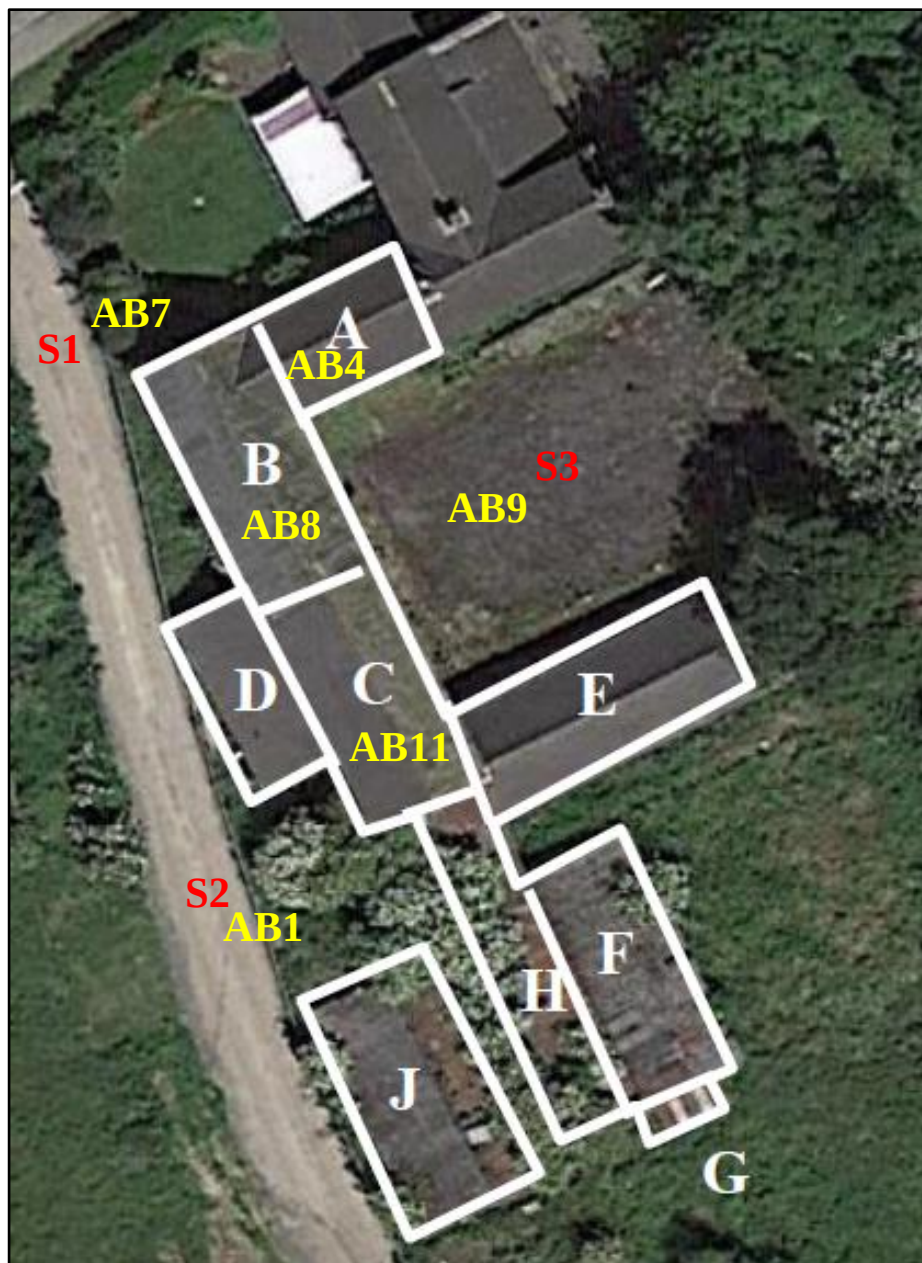
3.7.2. This survey was carried out by three surveyors, two surveyors hold Natural England class bat survey licences, and one surveyor was an experienced surveyor working as agent under other survey licences. The surveyors were positioned around Buildings A, B and C so that all external areas of the buildings could be observed during the survey. An Anabat detector was placed next to each surveyor, as well as one Anabat detector inside each of Buildings A, B and C.

3.7.3. The map below shows the location of each surveyor (S) and Anabat detector (AB) during the survey.

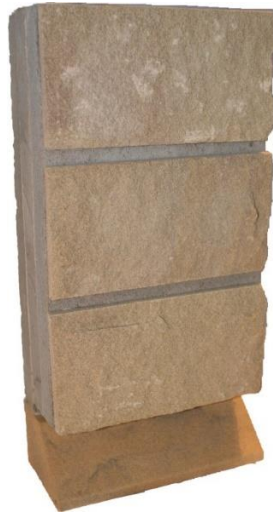
4.3.2.7. Replacement bat roosts will be incorporated in the walls of the new build garage block on the site in the form of integrated bat bricks. These will be the 'Habibat Bat Box – Custom Stone Facing' as shown below. Two of these boxes will be provided, one on each gable end of the garage block.

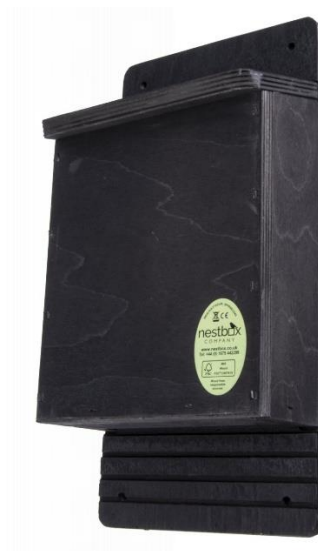
4.3.2.8. In addition, two ‘Improved Crevice Bat Boxes’ will be provided on the existing buildings. The nature of these boxes are shown below.

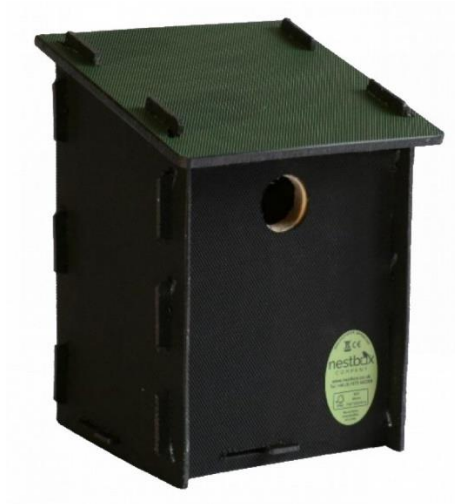
Eco Small Bird nest box:

4.5.2.5. The designs of these nest boxes are shown below.

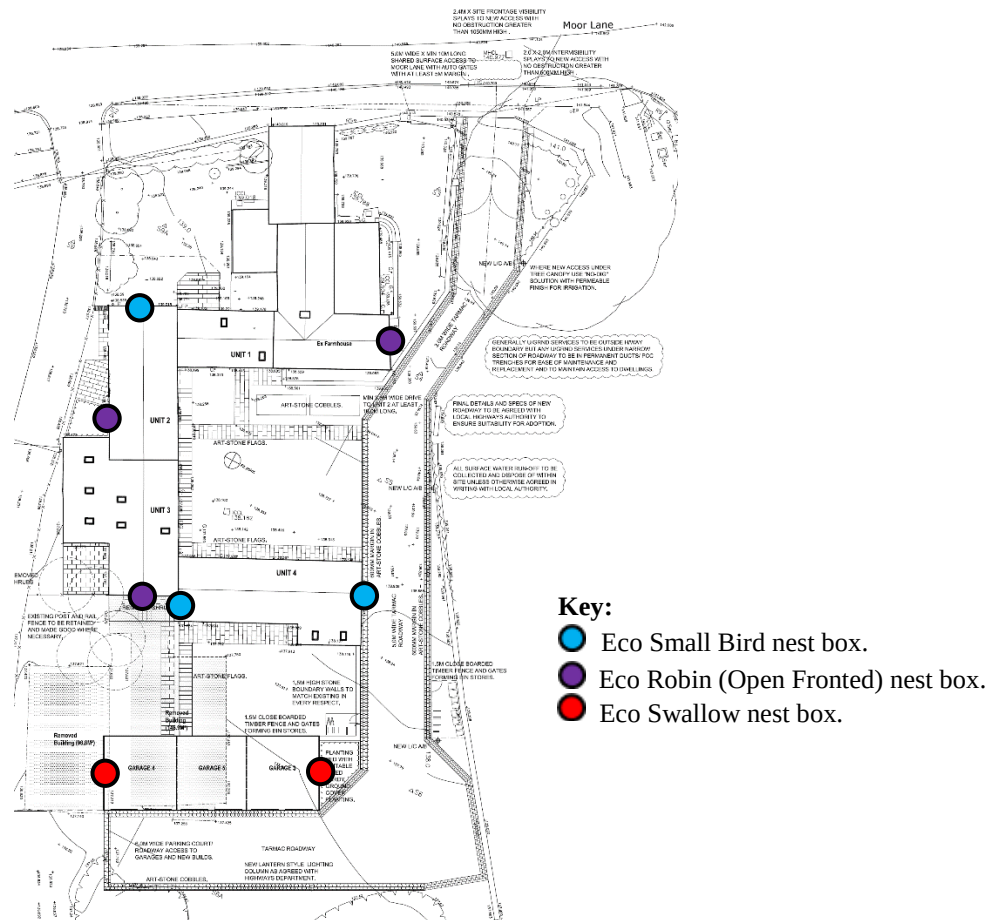
4.5.2.6. The nest boxes will be positioned in the locations shown in the diagram below:

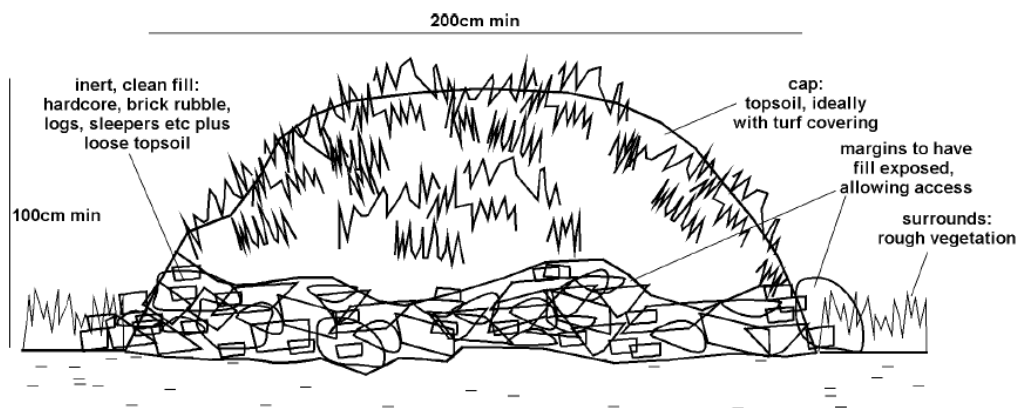
4.6.2.2. In order to mitigate for loss of potential reptile habitat, a new reptile refugia will be created on the edge of the site for reptiles to continue to use. This will be similar to the design shown below.

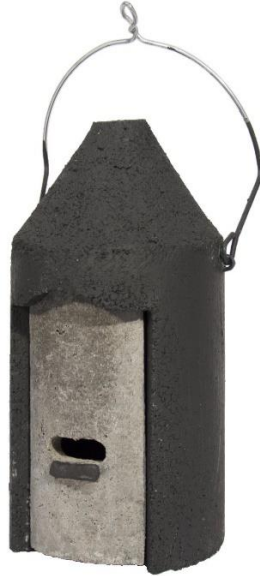
5.1. Additional biodiversity enhancements will be incorporated onto the site. Two 2F Schwegler Bat Boxes (General Purpose) as shown below will be fixed onto the trees in the north east corner of the site.

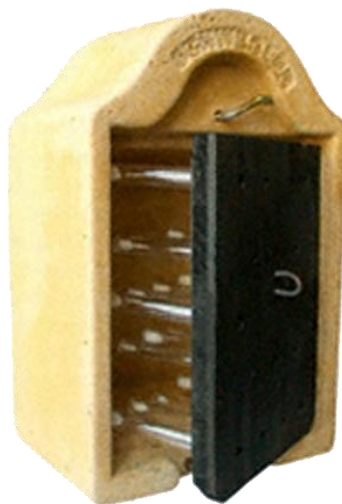
5.3. Four Schwegler Insect Houses for Solitary Insects will be erected on trees and fences around the site. The design of these is shown below.

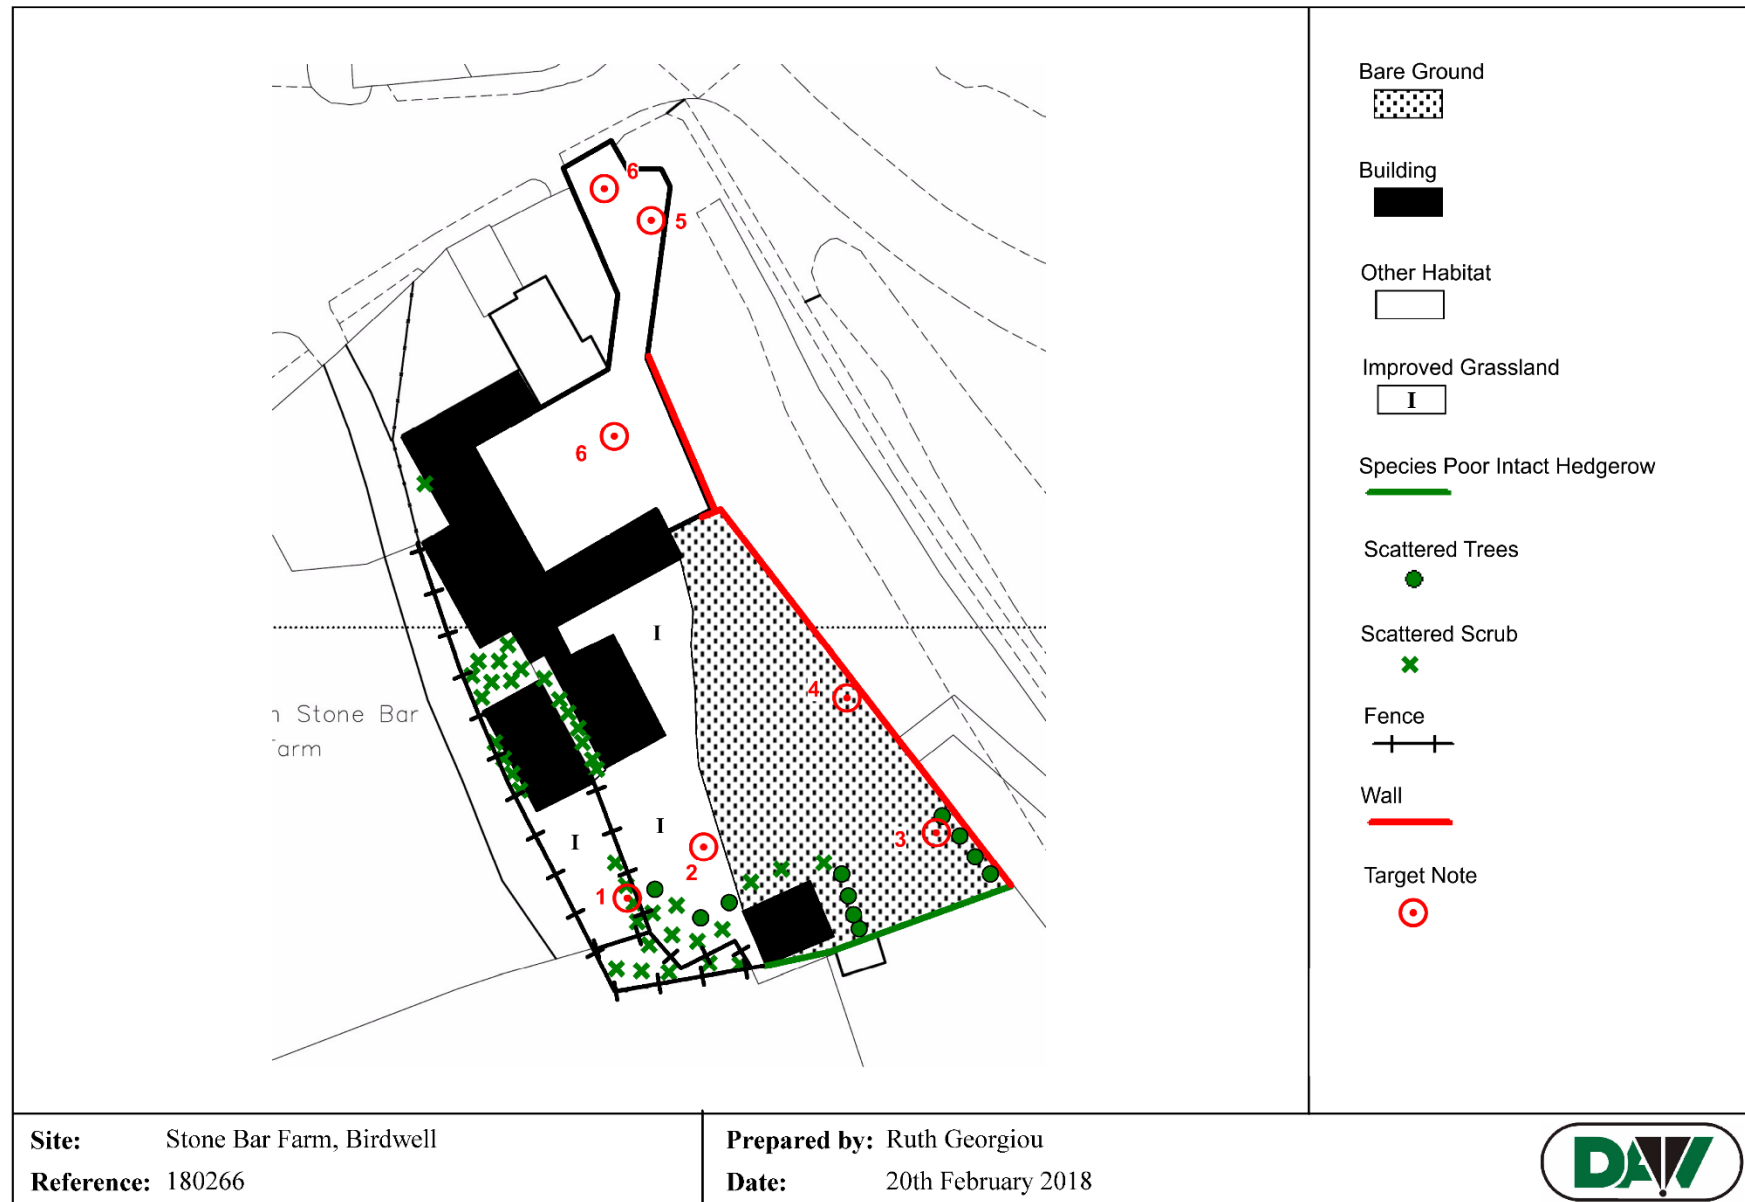
## Appendix IV. ANNOTATED MAP OF THE SURVEY AREA.

3.3.1. Appendix IV of this report contains annotated maps marked up with the varying habitats that are cross referenced to target notes in Appendix V of this report. The habitats on and adjacent to the site are: -
