Churchfield Lane, Darton, Barnsley

Desk Study Report

Morgan Ashurst PLC

Solmek Report Number S80821

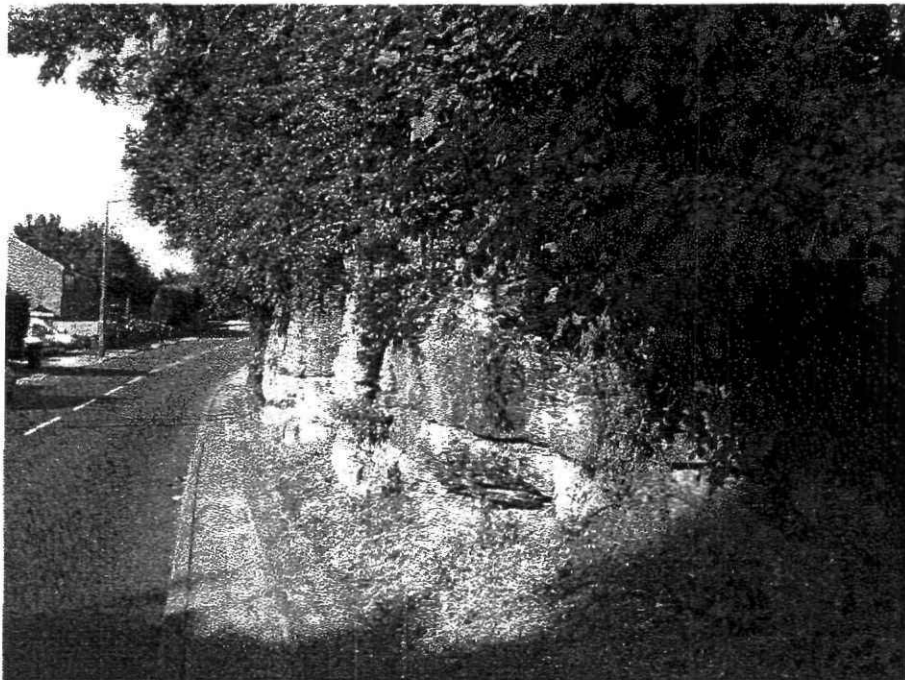
Plate 6: Rock exposure along Churchfield Lane to the south of the site

- 3.5 Churchfield Lane slopes down from the west to east along the southern boundary. A bus shelter and disused public toilet block are located along the pavement. Sandstone rockhead exposures were noted along the southern boundary (Plate 6); this extends approximately 2.5 and 3.0m from pavement level. Land to the south of Churchfield Lane consists of residential areas. Huddersfield Road lies to the north and further housing is located to the west adjacent to the M1 motorway.
