LOWFIELD ROAD TRAFFIC SIGNALS, BOLTON UPON DEARNE

**Stage 1 Road Safety Audit
Client: Gleeson Homes and Regeneration**

14/12/2021

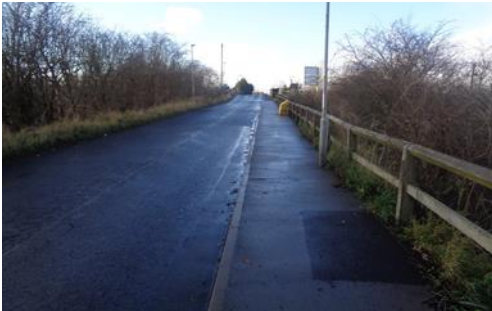
PROBLEM 2.1.1	
Location	Bridge over railway.
Summary	Potential for debris associated with an errant vehicle to foul the railway line.
<p>The existing bridge over the railway has a traditional masonry parapet and furthermore, the containment on the approaches is not ideal. The introduction of traffic signals may increase traffic speeds if drivers 'race to beat the lights' and if so, could increase the likelihood of a vehicle leaving the carriageway on the immediate approaches to the bridge. A larger vehicle may penetrate a fence or a parapet, possibly causing debris to foul the track on the railway alignment below, leading to an incident and subsequent injury</p>

RECOMMENDATION	
It is recommended that the risk of debris fouling the track is assessed and a mitigation measure is included in the design, if appropriate. 'Managing the accidental obstruction of the railway, road vehicles' (DfT, September 2020) is a useful reference.

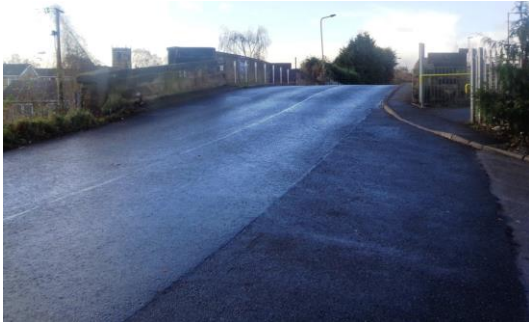
PROBLEM 2.2.2	
Location	Un-named access road (leads to Number One Auto Salvage).
Summary	Potential for a conflict involving a pedestrian crossing the access road.
<p>The drawings do not show any proposals for pedestrians to cross the un-named access road where the northern footway is to be widened. The development will lead to increased walking and if pedestrians are not appropriately accommodated, there is a risk of a person being struck and injured by a turning vehicle when crossing through the junction mouth.</p>

RECOMMENDATION	
<p>It is recommended that a safe, accessible, and convenient crossing is provided across the un-named access road.</p>
