# **STAIRFOOT ROUNDAABOUT/GRANGE LANE BRIDGE, BARNSELY**

**UPDATE PRELIMINARY ECOLOGICAL APPRAISAL  
AND PRELIMINARY ROOST ASSESSMENT**

Project name **Stairfoot Roundabout**  
Project no. **REH2026N02195**  
Client **Barnsley Council**  
Version **1.0**  
Date **02/04/2026**  
Prepared by **Mark Gough BSc (Hons)**  
Checked by **John Myerscough BSc (Hons) MSc**  
Approved by **Marc Jackson MRes**

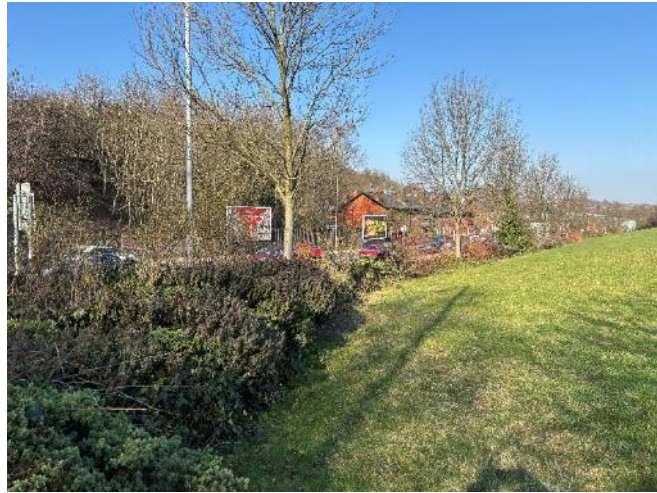
**Photograph 1:**

Area of modified grassland with a border of introduced shrub with individual trees, corner of Grange Lane and Doncaster Road.

- 3.2.11 A small number of urban trees were present across the Site, with all of them within either introduced shrub or modified grassland areas. Species included alder, sweet chestnut and silver birch. All were considered to fall into the 'small' urban tree category, and were either semi-mature or young. Some management of the trees was evident, although it did not appear to be having an adverse effect on tree health. No features suitable for roosting bats were present (Appendix 2, Photo 1).

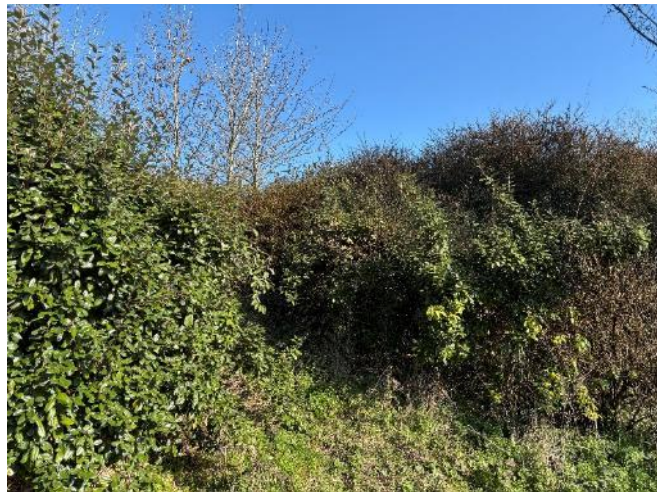
**Photograph 2:**

Introduced shrub on Doncaster Road, adjacent to footpath leading up to the Trans-Pennine Trail.

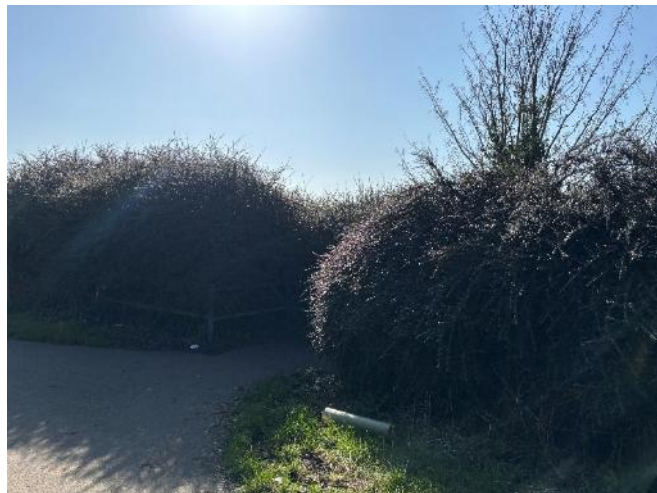
**Photograph 3:**

Small-leaved cotoneaster (Target Note 2) where the access footpath from Doncaster Road meets the Trans-Pennine Trail (northwest area of Site).

- 4.6.1 The presence of three species of cotoneaster was noted within several areas of the amended Site boundary (see target notes in Appendix 1, Figure 3). The three species of cotoneaster identified on Site (small-leaved, wall, and Himalayan) are listed as invasive species on Section 9 of the Wildlife and Countryside Act 1981. If removal is required, then any waste material containing an invasive species is classed as controlled waste under section 34 of the Environmental Protection Act 1990 and should be disposed of in accordance with the associated Environmental Protection (Duty of Care) Regulations 1991.

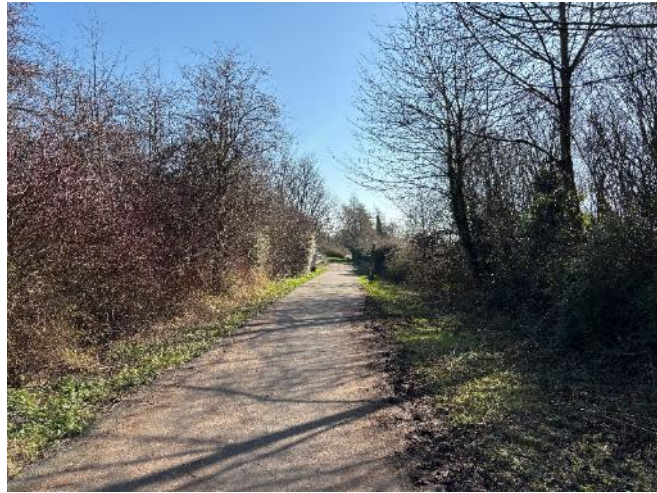
**Photograph 4:**

Areas of other broadleaved woodland and modified grassland adjacent to the Trans-Pennine Trail in the northwest of the Site looking southeast towards the former railway bridge.

- 3.2.8 Four sections of broadleaved woodland were present on either side of the Trans-Pennine Trail on the former railway embankment in the northwest and southeast of the Site. In the northwest of the Site, the woodland was primarily dominated by ash and hawthorn, with occasional silver birch and sycamore present. The majority of the trees were semi-mature or young, with some young stands of self-seeded ash growth. There was a shrub layer and ground flora of mixed native and ornamental species which included cotoneaster species, coralberry, St. John's wort, dogwood, ivy, common nettle, cleavers, wood avens, and dandelion (Appendix 2, Photos 4 and 5).

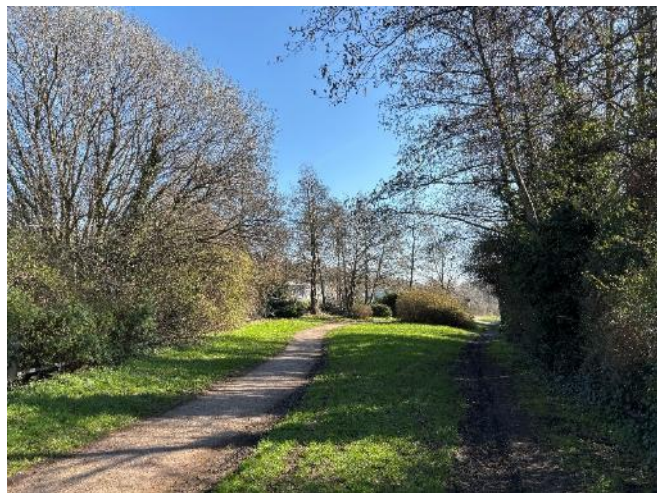
**Photograph 5:**

Areas of woodland, introduced shrub and modified grassland towards the southeast of the Site along the Trans-Pennine Trail

- 3.2.9 The woodland areas to the southeast of the Site featured more semi-mature aged trees, with some shrub understorey, species included ash, alder, sycamore, cherry, willow, sweet chestnut and hazel. The shrub layer and ground flora included ivy, cleavers, cow parsley, cotoneaster, bramble, yarrow, dogrose and flowering currant (Appendix 2, Photo 5).

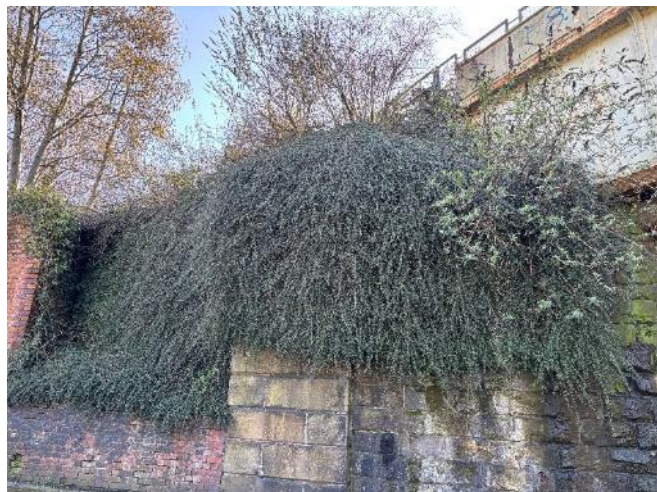
**Photograph 6:**

Wall cotoneaster overhanging bridge abutment stonework on corner of Grange Lane and Doncaster Road, with rainwater seeping down stonework (Target Note 6).

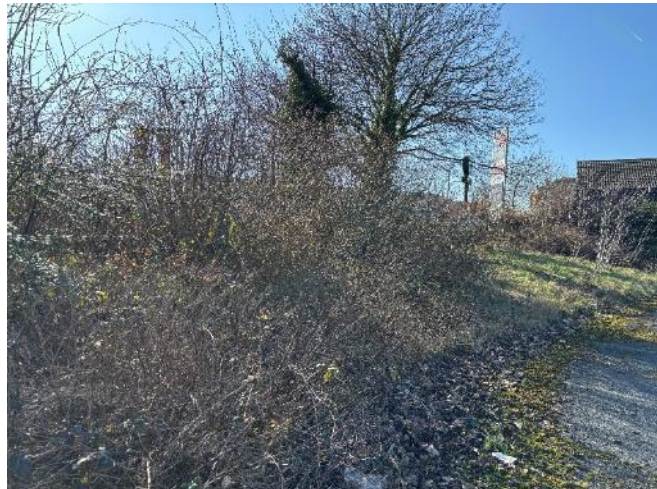
**Photograph 7:**

Area of mixed scrub adjacent to site of demolished pub, with modified grassland and part of the non-native ornamental hedgerow in the background.

- 3.2.7 Two areas of mixed scrub were identified within the revised Site boundary during the survey. One was adjacent to Doncaster Road, where a footpath led up to a section of the Trans-Pennine Trail in the northeast of the Site. On the previous update PEA report (Temple, 2024), it had been identified as part of the w1g habitat, but with the reduction in the Site boundary the habitat was changed to mixed scrub due to the lack of trees. The other area was adjacent to the area of modified grassland associated with the demolished pub in the southwest of the Site. Formerly identified as u1f, the designation was changed due to an increase in woody species within the area (Appendix 2, Photo 7). There was a difference in species composition between both areas, but generally, species included bramble, dogrose, dogwood, elder, and honeysuckle, with a ground layer of common nettle, ivy and cleavers.

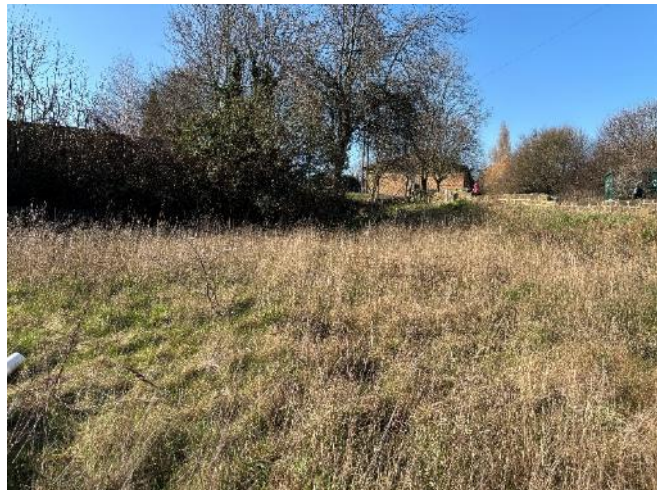
**Photograph 8:**

Area of other neutral grassland adjacent to the site of the demolished pub on the corner of Grange Lane and Doncaster Road, facing northwest.

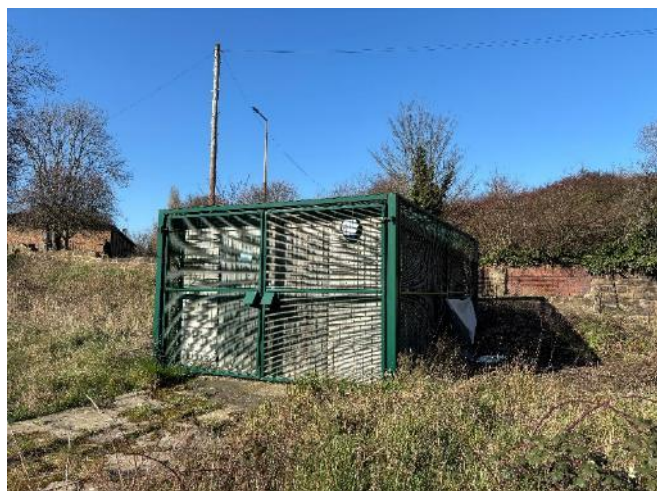
**Photograph 9:**

Heavily fenced off timber building within the other neutral grassland

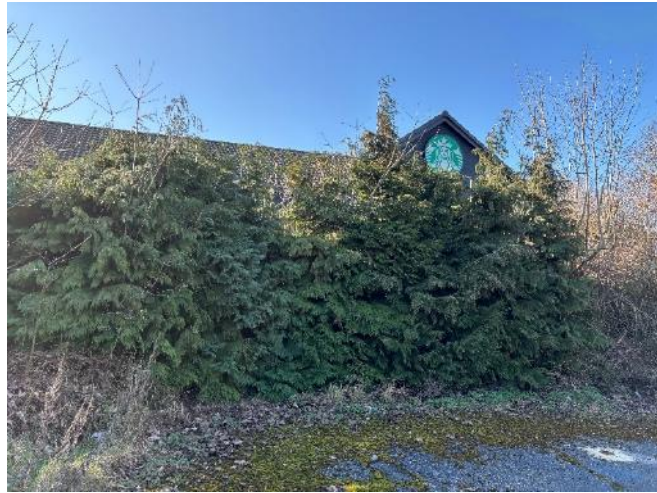
**Photograph 10:**

Part of the non-native ornamental hedgerow within the site of the demolished pub, facing west.

- 3.2.10 A single section of this linear habitat was identified to the southeast of the Site along the boundary. It began as a section of ornamental beech hedge and ended as a section of leylandii adjacent to the demolished pub area. The beech hedge showed signs of being managed, but the leylandii appeared to be unmanaged (Appendix 2, Photo 10).

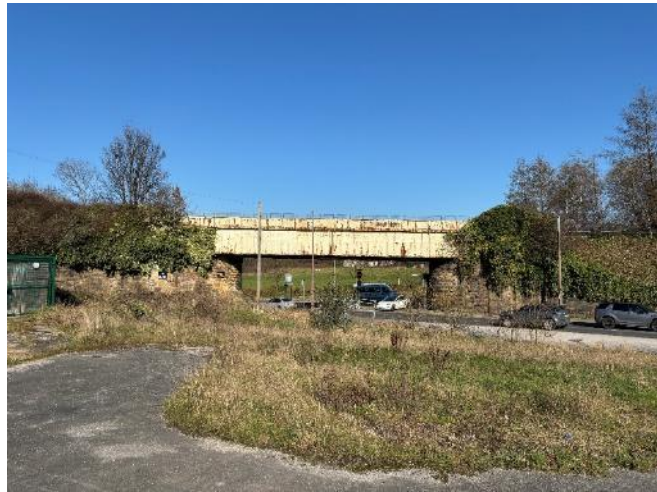
**Photograph 11:**

Structure	Description	Potential Roost Features (PRFs)	Factors Influencing Suitability for Bats	Structure Suitability	Recommendations
Grange Lane Bridge	Former railway bridge consisting of a steel riveted section that spans Grange Lane and sits on two stone abutments.	PRF 1 vertical crack in stone abutment on western side of bridge (Photograph 12)	exposed to light pollution and heavy traffic/noise pollution- No bat evidence (droppings, staining or feeding remains) identified	Overall, the bridge was considered to be of Moderate suitability, however when taking into consideration wider factors influencing suitability for bats (eg lighting, disturbance, connectivity), this assessment has been reduced to Low.	Further survey required, comprising a single dusk emergence survey carried out between May to August inclusive, as per best practice guidelines <sup>7</sup> .
		PRF 2 gap/void where western stone abutment meets steel structure of bridge span (Photo 12)	exposed to noise pollution, presence of feral pigeon roost and droppings, potential water ingress.

The former railway bridge which spans Grange Lane, facing northeast.

- 4.5.2 A single dusk emergence survey is recommended for the former railway bridge that crosses Grange Lane, in light of the results of the PRA survey on that structure, with a bat activity survey of the Trans-Pennine Trail where it crosses the bridge undertaken at the same time. The survey should be undertaken during May to August inclusive and follow best practice guidelines<sup>7</sup>.

- 4.8.1 The PRA of the former railway bridge that spans Grange Lane identified several potential roost features (PRFs) that warrant further investigation due to their inaccessibility from the ground. A single dusk emergence survey is therefore recommended prior to the proposed demolition of the bridge. In conjunction with the emergence survey, surveyors should also be stationed above the bridge to conduct a bat activity survey to establish if bats are using the bridge as a commuting corridor along the route of the Trans-Pennine Trail. The survey will need to be undertaken between May to August inclusive and follow best practice guidelines<sup>7</sup>.

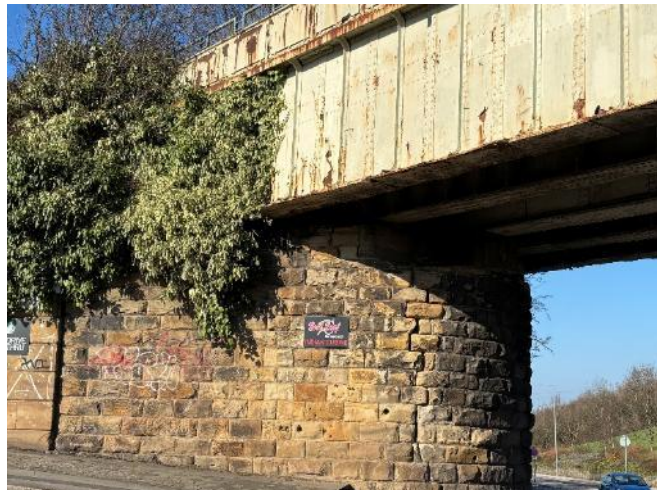
**Photograph 12:**

PRF 3 ivy overgrowing stone abutment on western side of bridge adjacent to Doncaster Road (Photo 12)	exposed to light pollution and heavy traffic/noise pollution		
		PRF 4 vertical crack in stone abutment on eastern side of bridge (Photo 13)	exposed to light pollution and heavy traffic/noise pollution-No bat evidence (droppings, staining or feeding remains) identified		
		PRF 5 gap/void where eastern stone abutment meets steel structure of bridge span (Photos 14/15)	exposed to noise pollution, presence of feral pigeon roost and droppings, potential water ingress.

Western abutment of the railway bridge illustrating vertical crack in stonework and overhanging ivy.

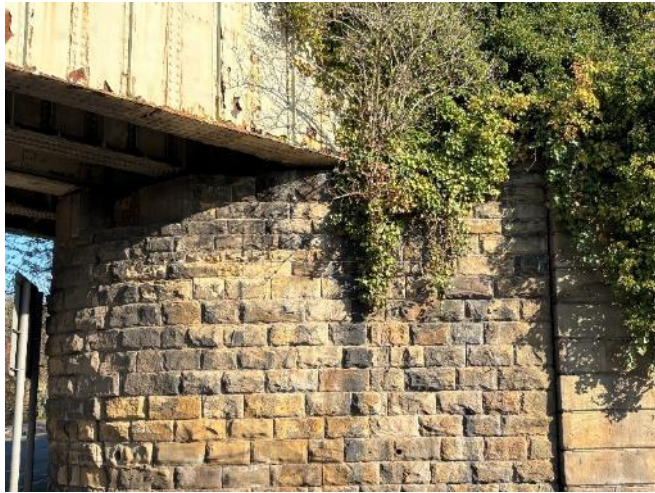
**Photograph 13:**

Eastern abutment of bridge, illustrating cracks in stonework, overhanging ivy, and void where steel bridge sits atop the abutment.

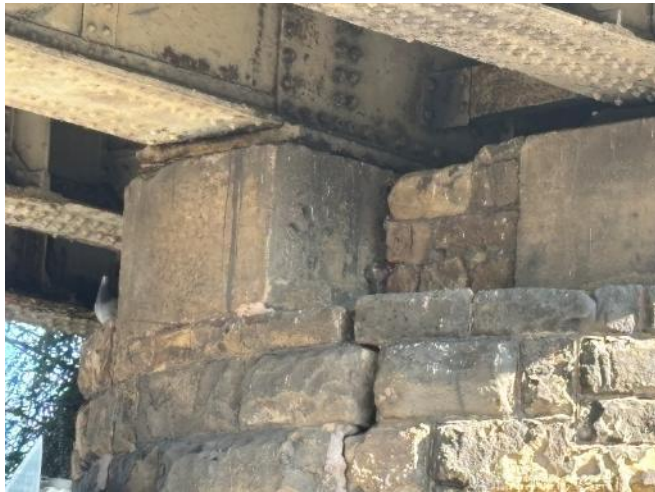
**Photograph 14:**

Closeup of void where steel bridge span meets the eastern stone abutment. Note feral pigeons present.

- 4.5.11 All wild birds are protected whilst nesting (this includes the feral pigeons which might be nesting and rearing young within the former railway bridge that crosses Grange Lane), with disturbance and destruction of active nests constituting an offence under the Wildlife and Countryside Act 1981 (as amended). Loss of vegetation would remove suitable nesting habitat for breeding birds. Were this to take place during the breeding season (March to September inclusive), there would be a risk that nests would be damaged or destroyed during the process. The removal of any individual trees, woodland, shrubs and mixed scrub should therefore take place between October and January. If this is not possible, a nesting bird check should be undertaken by a suitably experienced ecologist no more than 48 hours prior to removal. If evidence of nesting birds is identified, work should stop and a suitable no-work buffer zone around the nest area of at least 5m should be installed, until such time as a suitably qualified ecologist can confirm the nest is no longer in use by breeding birds.

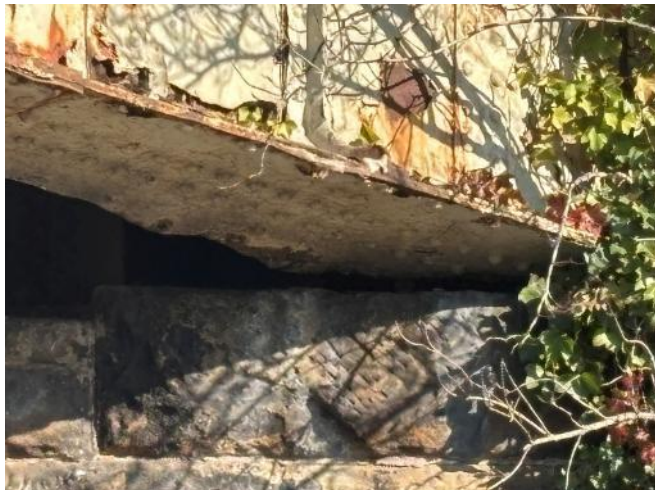
**Photograph 15:**

Another closeup of void where the steel part of the bridge meets the eastern abutment.

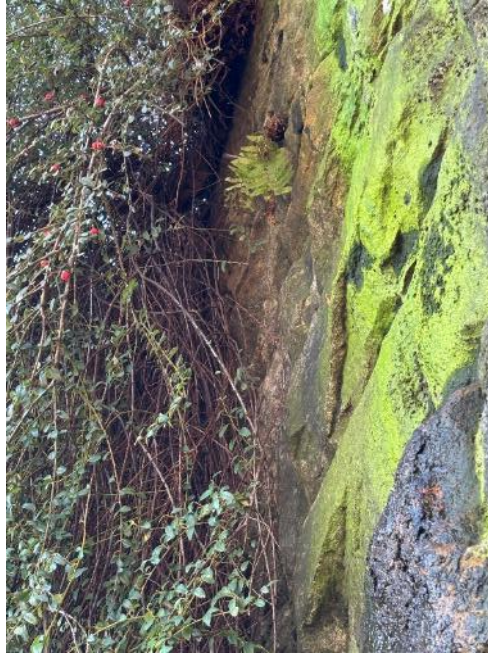
**Photograph 16:**

Image of eastern abutment with overhanging cotoneaster and wet stonework.

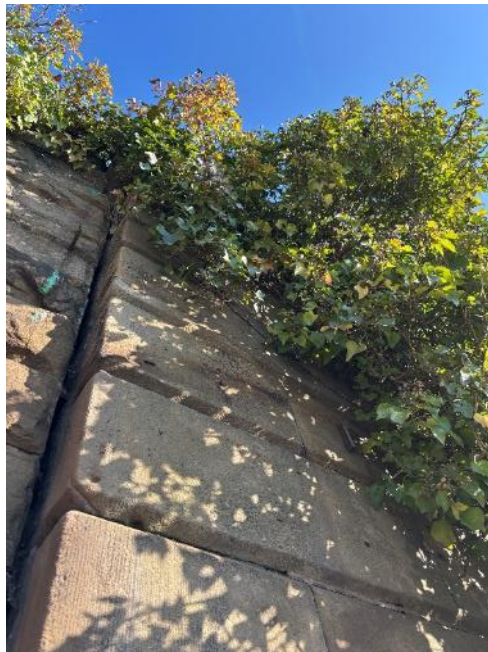
**Photograph 17:**

PRF 6 vertical crack in stonework where eastern abutment meets further supporting stonework (Photo 17)	exposed to light pollution and heavy traffic/noise pollution-use of torch revealed crack blocked with mortar, cobwebs, and of insufficient depth-no longer considered a PRF.		
		PRF 7 ivy overgrowing stone abutment on eastern side of bridge adjacent to Grange Lane (Photo 17)	exposed to light pollution and heavy traffic/noise pollution		
		PRF 8 wall cotoneaster overgrowing stone abutment on eastern side of bridge adjacent to Doncaster Road (Photos 6/16)	exposed to light pollution and heavy traffic/noise pollution, stones wet adjacent to feature indicating water ingress/egress from above.

Vertical gap in mortar between stonework on eastern abutment, with overhanging vegetation.
