# Bat Survey Report

## Rawling House Farm

22<sup>nd</sup> June 2015

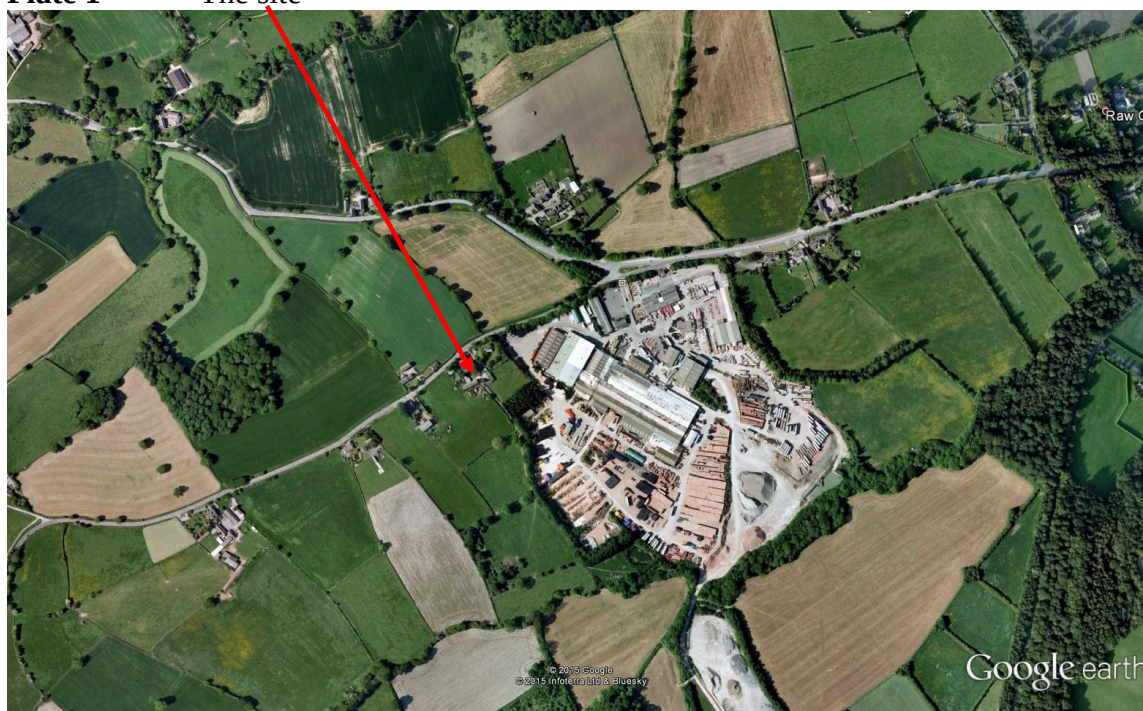
**Plate 1** The site

- 3.1 Rawling House Farm barn is an old stone built traditional two storey barn located 1.5km WSW of Cawthorne. The building has a single ridged roof with gables with a roof covering of York stone slates. There is three compartments to the barn and several doorways. On the west elevation is a single storey annex animal shed built of dry stone with a corrugated asbestos cement roof. Adjacent to the site on the eastern boundary is an industrial complex (pipe works). To the north is arable land; with the remainder comprising improved grassland used for pasture.

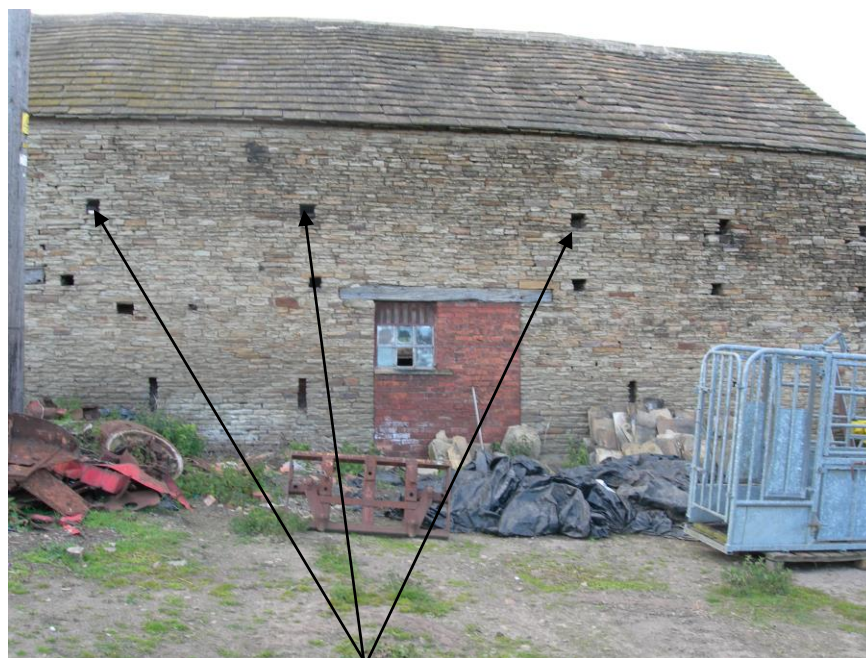
**Plate 2**

- 5.3.2 There are numerous places for bats to roost both in the single storey middle section and both hay lofts, e.g. up against wooden beams, crevices, under slates and against the ridge board. In spite of this only a scattering of droppings (12) were found on the floors of the middle section and the eastern hayloft. The ridge board, roof timbers, ceilings and all the mortice joints and cracks were somewhat cobwebby and dusty. There are many openings in the barn walls including entrances, open doors and hay loft access openings. In addition there are numerous 25cm (approximately) holes in the walls all around the building (see plate 2). Consequently, the barn may be drafty with fluctuating temperatures and therefore less favoured as a roost. Also several species of birds were nesting in the barn including Barn Swallow *Hirundo rustica* and Little owl *Athene noctua*.

25/30cm holes

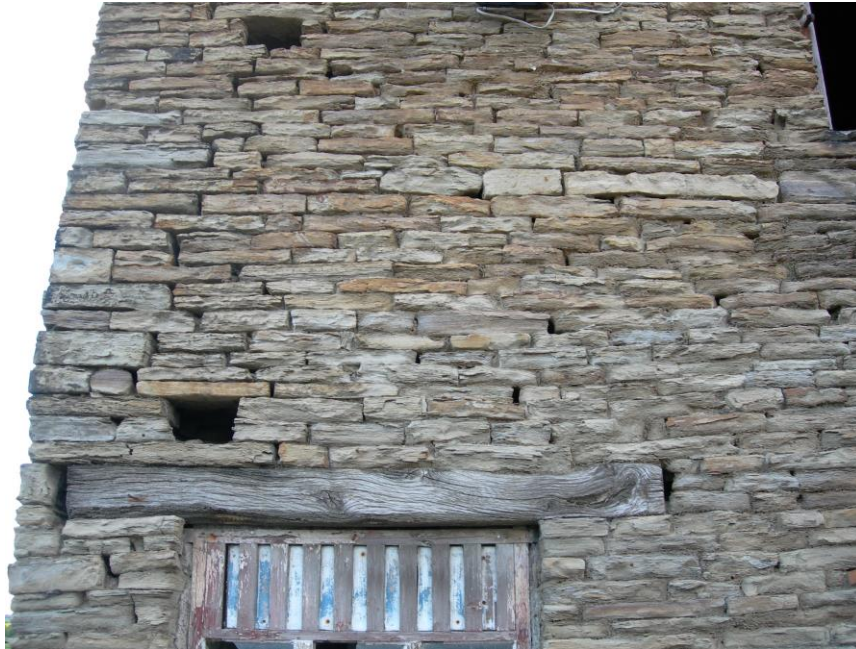
- 4.4.1 The external walls of the barn have a plethora of holes that could accommodate a bat roost. The holes, gaps and crevices can be found on all sides of the main barn building and many of these allow access to the wall interior. An example is shown in (Plate 2).
- 4.4.2 The single storey cow shed is built of stone on the western side and this is in many parts without mortar. Nevertheless, the building is low in height and considering the high potential of adjacent buildings it is considered to have less than low bat roost potential (see Plate 3). The eastern side of this building is brick built and generally in good condition therefore this side of the building has no potential.

**Plate 3** showing the abundance of holes and crevices etc

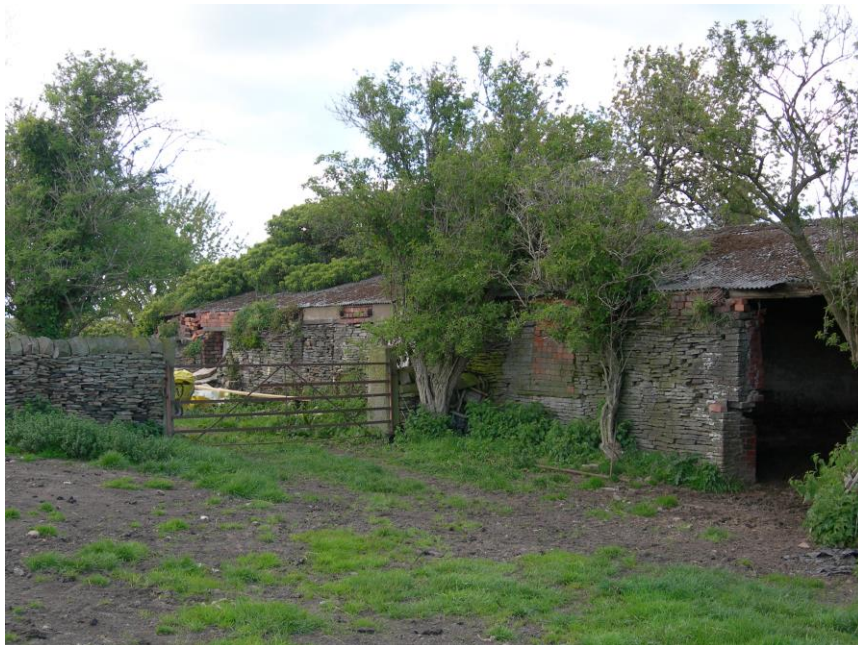
**Plate 4** Single storey livestock shed with sheet metal roof

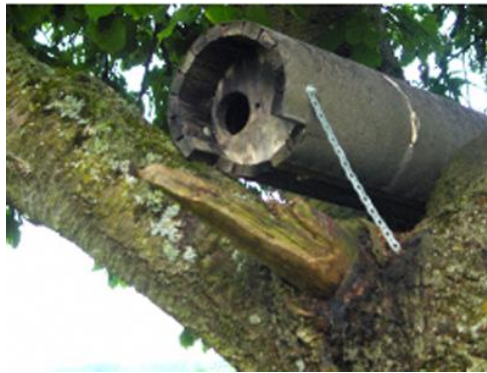
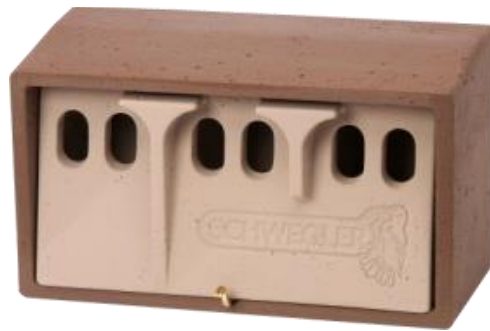
7.1 Little owl, Tree sparrows and Barn swallows are nesting in the barn. The following boxes should therefore be provided as mitigation in suitable locations:

- One Schwegler 20A Little owl box to be erected in nearby tree.
- One 1SP Sparrow terrace to be erected on the east or south elevation under eaves or gutter.
- Mitigation for Barn swallows can only be achieved by the construction of a lean-to or other open out building. If the LA insist on such mitigation then it can be provided for.
