# BANK HOUSE

Silkstone Bypass  
Silkstone

## HERITAGE STATEMENT

July 2021

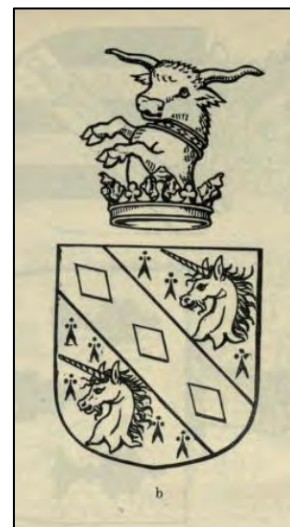
**Figure 3:** Coat of Arms of the Smyth family

Bank House possesses a decorative datestone on its north elevation bearing a coat of arms, the year “1805” and the initials “I.S.” and “I.R.”. The coat of arms bears close similarities to that belonging to the family of Smyth of Heath Hall and later Bowcliffe Hall (**Figures 3 & 12**; Turner 1991, 49). A conveyance of 1839 recorded the sale of The Hill Top estate by John Smyth of Bowcliffe (“J” often appears as an “I” in historic writing) to Robert Coldwell Clarke for £14,000 (Barnsley Archives ref CR/501). That this sale included the site is suggested by the proximity of “Hill Top” wood to the south-east of the site, and the form and Gothic Revival style of the building which is highly suggestive of an estate building. It is uncertain who or what the initials “I.R.” referred to. Robert Coldwell Clarke resided in Noblethorp Hall to the east of Silkstone, and owned Huskar Pit which is infamous in the area for the disaster of 1838 which led to 26 children losing their lives.

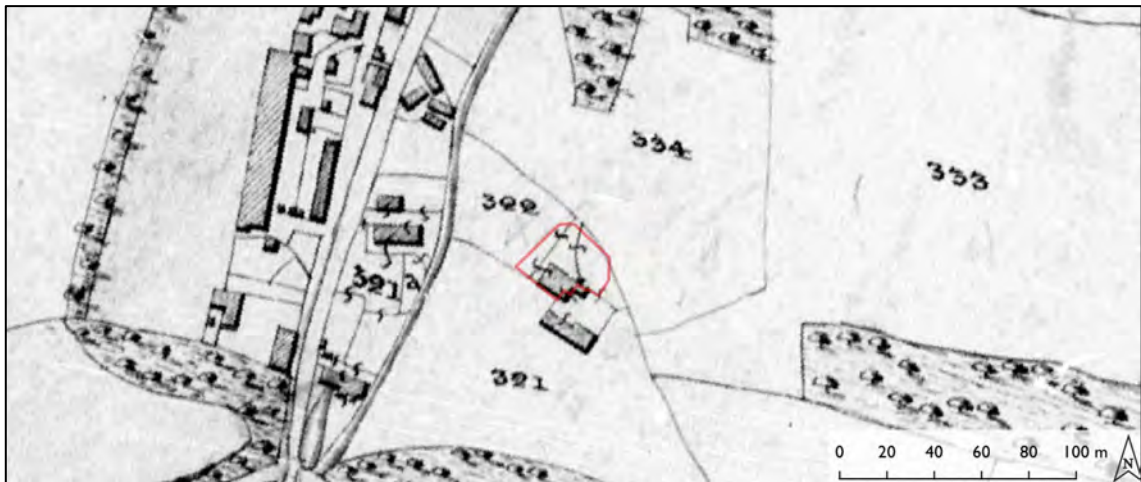
Figure 4: 1845 Silkstone tithe map  
(© The Genealogist © Crown copyright Images reproduced courtesy of The National Archives, London, England)

The tithe map (**Figure 4**) depicts Bank House as more-or-less occupying its present footprint except that its rear wings are shown extending further and joining what is later shown as an outbuilding. It is worth noting, however, that buildings on the map are somewhat simplified. A detached linear range, probably farm buildings, are also shown to the south-east of the house.

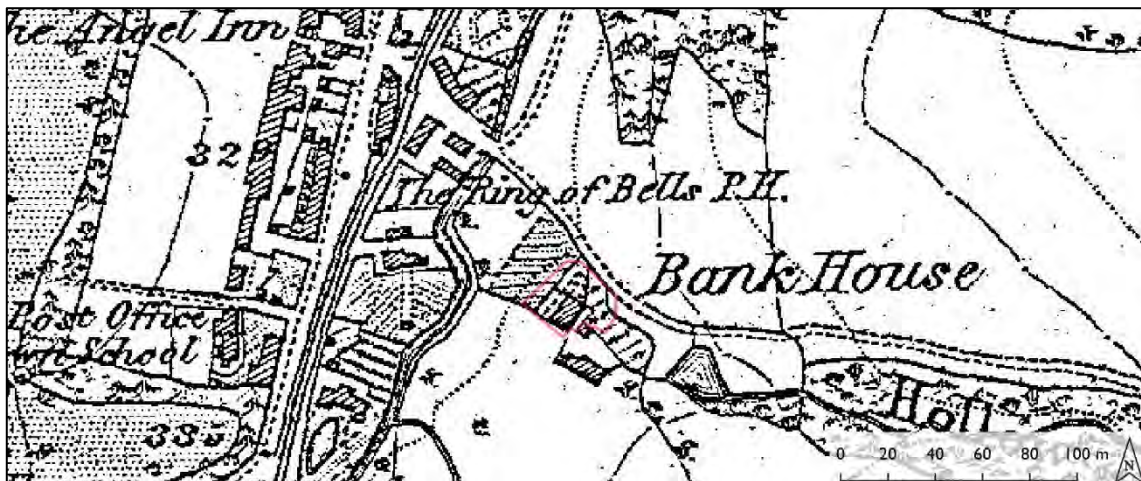
Figure 5: 1855 Ordnance Survey map

There is a tradition that Bank House was formerly the Angel Inn (Wood, 2000 and Historic England, 1987), before the license transferred to a property on High Street (shown on the 1855 OS map; **Figure 5**) and later became the Fox and Hounds (shown on the 1893 OS map; **Figure 6**). The earliest record identified for Angel Inn is in a directory of 1822 where it was listed as run by Benjamin Race. If the pub had been located at the site, it had moved by 1841 when it was recorded as operated by Edward Bailey. By 1852 the Angel was no longer listed, with the Fox and Hounds appearing instead.

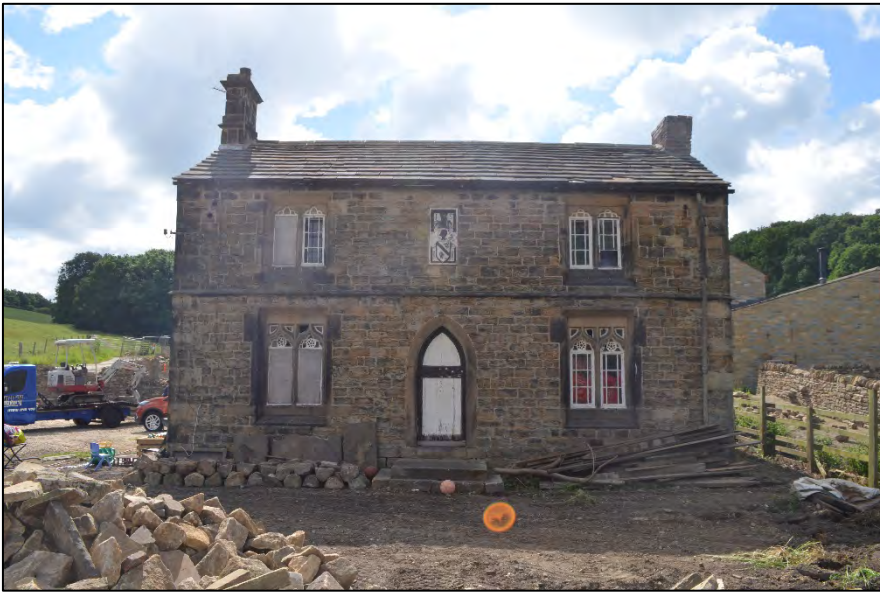
**Figure 7:** View of the north-east elevation of Bank House

The principal north-west elevation (**Figure 7**) forms the focus of architectural treatment with a well-ordered façade of three bays comprising a central pointed arched doorway with coat of arms above (**Figure 12**), and bays either side of deeply splayed mullioned windows with tracery and decorative leaded lights. The north-west gable of this range is blind (**Figure 13**), as too was the south-east gable prior to the insertion of door and window, potentially in the late 20<sup>th</sup> Century.

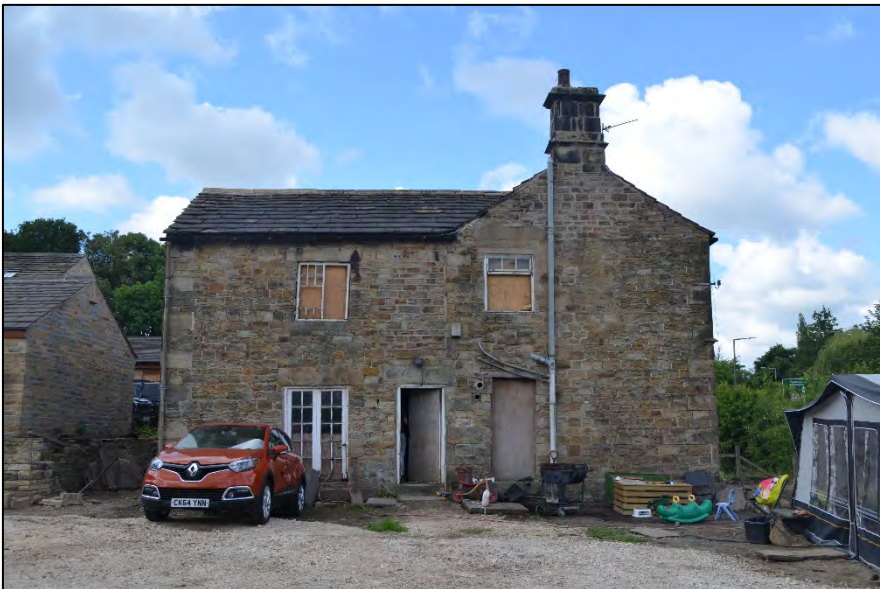
**Figure 8:** View of the south-east elevation of Bank House

The south-east elevation of the east wing (**Figure 8**) has a doorway and French-doors within an earlier window opening at ground floor, and window above with remains of a timber frame with

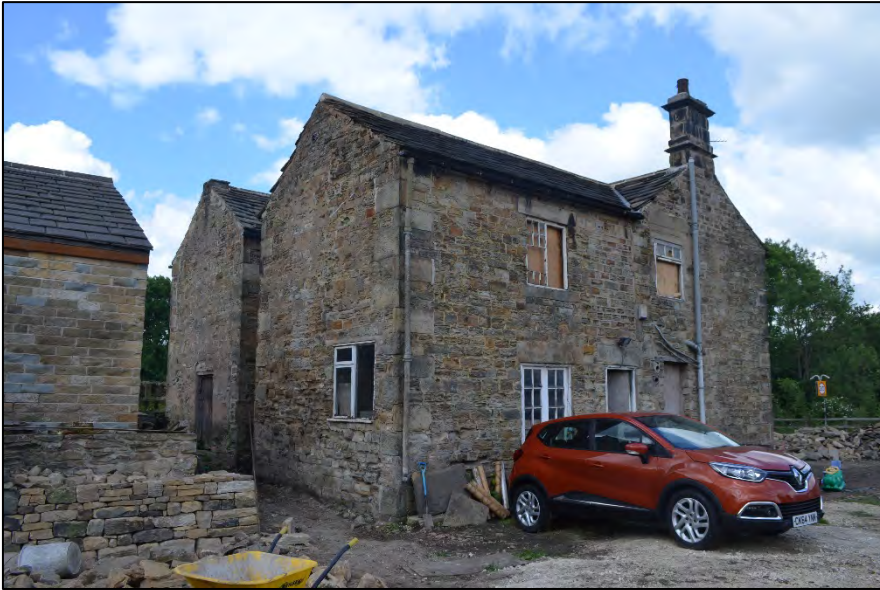
**Figure 9:** View of the south corner of Bank House

The south-west elevation of the west wing (**Figure 9**) contains a central doorway with tenoned and pegged doorcase and timber plank and ledged door. The north-west elevation has an inserted window at ground floor level and a large window above small panes and central upper top-hung casement.

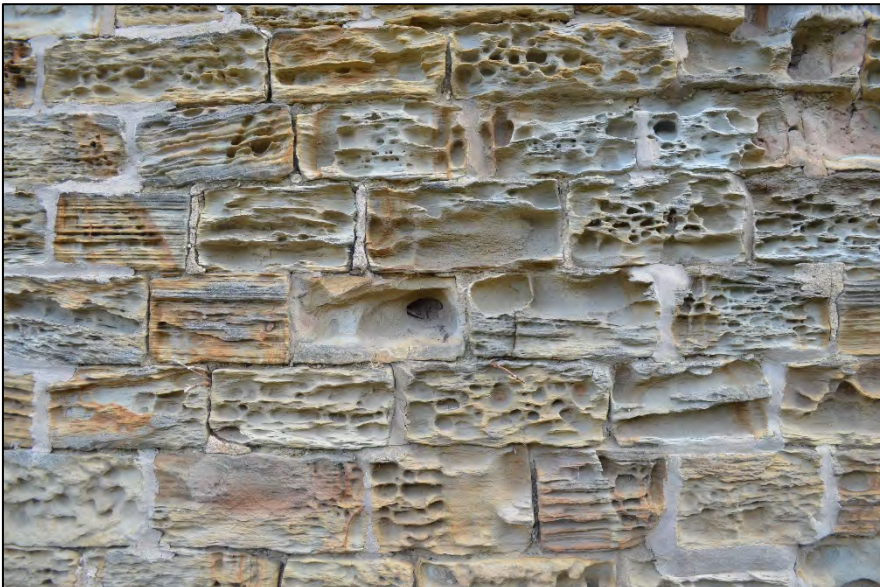
- Structural foundation movement was noted to the east and south walls, including historic and more recent movement.
- Extensive areas of severe weathering resulting in the hollowing of masonry (**Figure 10**).

**Figure 10:** Detail of eroded masonry and cement pointing on the north-west gable.

**Works Affecting Historic Fabric** – The proposed scheme intends to undertake essential works to conserve the building, including repair of eroded masonry, like-for-like replacement/repair of roof covering; and stabilisation and remedying of damage caused by structural movement. Remedial works have been designed in accordance with a structural survey (Structural Surveys, 2021). The scale of works ranges across the building, with the most significant interventions comprising the proposed dismantling and rebuilding of the rear wings to address the leaf separation and foundation movement. These works amount to the demolition of secondary extensions to the building. The rear wings will be rebuilt to their existing appearance reducing potential harm to the character of the building; and the frontage range, wherein the majority of the architectural interest of the building lies, will be unaffected. The harm to historic fabric, whilst regrettable, has been shown to be necessary to remedy severe structural problems and will therefore contribute to the long-term preservation of the remaining building. Overall, the scheme is deemed to have a **neutral to limited positive effect** on the significance of the building.

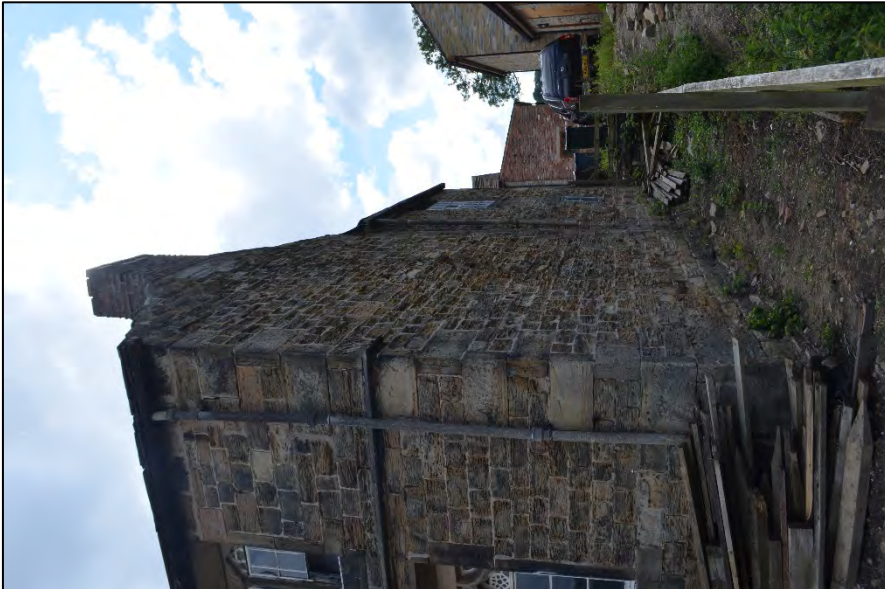
**Figure 13:** View of the north-west elevation

small panes and side hung casement. The south-west elevation of the east wing contains a single inserted window (**Figure 13**).

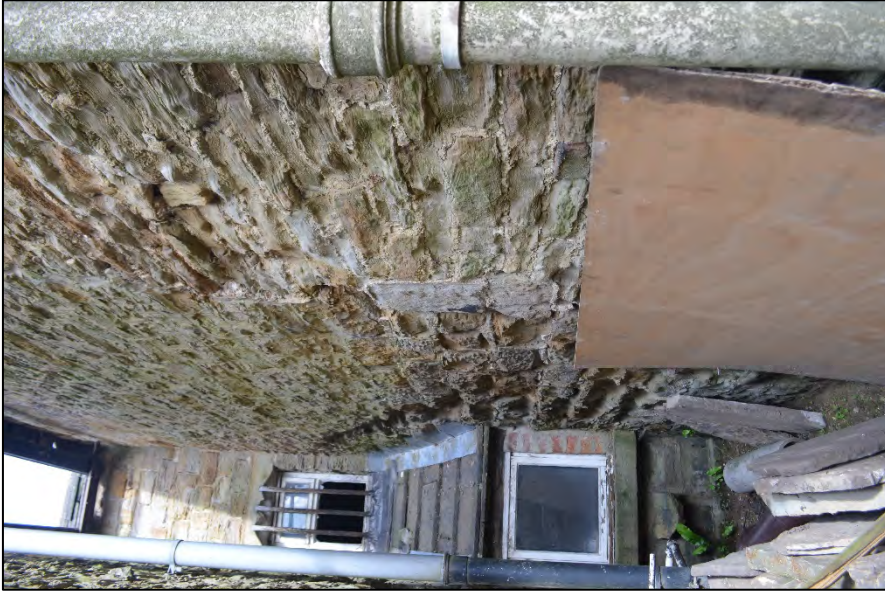
**Figure 14:** View of the space between the south-east wings

The rear wings are extensions to the frontage, on to which they abut at straight joints with minimal to no tying in. The gap between the two wings (**Figure 14**) falls either side of a ground floor lean-to at the rear of the frontage range with concrete tiles and brick masonry evidently of late 20<sup>th</sup> Century date. A first-floor window above with inserted security bars and a modern frame lights the head of the stairs within. The walls of the wings to either side were historically blind, with a small, inserted window in the side of the west wing.

**Works Affecting Layout and Circulation** – The proposal includes alterations to the building to create an enclosed corridor within the gap between the two rear ranges, and the subdivision of room **F4**. This alteration will enable improved access between rooms at first floor level. The wings, as historic extensions, resulted in alterations to the original layout of the building. Other aspects of circulation within the building were changed by further alterations in the 20<sup>th</sup> Century. The proposal will return the rooms of the front range to their original extent, whilst the addition of the corridor will not affect the core element of circulation between floors. This alteration is considered to have a **neutral effect** on the significance of the building.

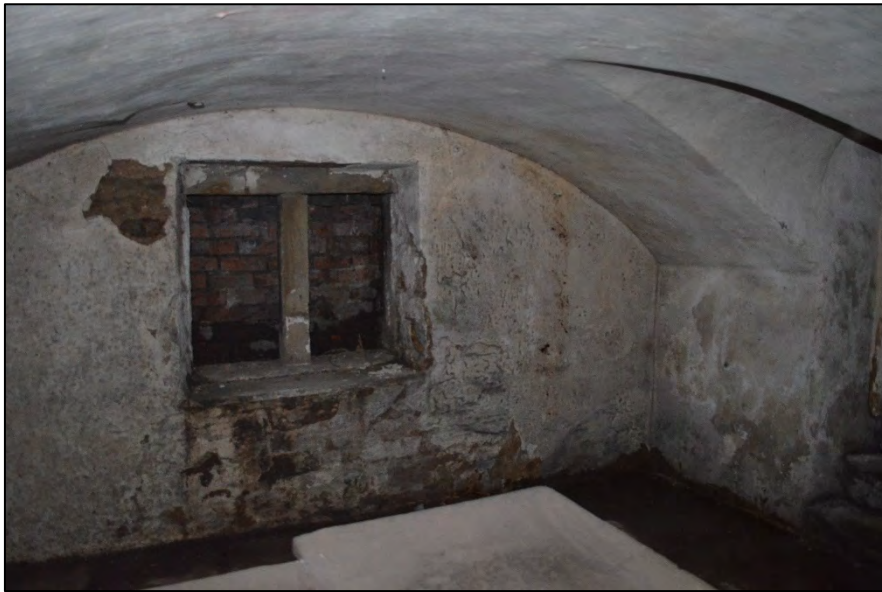
**Figure 15:** View of cellar room **C1**, looking north.

The cellar, room **CI** (**Figure 15**), is vaulted, with stone flag floor and plastered walls, and contains several stone slab tables, or throwls. A blocked stone mullioned window is present in the north-east wall.

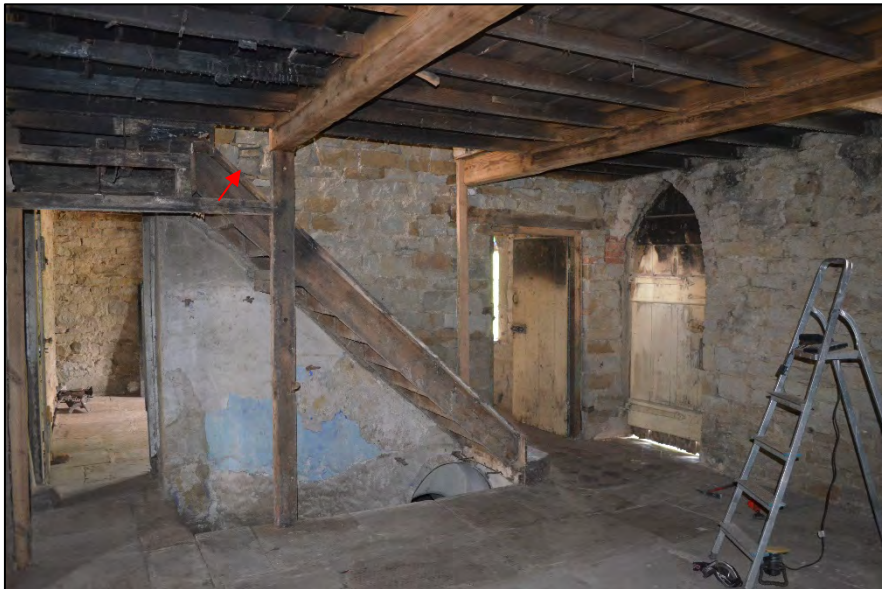
Internally the building comprises two rooms (**G1** and **G2**; **Figure 16**) to the frontage range, both with stone flagged floors, bare stone walls (the plaster having been removed), and ceilings exposing the beams of the floors above (lath and plaster having been removed). Fireplaces with stone surrounds are present in the end walls of each room, although no historic fixtures survive. Staircases against the north-west wall of **G1** access the cellar and first floor. The cellar stair is of stone construction and appears original, whilst the timber stair to the first floor shows signs of modification including: replaced treads and risers; a reduced angle such that the steps pitch back; and added post supporting the end of a floor beam which has evidently been cut back with blocked joist pocket evident in the wall to the side of the stairs (**Figures 16 & 23**). There is an oral tradition for this staircase having been moved, although no blocked stairwells were observed. Its present location works with the planform of the building, and it is possible that it was originally located here, whether or not it was removed for a period, with the original stairs potentially lying at a steeper pitch.

**Figure 16:** View of ground floor room **G1**, looking west indicating location of blocked joist socket.

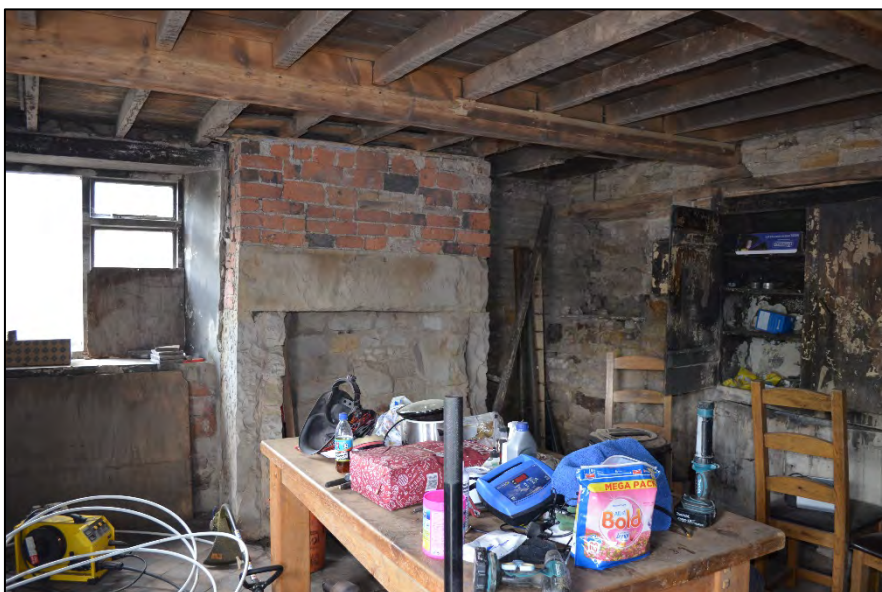
**Figure 17:** View of ground floor room **G3**, looking south

Within the east wing is a former kitchen, room **G3** (**Figure 17**), with large stone framed range, evidence for a removed side oven or copper, and a range of fitted storage including recessed shelving, a spice cupboard, and a fitted cupboard. The latter two have panelled doors and wrought iron hinges. The floor in the kitchen is of red and black quarry tiles, laid on earth, whilst the beams of the floor above are exposed in the ceiling (lath and plaster having been removed). The door to **G1** is an insertion, with an earlier blocked door evident to its south. The door to **G5** is similarly an insertion, with a partial brick blocking suggesting it may have been put through a former window opening.

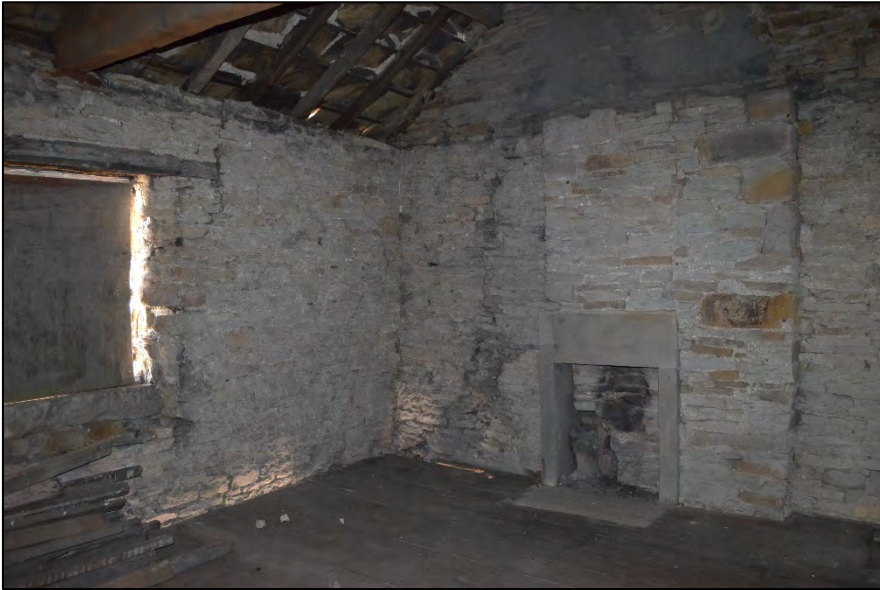
**Figure 18:** View of first floor room **F3**, looking east

At first floor, there are two chambers to the frontage range (rooms **F1** and **F2**) accessed from the top of the stairwell which extends in a short corridor north to provide separate access to a third chamber above the north wing (room **F4**). Room **F3** above the south wing is accessed through room **F1**, although scars in the floor indicate the former presence of inserted studwork partitions which also enclosed a small bathroom in the east corner of the room. All the rooms have timber boarded floors, those in **F1** and **F2** being of greater width and likely older; bare stone walls (plaster having been removed) and ceilings open to the roof structure above (lathe and plaster ceilings having been removed) (**Figures 18-20**). Chimney breasts with fireplaces are present in each room, although no historic fittings survive. The doors to **F3** and **F4** are both insertions, the former cutting through a roof scar on the south-west facing wall for an earlier single storey wing (**Figure 19**).

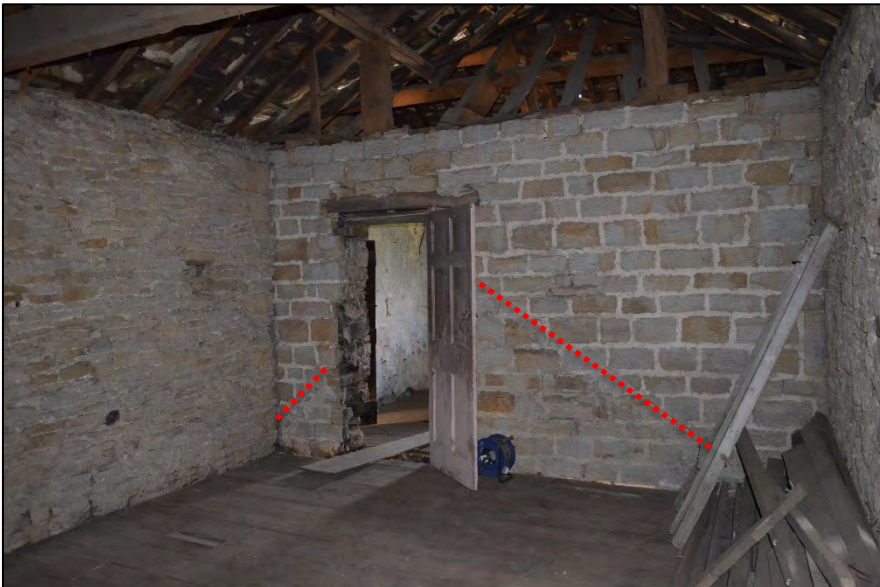
**Figure 19:** View of first floor room **F3**, looking north-west noting roof scar

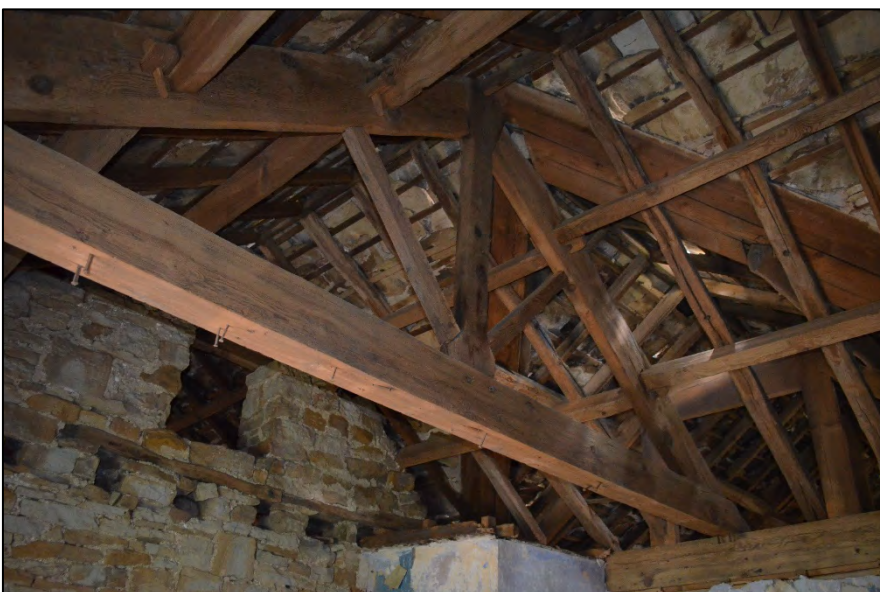
**Figure 20:** View of the roof structure above first floor room **F2**, looking east

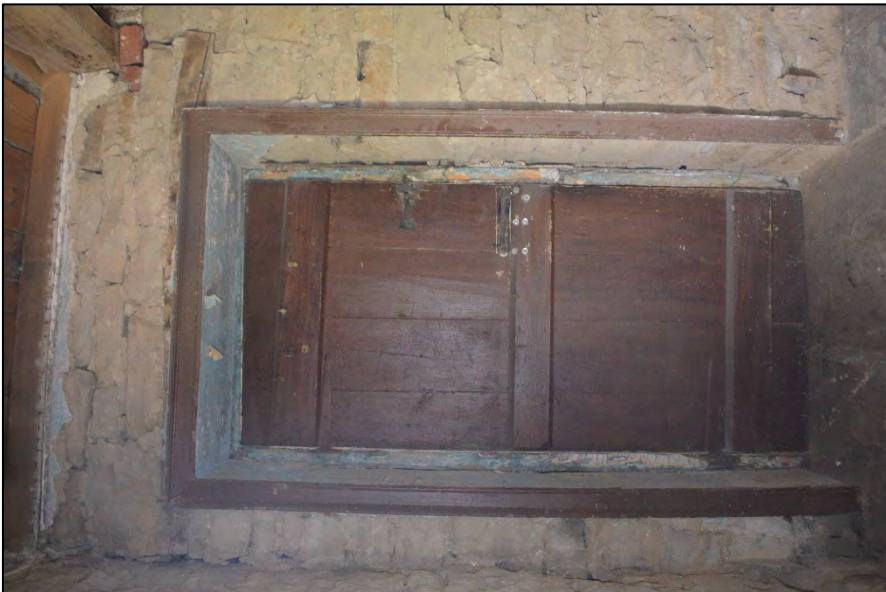
No historic fixtures and fittings survive beyond the early 19<sup>th</sup> Century plank and ledged doors with wrought iron hinges survive between rooms **G1/G2** (**Figure 21**), between the stairwell and rooms **F1** and **F2** (**Figure 22**), and to the cupboard in **F1**; and the cupboards in the former kitchen room **G3**. Later 19<sup>th</sup> Century doors are present elsewhere, but are of less heritage interest, including between **G3/G5**, **G2/G1**

**Figure 21:** View of plank and ledged door with surround in room **G2**, looking north-east

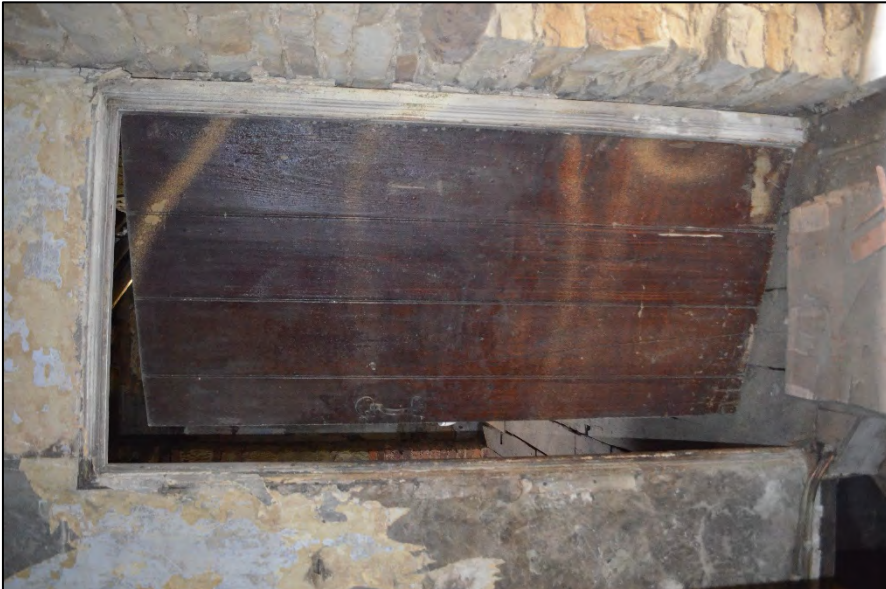
**Figure 22:** View of plank and ledged door to **F1**, looking north-east

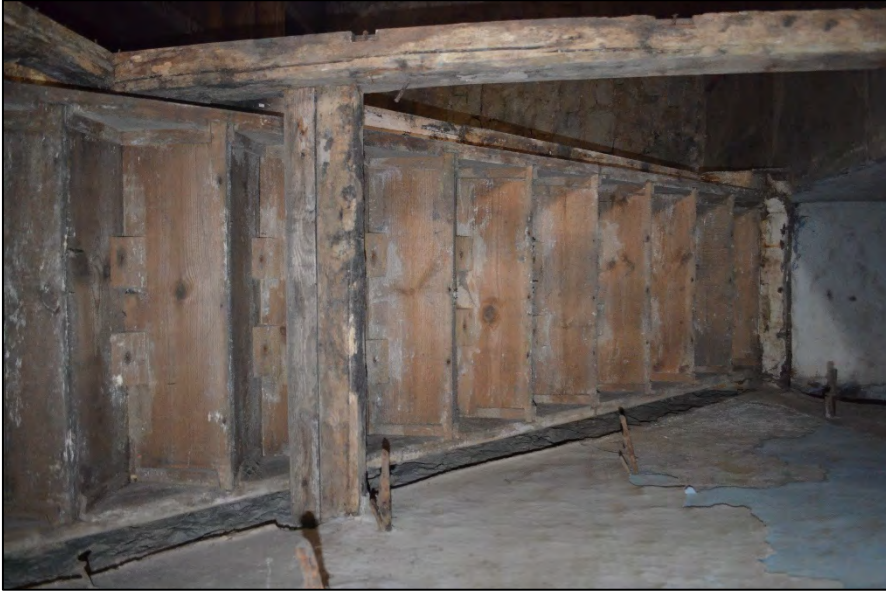
**Figure 23:** View of the underside of the stairs in **G1**, noting replaced risers.
