GEO-ENVIRONMENTAL REPORT

job number	C4260/24/E/6523	date	24/05/2024
site address	Goldthorpe Housing Project Victoria Street Goldthorpe, Rotherham S63 9HN		
written by	J.Finch	checked by	S.Alexander
issued by	J.Finch

Report on a Phase 2 Geo-environmental Investigation

Location:	Goldthorpe Housing Project Victoria Street, Goldthorpe, Rotherham, S63 9HN	
For:	Barnsley Metropolitan Borough Council	
Report No.	C4260/24/E/6523	Report date: May 2024

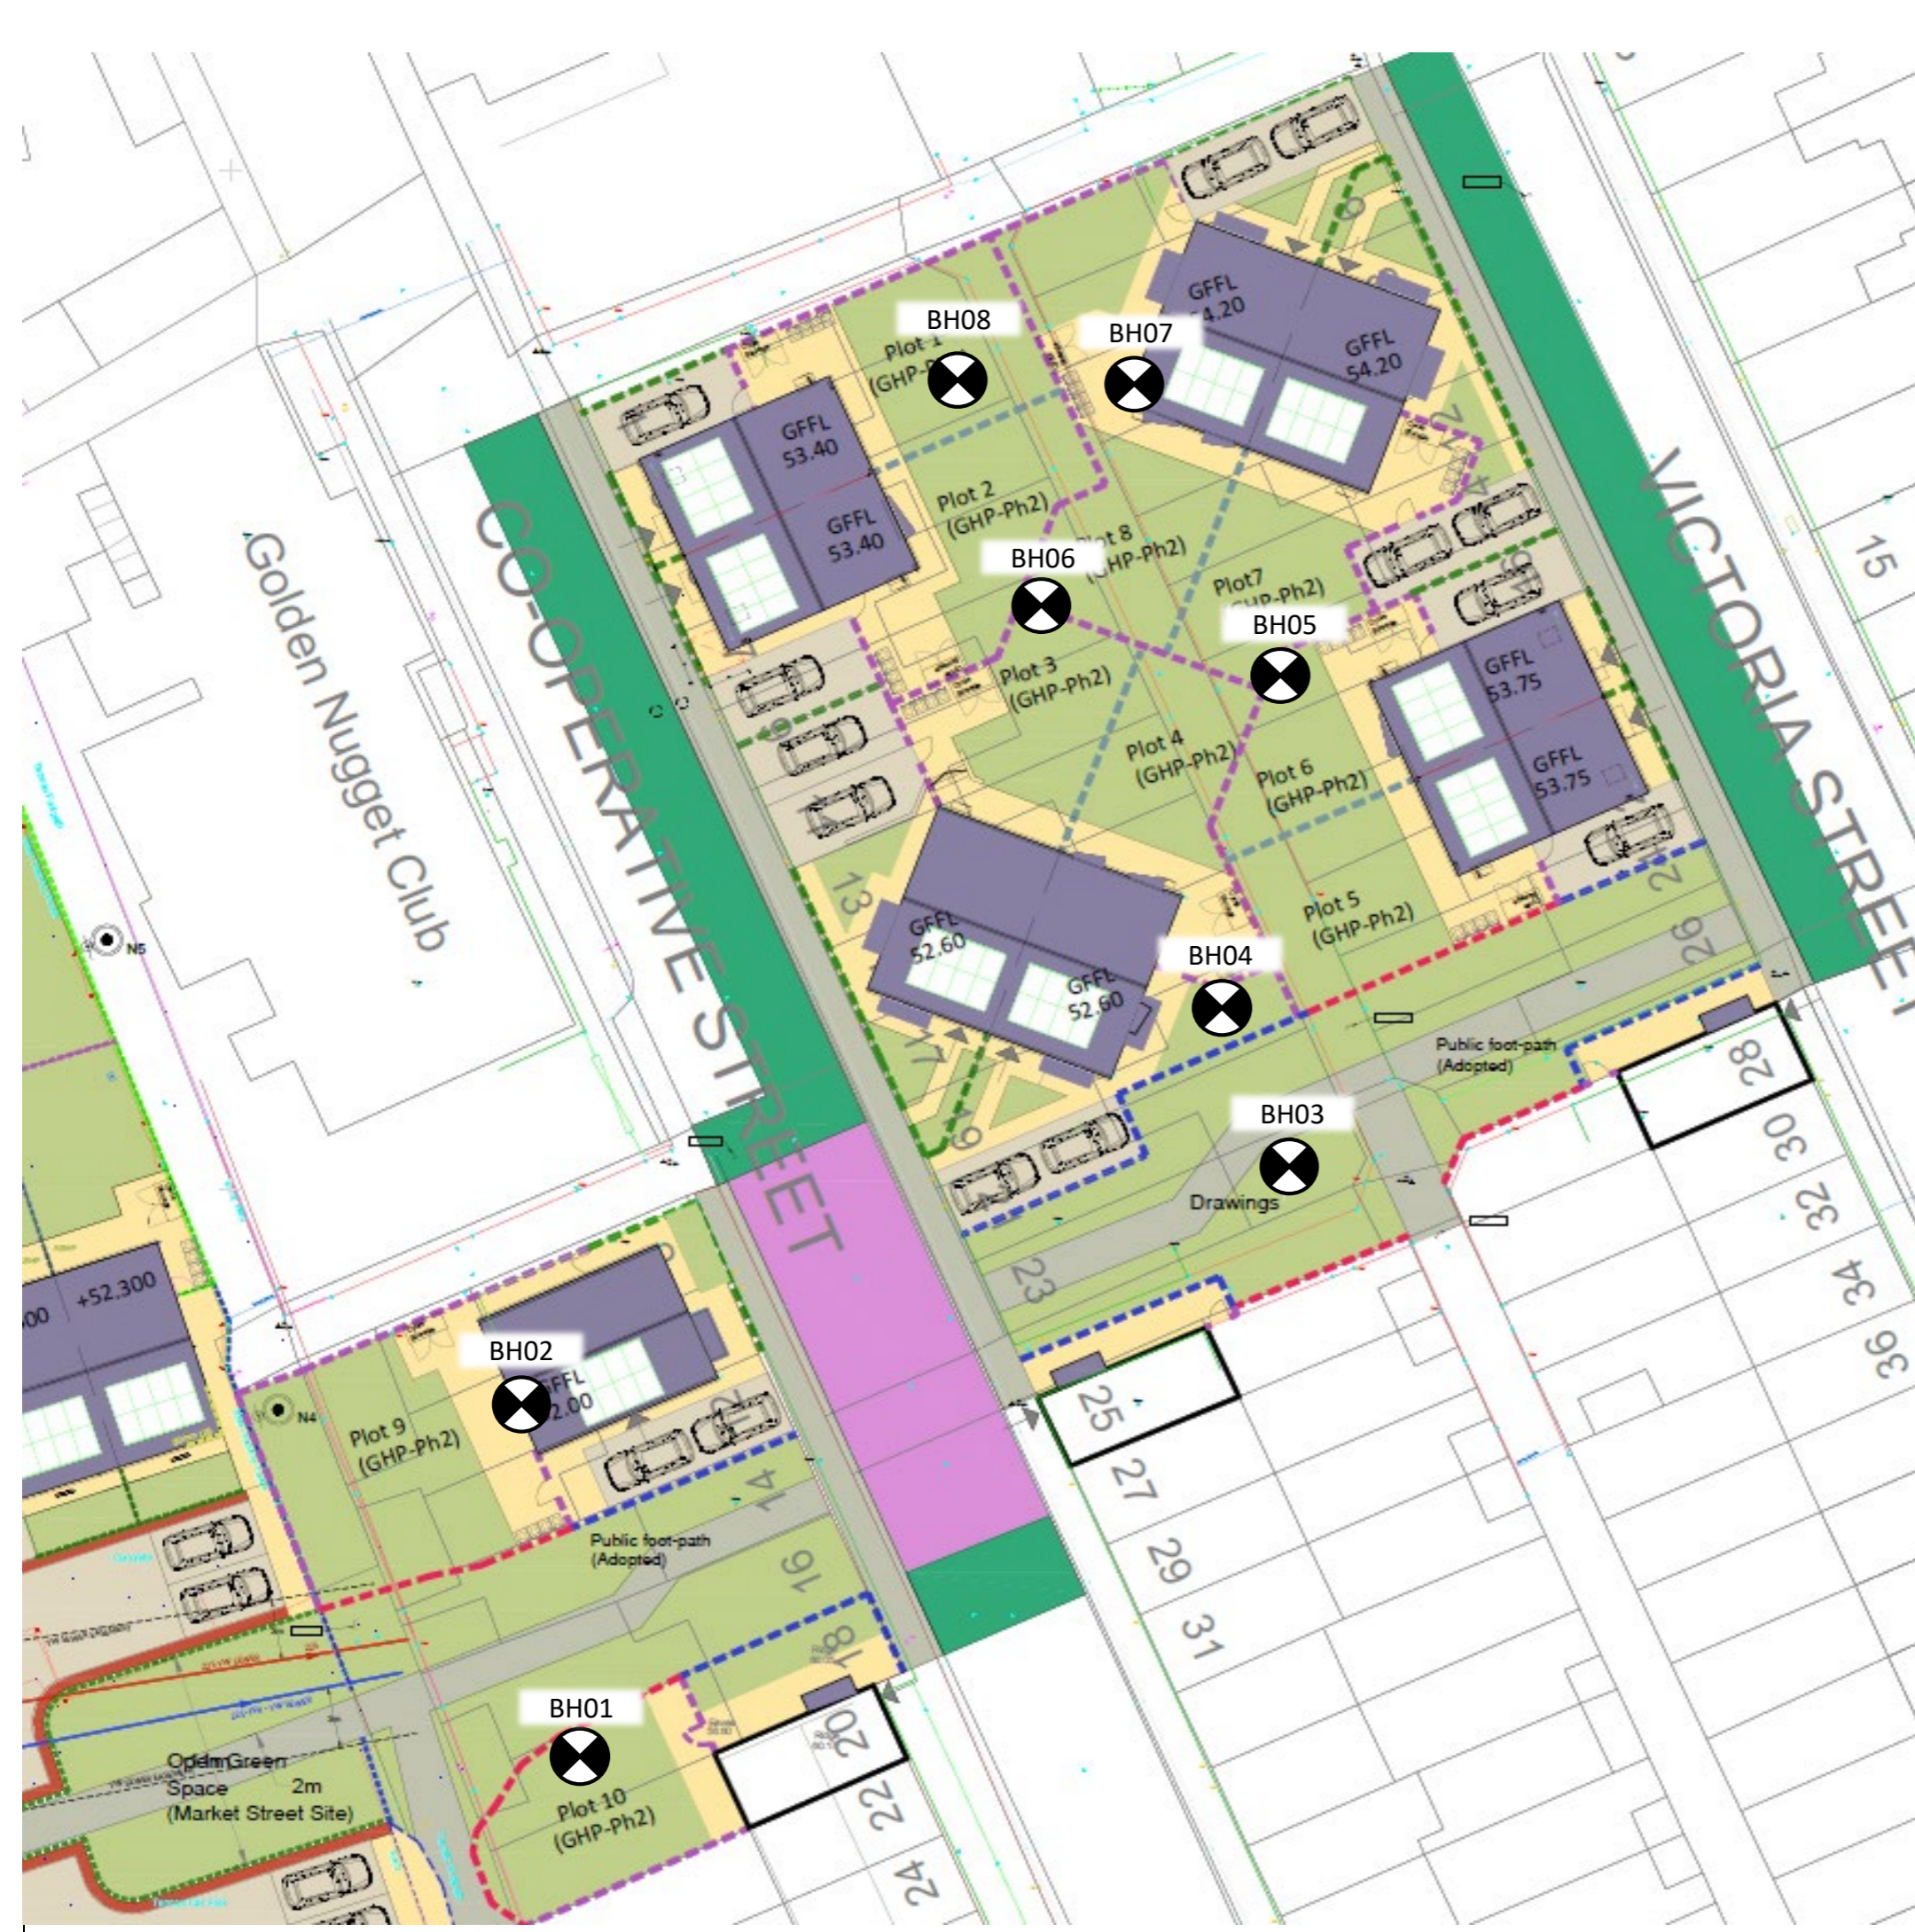
Goldthorpe Housing Estate

Notes:
Investigation positions approximated from site operative's notes.

The investigatory locations are shown on the site plan which is presented in Appendix 1 to this report.
