# Design and Access Statement

Proposed development at Rose Tree Court, Cudworth, Barnsley

# Design and Access Statement for Proposed Development at Rose Tree Court, Off Sycamore Avenue, Cudworth, Barnsley

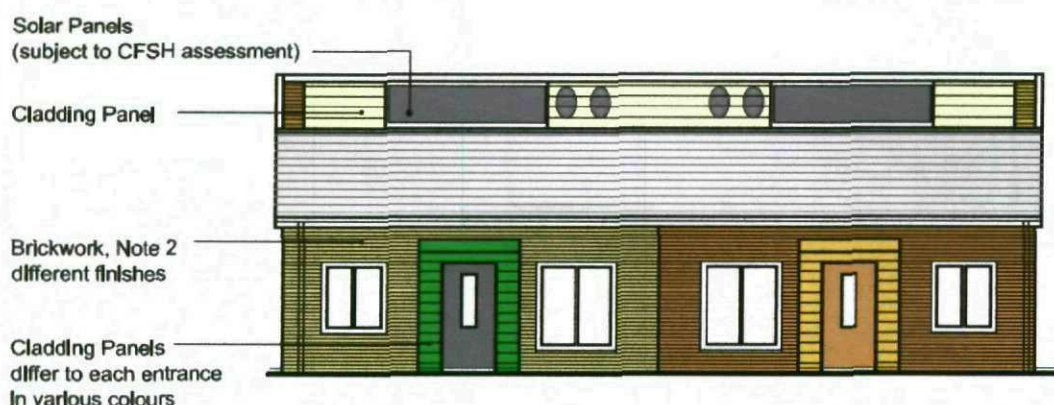
## 2B 3P BUNGALOW

2 types of contrasting brickwork provide a variety to the streetscape

Various cladding colours to each bungalow provides a sense of individuality to the street front.

Solar Panels to south facing elevation

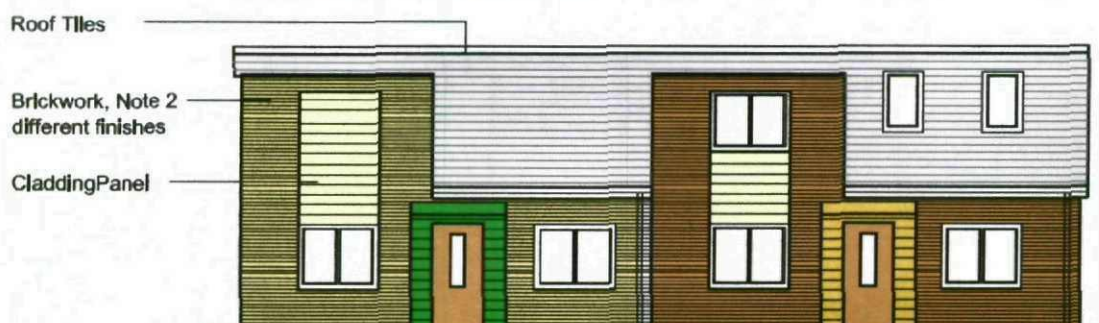
## 2B 4P / 3B 5P BUNGALOW

Note Towers split the roof up whilst providing adaptability for future use if required. Please refer to right hand side adopted elevation

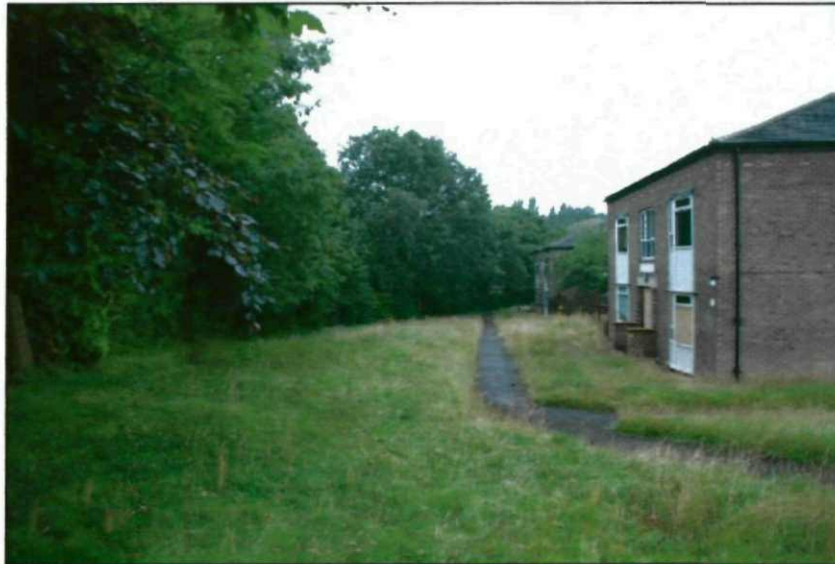
**Plate 1:** The rear of Block 1, showing semi-improved grassland and tree line boundary

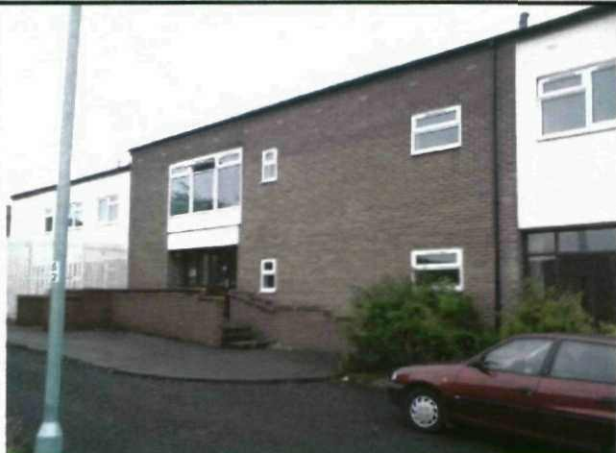
| <b>Block 1</b> | |

| | Description: Two storey brick built/rendered 60's style flats with multiple pitched rosemary tiled roof and PVC double glazed windows. The flats have been vacant for the past 18 months. The |

| | <p>roof void featured a king post design with bituminous roofing felt beneath the tiles.</p> <p>Potential Bat Features: Small gaps between the lead flashing and windows, missing mortar between the brickwork, and gaps behind the fascia boards all offer pockets for roosting bats. Raised roof tiles at the gable end may allow bats access to the roof space. Open windows provide access for bats to the interior of the building. Gaps were evident at the eaves from inside the roof void.</p> <p>Bat Evidence: None</p> <p>Potential for roosting bats: Confirmed roost</p> |

Block 1 supports a common pipistrelle roost in the south-eastern corner of the building (Plate 2). Given that the bat surveys were undertaken at an ideal time of year, and in suitable weather conditions and only one common pipistrelle bat was found, it is considered that the roost has been accurately assessed and that it is of low conservation importance. It is considered most likely that the roost is occupied by low numbers of non-breeding female and/or male bats. The generally low level of bat evidence and emergence activity suggests that the building does not support a breeding colony.

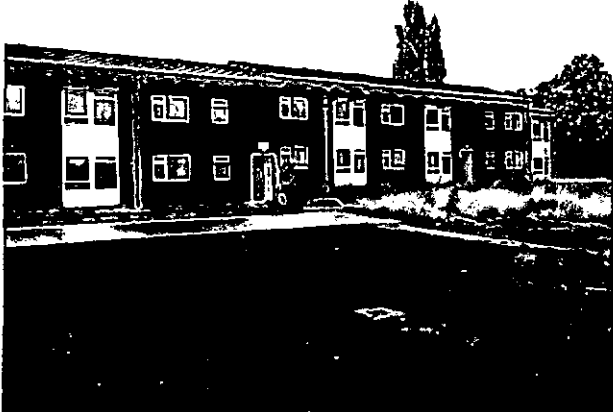
| <p><b>Block 2</b></p> | <div data-bbox="598 630 1212 1043"> </div> <p>Description: As block 1 but with additional dormers and porch to rear. No access could be gained to the roof void.</p> <p>Potential Bat Features: Gaps between the fascia and barge boards, between lead flashing and the windows and gable, and missing mortar all provide potential roost sites for small numbers of bats. Missing, slipped and raised roof tiles at the gable end may allow bats access to the roof space.</p> <p>Bat Evidence: None</p> <p>Potential for roosting bats: Moderate</p> |

No bat evidence was recorded from Block 2. However, the building has potential to support roosting bats, by virtue of loose roof tiles; lifted ridge tiles; loose lead flashing; and gaps caused by missing mortar. As such, works to Block 2, and elsewhere in Block 1, will need to proceed in accordance with the sensitive demolition protocol detailed in Appendix 2 (to protect bats against inadvertent injury, in the event that they are present). If bats or signs of bats are found at any stage; the works should immediately stop and a suitably qualified ecologist be consulted for advice.

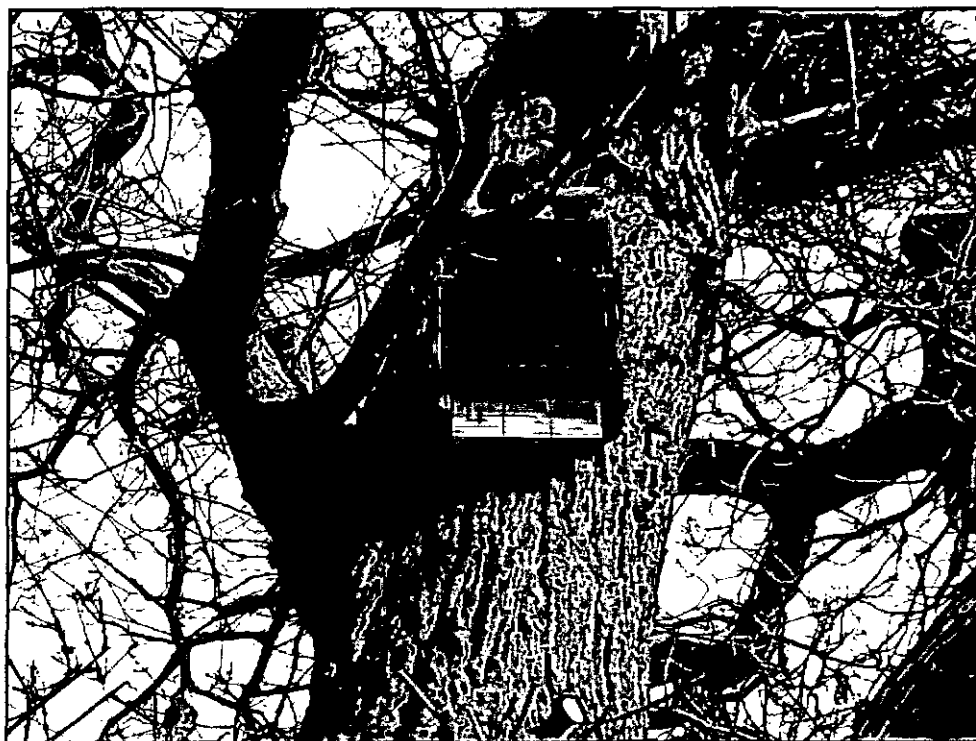
**Plate 3:** Tree-mounted woodcrete bat box

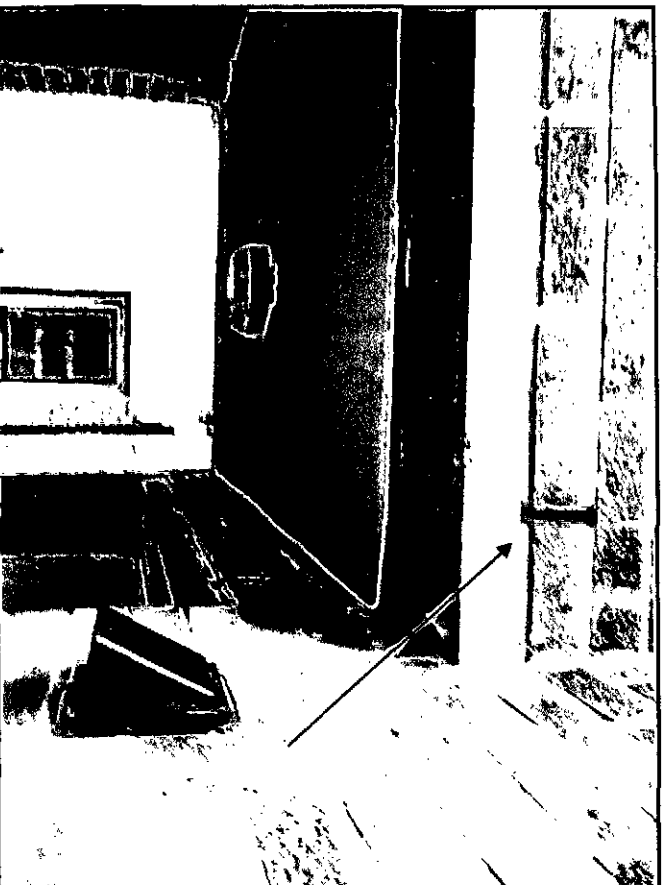
*Missing mortar*
