## GEOENVIRONMENTAL DESK STUDY REPORT

Land off Whaley Road  
Barugh Green  
Barnsley

6709-JPG-XX-XX-RP-G-0601-S2-P02

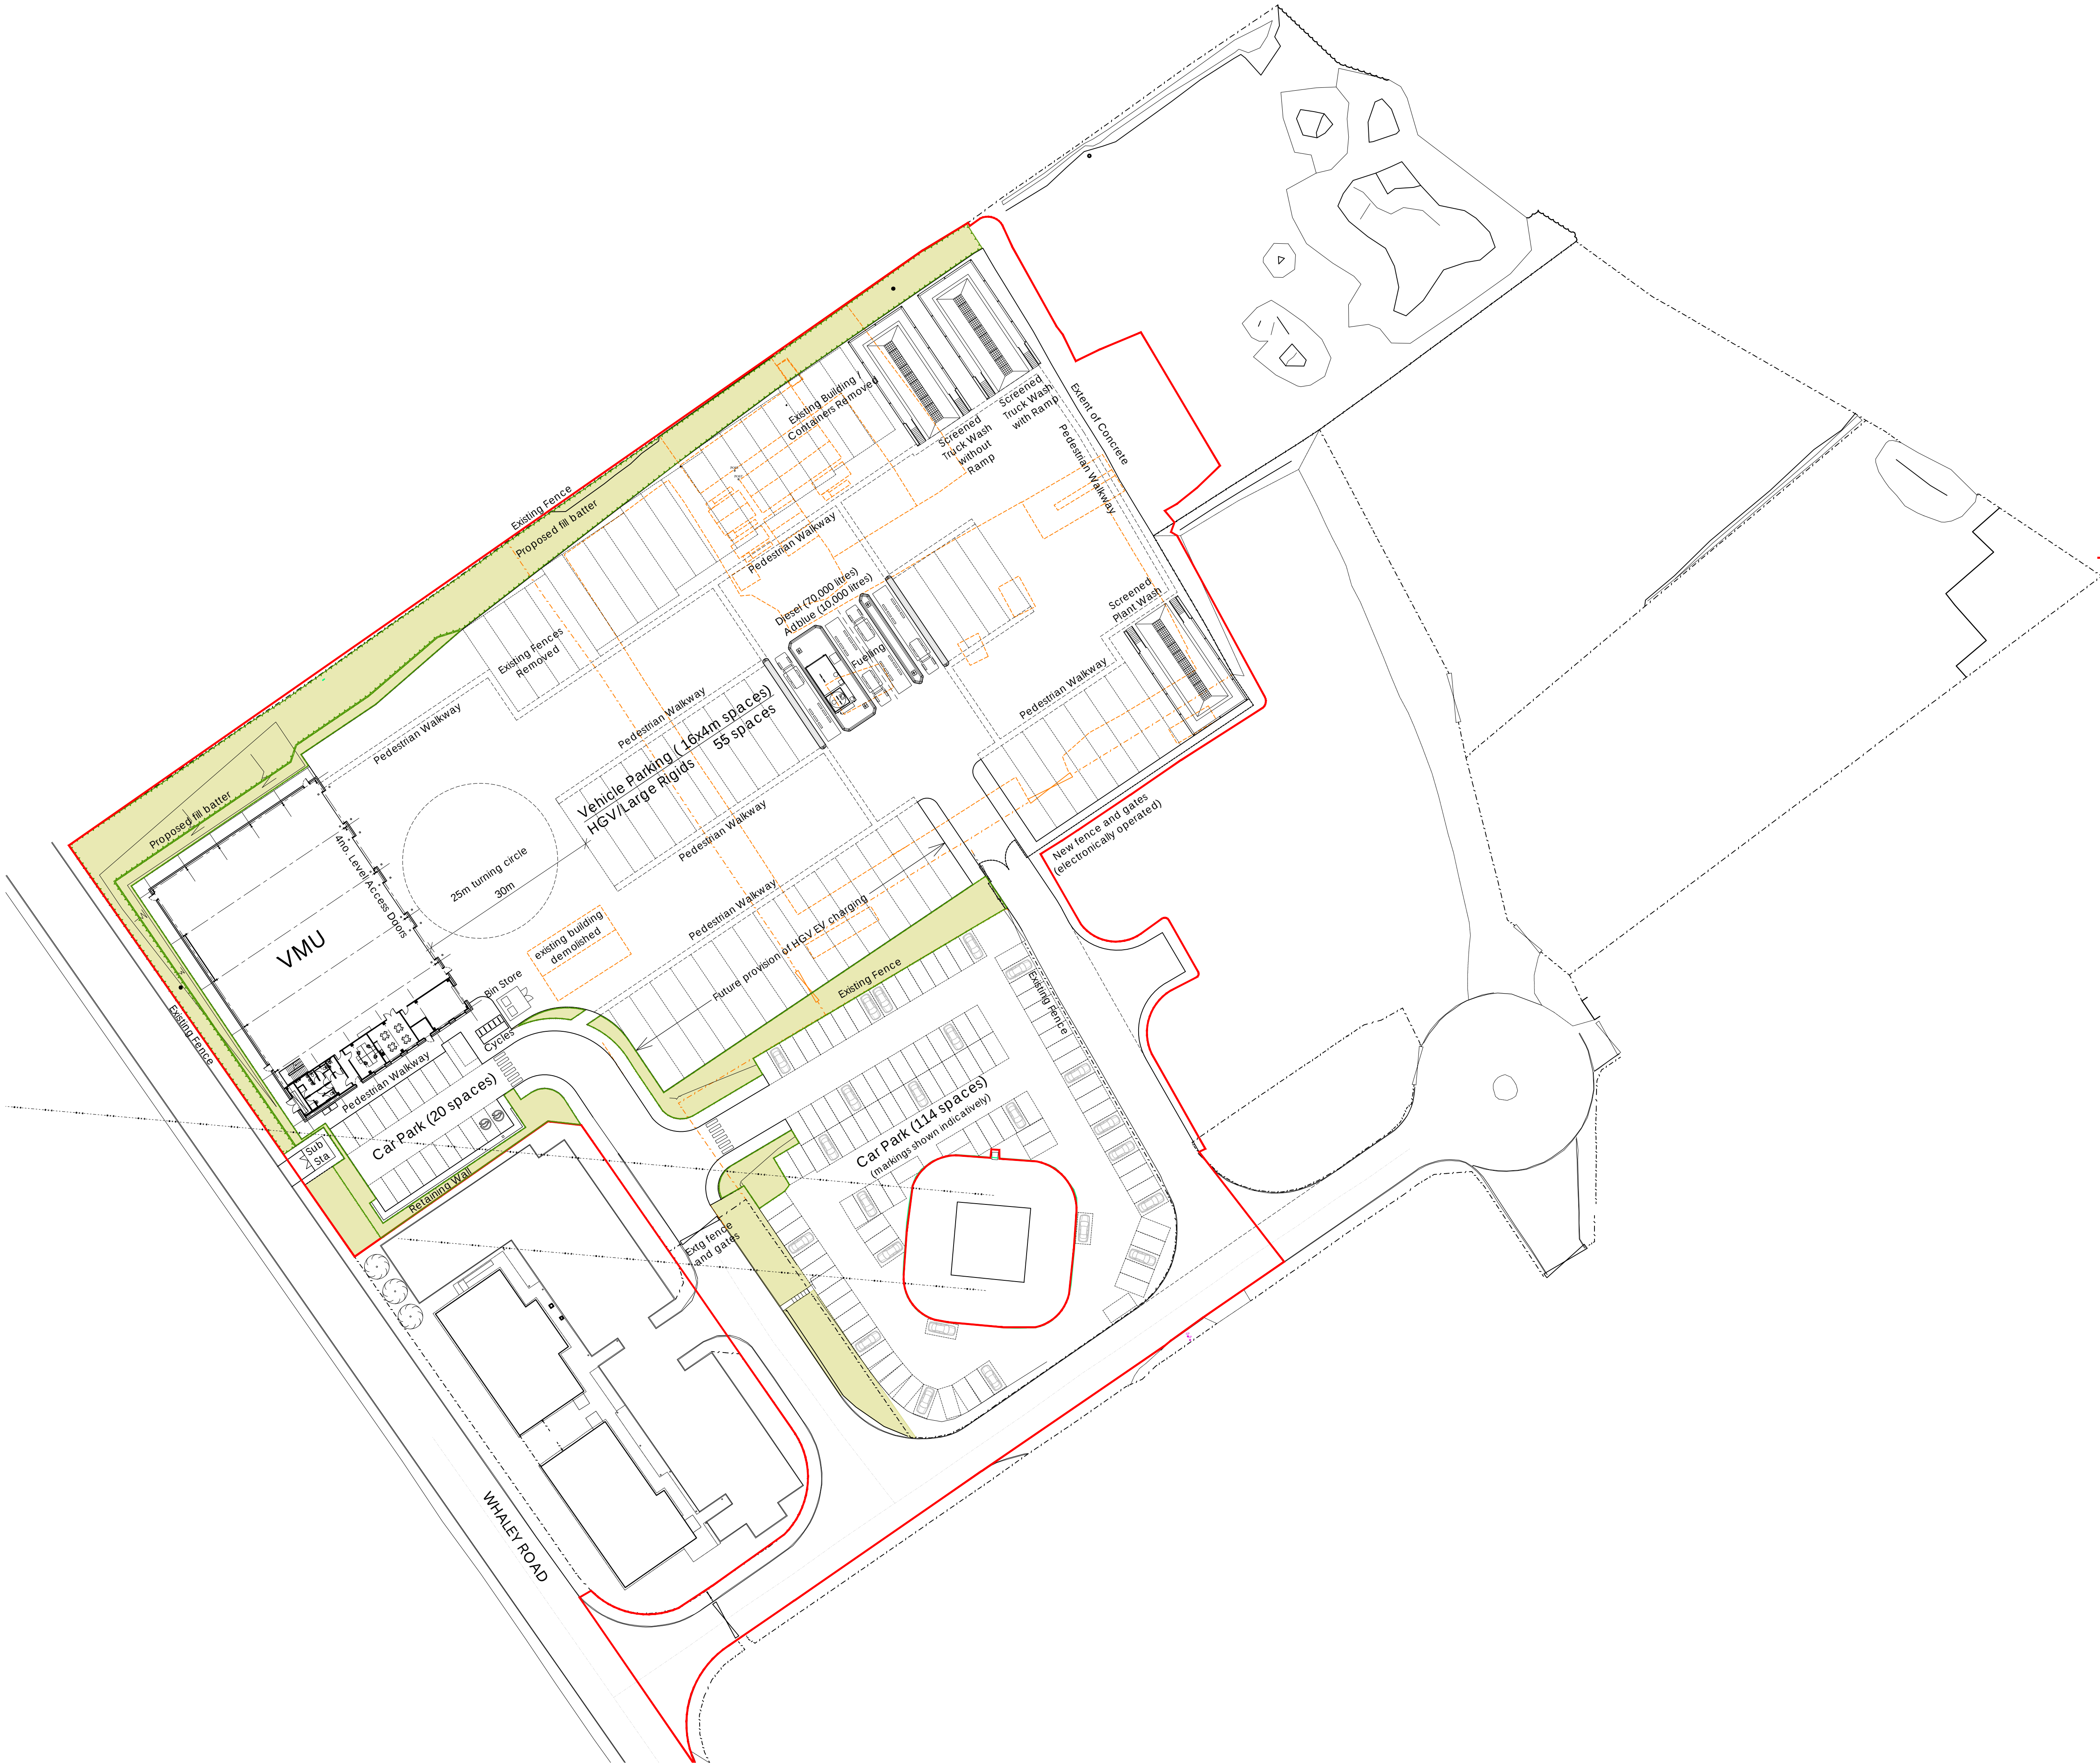
This shows the proposed Vehicle Maintenance Unit building in the west of the site, with extensive areas of hardstanding, comprising mostly vehicle parking across the remainder of the site.

- AJA Architects. Proposed VMU & External Works, Whaley Road, Barnsley. Proposed Site Plan. Drawing No. 7628-010 D, dated 30.07.26.

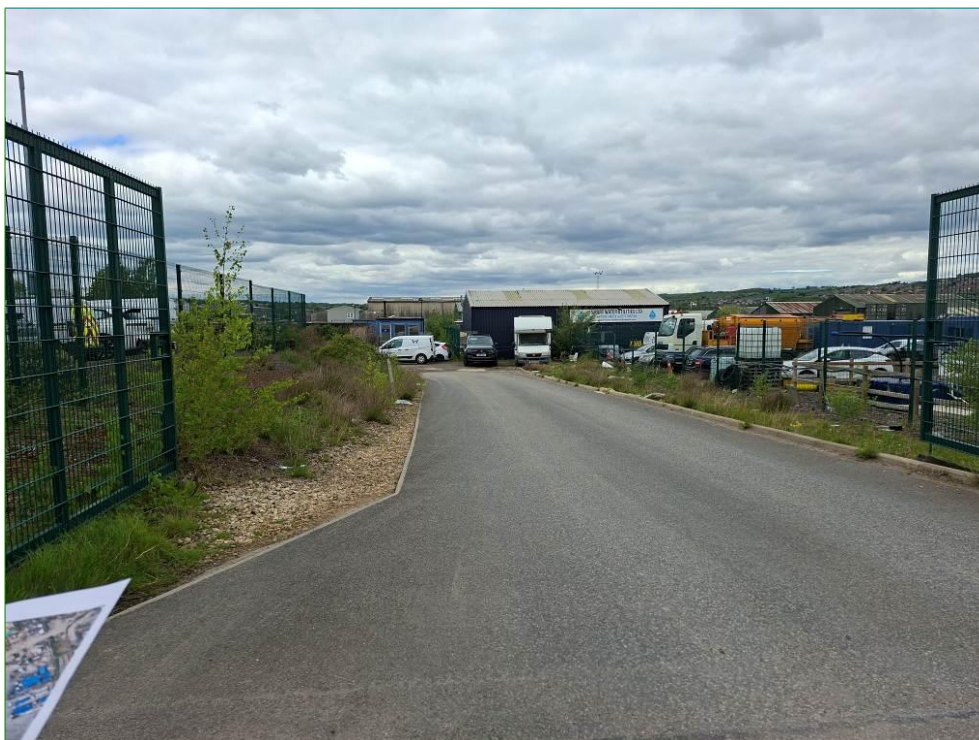
Photograph 1: Southwest Access to West Tenant.

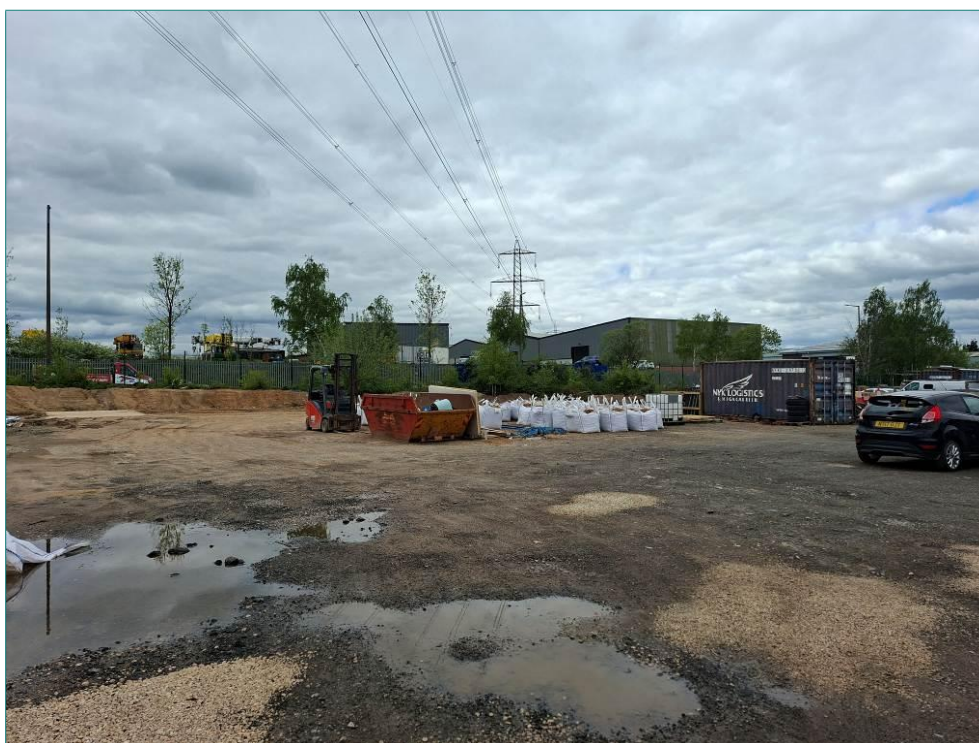
Photograph 2: Western Tenant Compound.

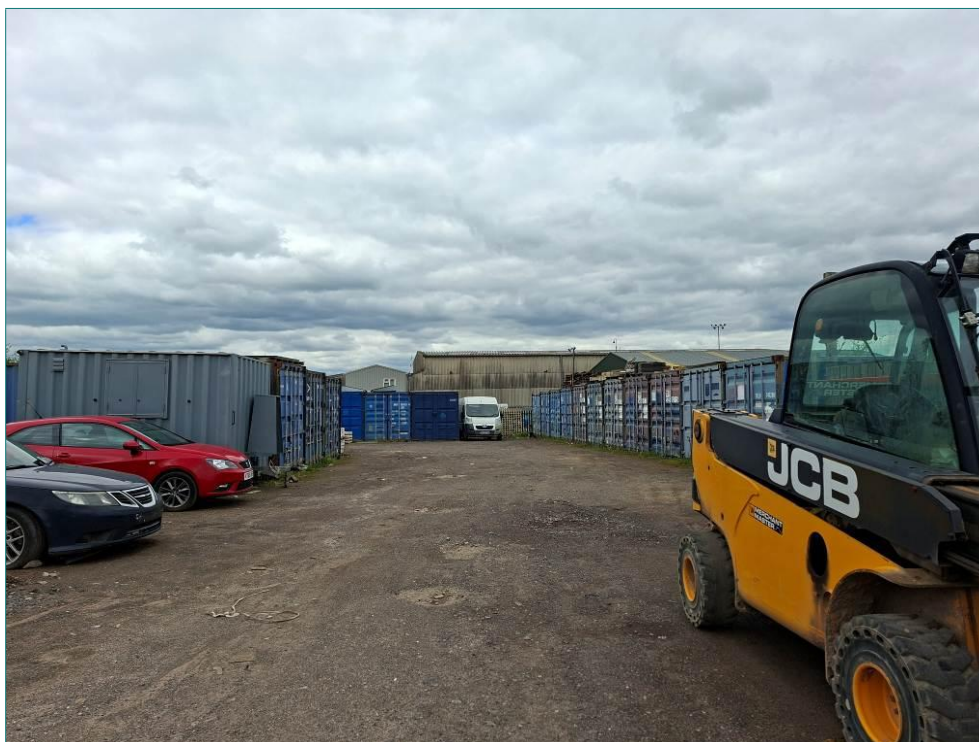
Photograph 3: Western Tenant Compound.

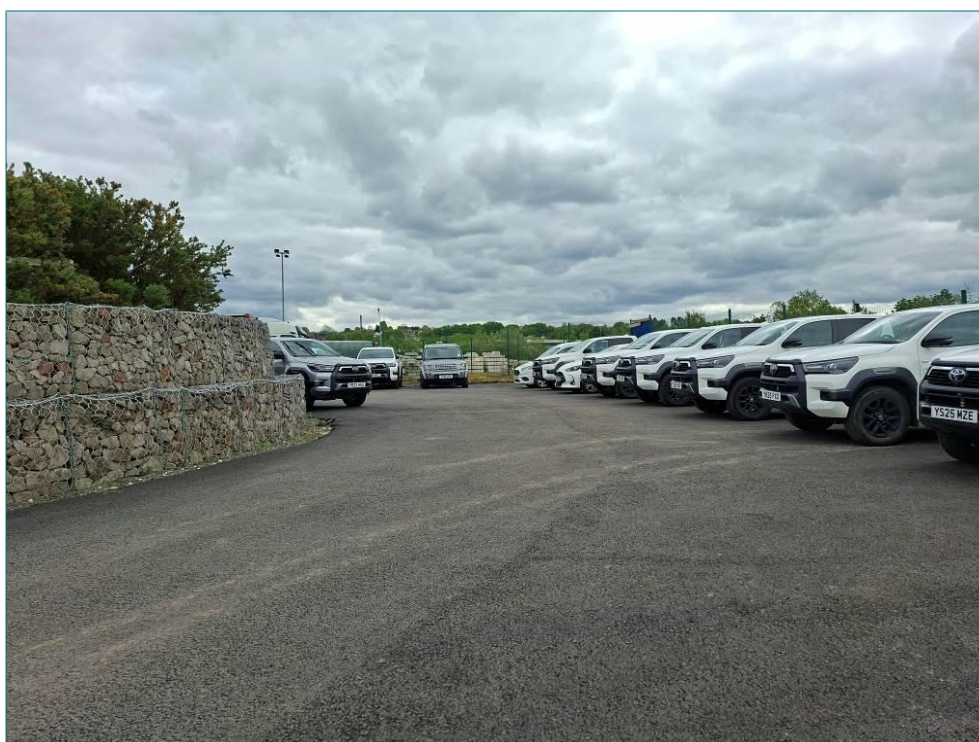
Photograph 4: Southern Car Parking and Pylon Retaining Feature.

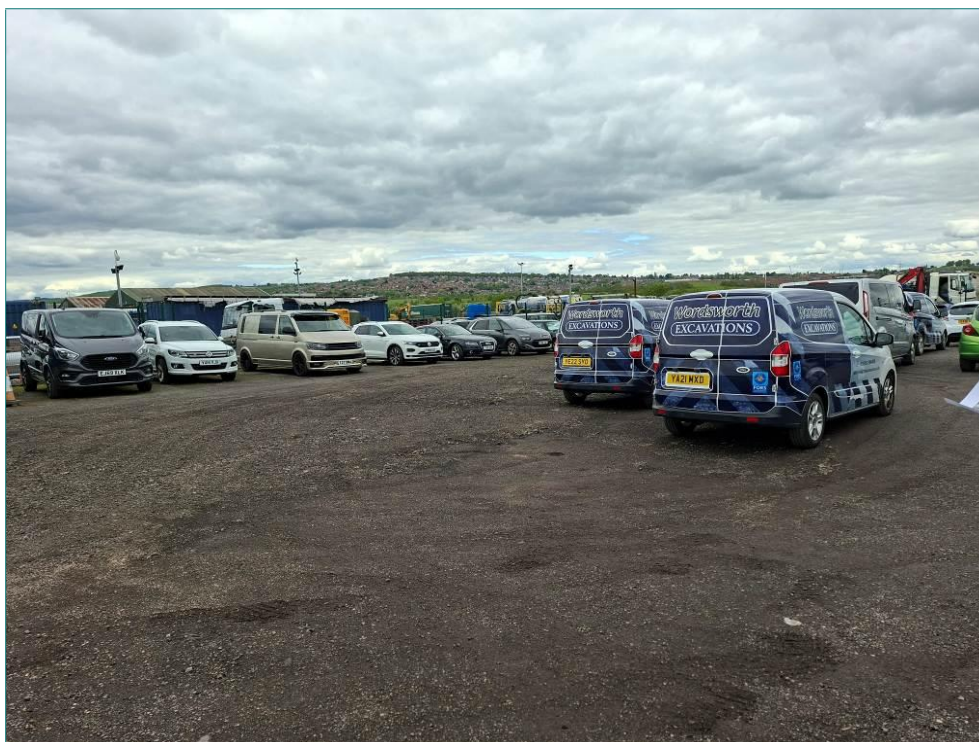
Photograph 5: Southern Car Parking.

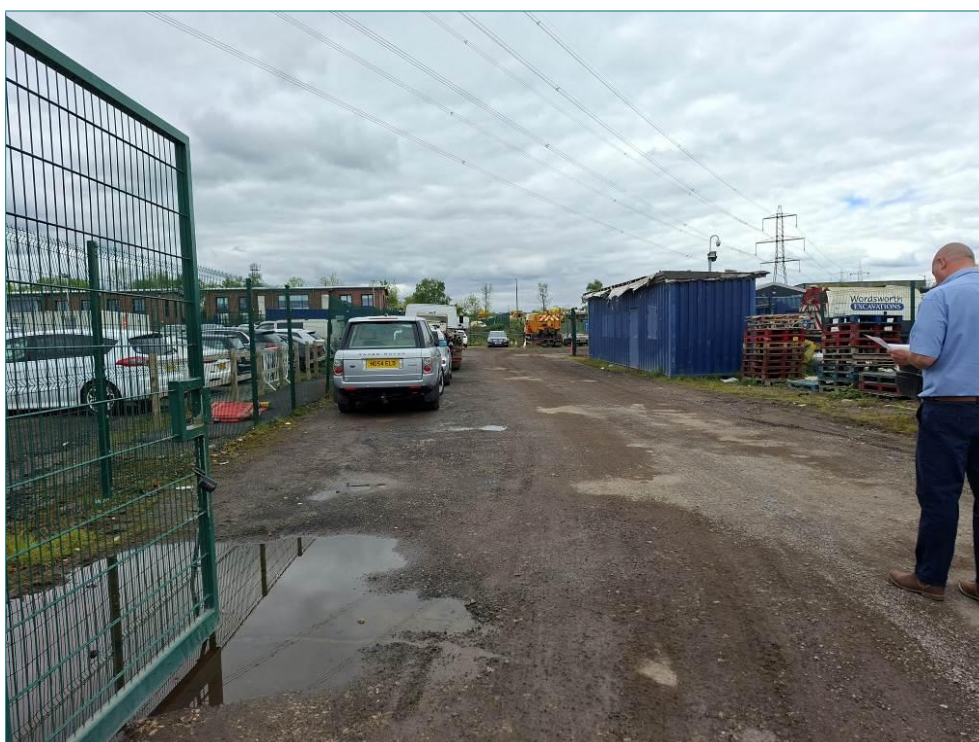
Photograph 6: Entrance to Central Tenant Compound.

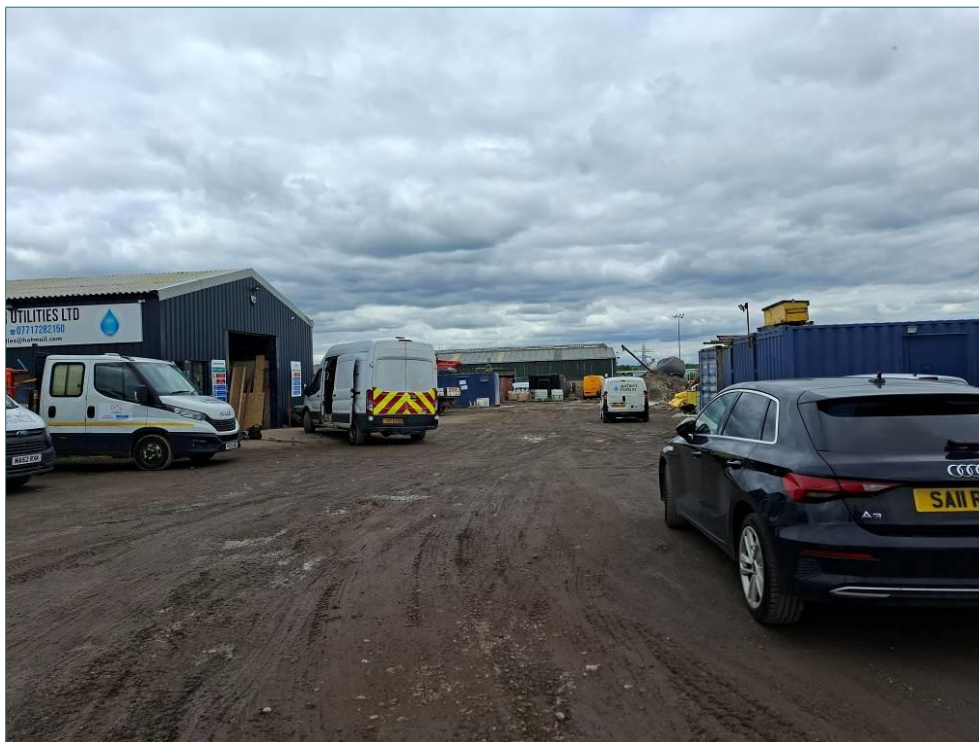
Photograph 7: Central Tenant Compound.

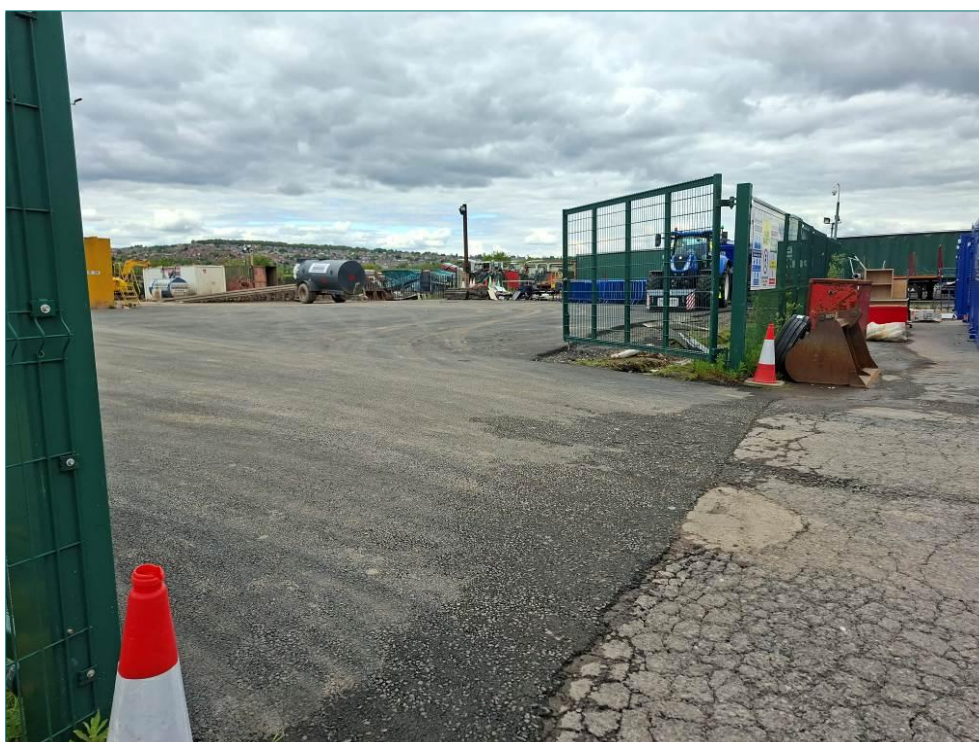
Photograph 8: Entrance to East Compound (Wordsworth).

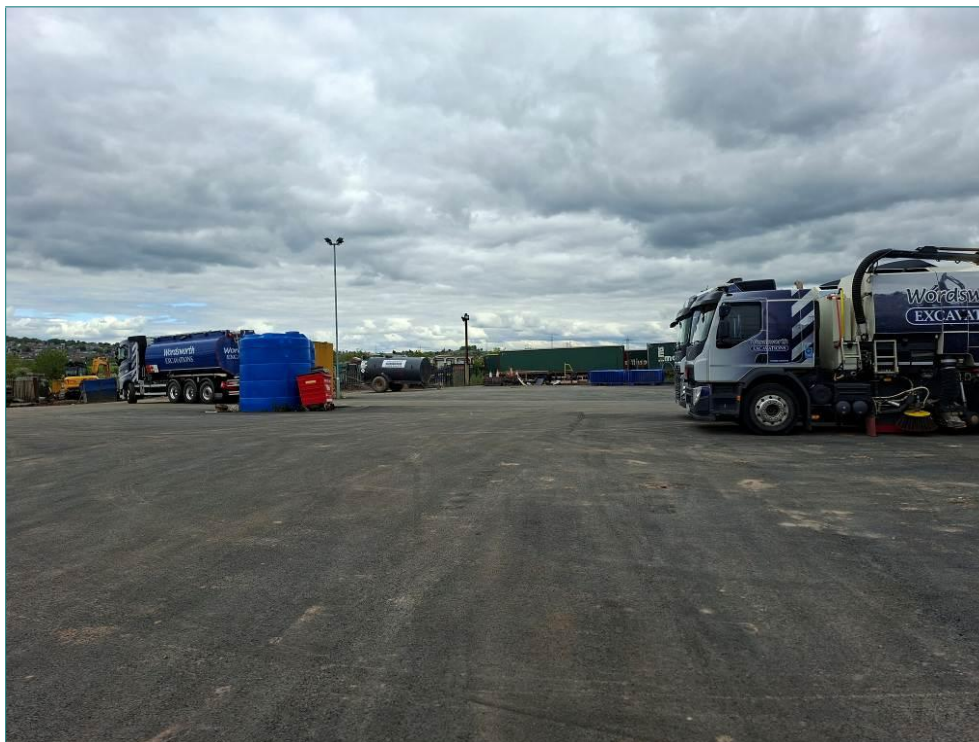
Photograph 9: Wordsworth Compound Area.

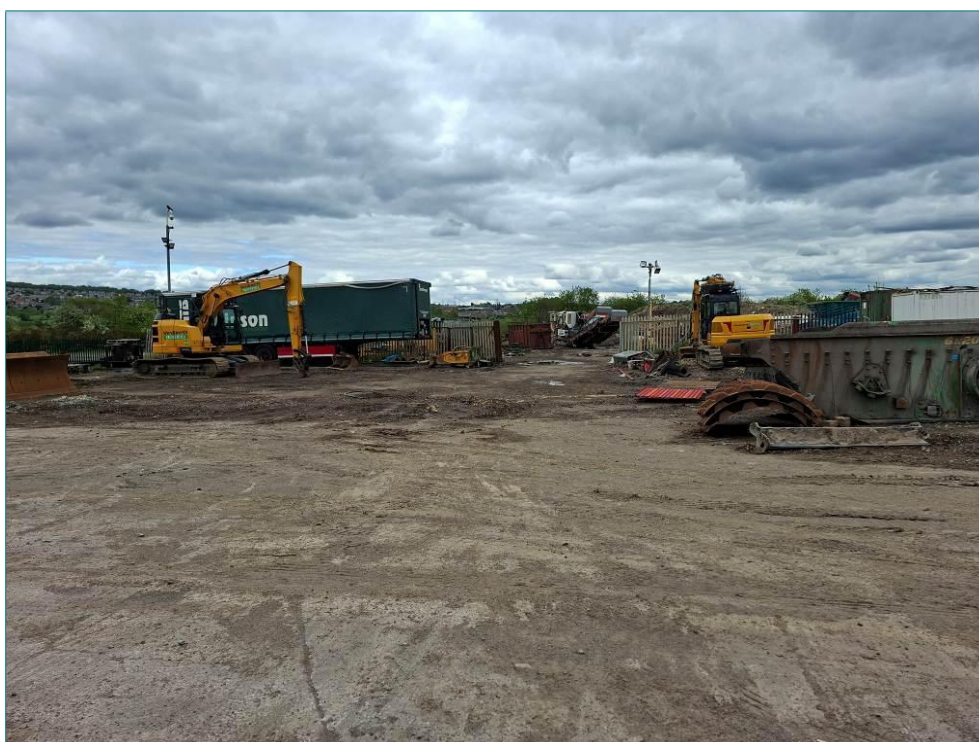
Photograph 10: Wordsworth Compound Looking Northeast, Crushing Area.
