Outbuildings at Annat Royd Farm Ingbirchworth

Bat and Nesting Bird Survey Report

5th August 2020

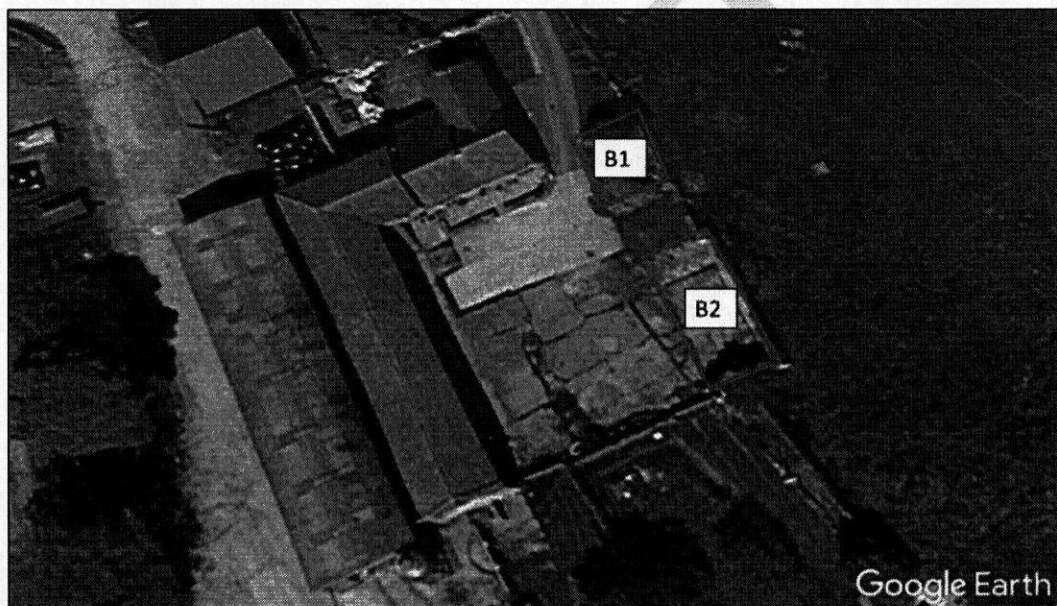
Figure 2. Building plan

5.2.1 For ease of description, the two buildings have been numbered and are shown in Figure 2.

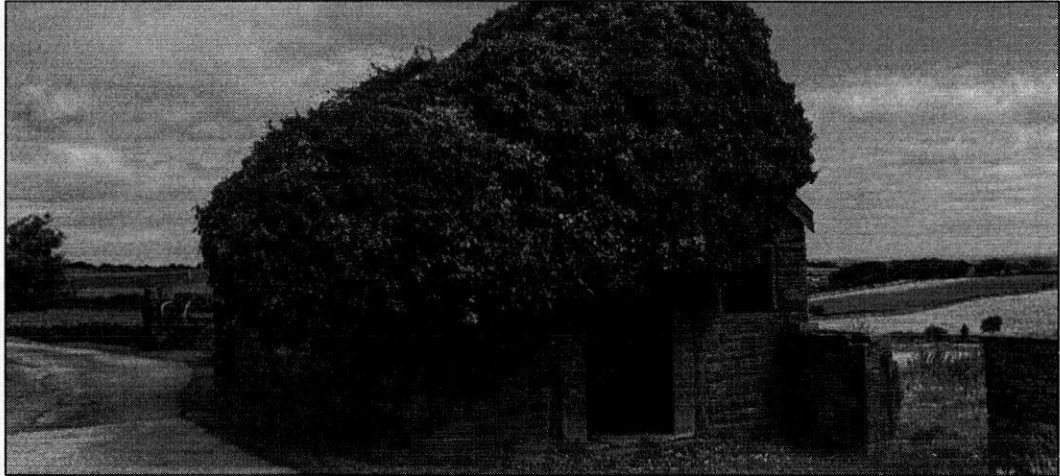
5.2.3 Building 1 comprises a c.5m x 5m 19th Century stone-built single-storey outbuilding with a pitched corrugated asbestos sheet covered roof (Plates 1 & 2). The building's walls are solid stone and the roof has wooden barge boards. An open door and two open window frames are present in the southeast gable, with a part-boarded window opening in the northwest gable. The building has extensive ivy *Hedera helix* cover on the southeast gable with extensive Russian vine *Fallopia baldschuanica* cover on the northwest gable.

Plate 1. South corner of B1

- 6.3.4 Demolition of B1 will either need to be undertaken outside the bird nesting period (March to September inclusive) or the works will need to be preceded by a nesting bird check undertaken by an experienced ecologist.

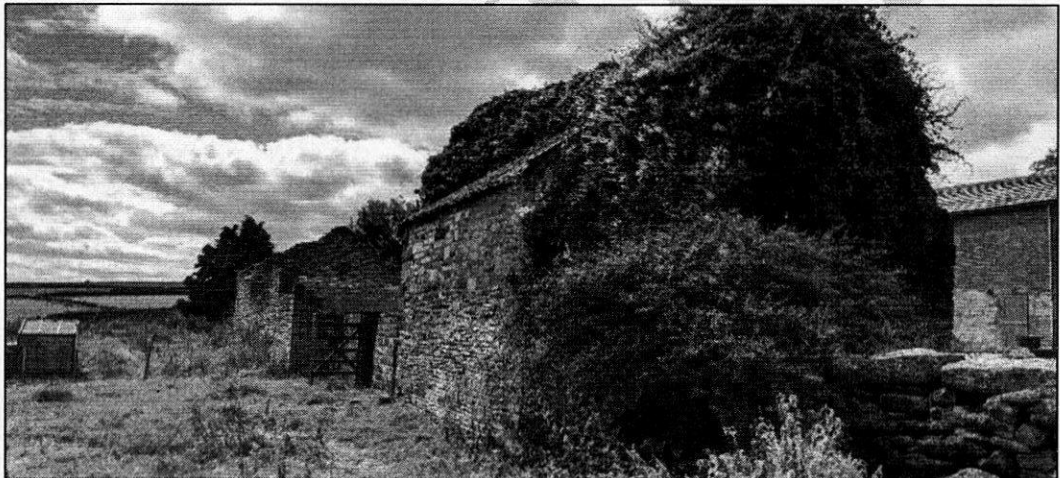
Plate 2. North corner of B1 with B2 in left of image

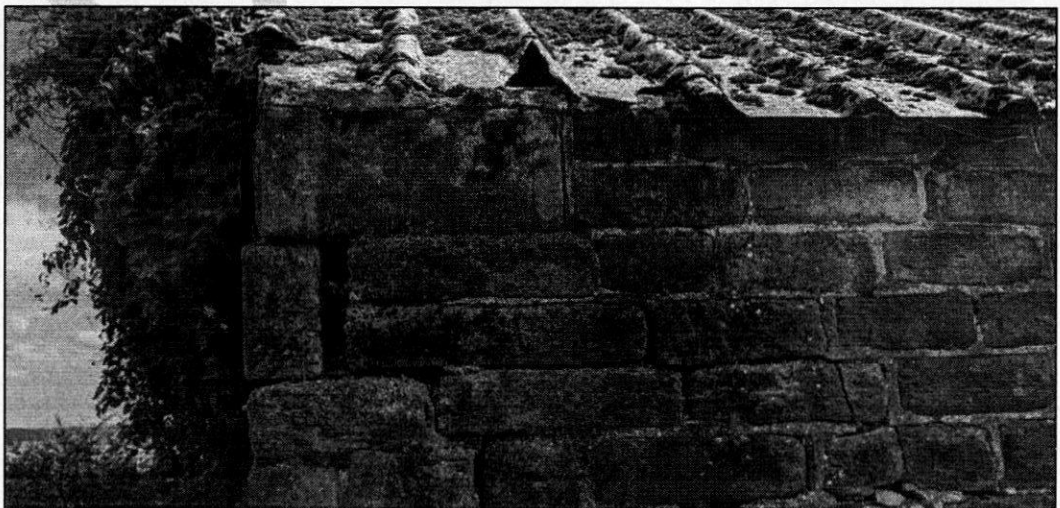
5.2.4 Potential bat roost features on the exterior of B1 comprise occasional and mainly shallow open joints (Plate 3) and access to the wall tops. No suitable crevices between ivy stems and masonry were noted during the inspection.

Plate 3. Example of open joints and access to wall top on B1

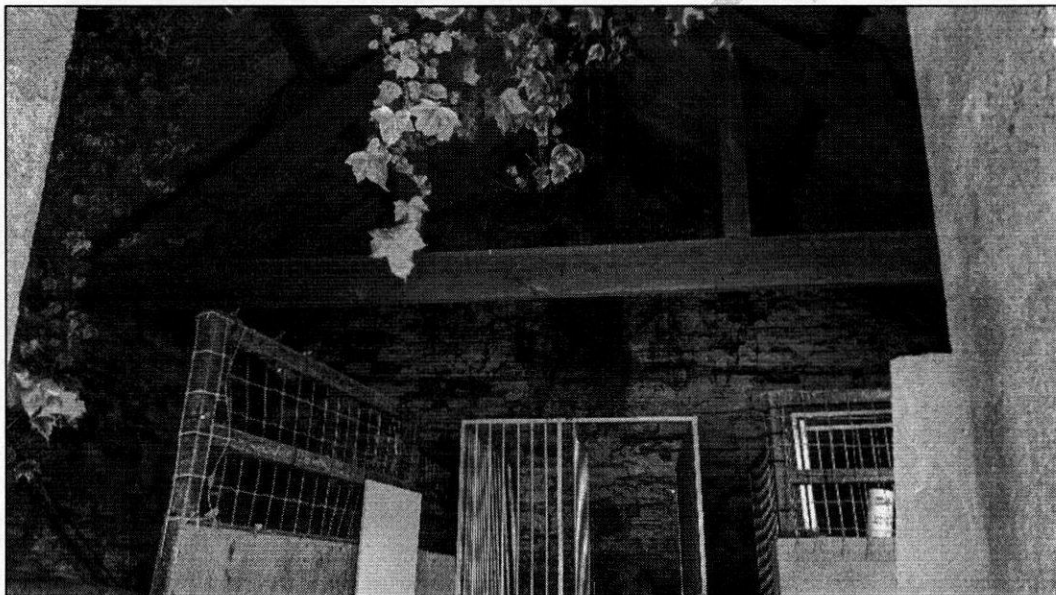
- 5.2.5 Internally, the unlined roof of B1 is suspended on one central king-post roof truss and wood purlins. The building is used as kennels with two metal dog cages and other small areas for storage. Single broad diameter horizontal timbers are built into both gables with the internal walls largely white-washed.
- 5.2.6 A low number of crevices associated with masonry joints are present on the interior of the building, with a crevice above the timber within the southeast gable. A single disused swallow *Hirundo rustica* nest was also recorded on the roof truss. It was notable that numerous swallows were actively nesting in a section of the main barn (outside survey area) at Annat Royd Farm, at the time of survey.

Plate 4. Interior of B1

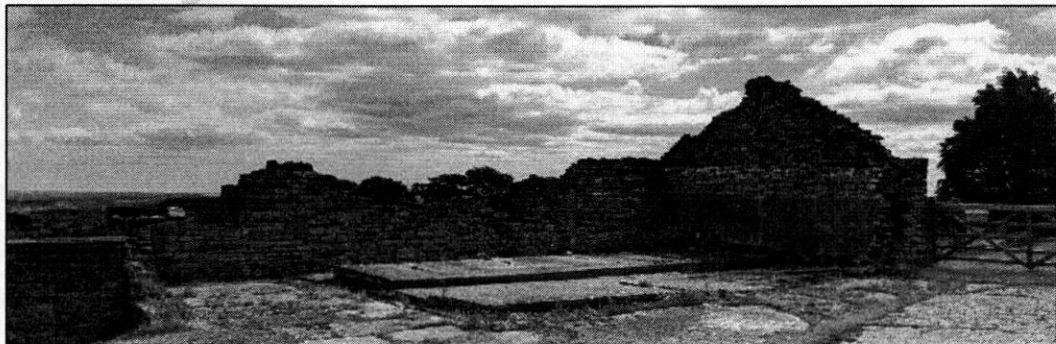
- 5.2.7 Building 2 comprises a part demolished stone dairy that now comprises two remnant solid-stone walls, with an average height of c.2m. The wall tops are exposed allowing weather ingress to the wall's core which is likely to result in unfavourable conditions for roosting bats. There are numerous open joints between masonry however these were found to mainly quite sandy and lacking significant bat roost potential.

Plate 5. East corner of B2

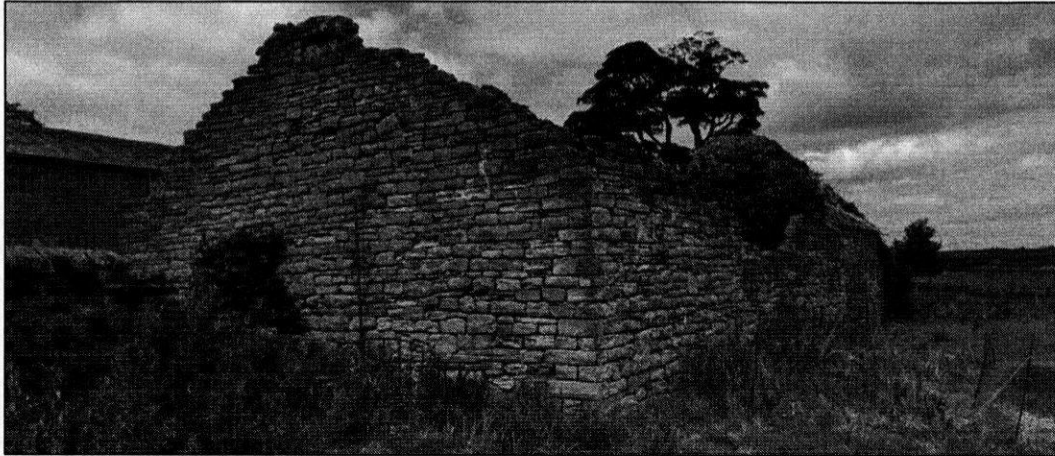
Plate 6. West corner of B2

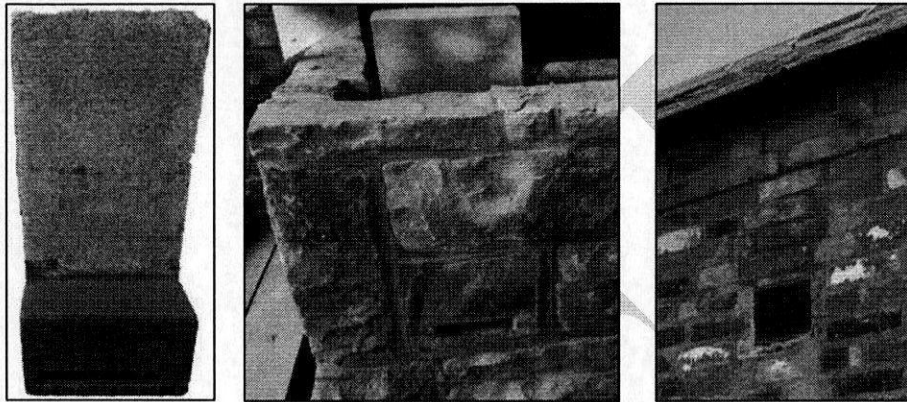
Plates 7, 8 & 9. Build-in WoodStone Bat Box

- 6.3.3 It is recommended that one integrated bat box, of a design such as the Build-In Woodstone Bat Box (Plates 7, 8 & 9), is included at wall top height in a south or west facing elevation of the new building. In addition, house sparrow *Passer domesticus* were noted on site during the survey and it is recommended that an integrated nest box, such as the Vivara Pro WoodStone House Sparrow Nest Box (Plate 10), is installed in a north or east facing elevation of the new building.

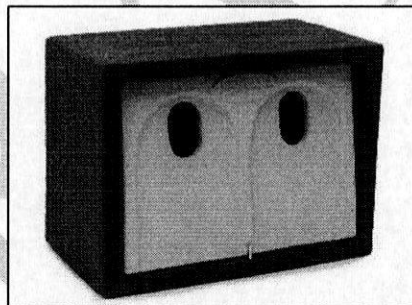
Plate 10. Vivara Pro WoodStone House Sparrow Nest Box
