**DESIGN & ACCESS STATEMENT**

**FIELD BARN  
OFF HERMIT HILL LANE, WORTLEY**

**PROPOSED CONVERSION OF REDUNDANT STONE FIELD BARN  
TO A SINGLE TWO BEDROOMED HOLIDAY COTTAGE**

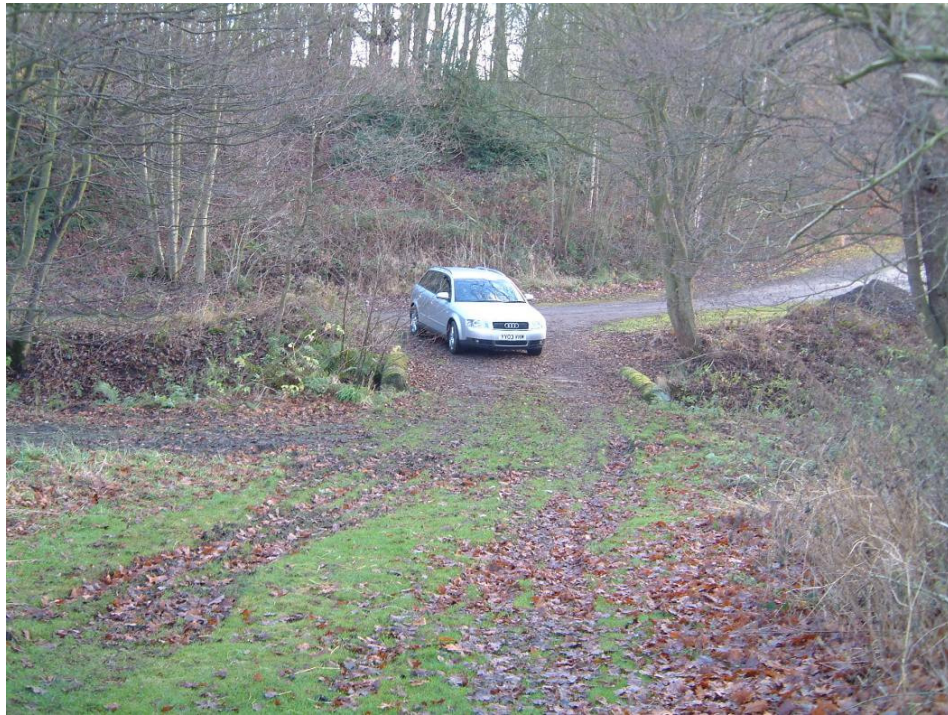
**1. Existing vehicular access to field barn from private drive via bridge over adjoining stream through Hollins Wood**

Access to the holiday cottage would remain as existing, from the private drive linking Hermit Hill Lane with the residential properties at Dyke Bottom, via a bridge over the adjoining stream, and through an existing field gate. Independent parking for two cars would be located just over the bridge, within Hollins Wood to the right hand side of the vehicular track where a natural clearing exists. From the parking area, access to the barn would be pedestrian only through the adjoining field alongside the existing stone field boundary wall as described and detailed elsewhere. The pathway to be of sufficient width, 1.8m, to allow for ATV access to transport logs, laundry and guests' luggage.

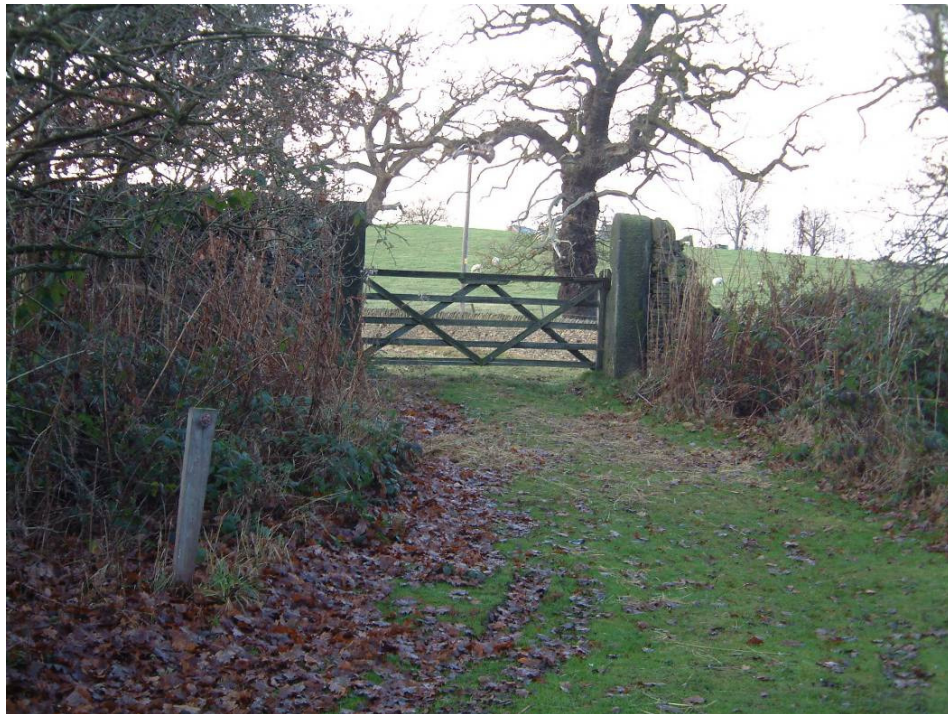
**2. Existing gated vehicular access to field barn from Hollins Wood**

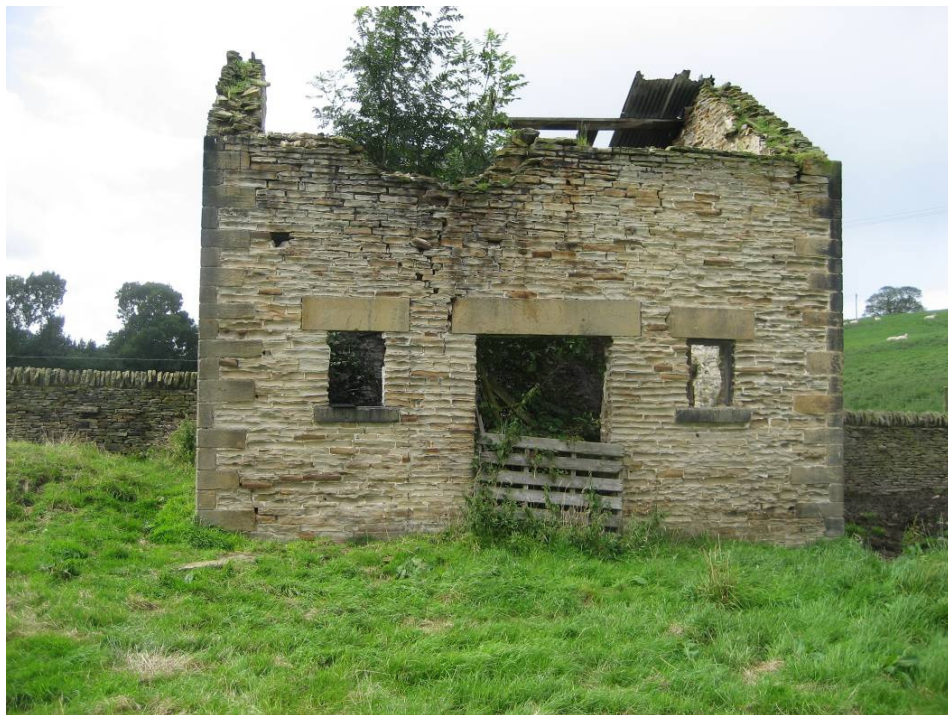
**4. South east elevation of redundant field barn set within the north west corner of the field against existing field boundary walls.**

**The barn, constructed in coursed delph stone with dressed stone lintels, sills and quoin stones, is architecturally attractive and will have originally been constructed as a feature building within the surrounding landscape of Wortley Hall**

The barn, constructed to a high standard as a feature building, to house animals at ground floor with hay storage over, in coursed delph stone with dressed stone lintels, sills and quoin stones, is architecturally attractive and unusual for the area of South Yorkshire being found more typically in the Yorkshire Dales.

The barn is constructed throughout in coursed delph stone walling with dressed stone quoins to the corners and heavy stone lintels and sills to door and window openings. Externally the stonework has suffered considerable weathering. The roof, which was stone slate clad originally and, at a later date clad with steel sheeting, has now collapsed causing localised damage to areas of stone walling through the displacement of supporting timbers.
