project: Far Westhorpe Farm

client: Mr + Mrs Pearson  
drawing: Historic Barns #7+#8  
Work to historic fabric

drawing number: **24-39-304**

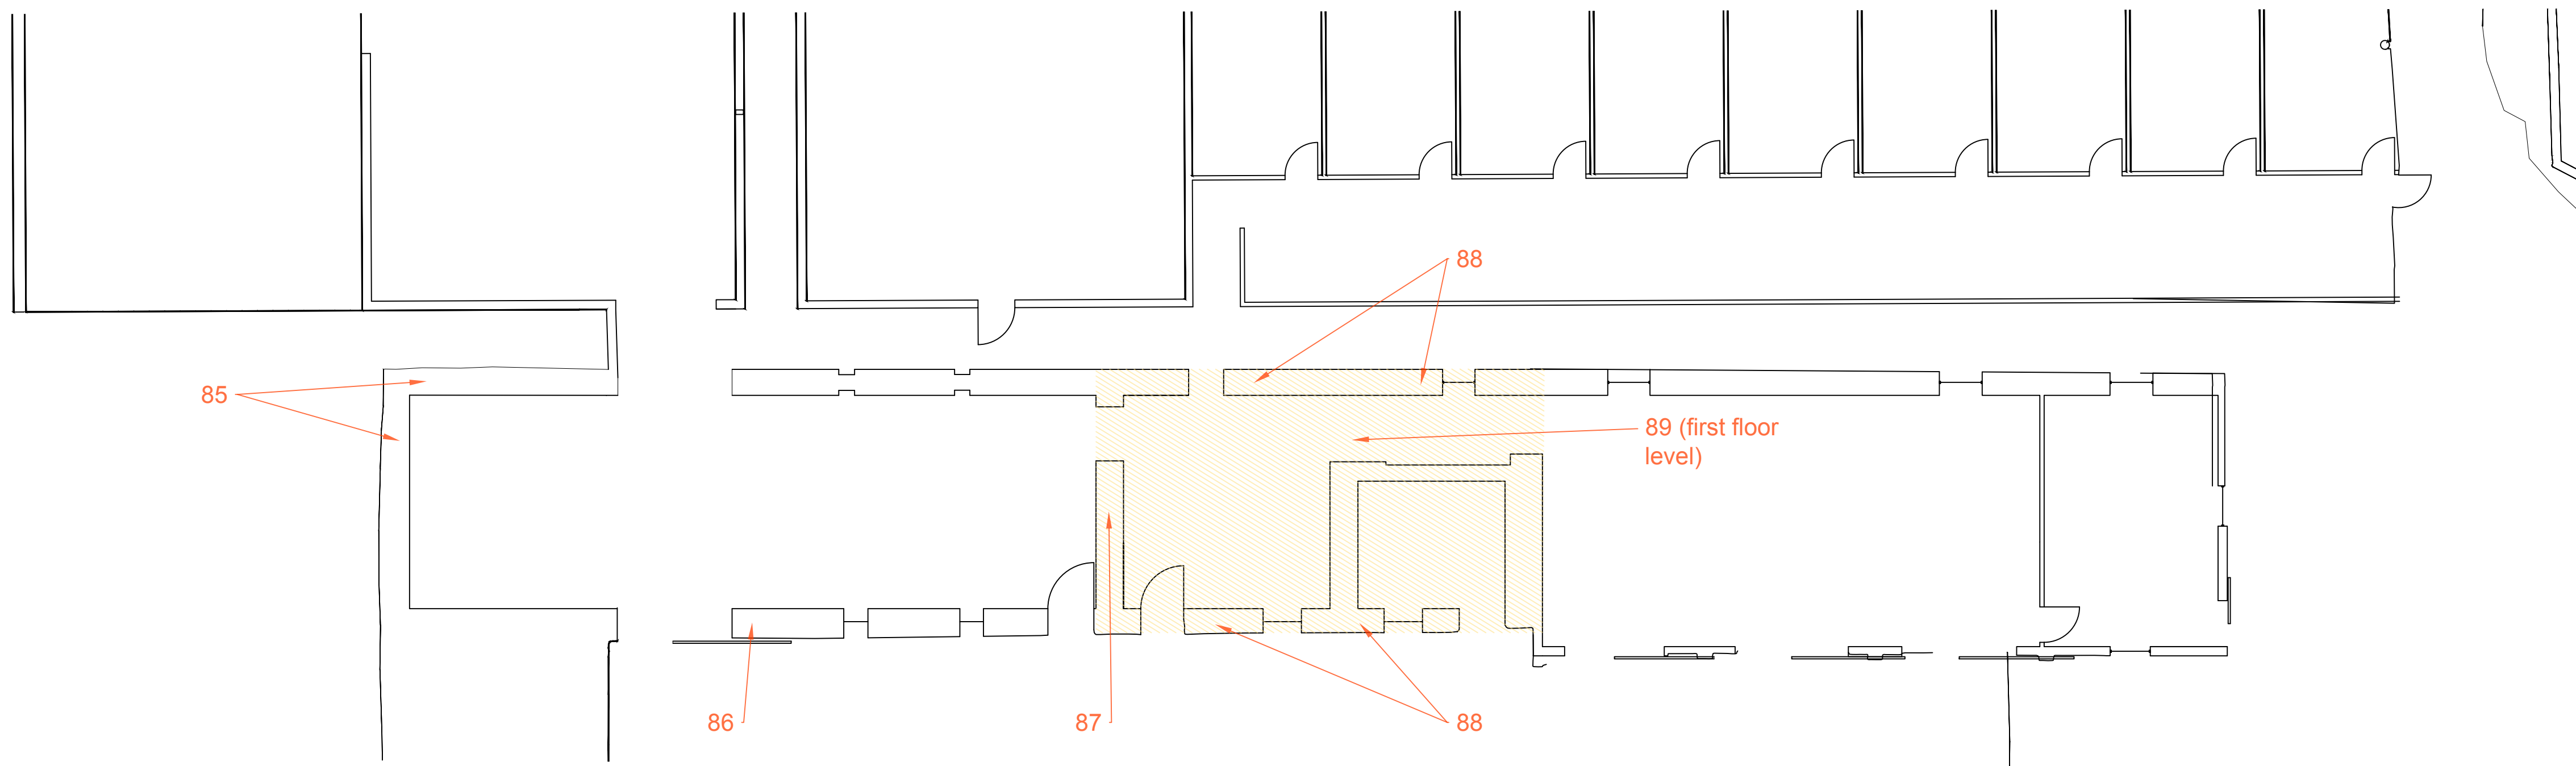
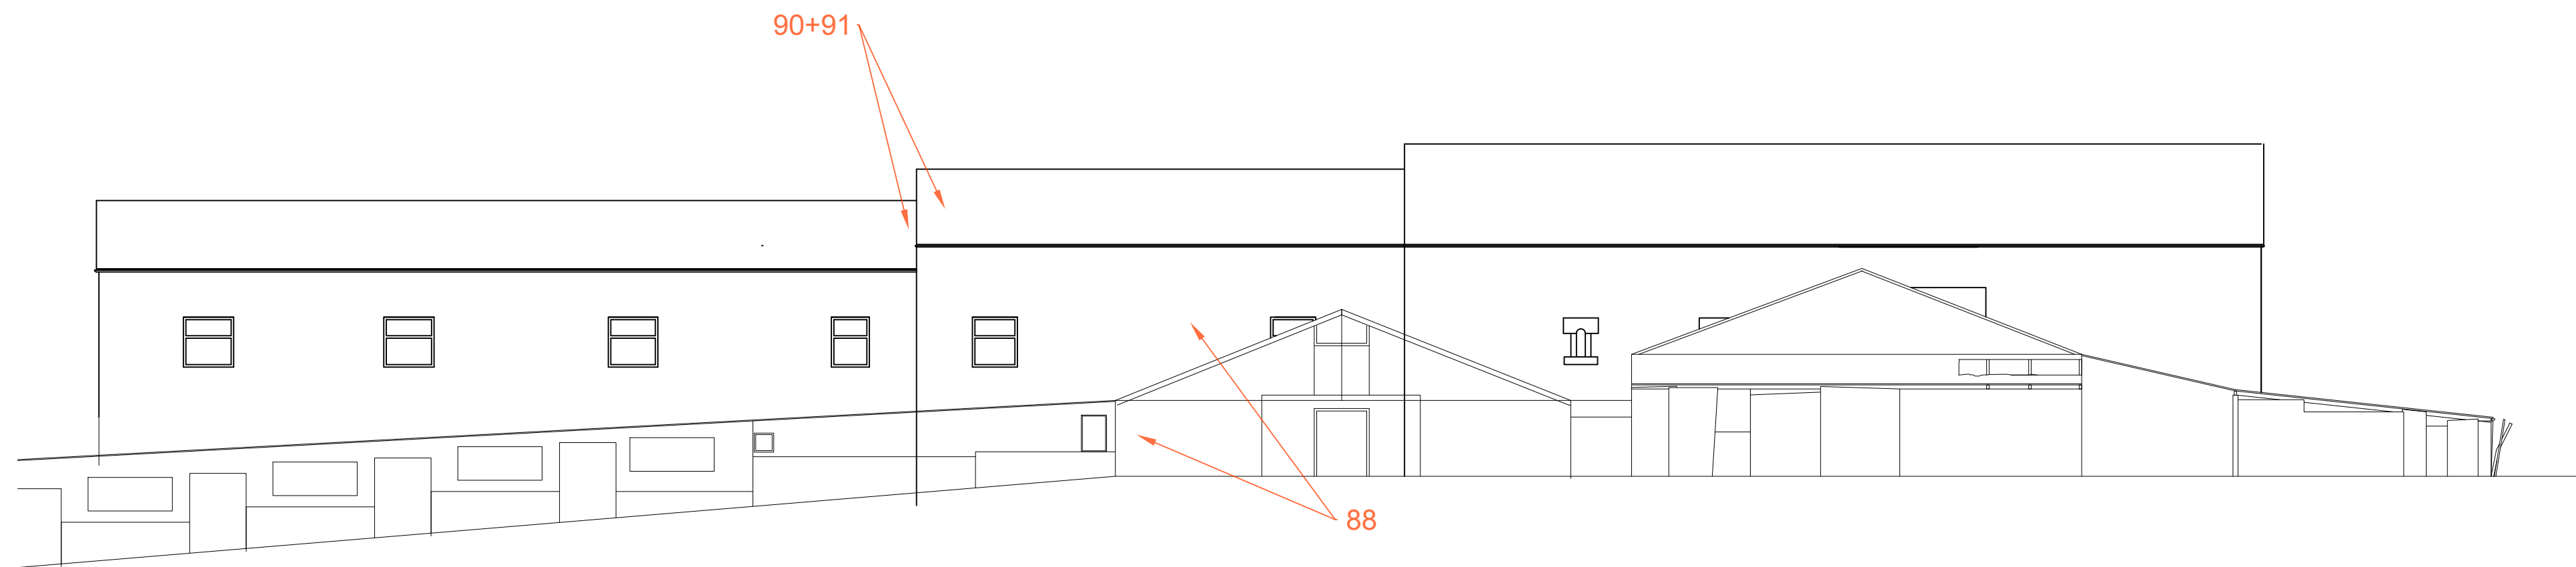
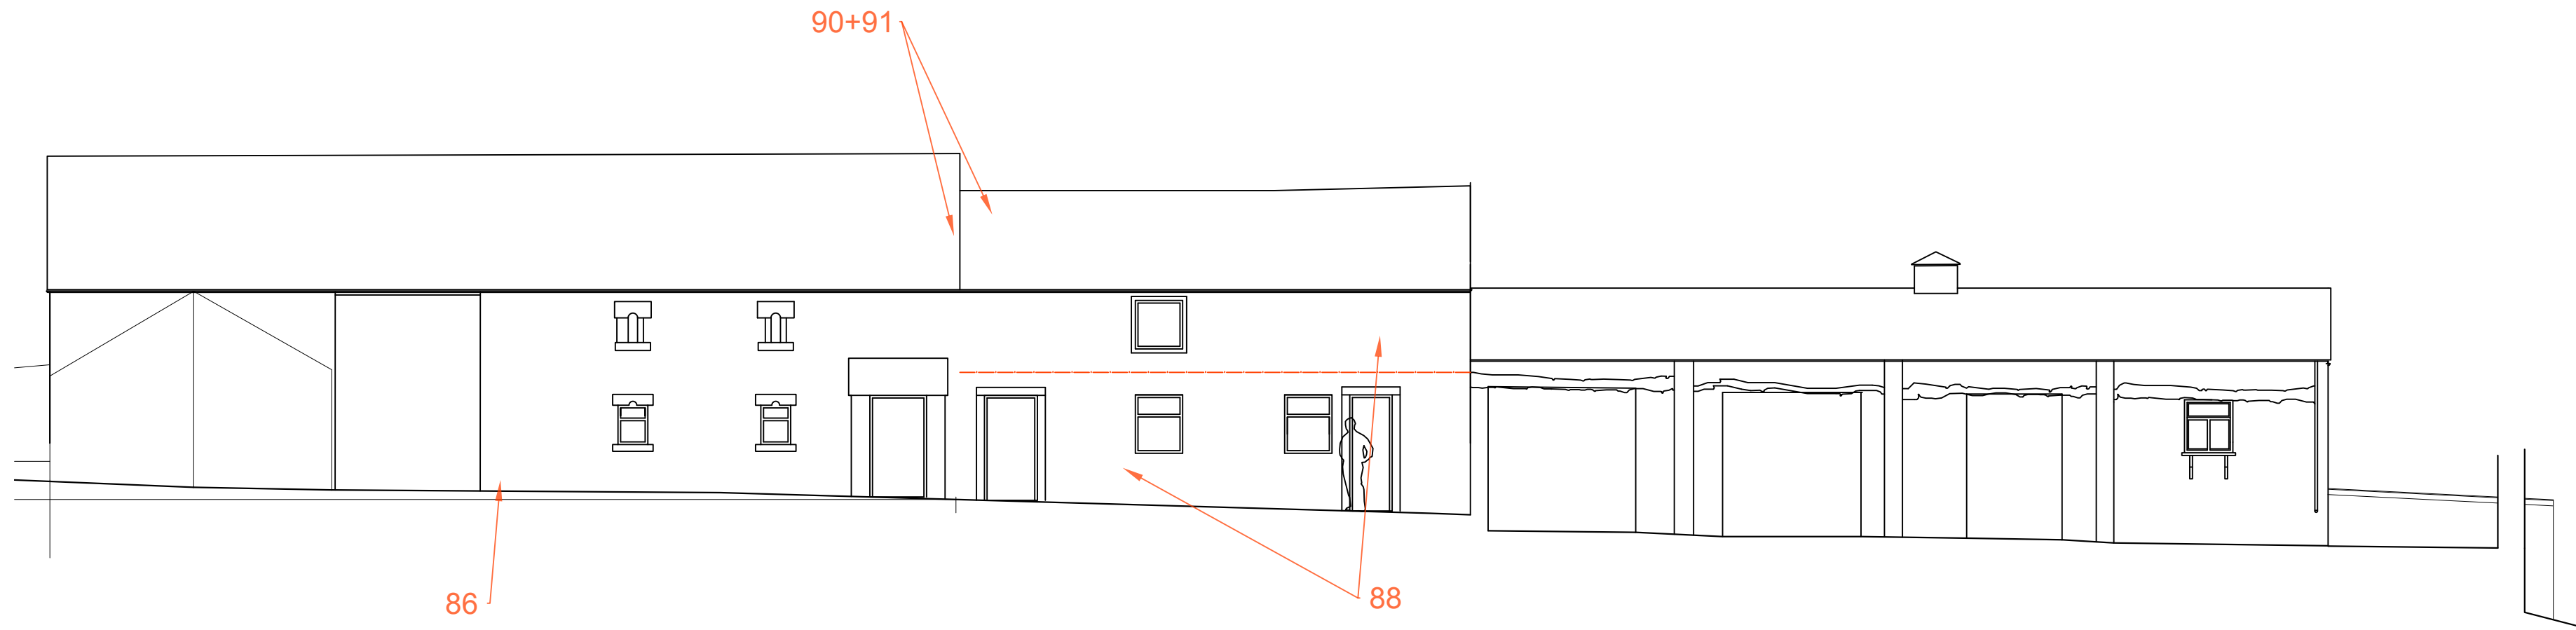
85. Bulging external wall wall in Barn #7 carefully removed and rebuilt using the salvaged stone throughout, with new footing if required.
86. Local underpinning to the jamb of the main door opening.

87. Internal gable wall in Barn #7 to remain in place, with local repairs and strengthening to detail / approval.
88. External walls of Barn #8 carefully removed and rebuilt using the salvaged stone throughout, with new footing if required.

89. Local repair to the head of the archway in the intermediate wall in Barn #8.
90. Specialist inspection of roof timbers to be carried out for beetle and fungal attack and check calculations. Timbers replaced as required for structural safety.

91. For both barns, corrugated cementitious roofing sheet carefully removed for disposal according to the material type. New roof covering provided of natural slate, on softwood battens, on permeable underlay supported by new carcassing, retaining as much of the timber primary structure as possible.
