Northern Academy of Vocal Excellence, Barnsley

Bat Roost Suitability Assessment & Interim Emergence Survey

14/09/2023

Currie & Brown

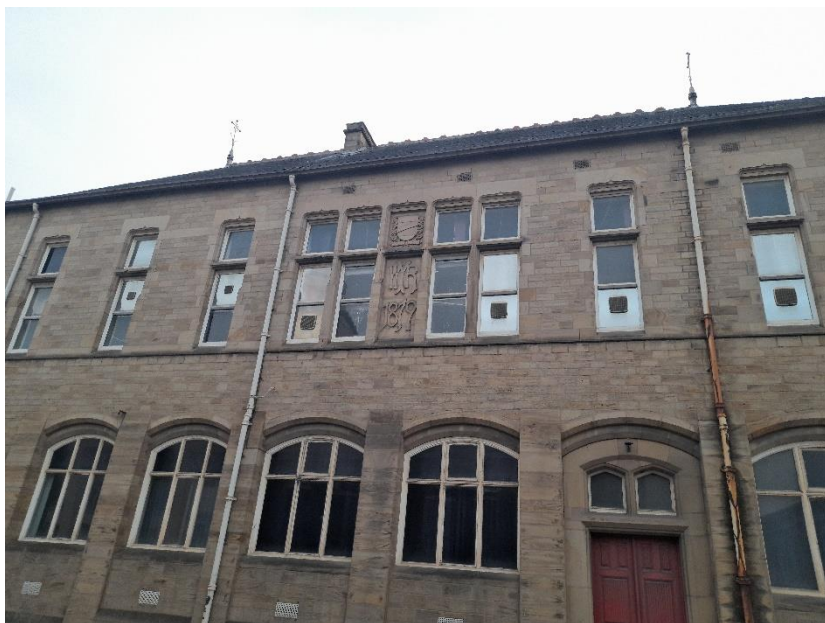
18. The Site comprises a single building of dressed sandstone construction, 2–3-storeys high, and numerous hipped or double-pitched slate-tiled roof sections. The building has a three-storey turret reminiscent of a belfry on its northeastern corner, with a steeply-pitched slate-tiled conical roof. Construction was completed in 1879, as evidenced by the engraving on the building's eastern elevation.

Figure 2 Surveyed building.

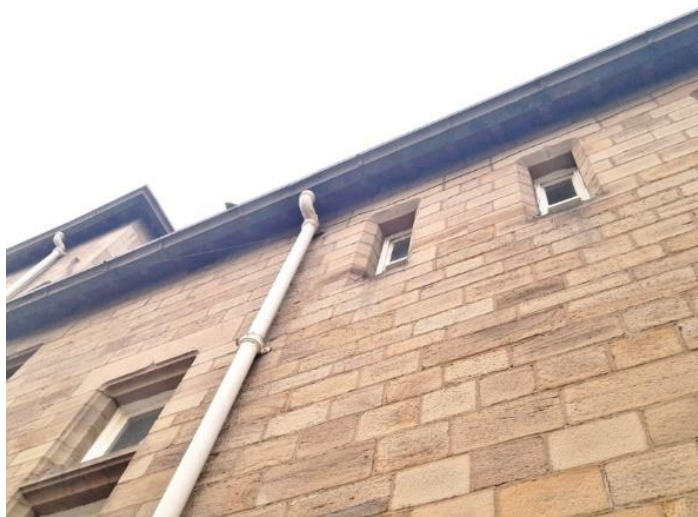
21. Open, overhanging eaves are present on all elevations of the building and may offer potential access to wall tops and internal roof voids.
22. While the roofs are in generally good condition, some of the tiles were noted to have slipped, offering PRFs for individual crevice-roosting bats.
23. Occasional peeling was noted of the lead flashing at the junctions of rooves and brickwork, offering further PRFs for individual bats.
24. Metal guttering runs along all faces of the building, but sits flush with the eaves, offering no additional gaps which may function as PRFs.

Figure 4 Overhanging eaves on south elevation, typical of all elevations; metal guttering also visible.

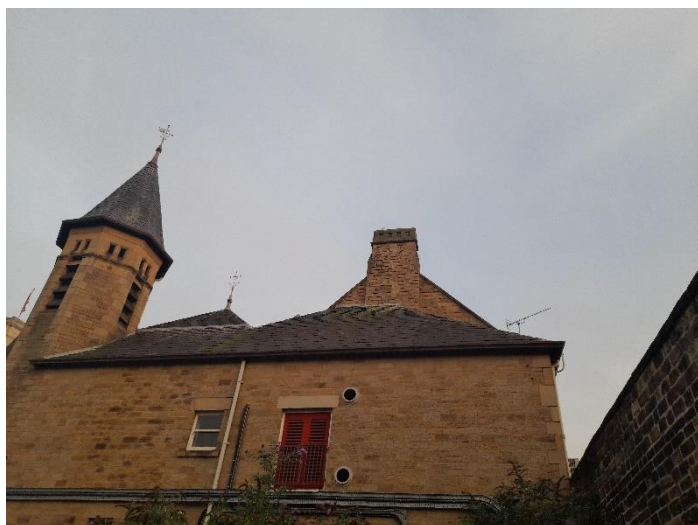
Figure 5 Northern roof showing slipped tiles and peeling flashing.

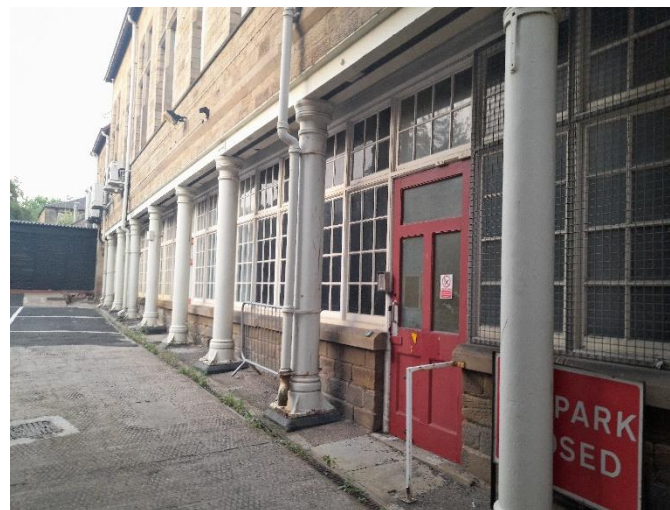
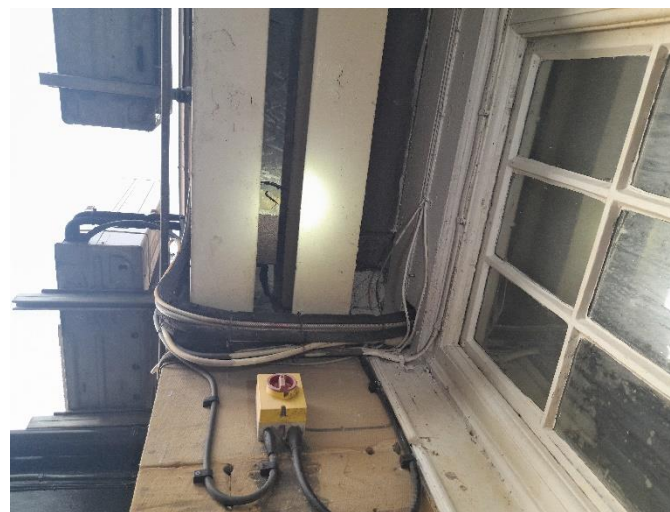
25. The western ground floor of the building supports a colonnade, with the building set slightly back relative to the upper floors. The columns support a pair of metal beams with concrete between, which is largely intact, but features two small gaps at the northern end which appear to lead up into a cavity wall space. This may act as a PRF for crevice-roosting species.

Figure 6 Colonnade; gaps between metal beams.

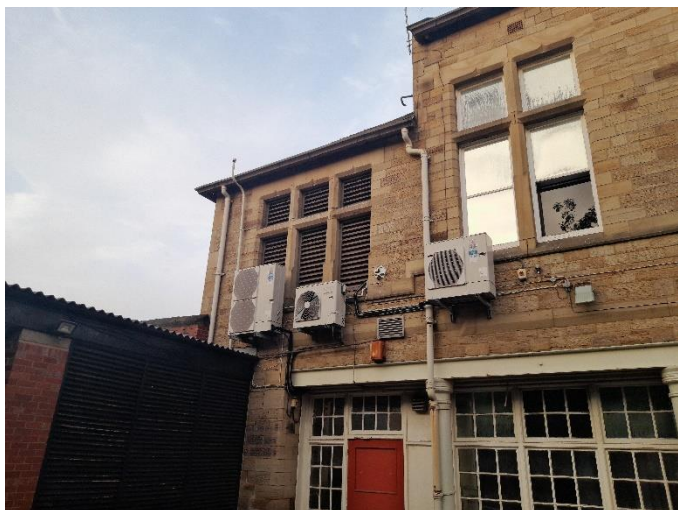
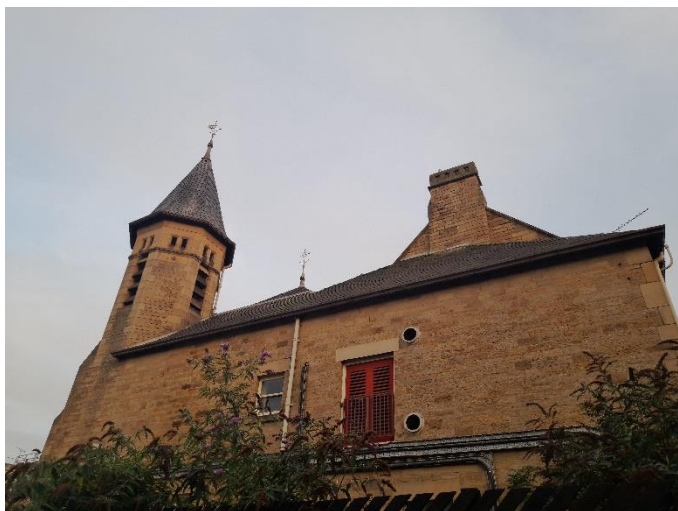
26. The western and northern elevations support several louvred vents and vented doors, with more present on the turret. These form PRFs for moderate numbers of crevice-roosting bats and may also provide access into the building's internal structure. Additional metal vents likely link to metal ducts inside the building, and so offer minimal roost suitability.

Figure 7 Louvre vents on western and northern elevations.

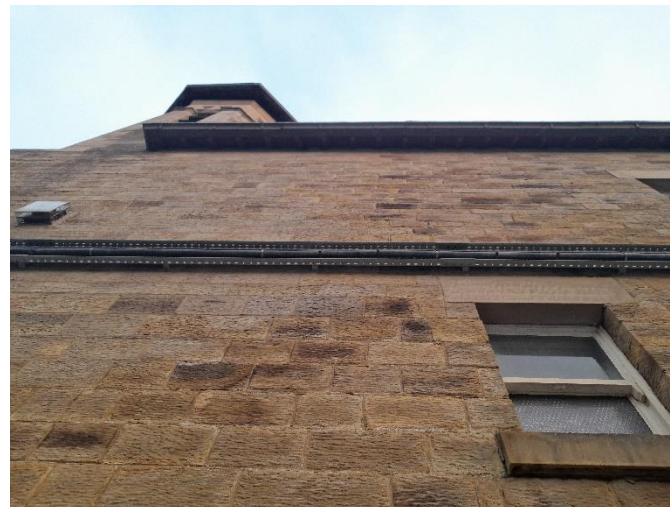
27. The northern elevation also supports a metal duct, which is closely-fitted to the stonework and supports no PRFs; and a vented ground-floor window which, given its low elevation, is unlikely to act as a PRF.

Figure 8 Duct and vented window on northern elevation.

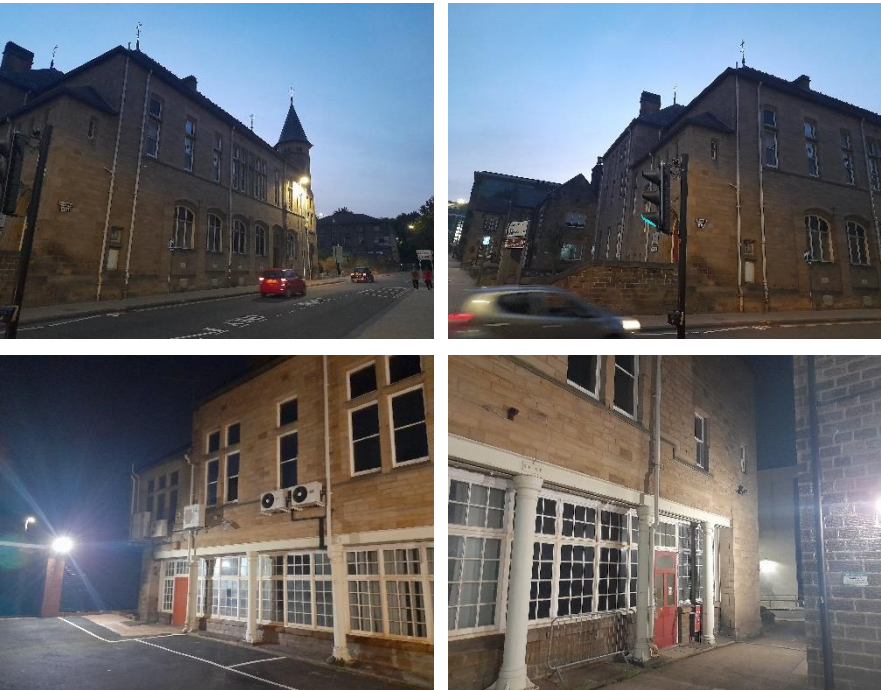
28. The building is moderately well-lit at night by nearby streetlamps. However, this lighting is focused primarily on the ground floor, with the upper floors and rooves largely unlit.

Figure 9 Nocturnal illumination around the building.
