28<sup>th</sup> May 2026

Our Ref: C10128A/AL/11206

**Re: C10128A, Woolley Colliery Road, Darton - Supplementary Ground Investigation Letter Report - Southern Site Area**

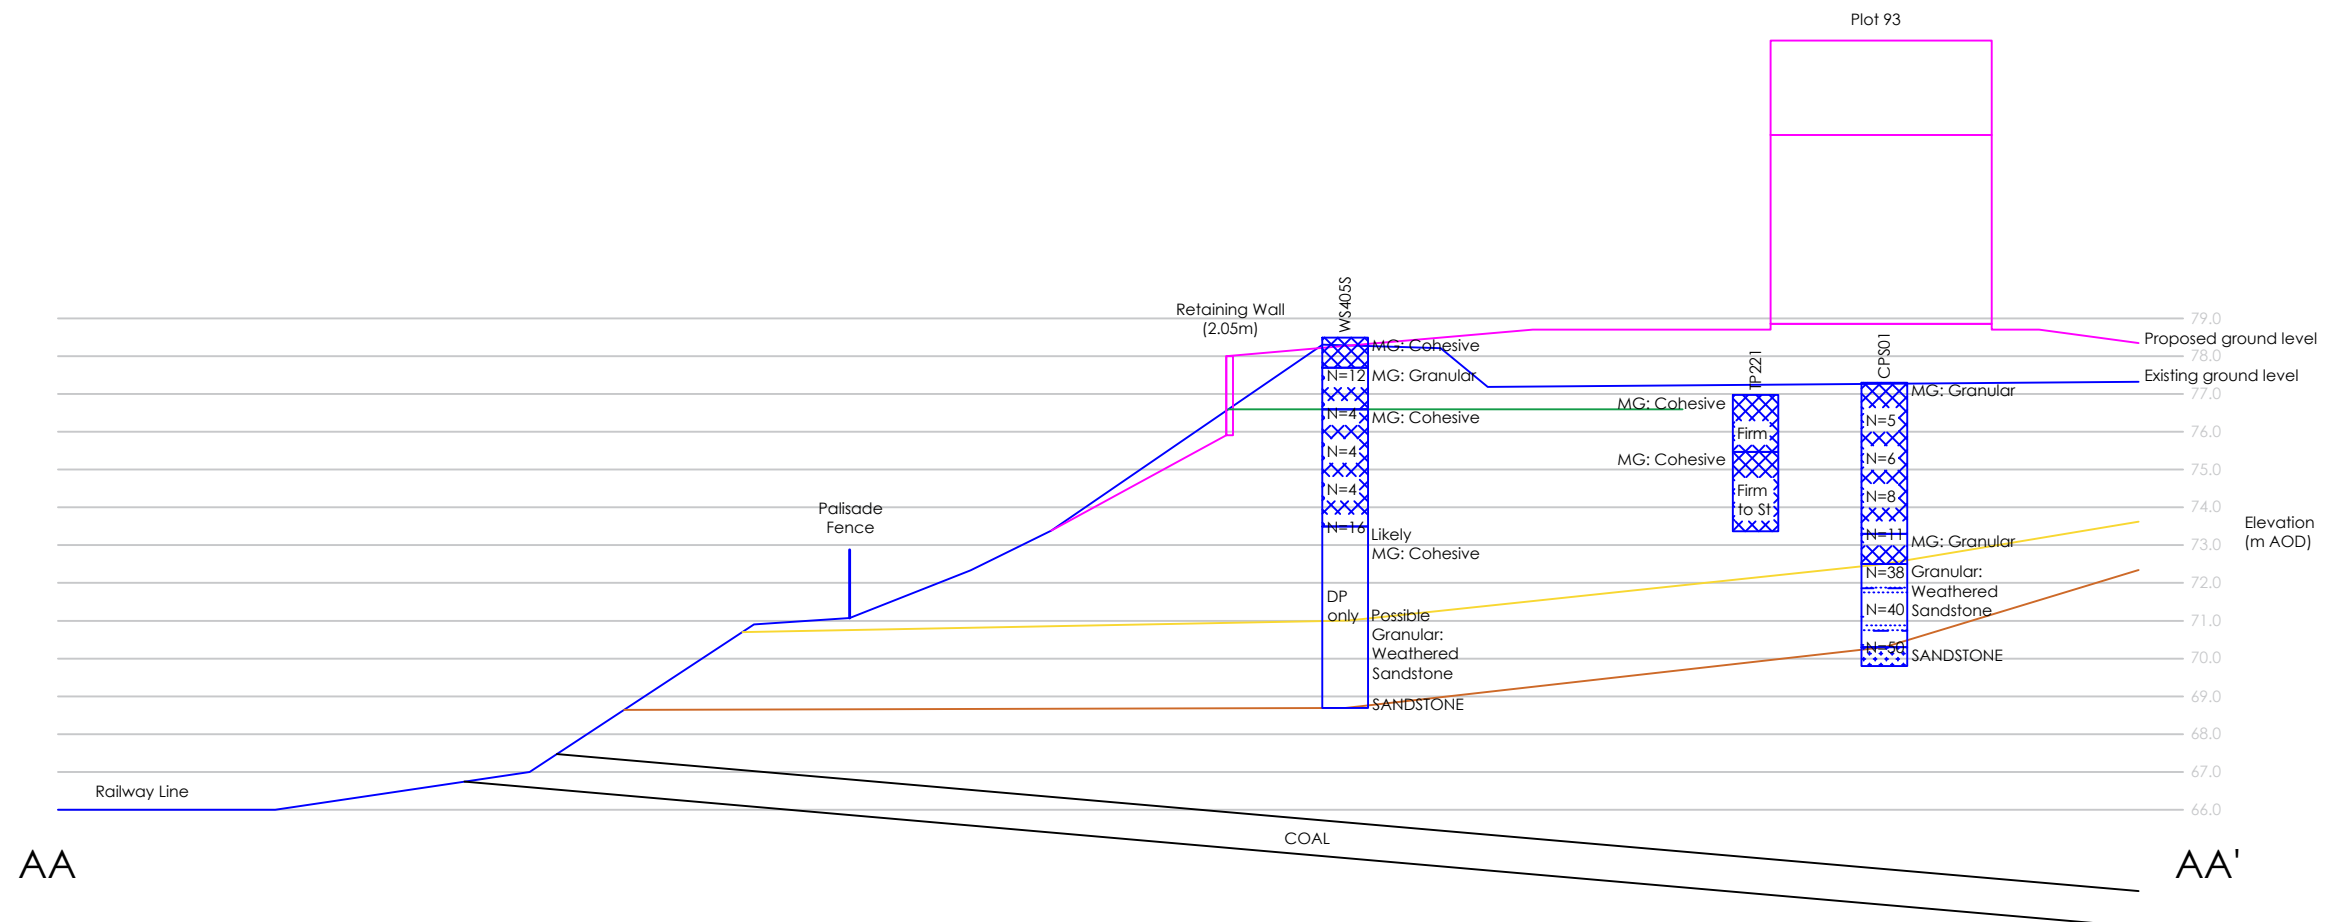
DRAWING NO. C10128A/S/04	REVISION NO. 0
DRAWN BY AL	APPROVED BY AMG
DATE May 2026	SCALE 1:200
	PAPER SIZE A3

**Slope Stability Cross Sections**

Therefore, due to the changed circumstances of greater ground raising, and identified poorer ground conditions in the vicinity of the slope, this assessment has been undertaken on the area of identified deep low strength made ground, which is also coincident with the area of proposed greatest ground raising. Two updated cross-sections were therefore produced (Sections AA-AA' and BB-BB'), for the section of slope opposite Plots 93 and 94 respectively (see Drawing No. C10128A/S/04 for an illustration of the sections, including their locations).

Cross-sections at these locations were compiled for both the existing and the proposed scenarios (i.e. including proposed ground raising). As per the previous assessment, it has been assumed that the proposed buildings will be supported on piled foundations, and loads imposed by the buildings will not be transferred onto / into the slope. It should however be noted that the addition of a retaining wall into the proposed scheme will have significant implications, which are discussed further below.

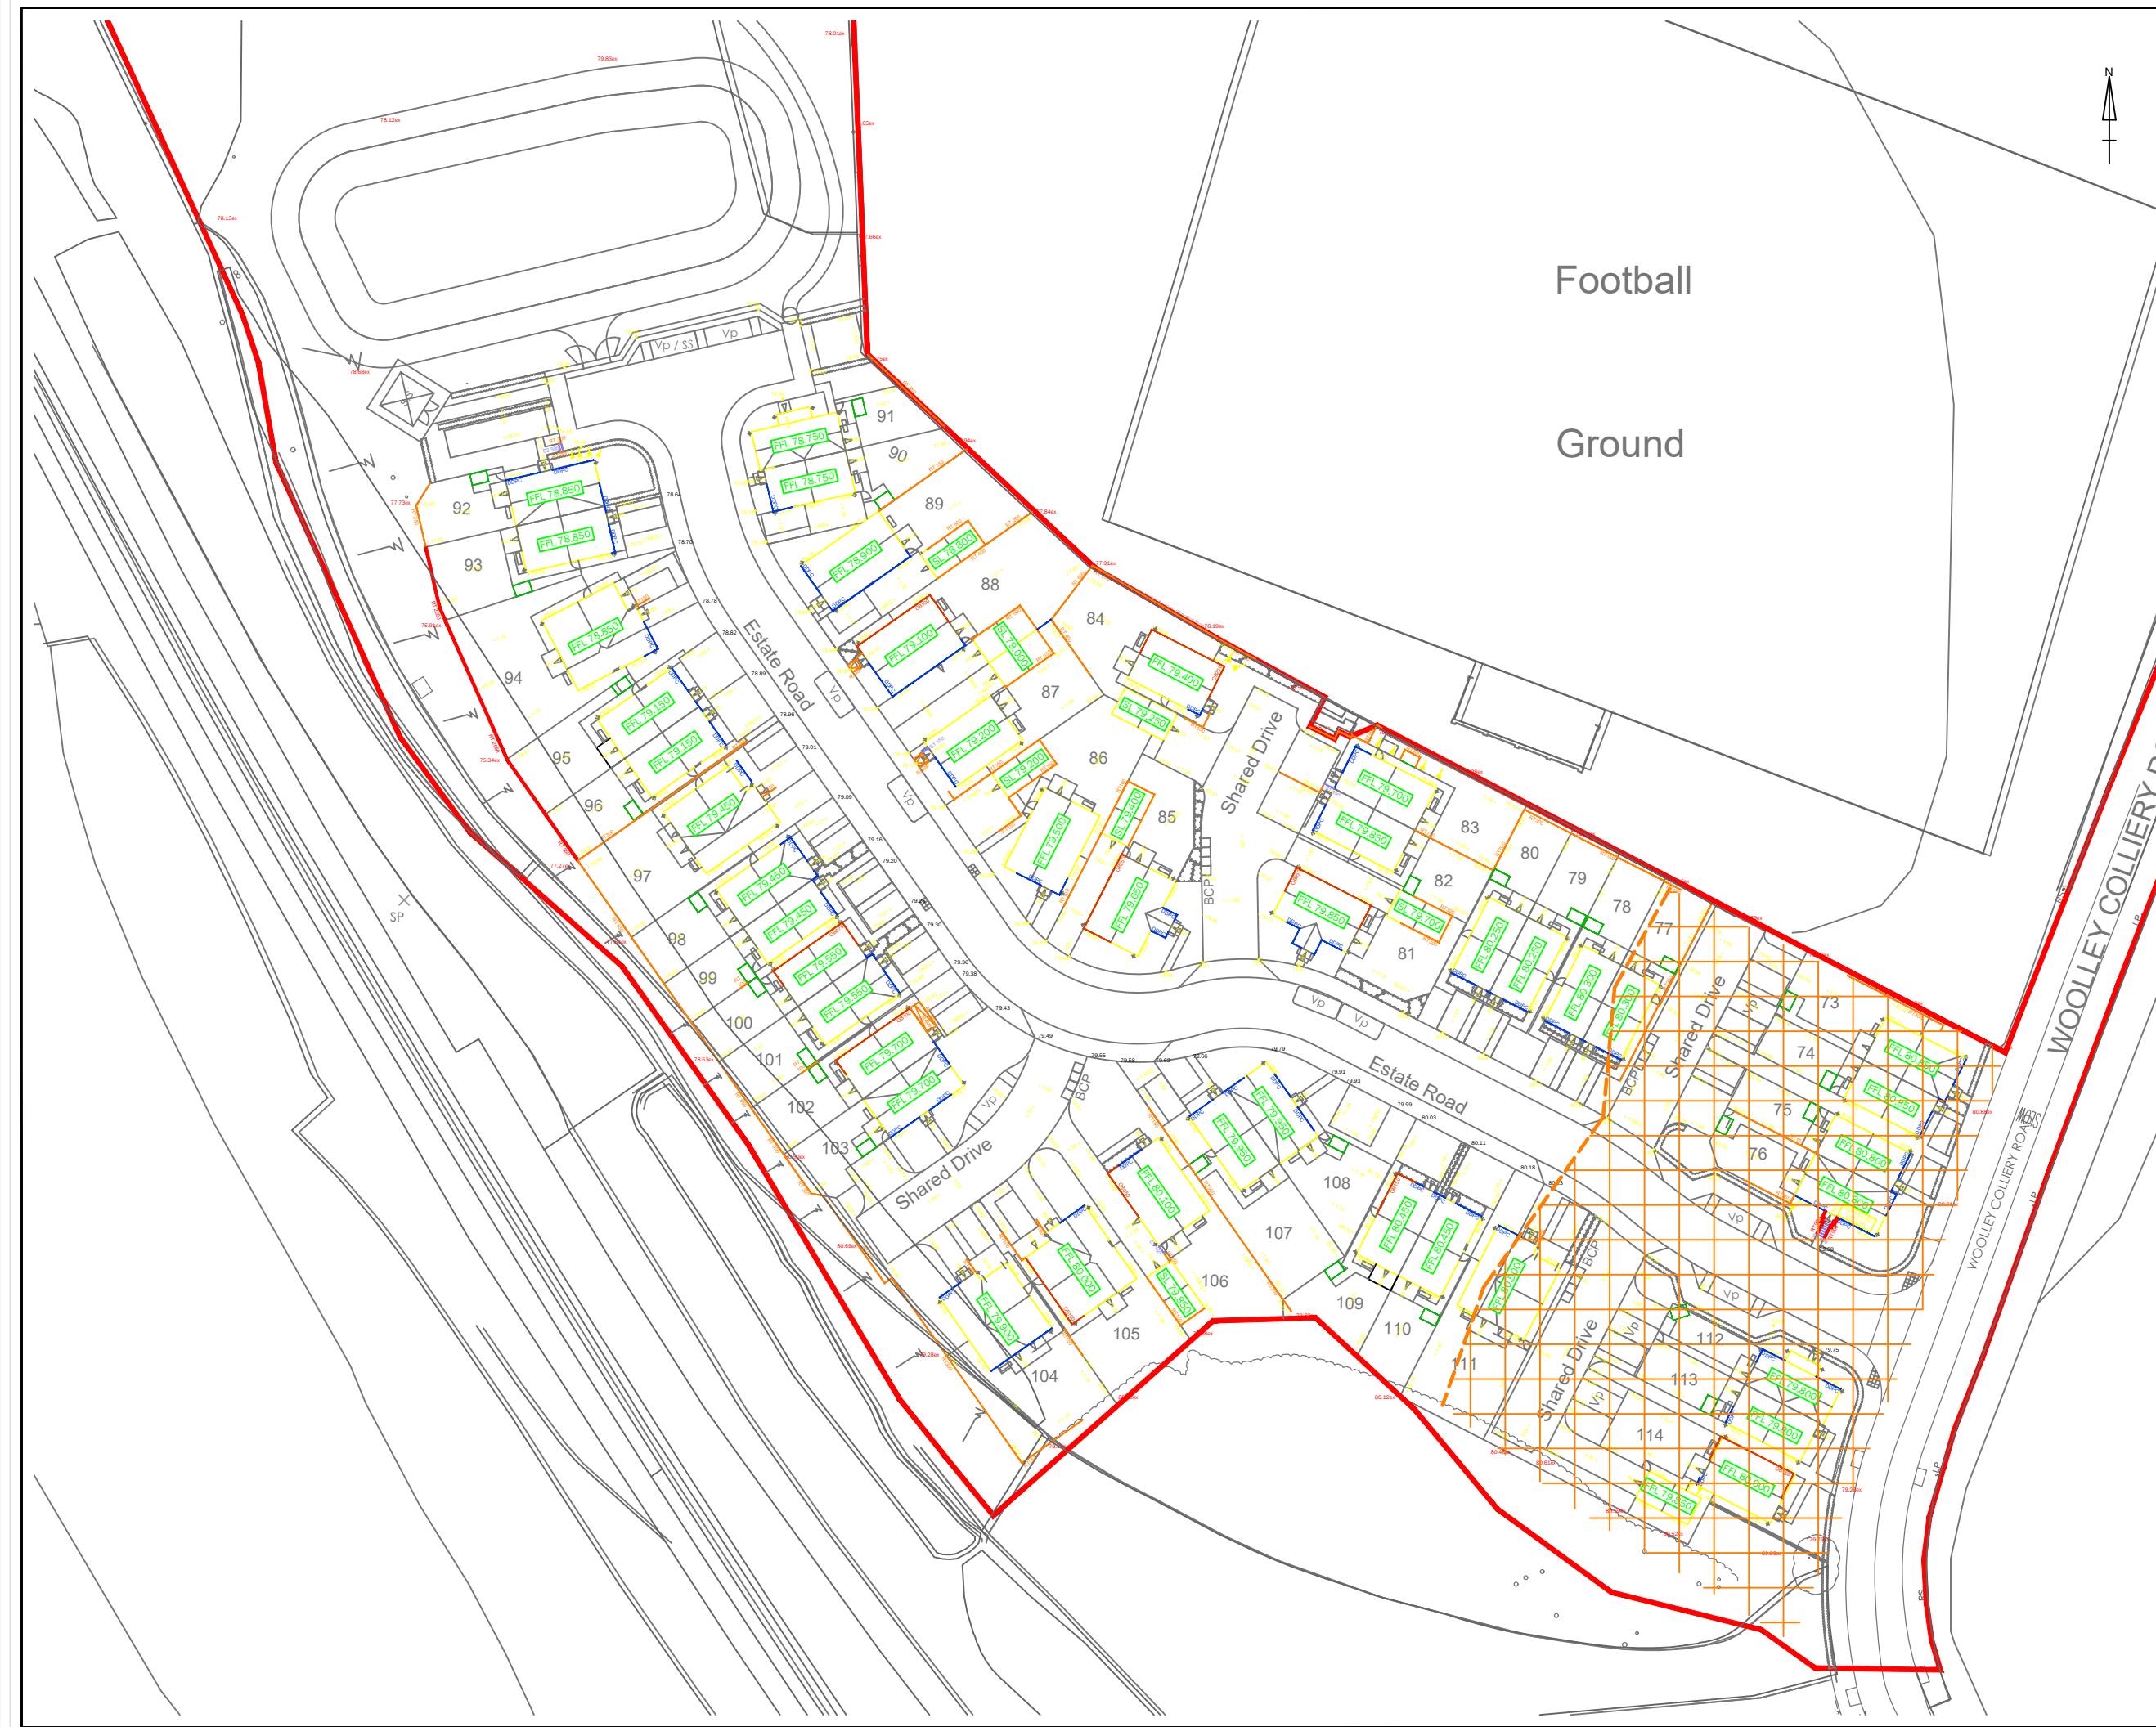
DRAWING NO. C10128A/S/06	REVISION NO. 0
DRAWN BY AL	APPROVED BY AMG
DATE May 2026	SCALE 1:500
	PAPER SIZE A3

- Approximate Development Boundary
- Indicative extents of area surfaced with asphalt

**Indicative Asphalt-Surfaced  
 Area Plan**

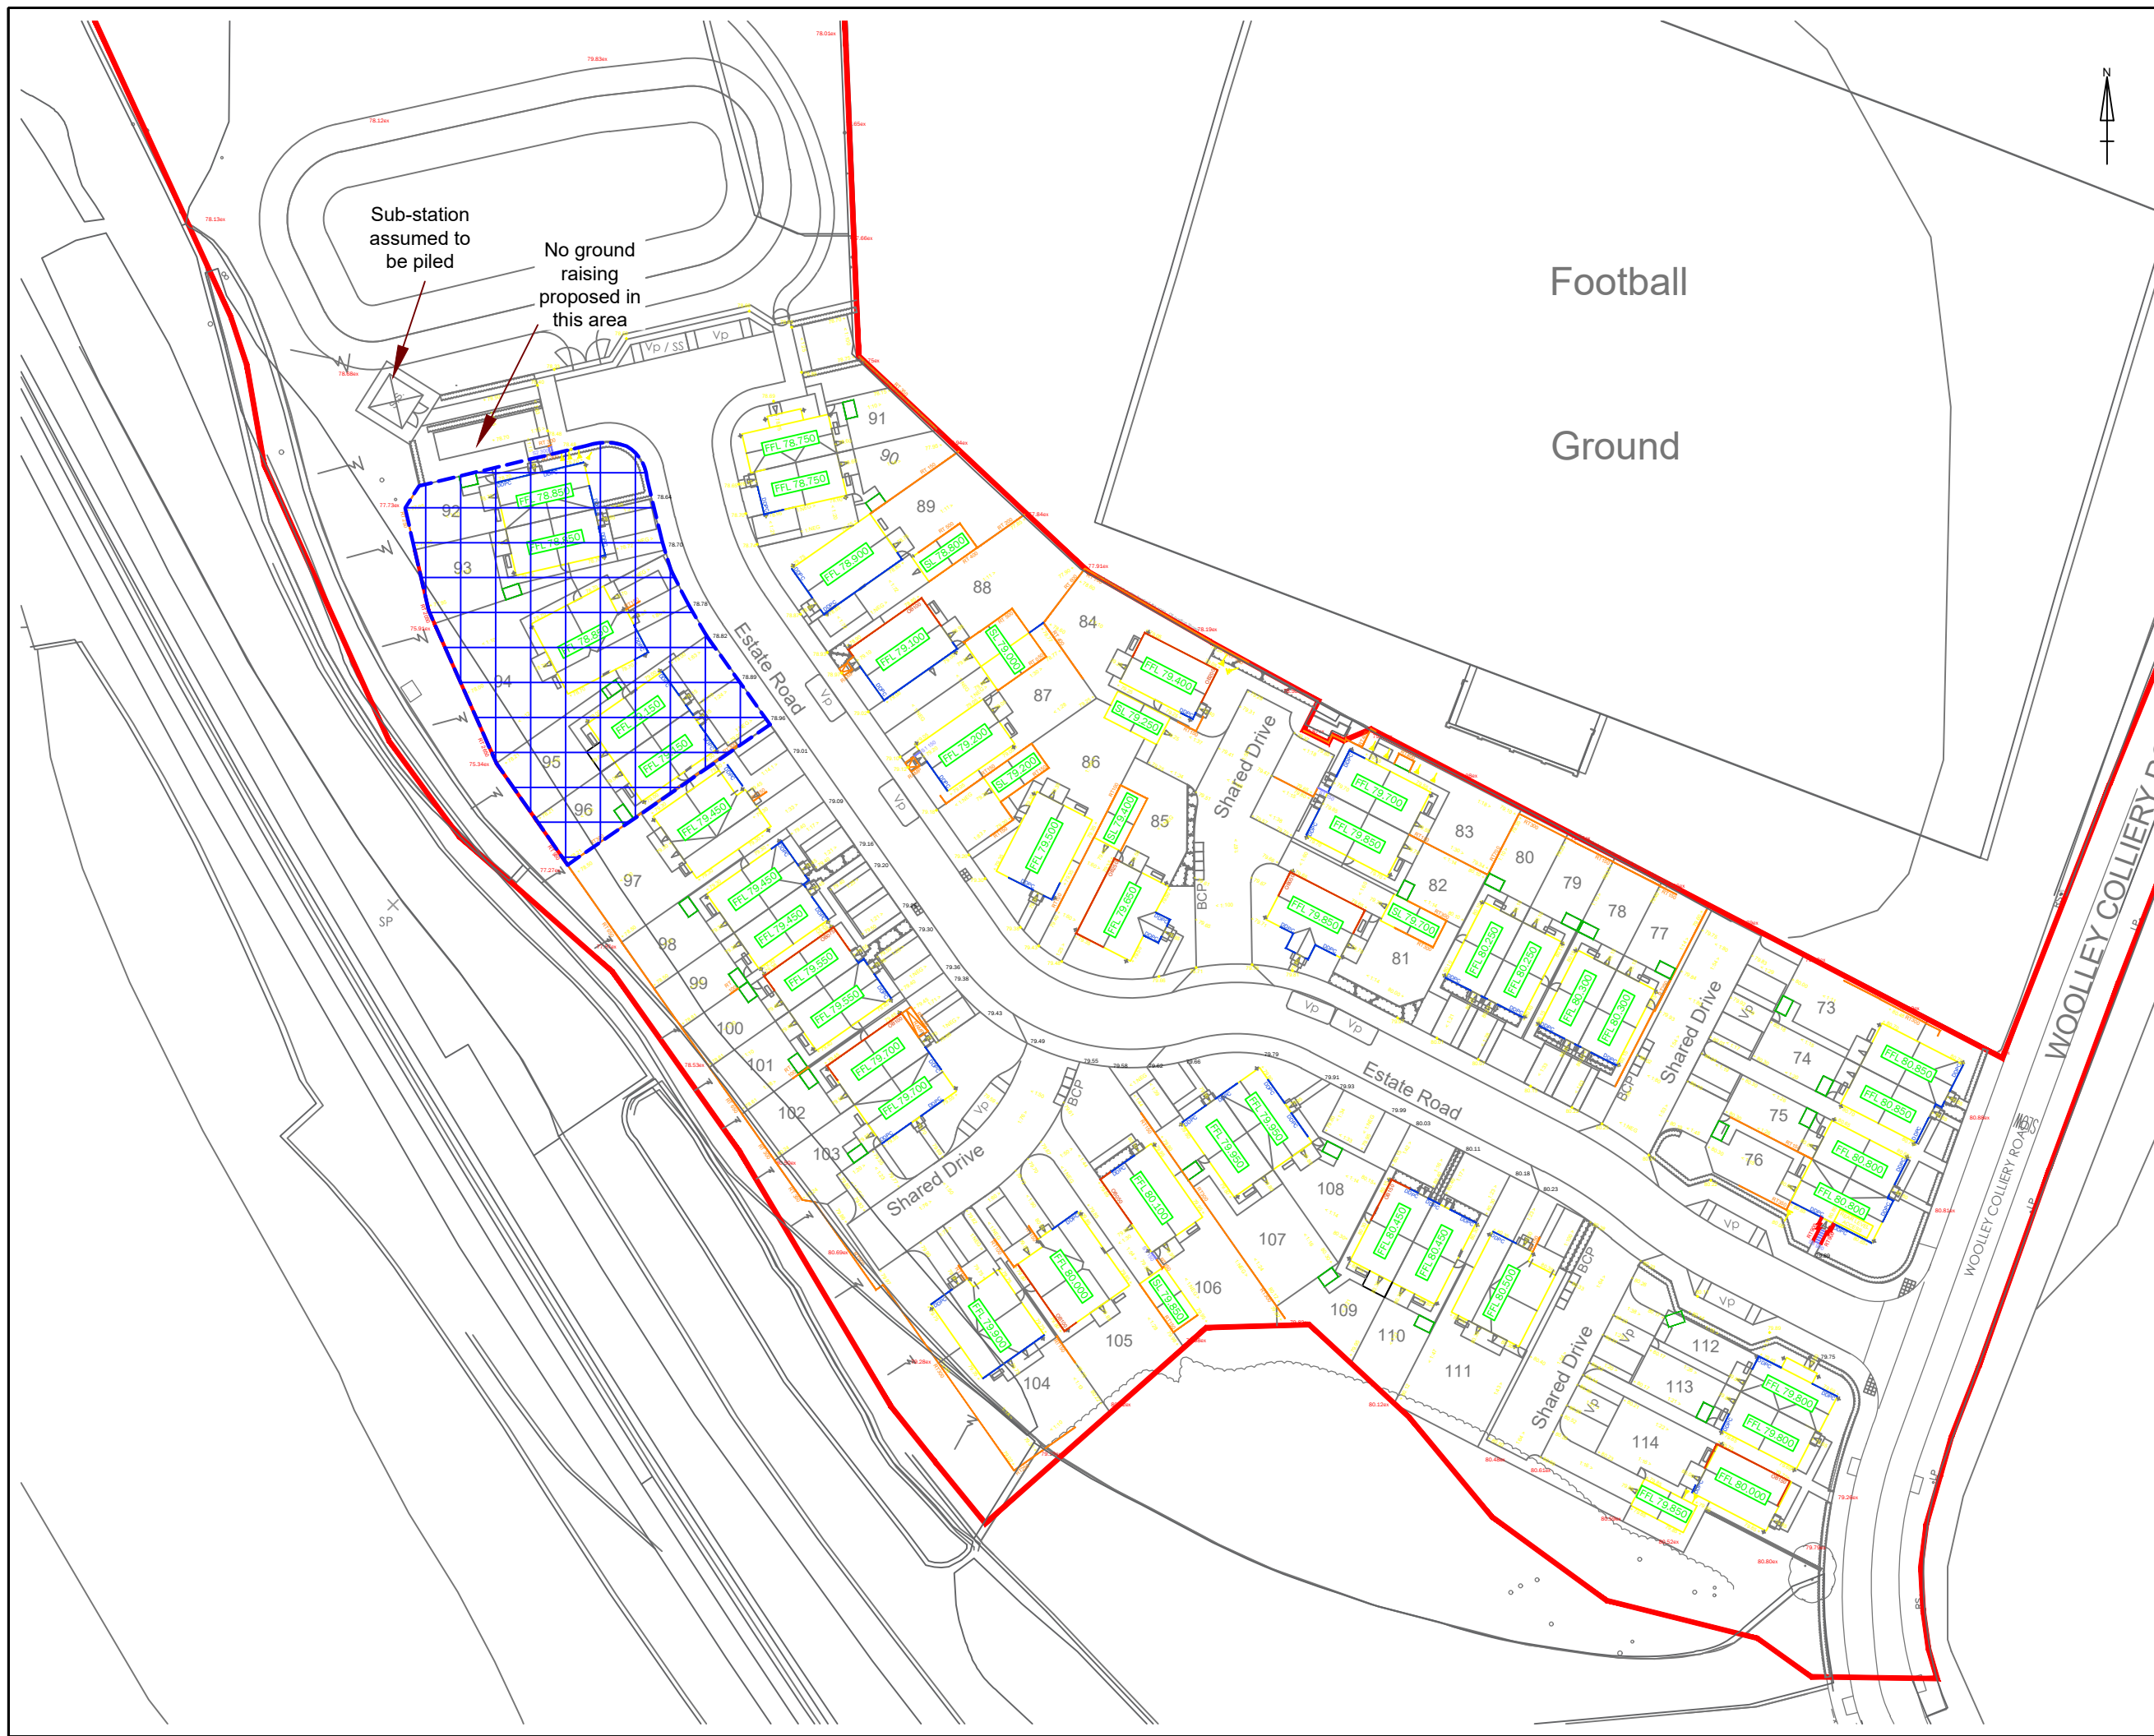
DRAWING NO. C10128A/S/07	REVISION NO. 0
DRAWN BY AL	APPROVED BY EP
DATE May 2026	SCALE 1:500
	PAPER SIZE A3

- Approximate Development Boundary
- Indicative extents of area potentially subject to excessive consolidation / creep settlement and requiring enhanced geotechnical remediation works.

**Plan Showing Indicative Extents  
 of Enhanced Geotechnical  
 Remediation Area**

From examination of the above-referenced HBL cut and fill drawing, it is noted that the greatest proposed raising of ground levels is coincident with the area of greatest depth of existing made ground, adjacent to the site's western boundary (e.g., vicinity of plots 93-96), with up to c. 3m of ground raising and up to c. 7.5m depth of made ground in that area. Further east, adjacent to Plots 88 and 89, ground raising of c. 2.5m is also proposed. These worst-case areas have therefore been subject to settlement assessments.

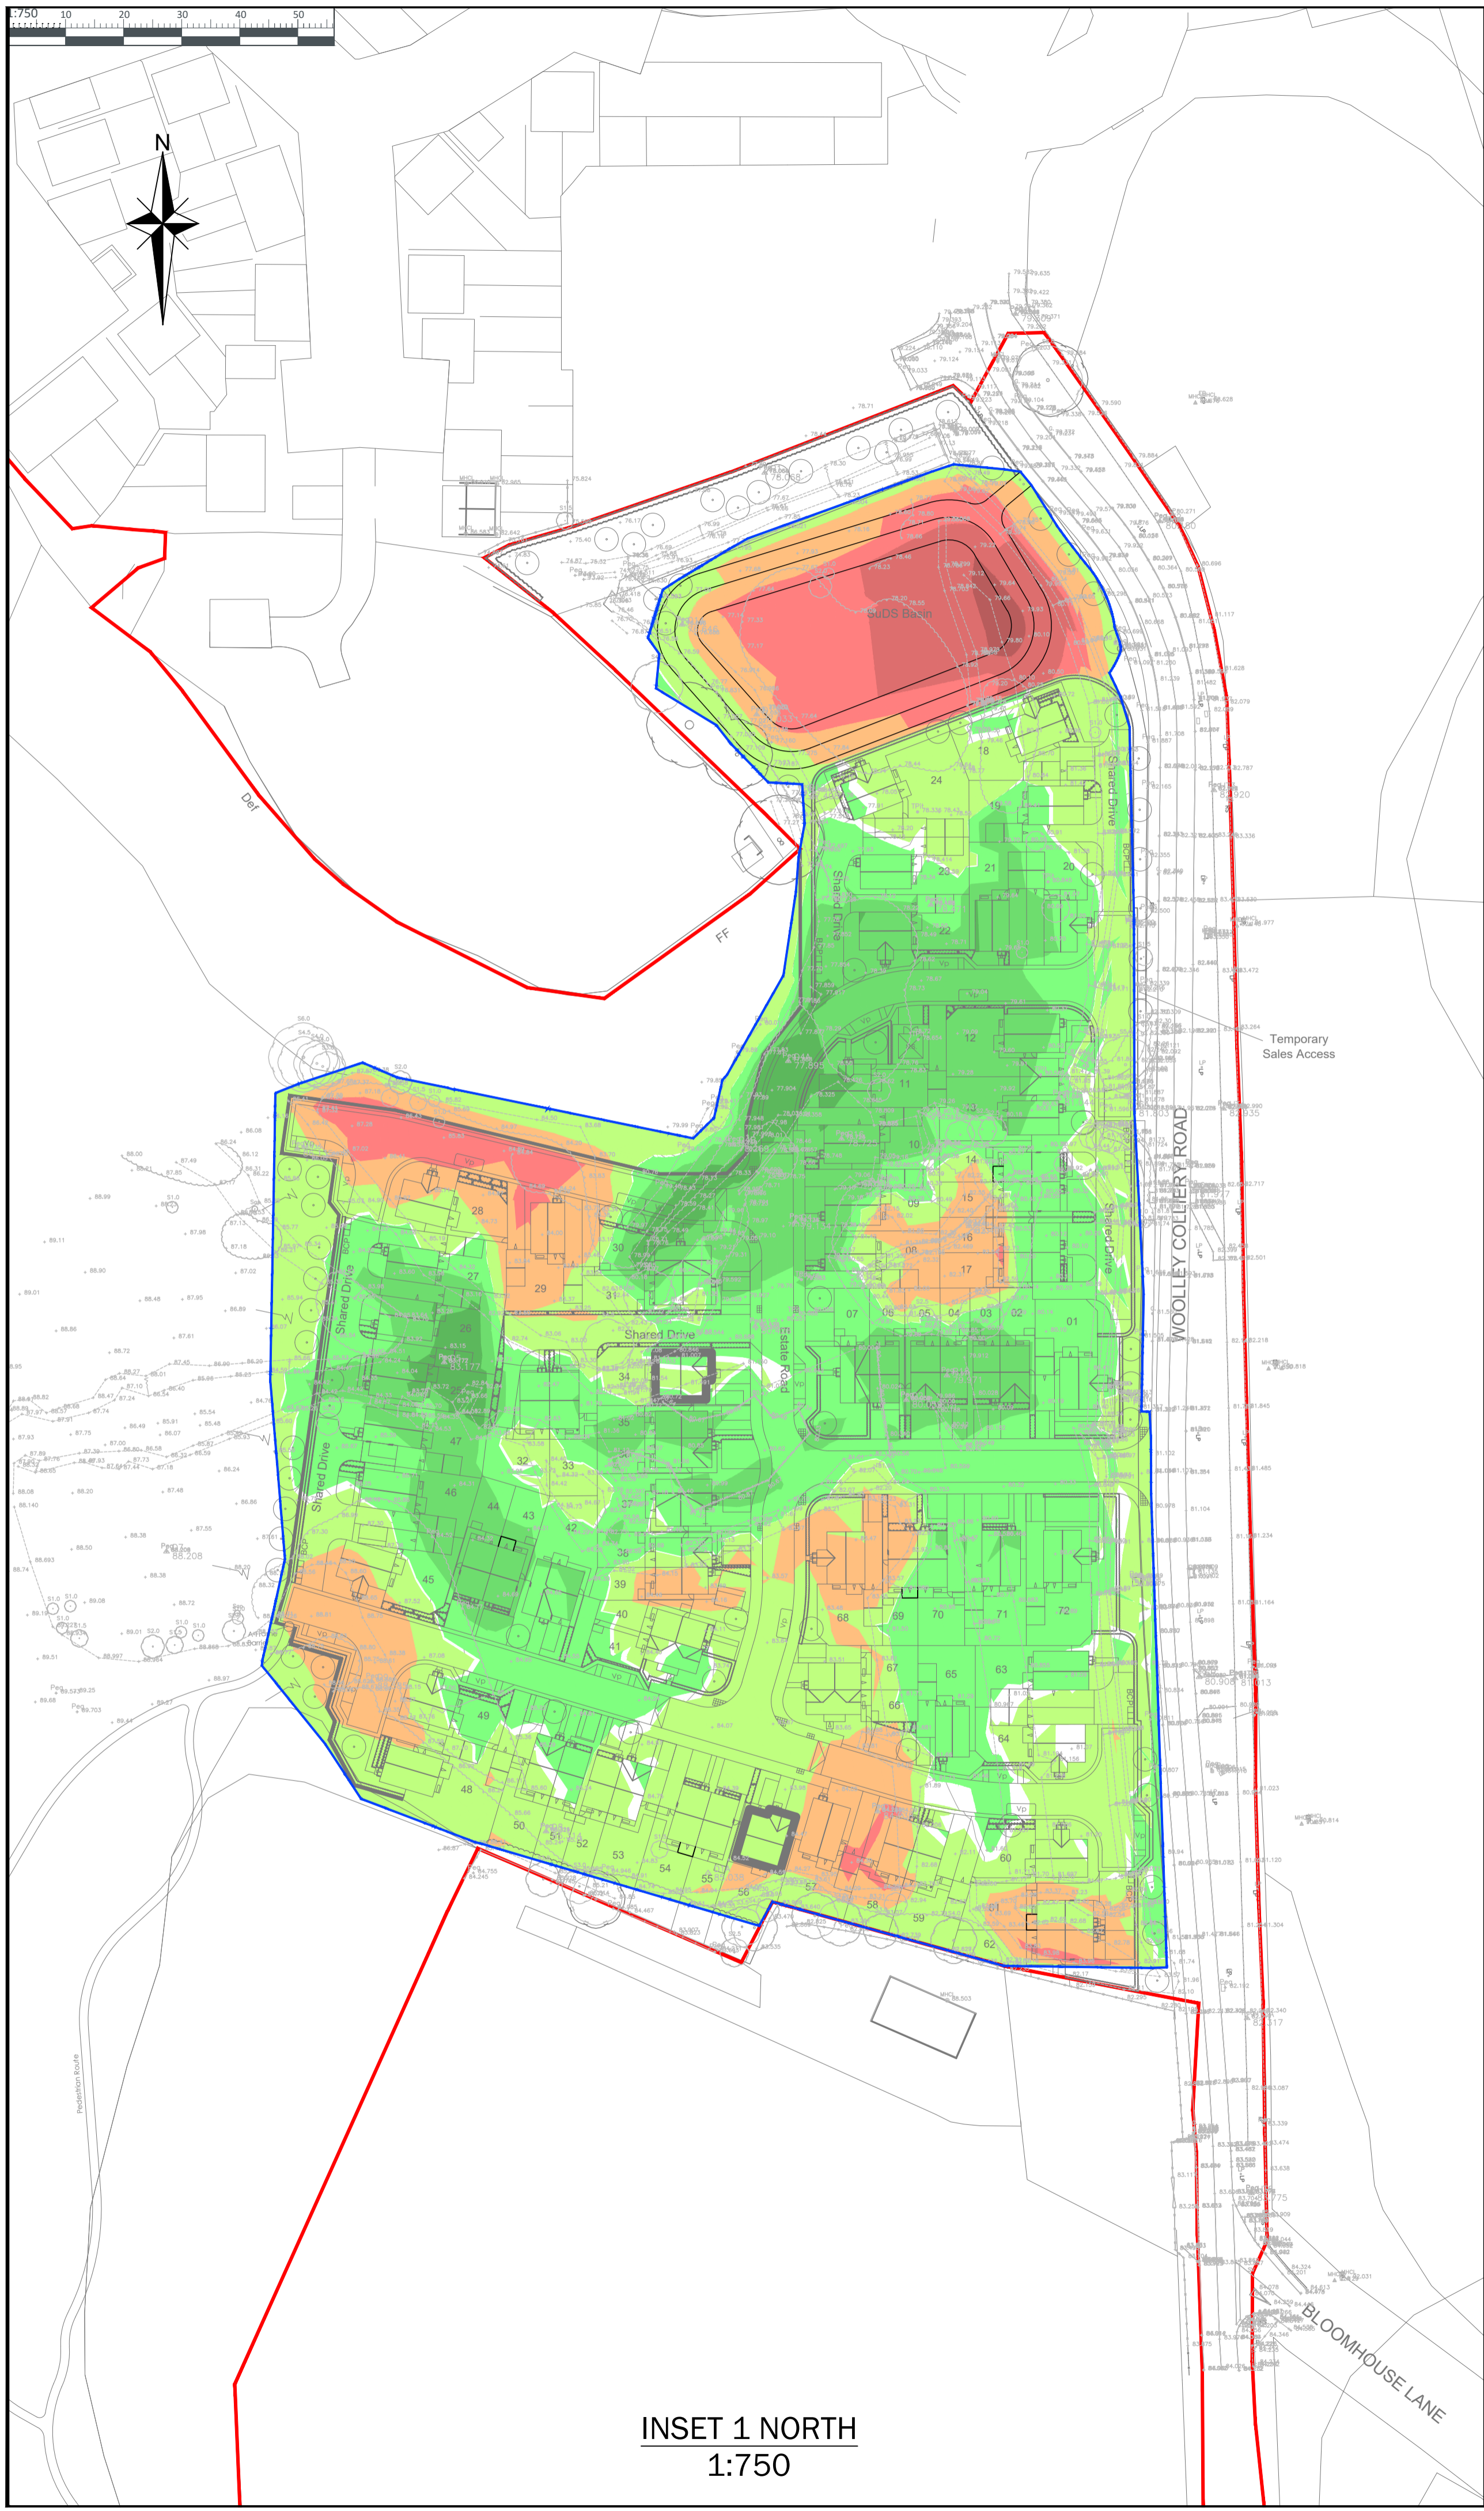
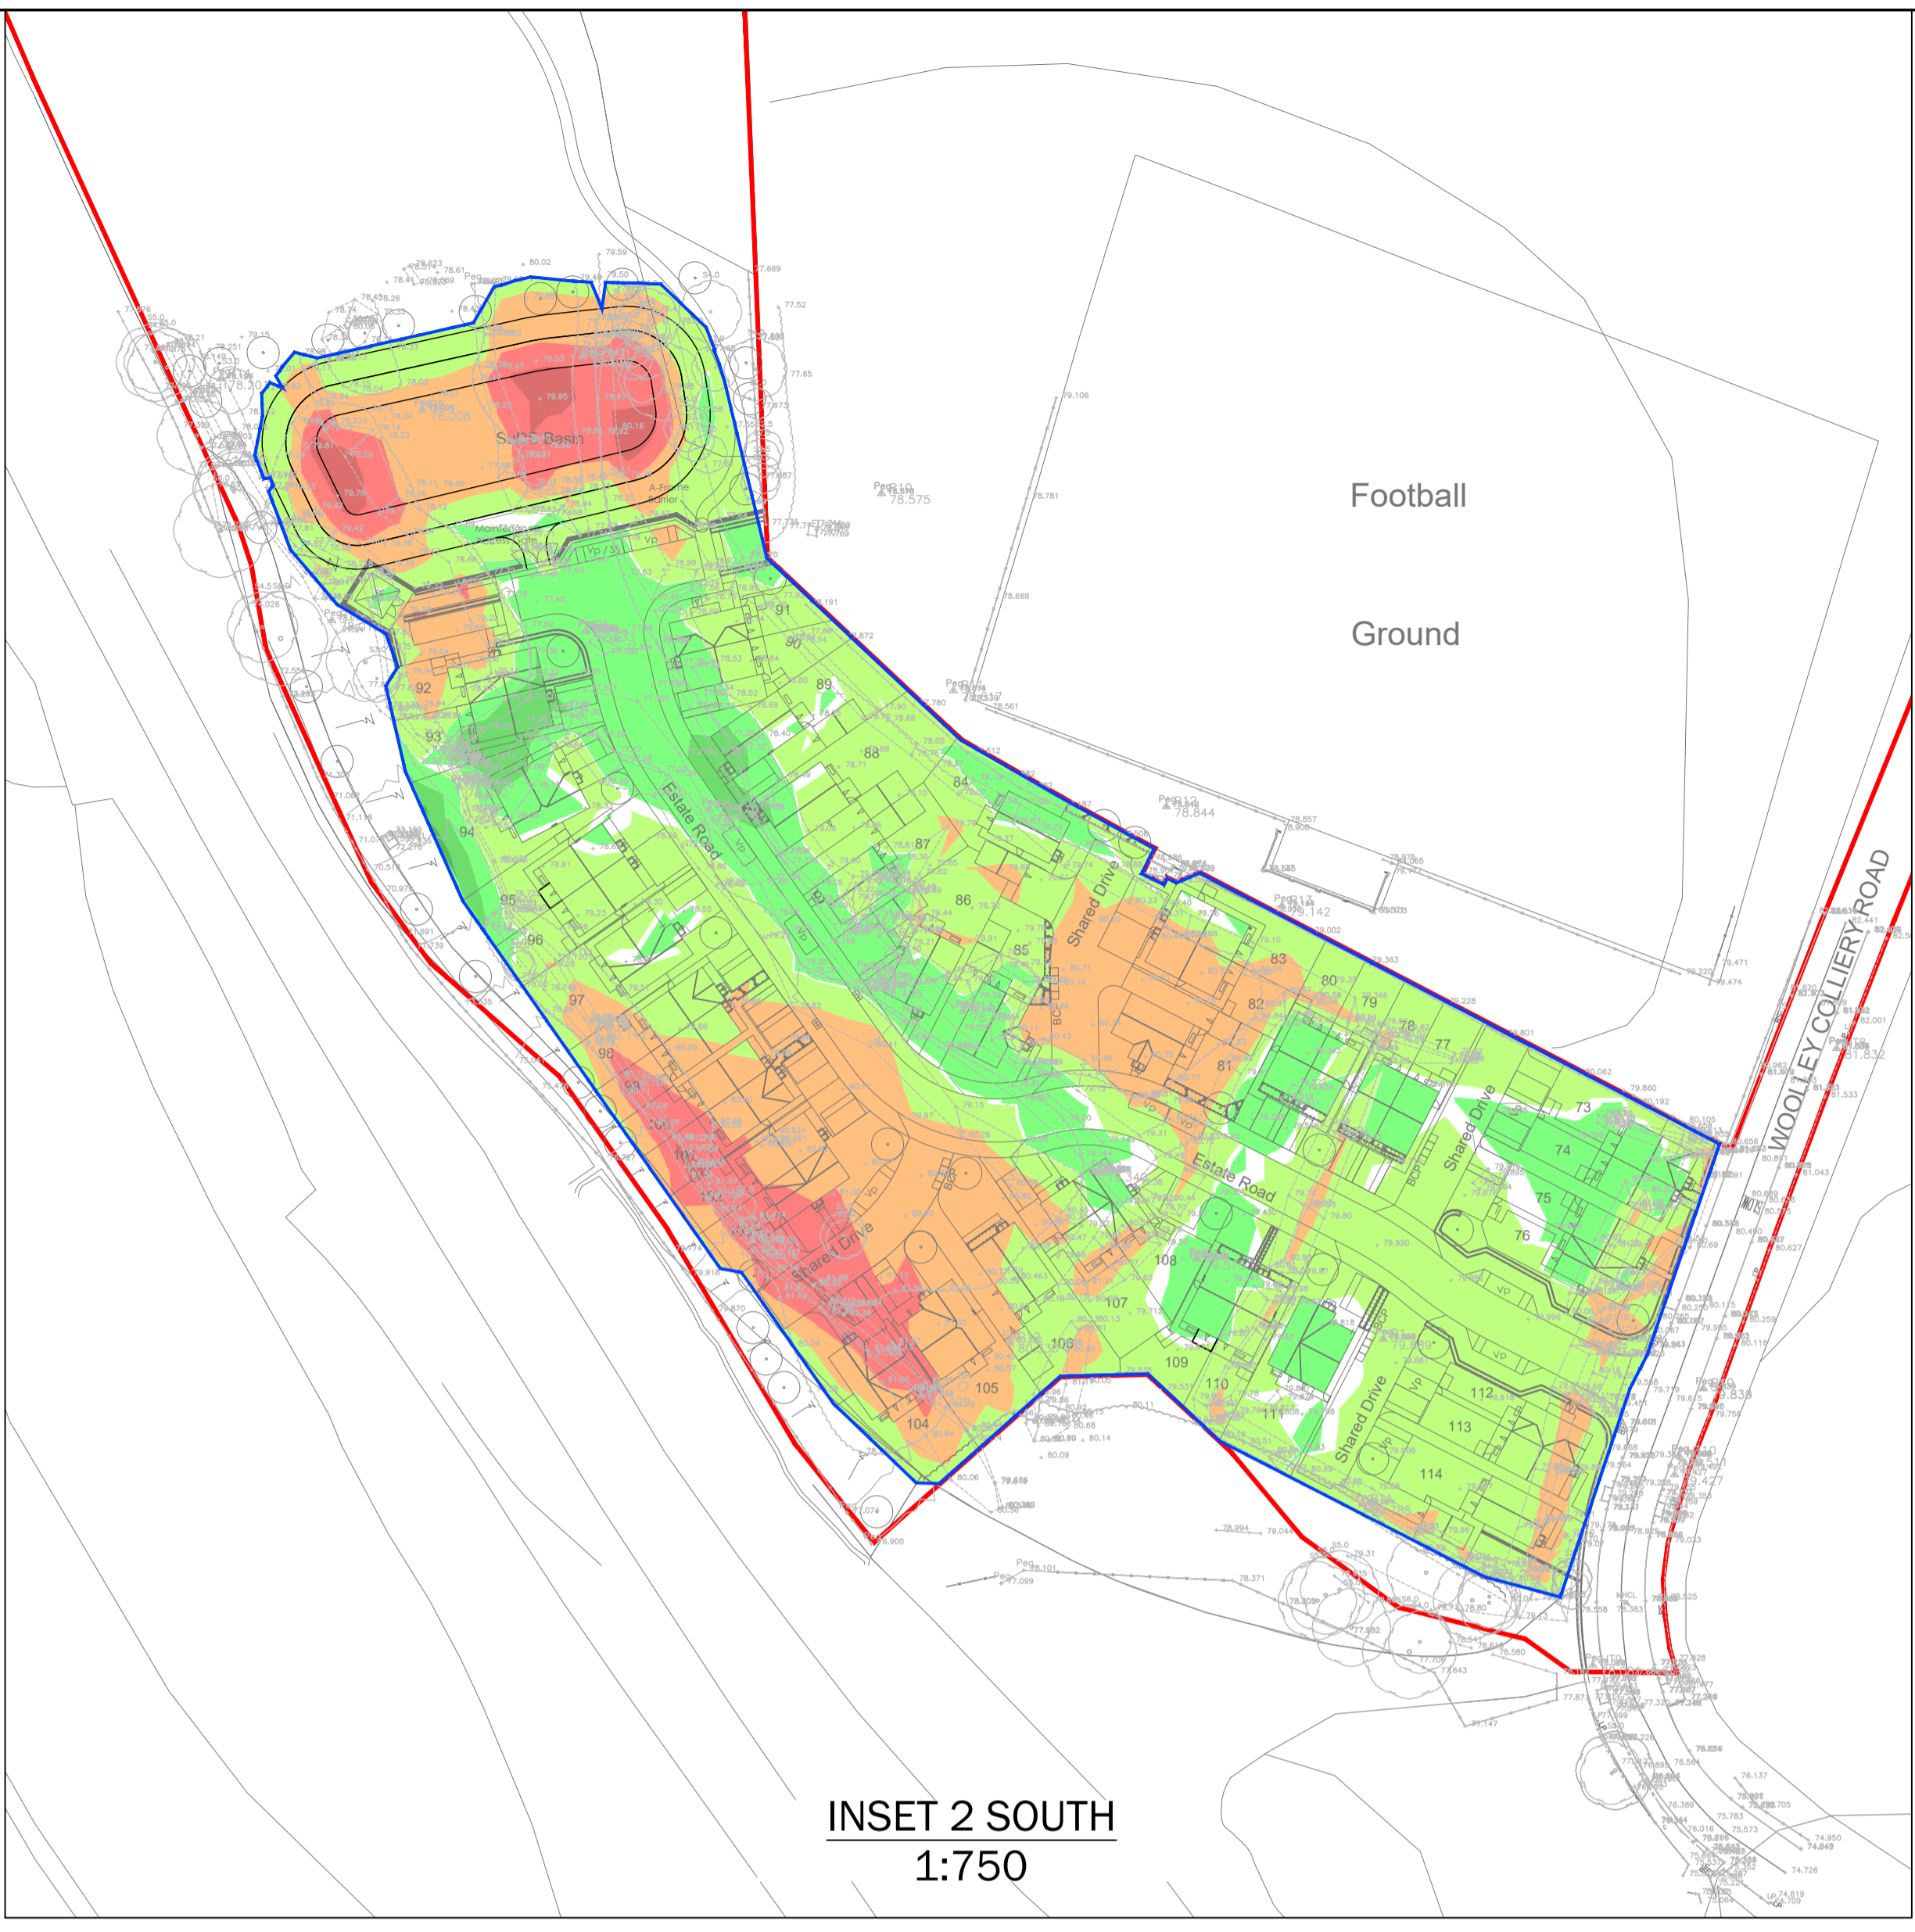
**EARTHWORKS ASSESSMENT NORTH**

- SITE BOUNDARY
- CUTFILL BOUNDARY EXTENTS
- + 75.50 EXISTING TOPO

Cut and fill earthwork proposals have been provided by the client (HBL Drawing No. 10701-HBL-XX-XX-DR-C-5205, rev. P01, included in Appendix A). This shows that in order to reach an assumed formation level of 600mm below finished ground level (FGL), levels are to be raised from existing in the majority of the site, typically by up to c. 2 m, but locally by up to c. 3m, along part of the western site boundary. Levels are to be locally cut from existing, including by up to c. 3m in the south-west of the site, and by up to c. 4m in the northern end of the site, to form the attenuation basin. The drawing shows that the cut and fill earthworks will result in a surplus of material.

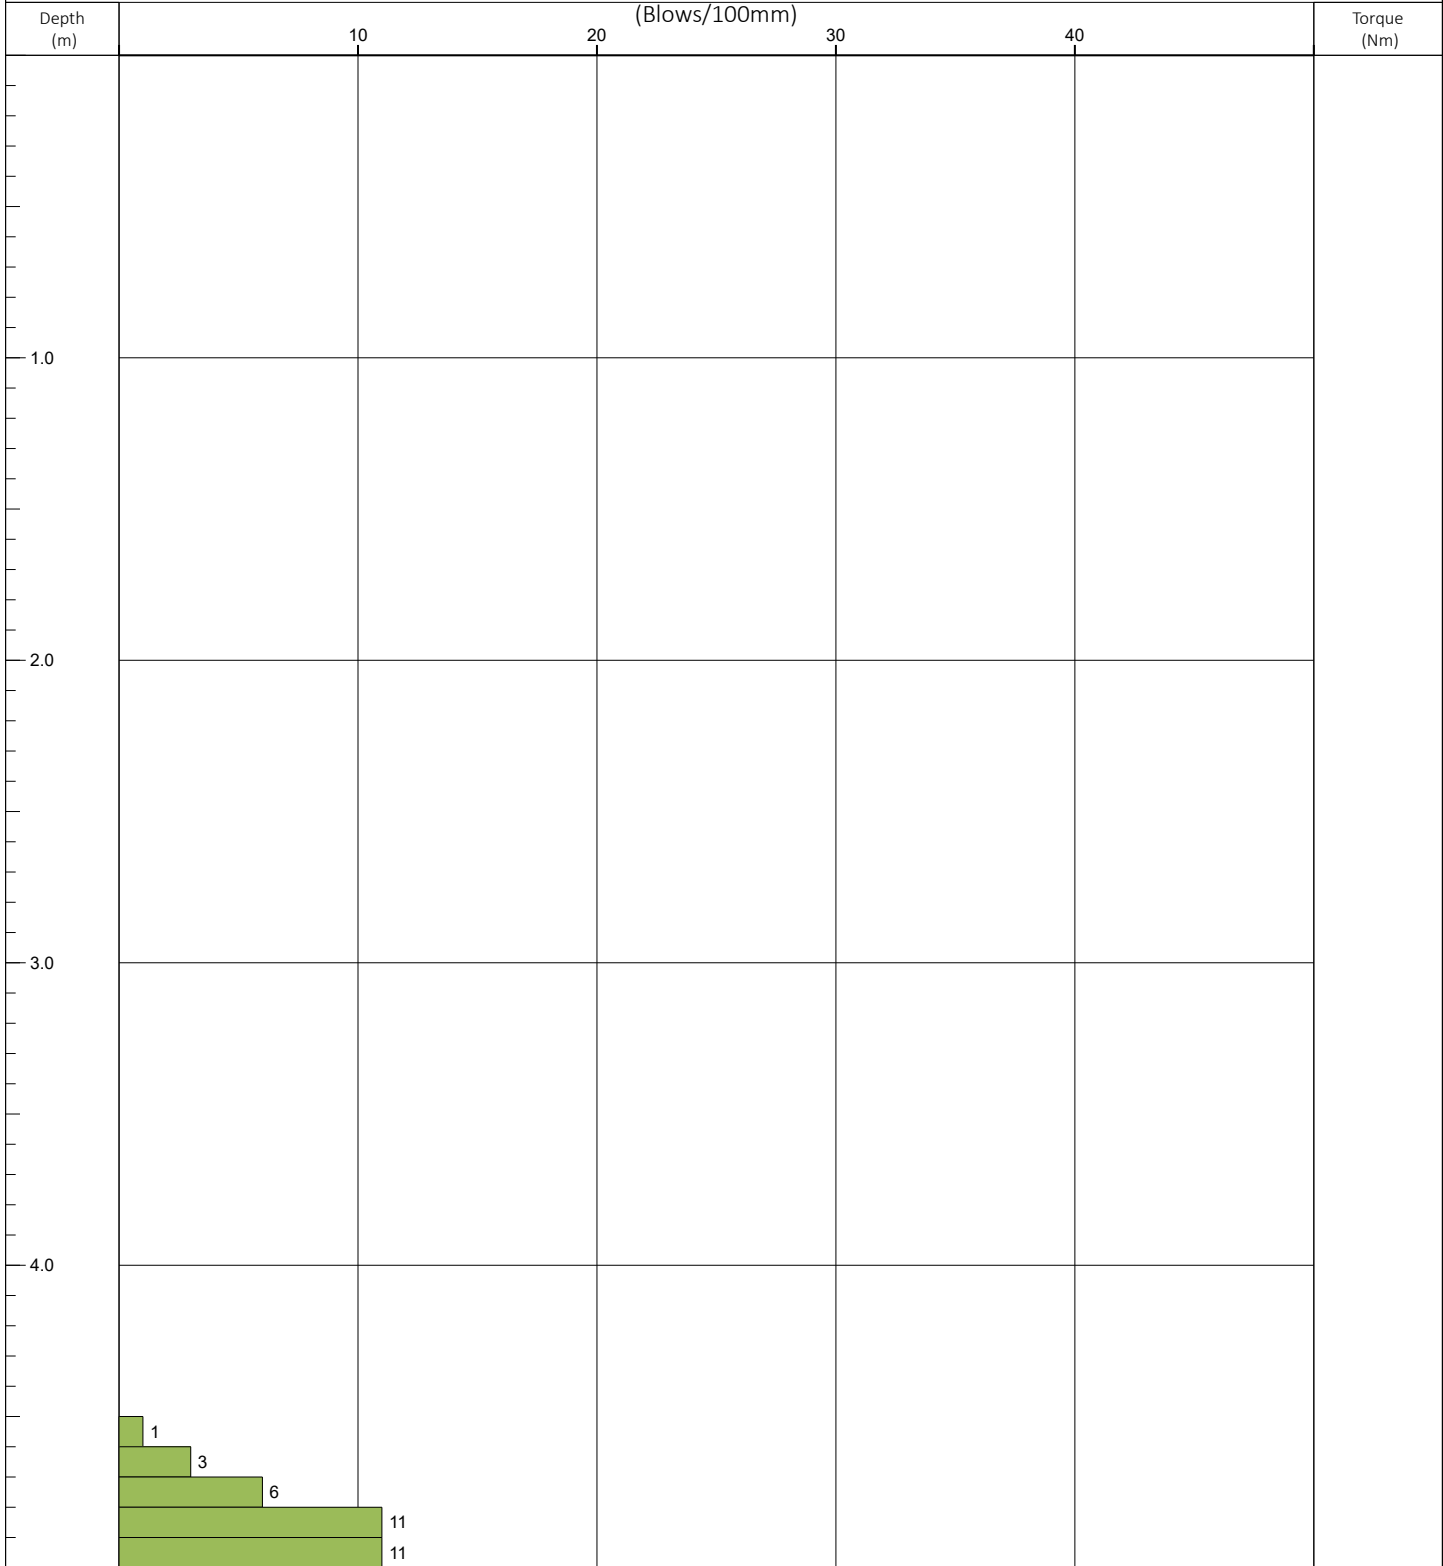
1. Dynamic probe follow-on from WS404S. 2. Refusal at 5.80m bgl.

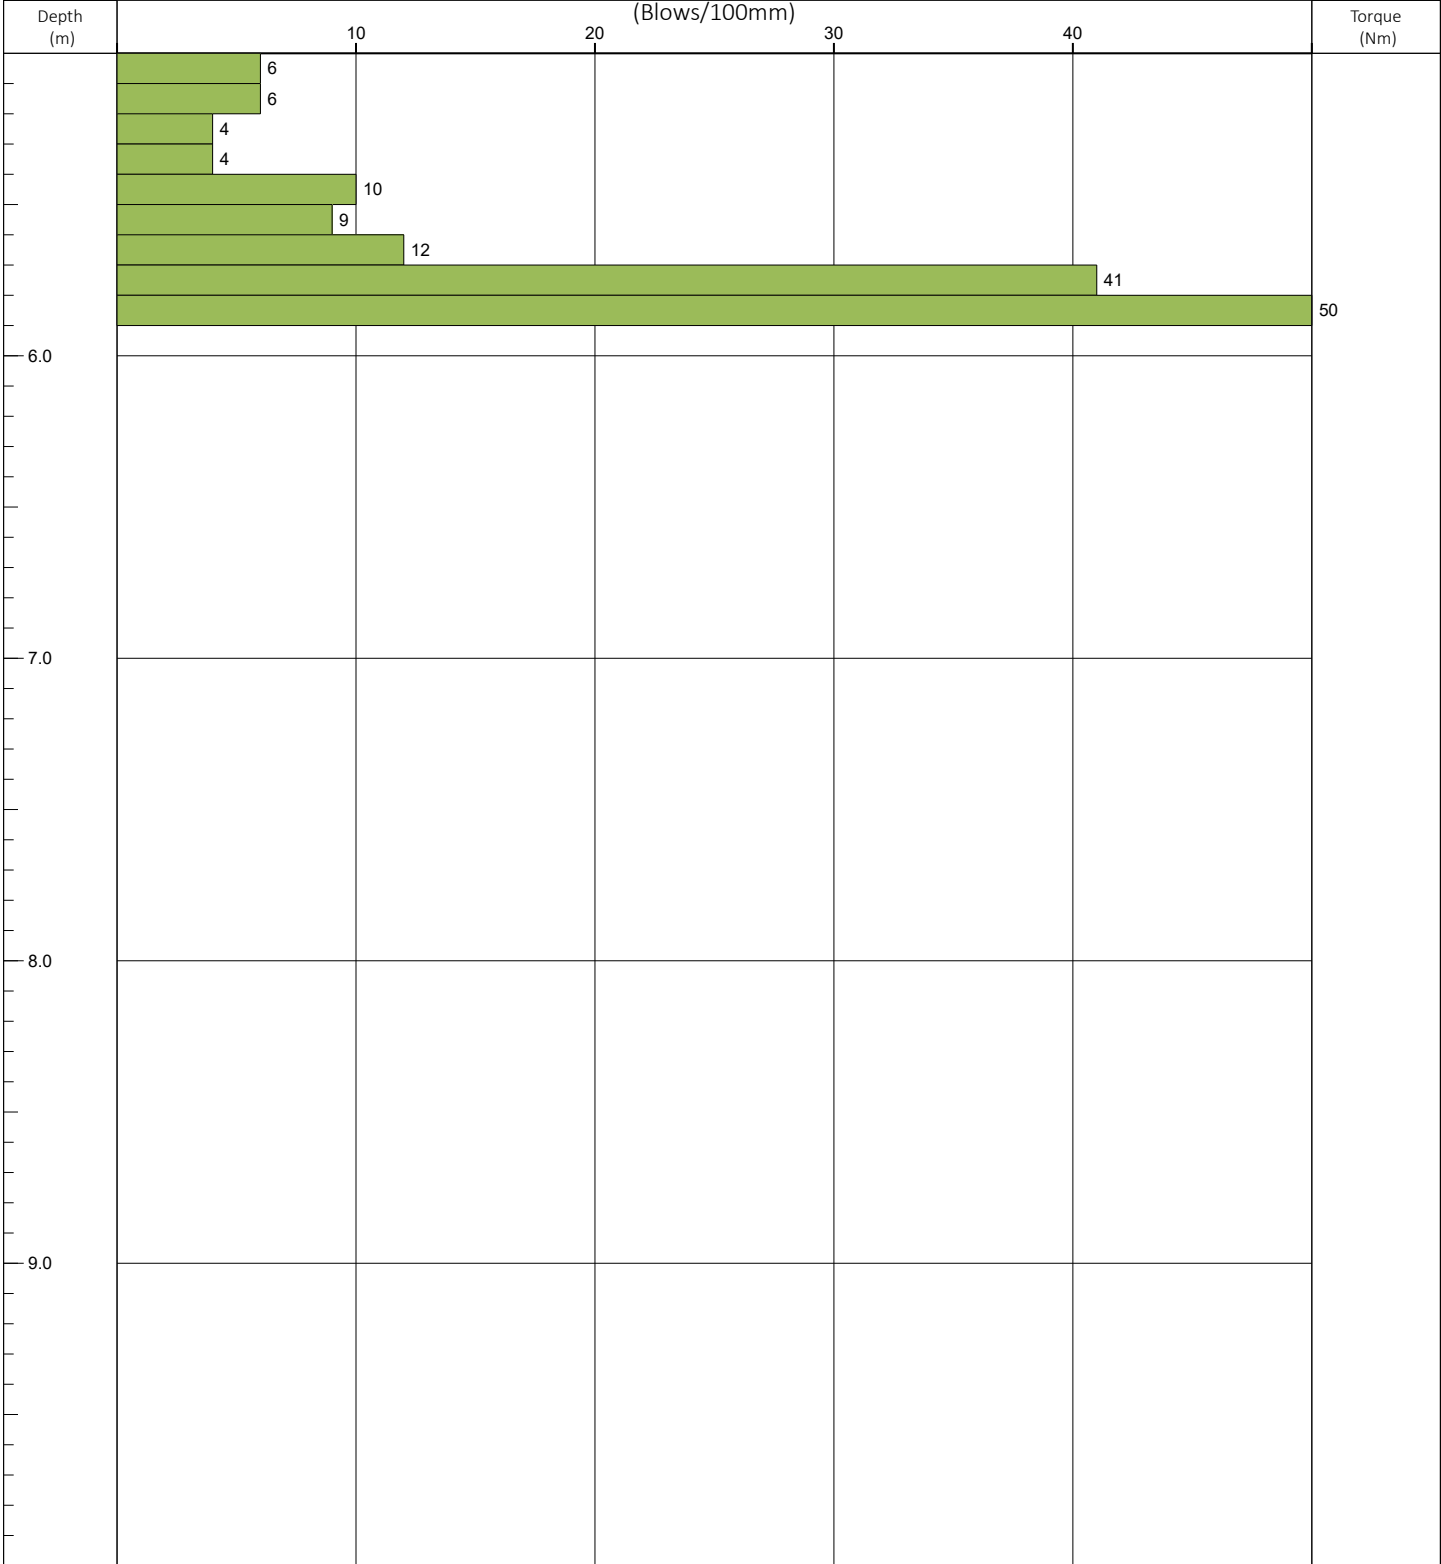
1. Dynamic probe follow-on from WS404S. 2. Refusal at 5.80m bgl.
