28<sup>th</sup> May 2026

Our Ref: C10128A/AL/11206

**Re: C10128A, Woolley Colliery Road, Darton - Supplementary Ground Investigation Letter Report - Southern Site Area**

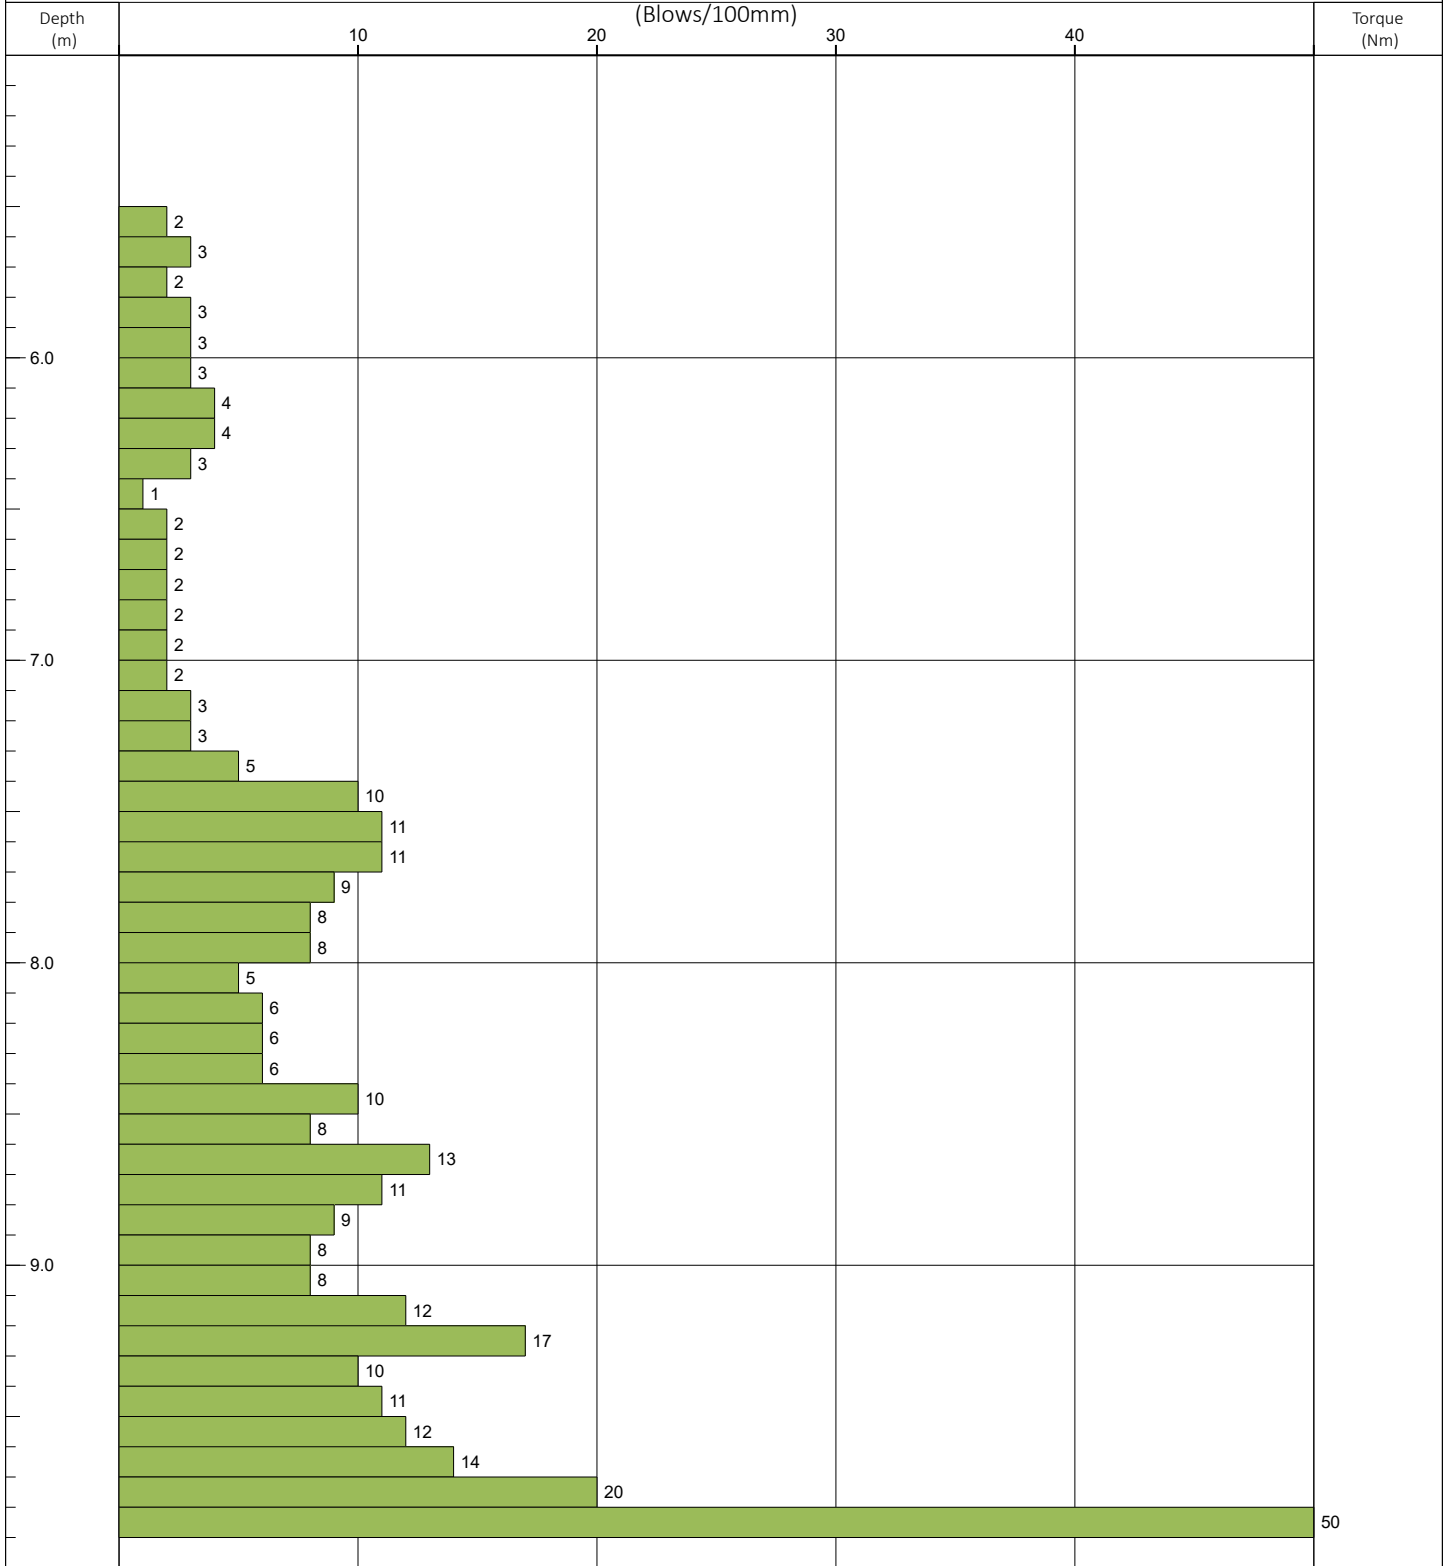
1. Dynamic probe follow-on from WS405S. 2. Refusal at 9.80m bgl.

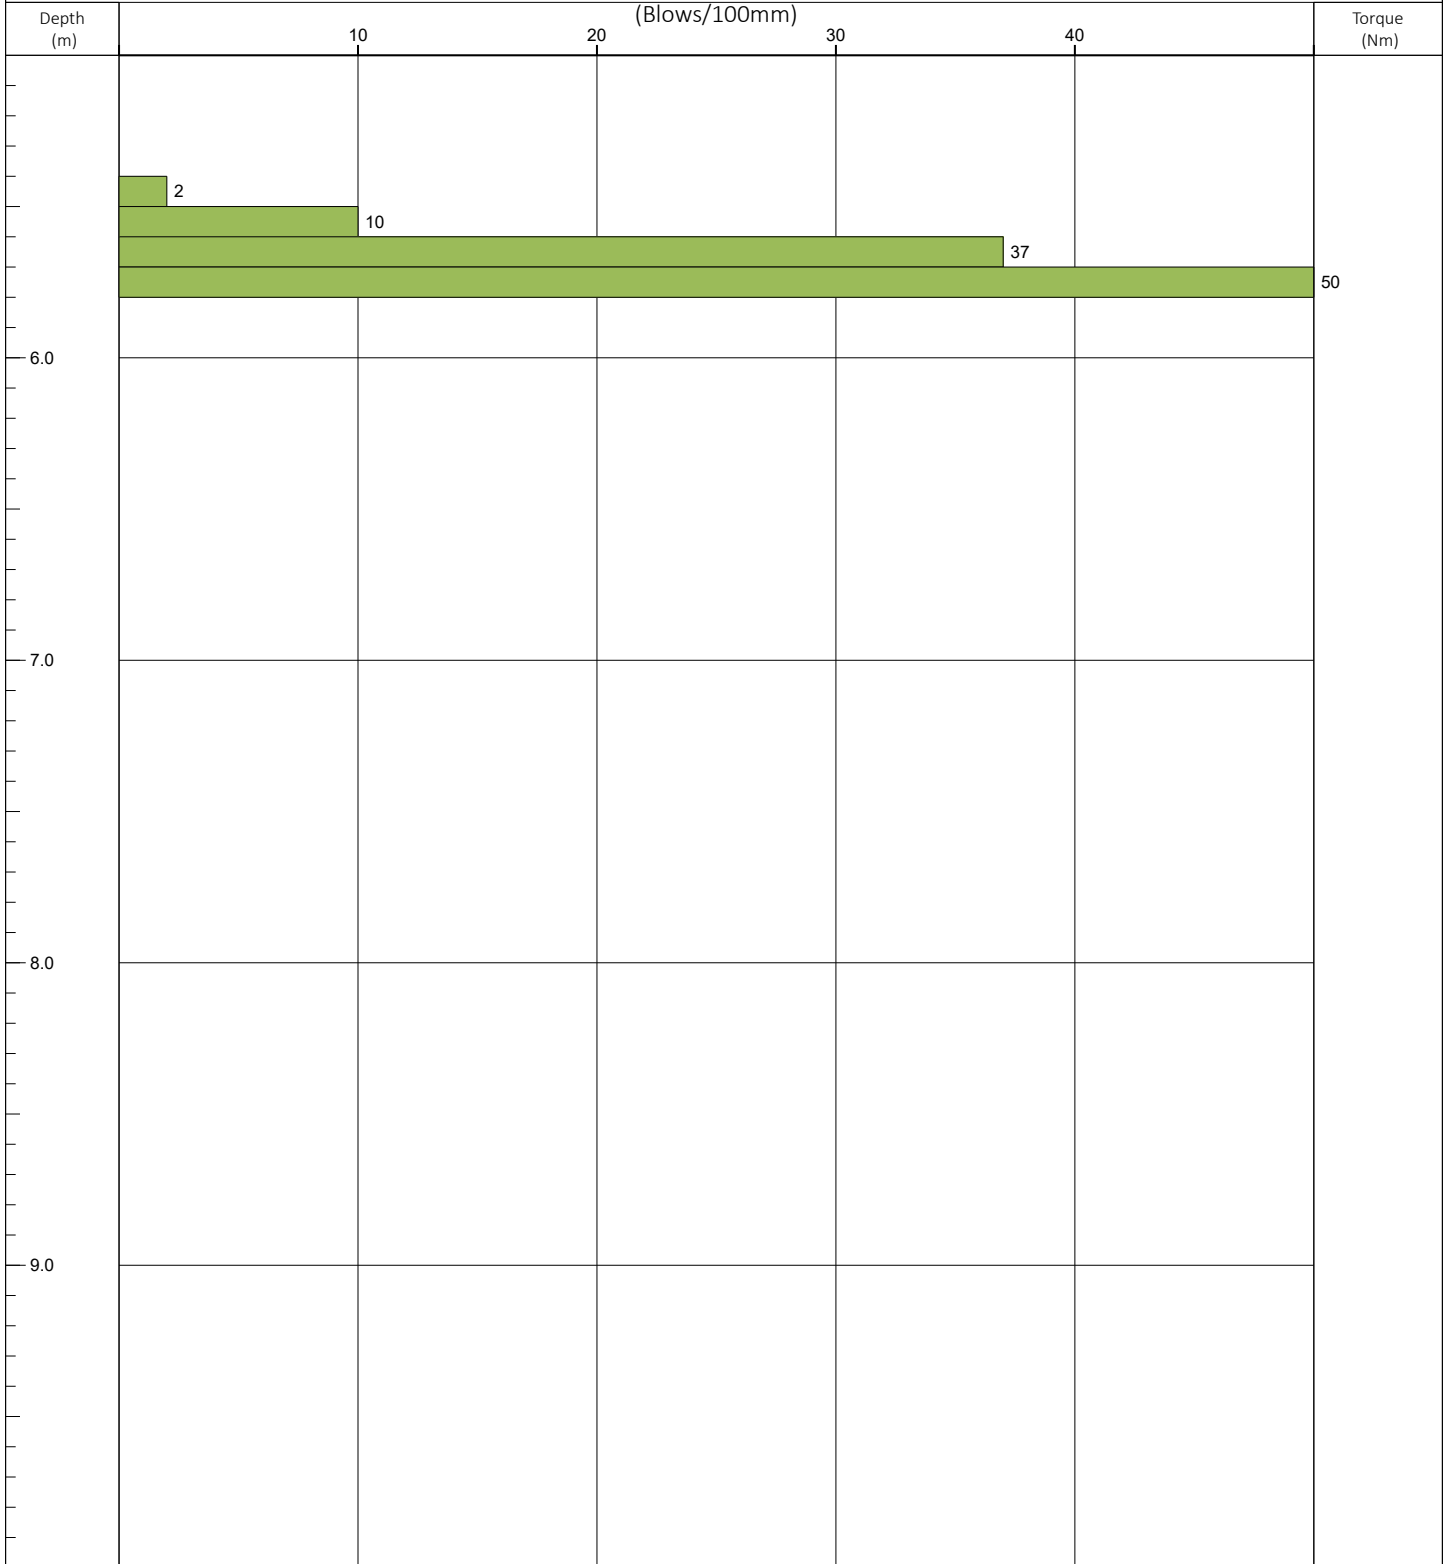
1. Dynamic probe follow-on from WS406S. 2. Refusal at 5.70m bgl.

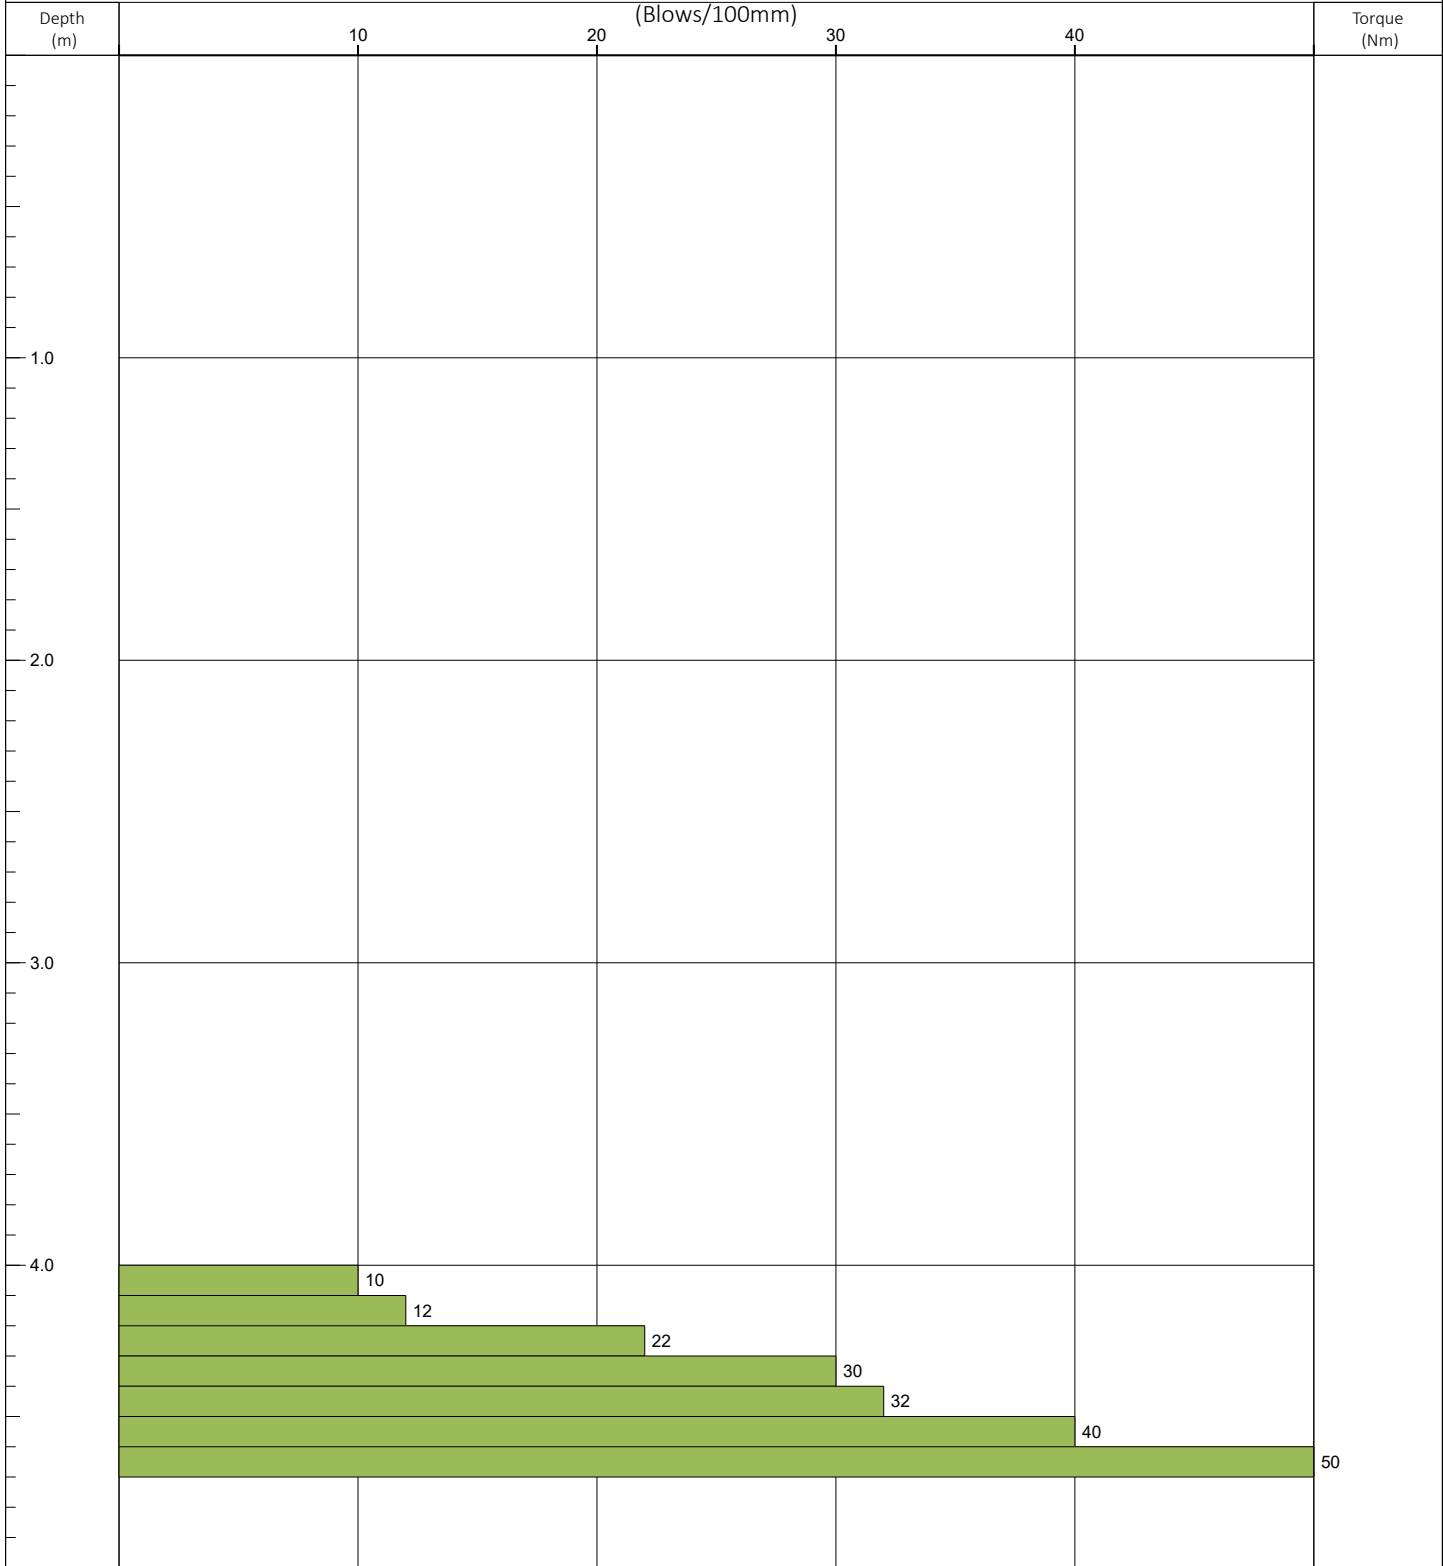
1. Dynamic probe follow-on from WS407S. 2. Refusal at 4.60m bgl.

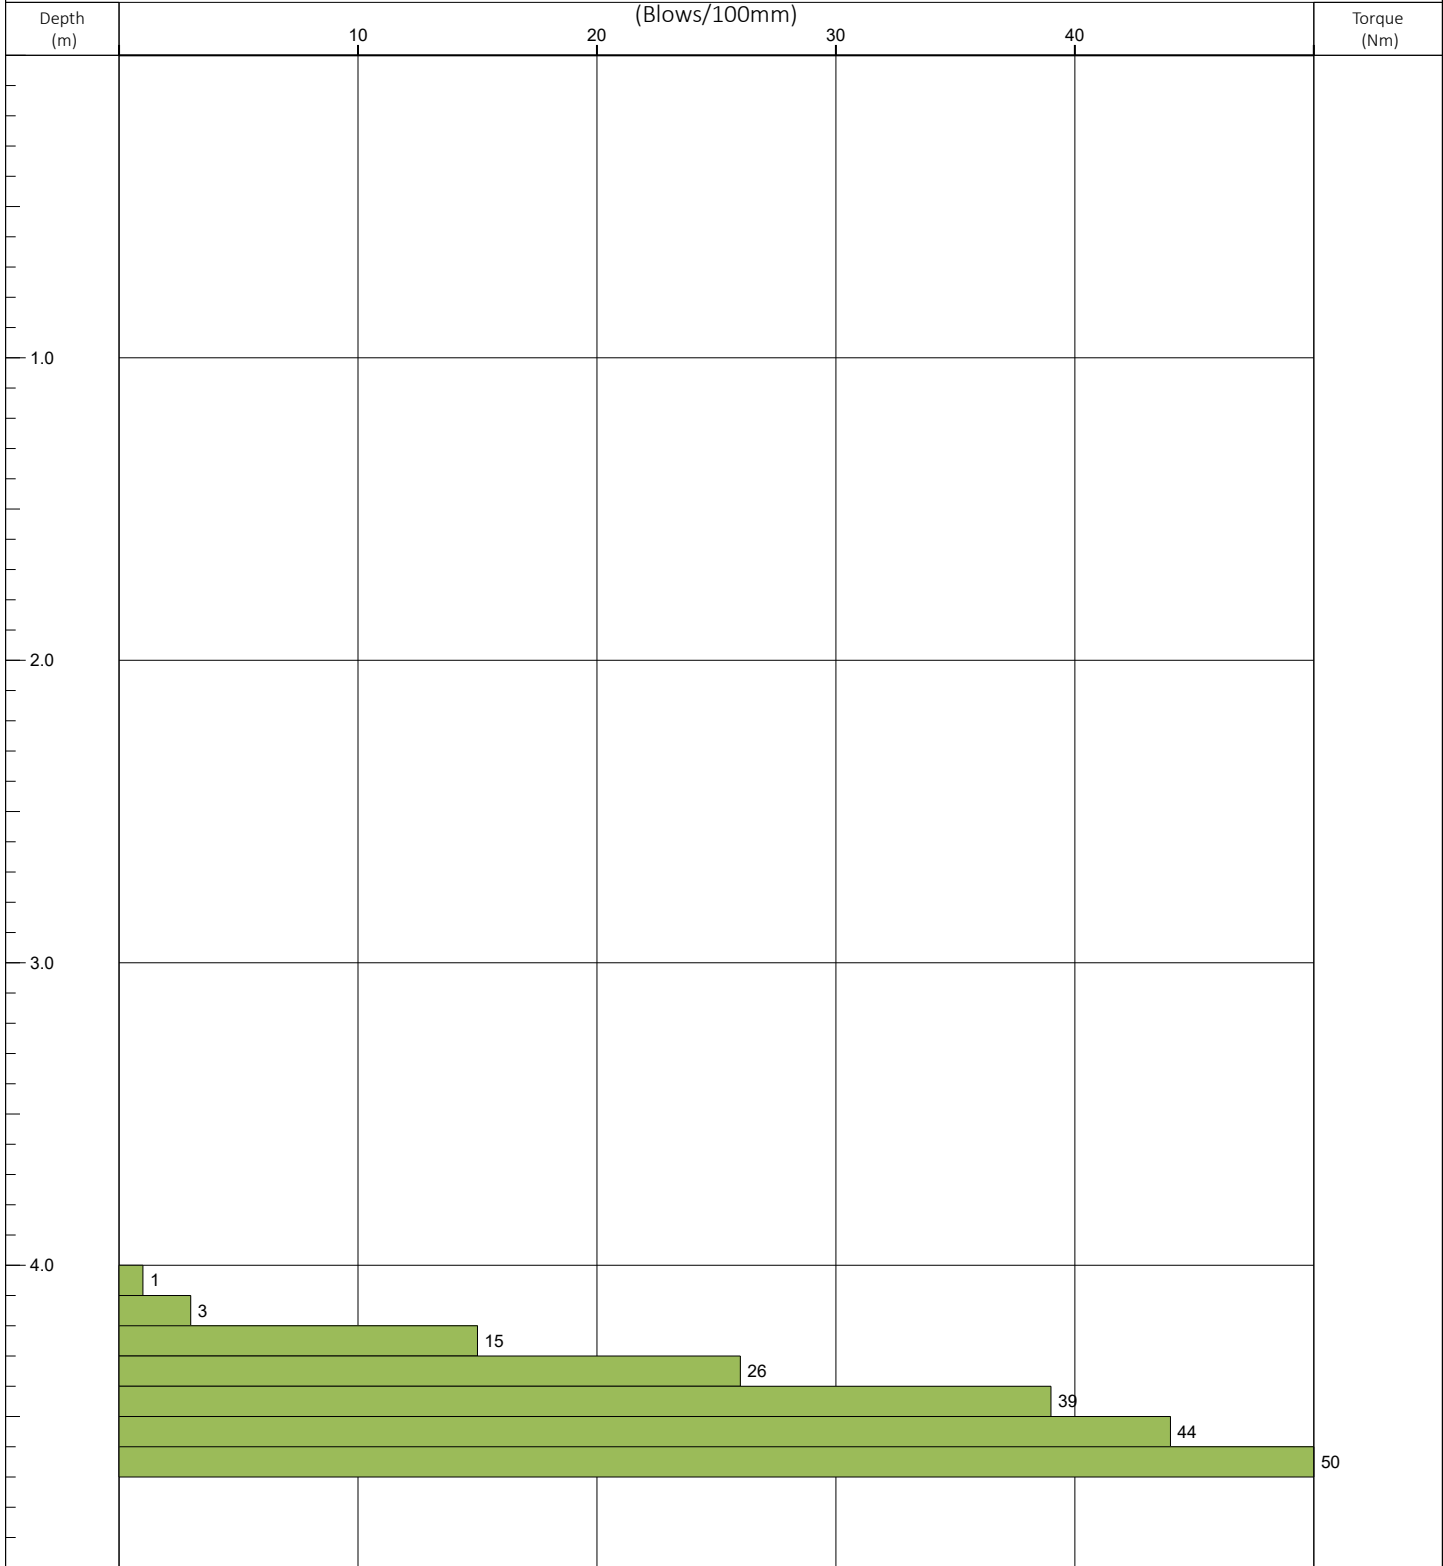
1. Dynamic probe follow-on from WS408S. 2. Refusal at 4.60m bgl.

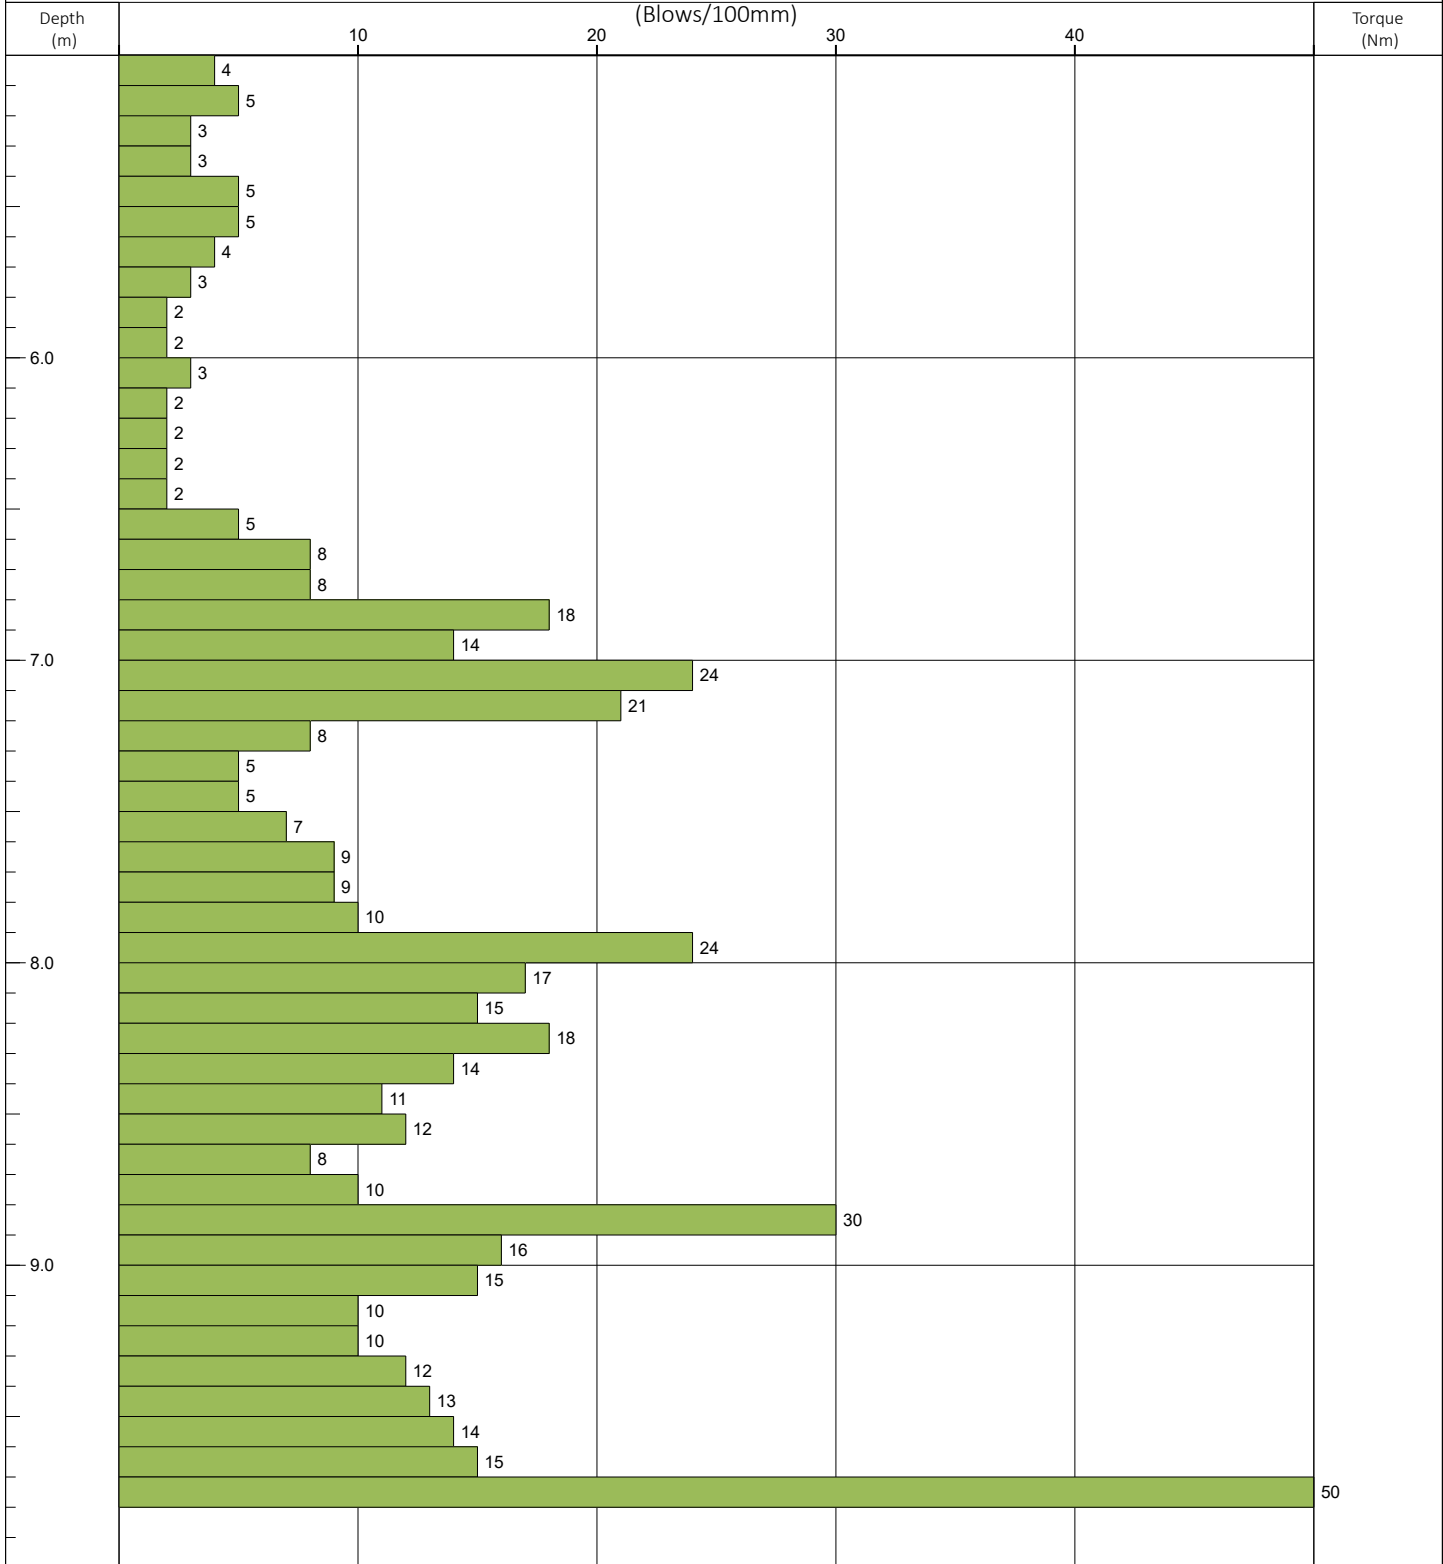
1. Dynamic probe follow-on from WS409S. 2. Refusal at 9.70m bgl.

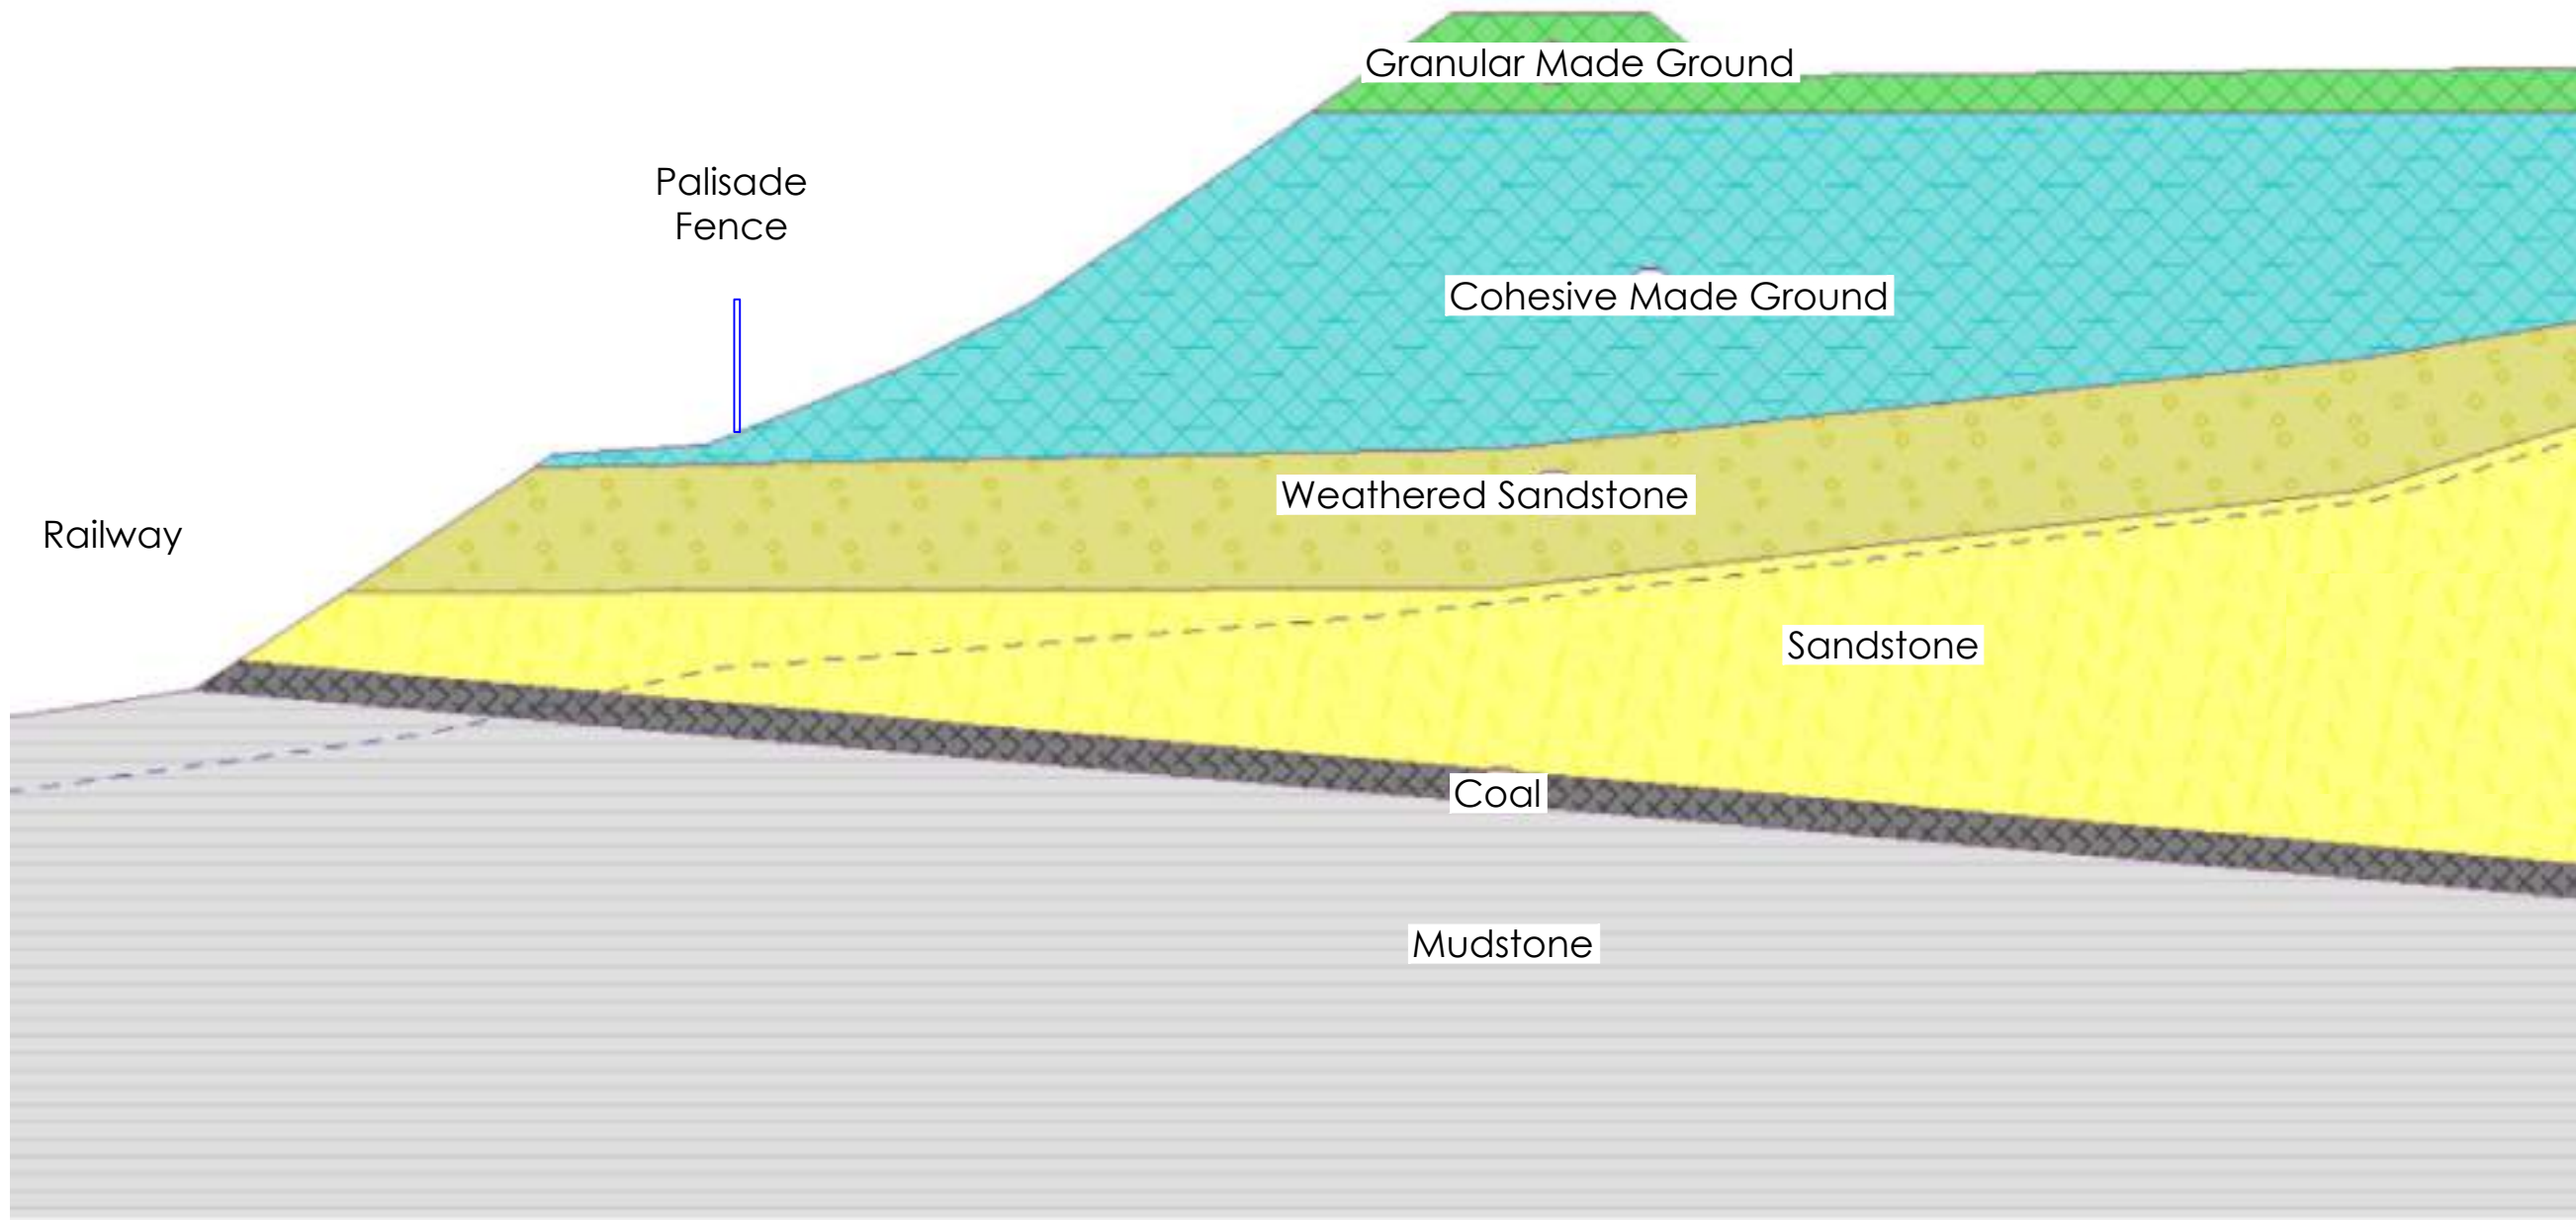
DRAWING NO. C10128A/S/SA01	REVISION NO. 0
DRAWN BY AL	APPROVED BY AMG
DATE May 2026	SCALE 1:500
	PAPER SIZE A3

DRAWING TITLE  
**Indicative Slope Cross-Section  
 with Proposed Ground Raising /  
 Retaining Wall**

As noted above, it is understood that the current requirements for up-filling will require the provision of a retaining wall near to the crest of the slope. Therefore, any slope improvement works will need to take into account the requirement to improve slope stability, the influence of the proposed retaining wall, and the additional loading due to the placing of up-fill materials to the rear of the retaining wall.

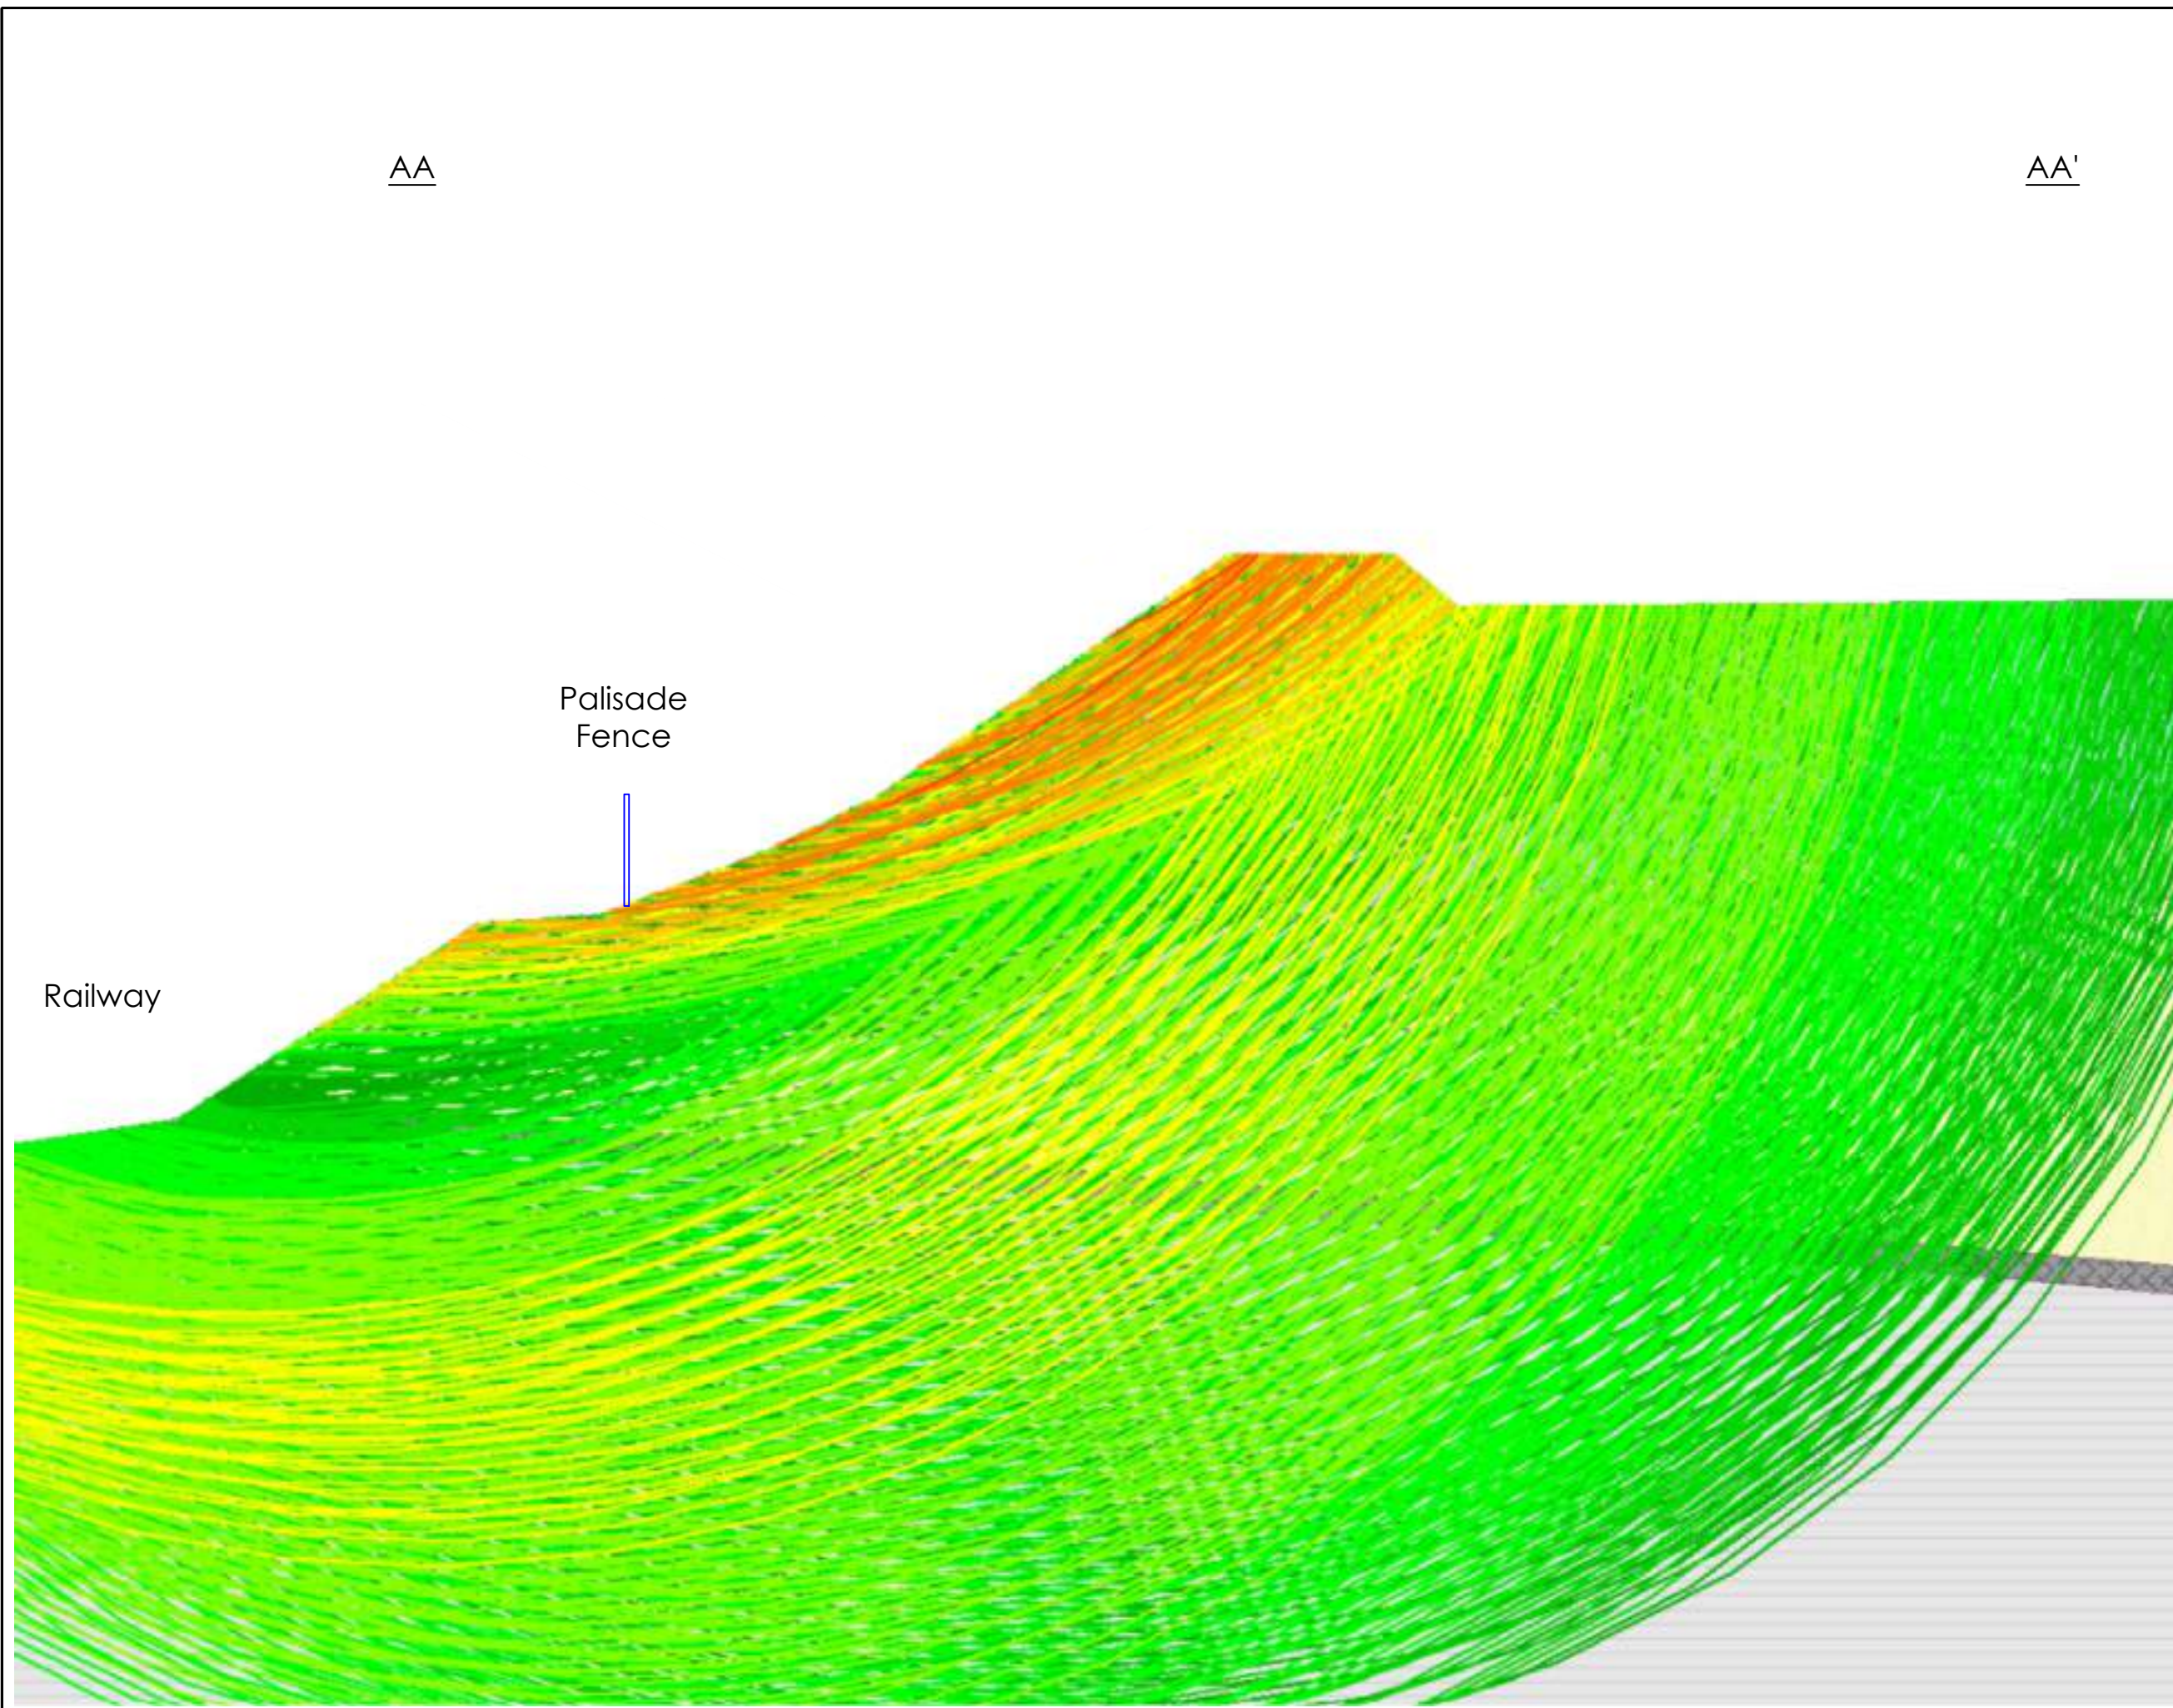
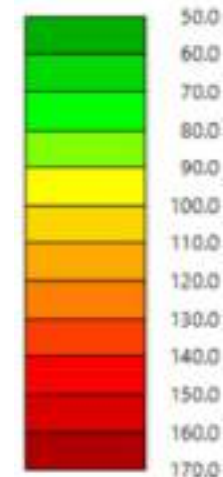
DRAWING NO. C10128A/S/SA03	REVISION NO. 0
DRAWN BY AL	APPROVED BY AMG
DATE May 2026	SCALE 1:500
	PAPER SIZE A3

Utilisation (%)

**Results of Slope Stability  
 Assessment - Existing Scenario**

This assessment shows some utilisation values at the critical failure plane being greater than 100%, indicating the slope stability does not satisfy the requirements of Eurocode (see Drawing Nos. C10128/S/SA/03 and 04 in Appendix C).
