## 2 Hill Top, Cawthorne Heritage Statement

**2 Hill Top, Cawthorne, South Yorkshire**  
**Heritage Statement**

| Type of Project | Heritage Statement |
| Client | Axis Architecture |

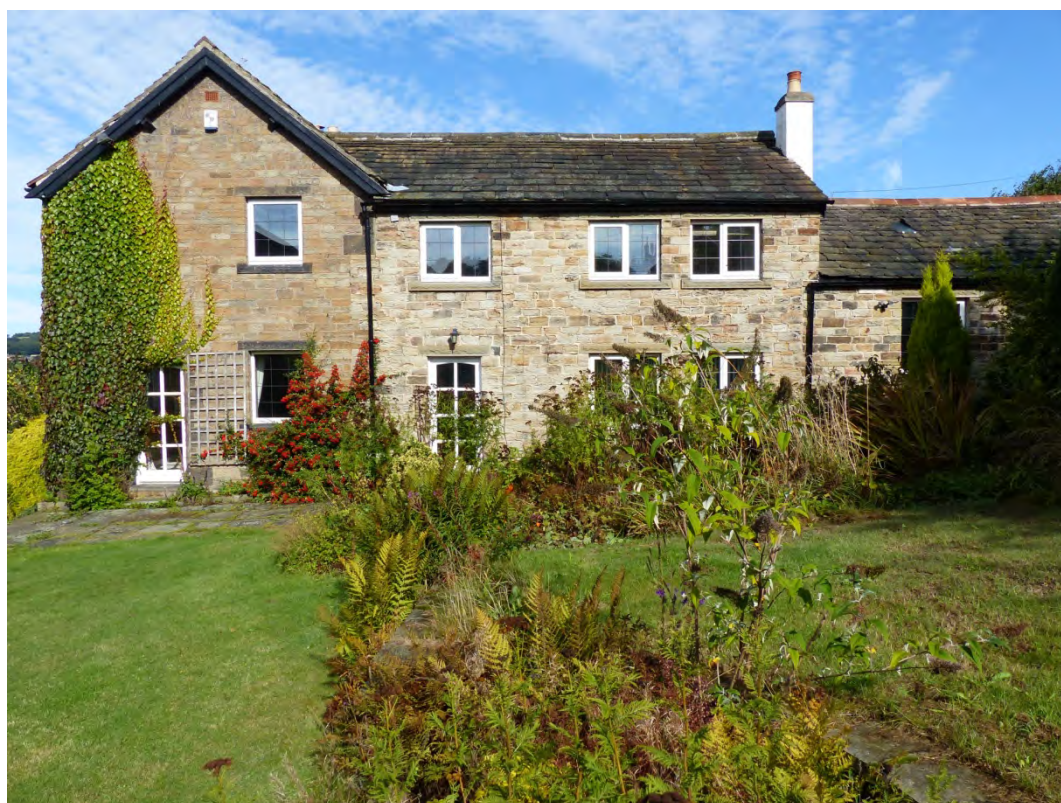
Plate 1: Front elevation of 2 Hill Top

An Heritage Statement has been compiled by ArcHeritage concerning 2 Hill Top, Cawthorne in South Yorkshire (Plate 1). The purpose of this document is to establish the history and significance of the property, and to provide an assessment of the impact future planned works will have on the established significance and provide the justification for the development.

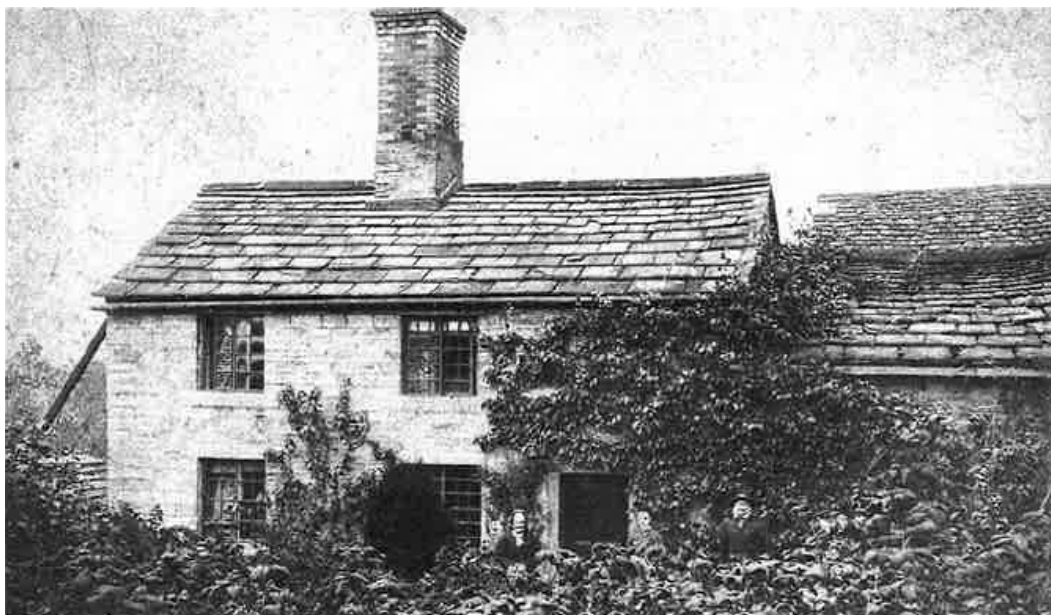
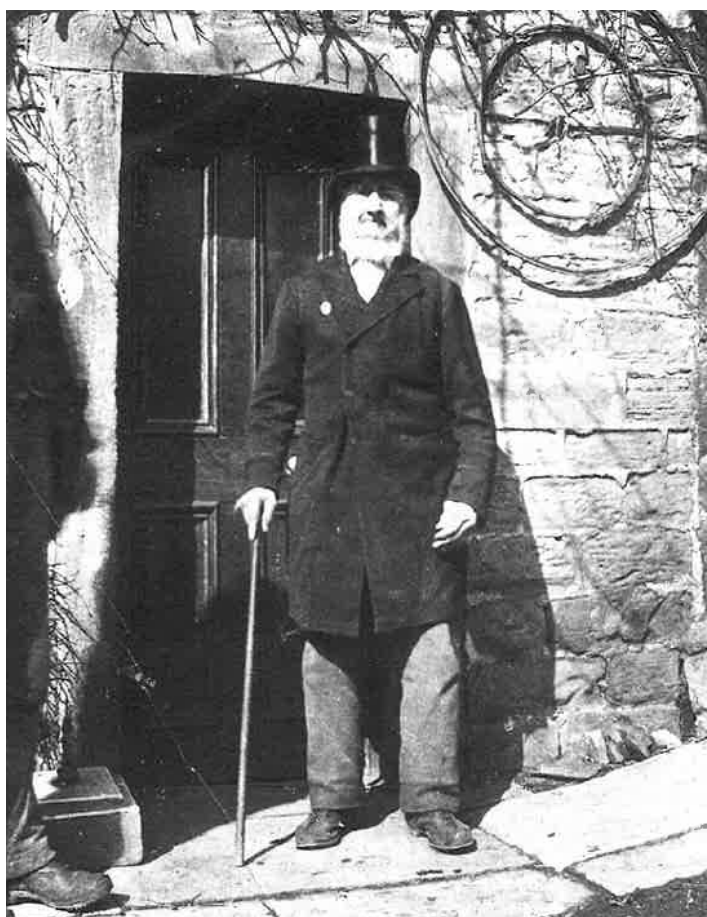
Plate 2: Photo of front elevation of 2 Hill Top c1880

gardener for Cannon Hall. The photos (Plate 2 & Plate 3) show excellent details of what the house looked like at the end of the 19<sup>th</sup> century. The style of the house during this period is likely very similar to what it would have looked like when it was first constructed. The single storey addition to the east is may have been added sometime after the buildings construction, it is also possible the windows and door were replaced at some point in the 19<sup>th</sup> century prior to these pictures.

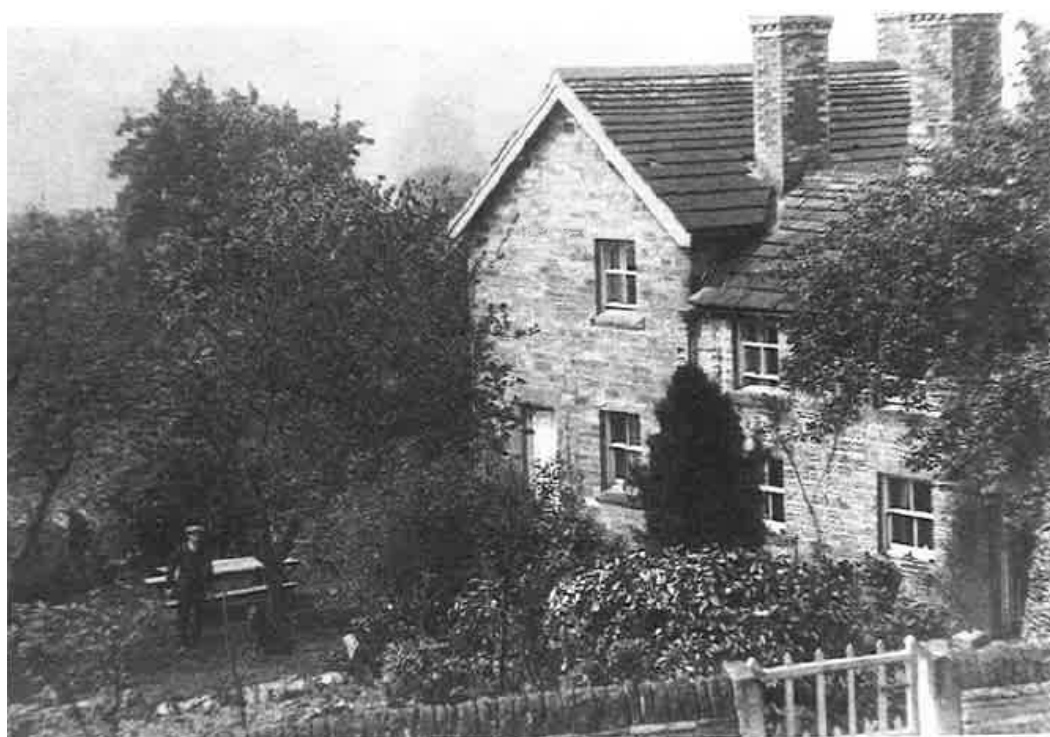
**Plate 4: Photo of front elevation of 2 Hill Top c1900**

A picture likely from the early 20<sup>th</sup> century (Plate 4) when Douglas Charlesworth owned the property shows the house as having undergone some major changes in the short time between the 1880 photo and when this photo was taken. A large gable fronted addition was added to the west of the house almost doubling its floor space. There are a total of three chimneys present and the windows have all been changed. The external boundary wall appears to have been unchanged.

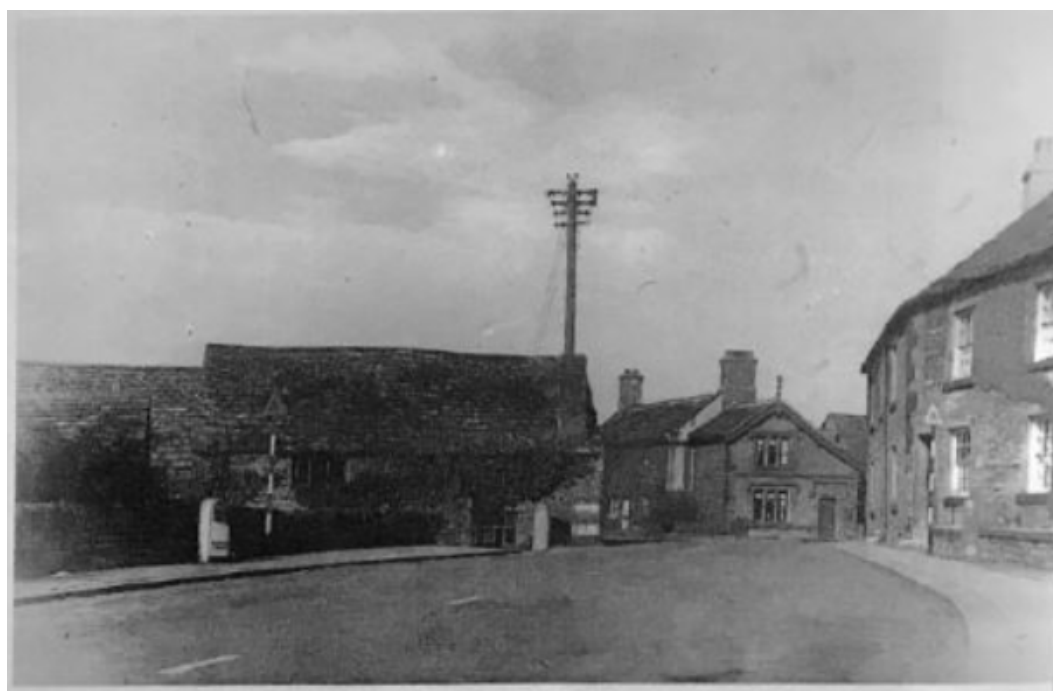
**Plate 5: 1950s photo of Cawthornes first school and priest house, demolished 1962.**

An OS map from 1931 (Figure 7) shows the house little changed from the previous map, with only the small rear addition now missing or not illustrated. The next OS map (Figure 8) from 1960-61 again shows the house very much unchanged. This would be the last map to show the former school prior to its demolition in the 1960s. A photo taken of the former school ( Plate 5) from the 1950s shows how it looked just prior to its demolition. The map also helps us establish when the northwest addition was added, clearly sometime after this map of 1960 and before the photo from the 1980s.

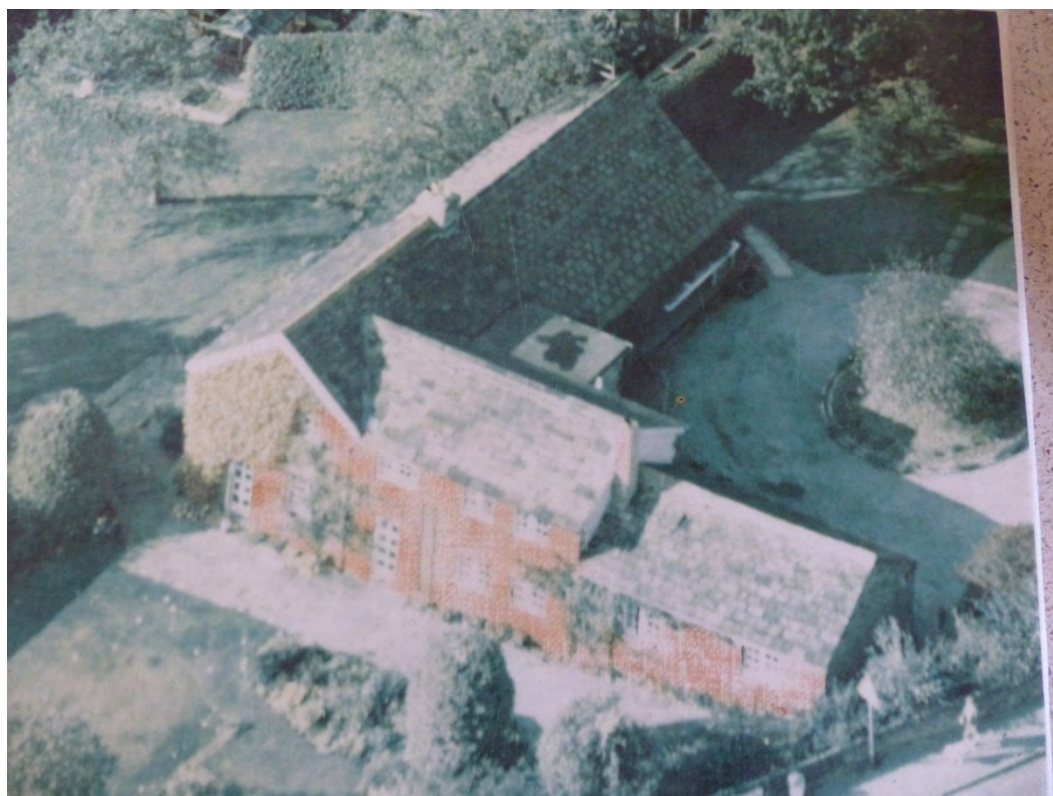
**Plate 6: 1970-80s aerial photo of 2 Hill Top.**

An undated photo presumably from the 1970s or 1980s (Plate 6) shows the house prior to the conversion of the garages to the rear. It also shows a flat roof addition to the corner of the building. The red colouring of the house appears to have been added to the photo after it was taken.

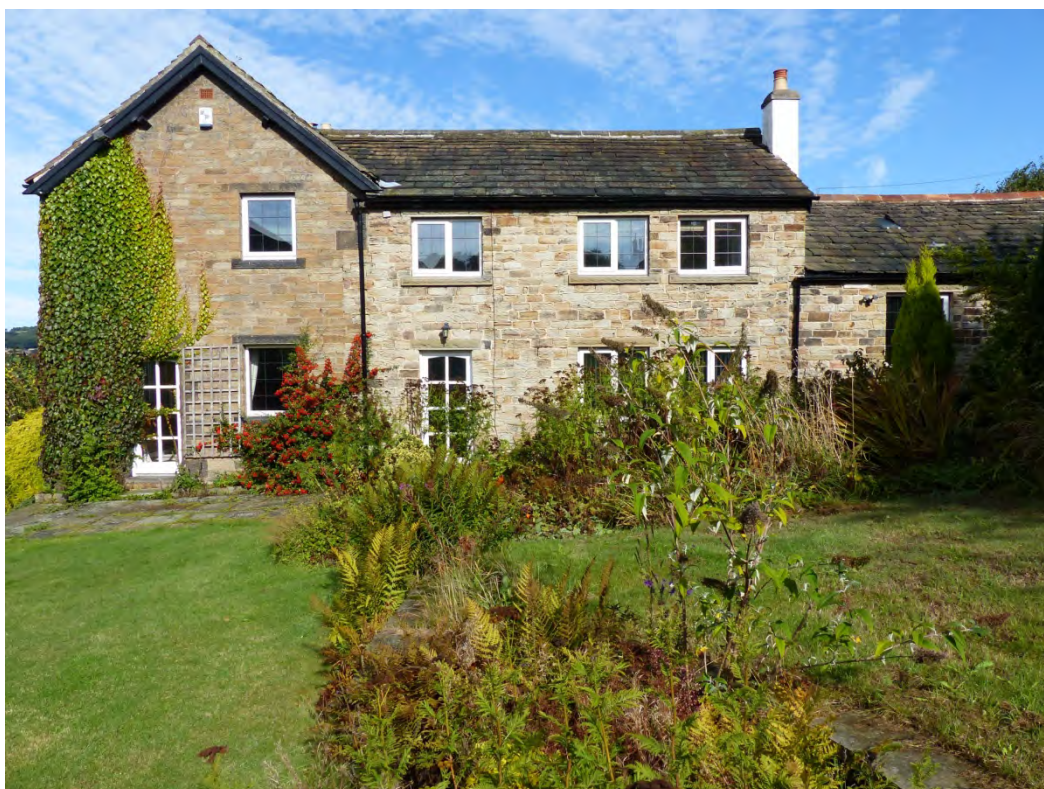
Plate 17: South elevation of 2 Hill Top, looking north

The south elevation (Plate 17) would have originally been the front elevation of the house. It is now formed of three parts, the original farmhouse at the centre, the single storey addition to the east and the early 20<sup>th</sup> century gable fronted addition to the west. The photo from the late 19<sup>th</sup> century (Plate 2) shows the house as it is assumed to have been when first built. The central portion of the elevation is three bays and two storeys composed of regularly coursed quarried gritstone recently re-pointed with a concrete based mortar. The windows are modern replacements with replacement stone sills and lintels (Plate 19). The historic photos show that the door was originally on the east end of the elevation and there may not have been a window at the east end above it, likely only added after the door was moved. Looking at the historic photos also shows that the wall was raised along with the roof. This stack replaces several much larger ornate chimneystacks seen in the photo from the early 20<sup>th</sup> century (Plate 3). The east end of the south elevation is much the same as the central portion however the stone wall is laid in a slightly different style. The west gable fronted portion of this elevation (Plate 18) has walls of slightly darker stonework and quoins stones, otherwise this portion is similar to the rest. The roofs are all laid with diminishing stone slates and stone and ceramic ridge crestings, a single rendered chimneystack sits at the east end of the oldest portion of the house.

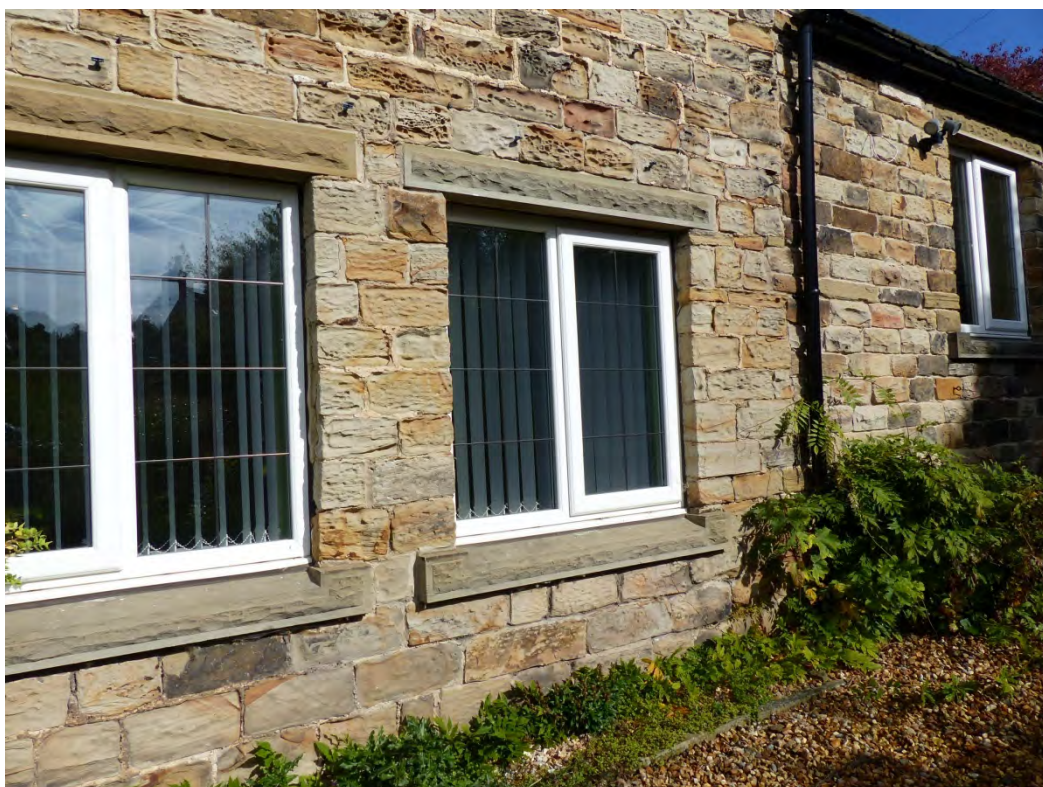
Plate 19: Detail of windows to central south elevation, looking northeast

All windows throughout the house are modern uPVC windows and the doors are all timber glazed replacements.

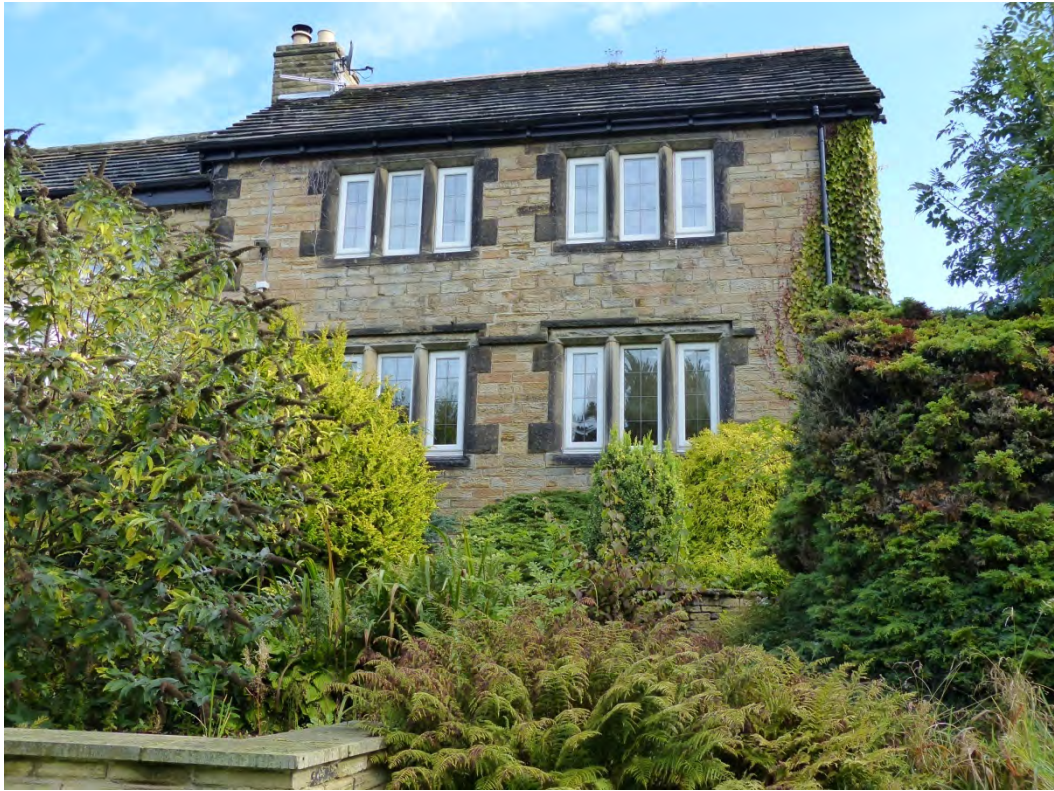
Plate 21: West elevation of southwest addition, looking east

The west elevation is composed of the early 20<sup>th</sup> century addition to the southwest (Plate 21) and the late 20<sup>th</sup> century addition wing to the northwest. This elevation faces out toward open fields and the open yard of the house. The early 20<sup>th</sup> century addition has four three light

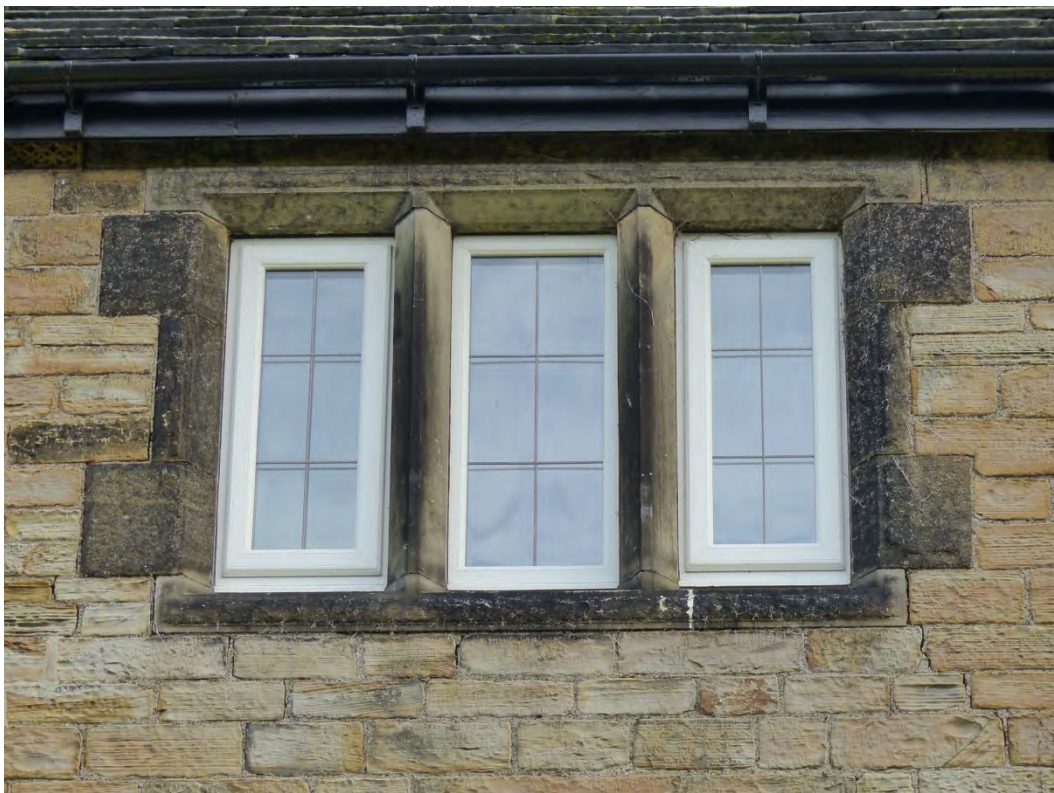
Plate 22: Detail of window to west elevation of southwest extension, looking east

windows with carved stone hood mouldings, mullions, lintels, sills and surrounds (Plate 22). These are in keeping with many historic windows throughout the town and are an interesting flourish to a house that did not previously have them, however the window lights are now uPVC replacements. A stone chimneystack sits at the north end of this addition. The northwest addition is no more than 50 years old. It is clad in stonework intended to match the older parts of the house. A modern conservatory and patio area are attached to the east end of this addition (Plate 23). The north and east elevations of this addition are of a similar style with the main entrance for the house now located in the east elevation (Plate 24).

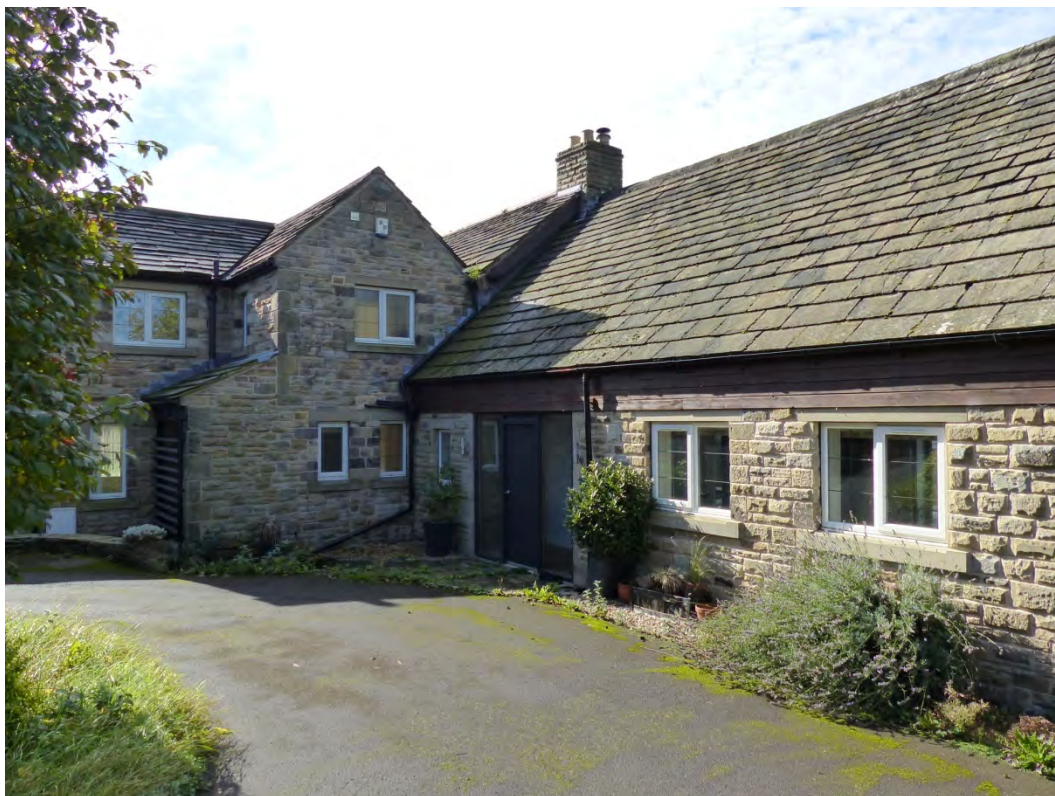
Plate 25: The east and north elevations of the house, looking southwest

Ignoring the modern northwest addition, the north facing elevation is composed of a small addition at the west end (Plate 25), the original body of the house, and the single-storey east addition (Plate 26). The interesting detail to note about this elevation is that all of the stonework appears to be modern. It appears that the stonework along these three different parts of the elevation has been re-clad, the stonework closely resembles that seen in the northwest addition. The age of the stone is not evident and many blocks are sharply cut.

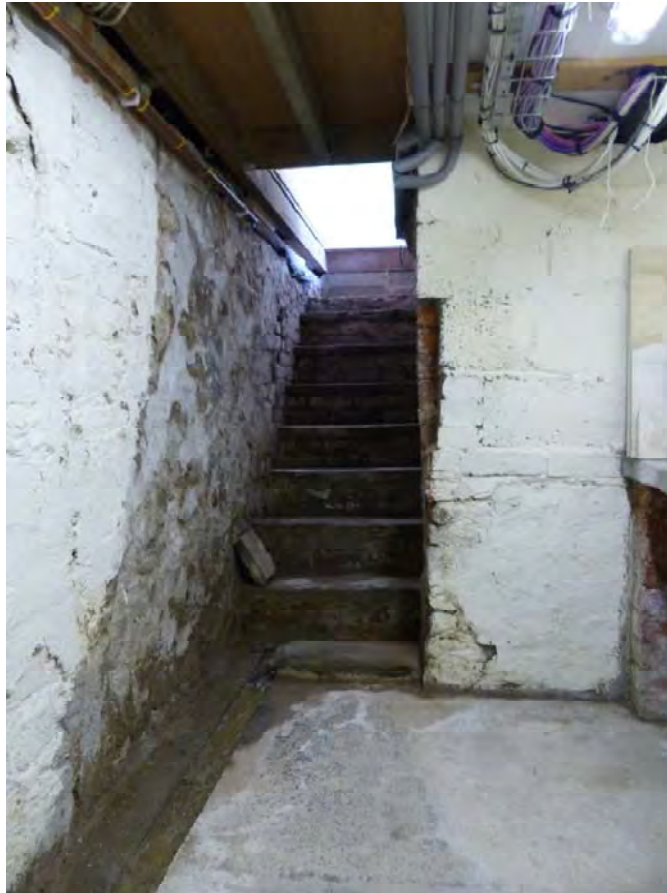
Plate 35: Steps down to basement, looking east

The basement of the house is accessed through a hatch in the west end of the original house. A set of brick stairs with stone treads leads down to the west (Plate 35) and run under the original body of the house and the southwest addition (Plate 37). The floor is modern concrete and the walls are mostly composed of brick. There are several stone benches set upon brick bases (Plate 36), many of the bricks and stone slabs appear modern, but may replace older materials. It is

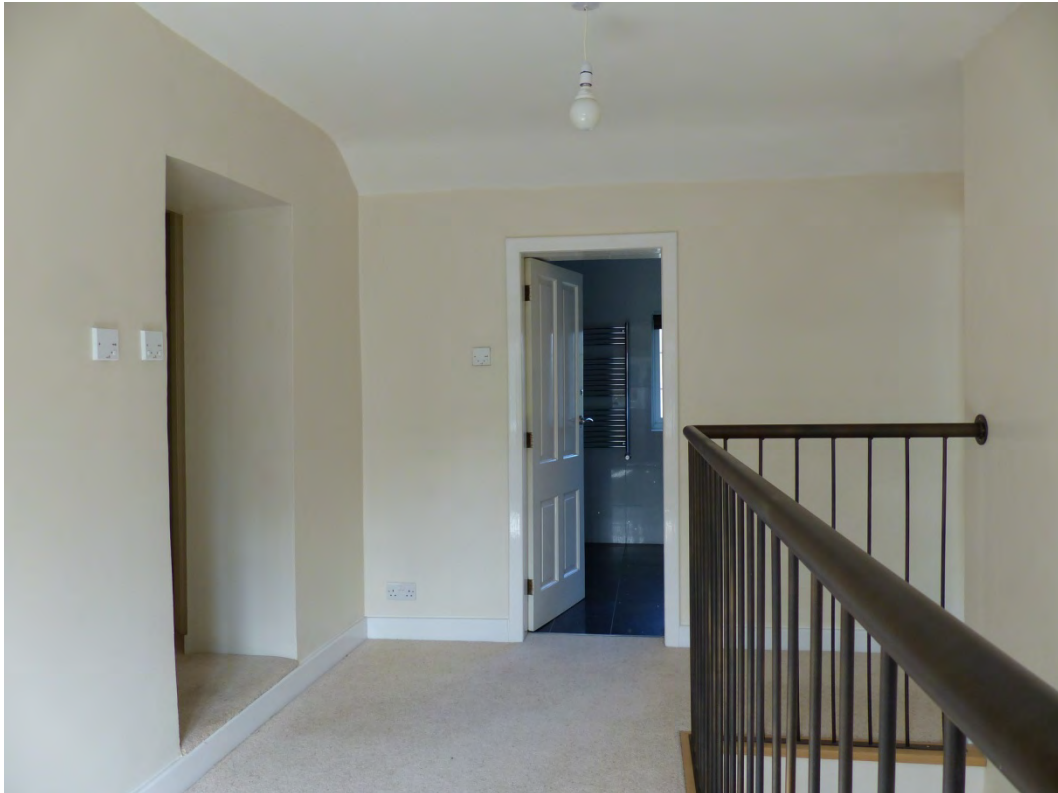
Plate 38: First floor landing, looking north

The first floor contains several bedrooms (Plate 39) and one bathroom over the original house and all of the subsequent additions. These rooms are all accessed from the staircase at the west end of the original house (Plate 38).

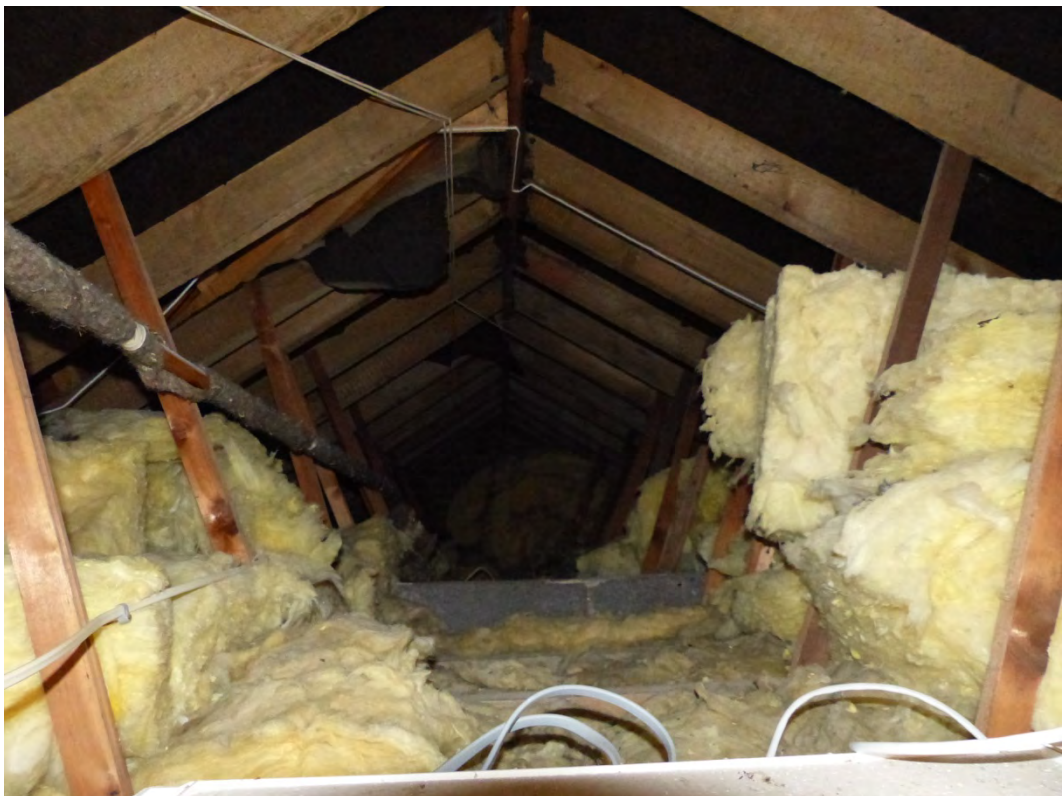
Plate 40: The internal roof above oldest part of the house, looking east

An inspection of the interior of the roof within the original portion of the house revealed that the entire internal roof structure had been replaced likely within the last 50 years (Plate 40). This may have occurred when the roof and walls of this portion of the house were raised.
