## GROUND INVESTIGATION REPORT

FORMER MONCKTON COKE WORKS, NR BARNSELY

FOR Hargreaves (UK) Services Ltd

**Ground Investigation Report**  
**Former Monckton Coke Works, Nr Barnsley**  
**for**  
**Hargreaves (UK) Services Ltd**

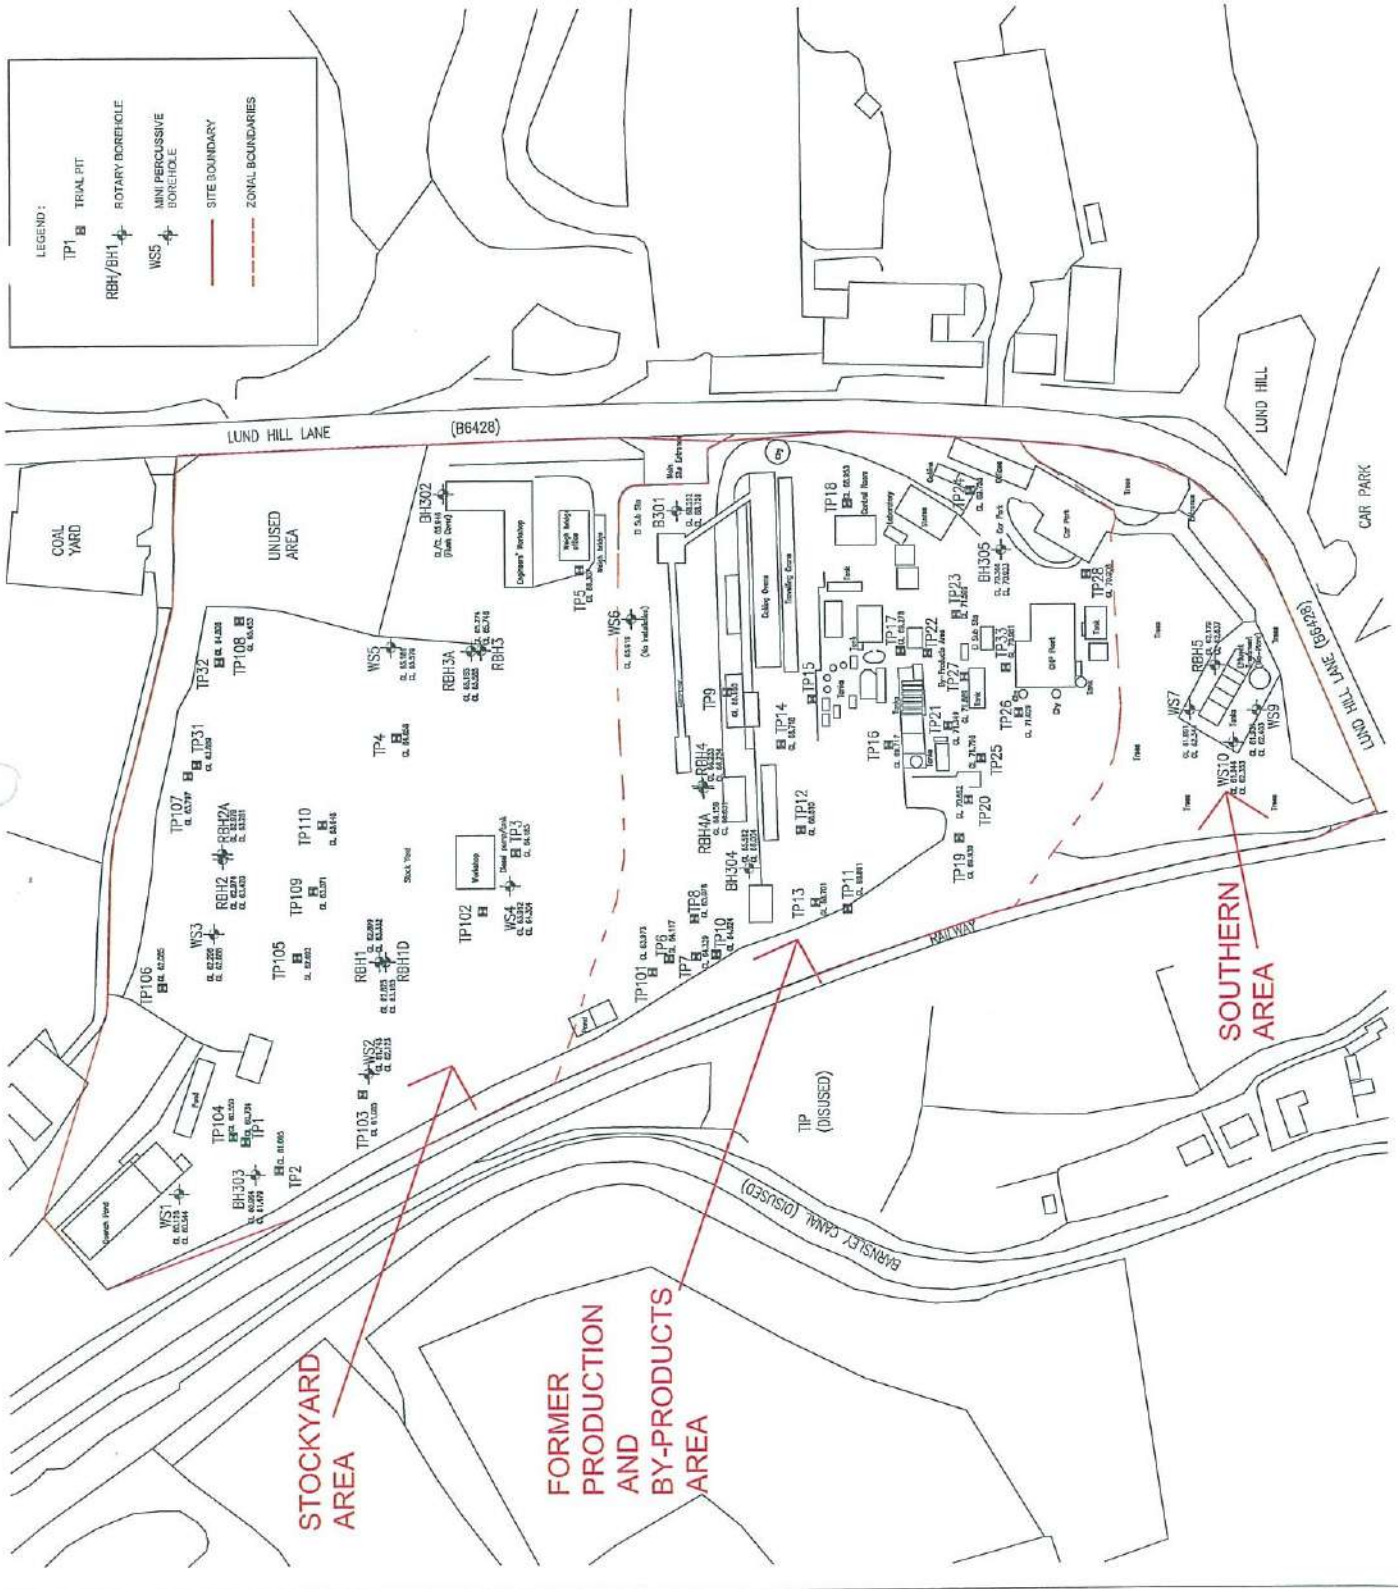
Drawing No. **G15009\_701** Rev.

A plan (prepared by the contractor Van Elle) showing the location of the exploratory holes is included as PPL Drawing No. G15009-701, included in **Appendix A**.
