## **DARFIELD-UPON-DEARNE ENHANCEMENTS**

### **ACCESS STATEMENT**

### **ARCHAEOLOGY STATEMENT**

### **ECOLOGY SURVEYS**

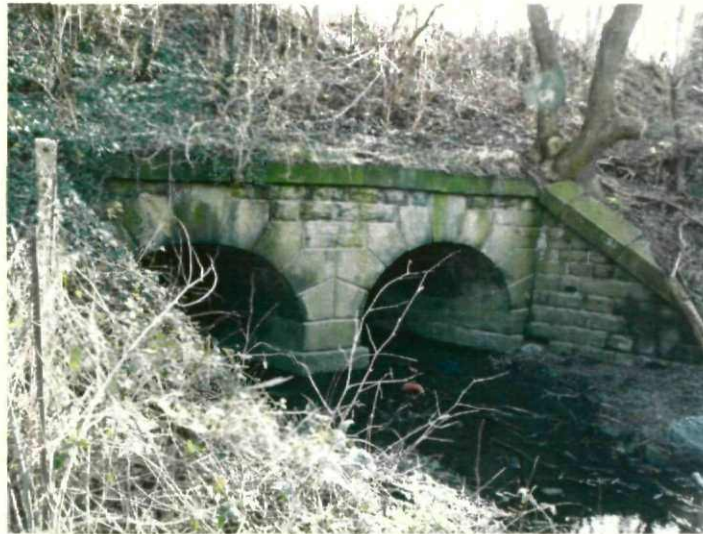
**Figure 3.** The bridge near Doncaster Road, through which the Dearne used to flow.

The river was not diverted from this course when the railway line was originally built (around 1840). The river passed under the railway line at the top of the present straight section and returned under a bridge near the Doncaster Road. This bridge still exists and a small watercourse passes under it today (Figure 3).

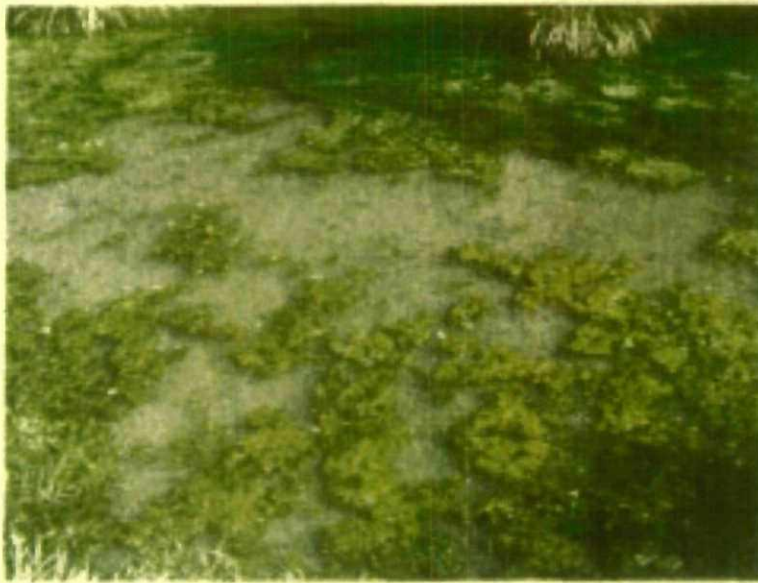
Photograph 5.  
Algae and large mats of common water-starwort (*Callitriche stagnalis*) cover the water surface.

The site is a terrific area and from the outset the pond looked suitable for great crested newts and other amphibians. As the results show, this is obviously not the case. Only one smooth newt and thirteen toad tadpoles were caught while using 80 bottle traps on each survey date. This amounts to a very low return considering that the pond looks so suitable for amphibians. Also, and surprisingly, very few aquatic invertebrates were found. It can only be assumed that those results are a consequence of last years (2007) heavy flooding in this particular area. The flooding seems to have washed the pond clear of much of its amphibian and invertebrate life. Only three-spined stickleback (*Gasterosteus aculeatus*) were found to be present in reasonable numbers.

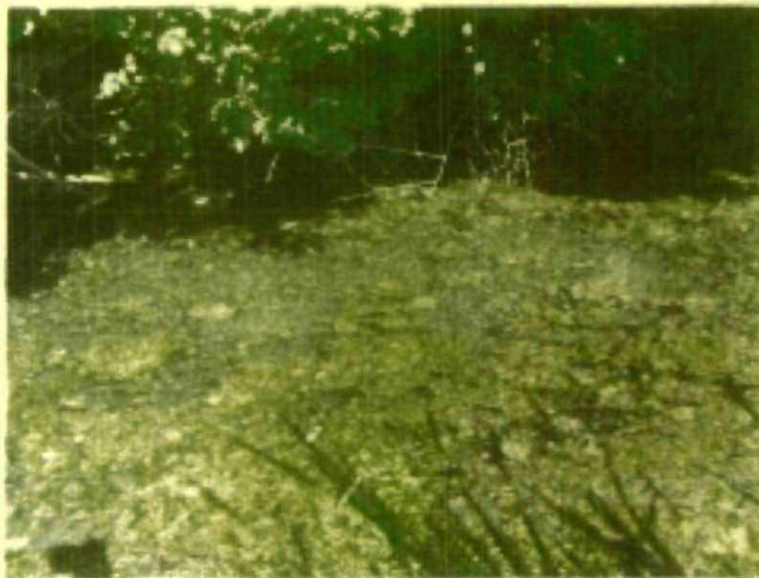
Photograph 6.  
There is a smell of raw sewage in the eastern parts of the pond. The quality of water in these sections of the pond look heavily polluted and dominated by algae.
