Our Ref: F1/HOO/03/WW

24<sup>th</sup> November 2023

Barnsley Road, Goldthorpe, Barnsley  
Shaft Investigation Results

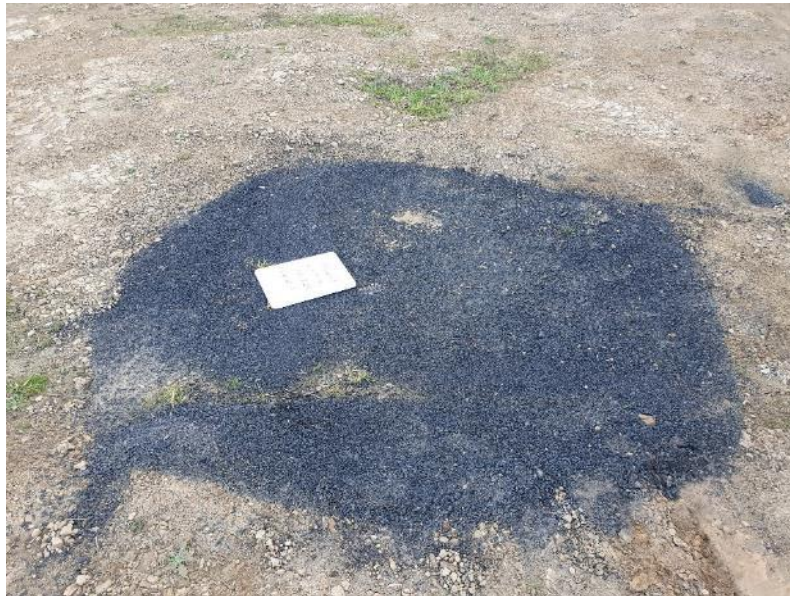
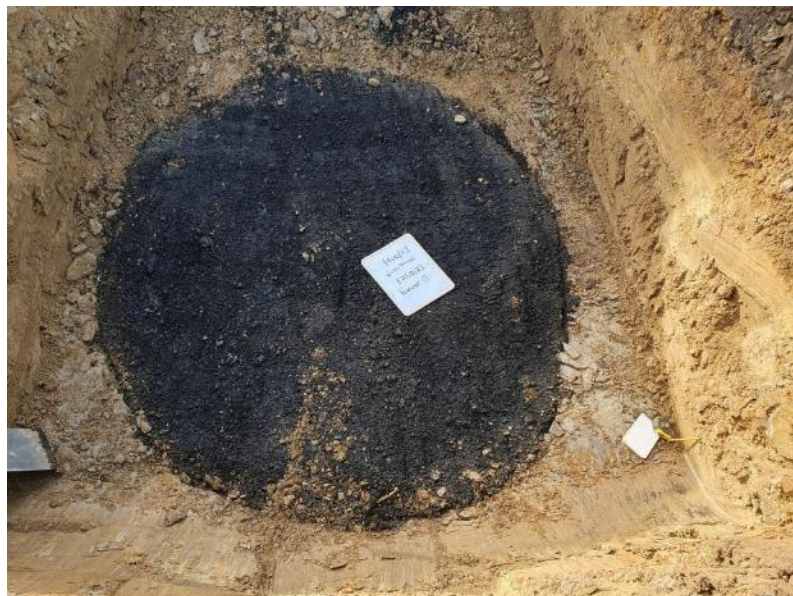
**Photo 1 and 2:** Mine Entry F1 at surface (Top) and at rockhead (Bottom)

#### Mine Entry 'F1' (445045.18, 404320.19)

At surface, the expression of the anomaly was circular in shape and comprised densely compacted made ground. The anomaly was visible due to a colour variation between the natural strata (Dark grey in colour) compared to a light greyish brown colour.

Excavation and stripping of the surface revealed a circular patch backfilled with made ground, easily distinguished by a colour variation from the natural greyish brown coloured siltstone to a dark grey colour. The made ground was predominantly reworked natural materials such as

mudstone, coal and clay. The depth to competent rock head was approximately 1.2m BGL, at a level of 36.0m AOD. The aperture at rock head was measured to be 2.2m in diameter. The excavation into the middle of the feature, indicated that the feature extended at least a further 2.5m, 3.7m bgl in total. From this, it is concluded that this feature is a mine shaft. The excavation was taken to 1.2m depth to assess the quality of the rock for founding a cap. This showed that the rockhead comprised siltstone, suitable for cap founding.

Based on stripping, and excavating down into the features it is concluded that the four features are mine shafts. It is recommended that the shafts are capped, founding on rockhead, with the cap extending the length of the radius of the shaft past the opening at rockhead (i.e. the cap will be twice the shaft diameter), the ground above the cap shall then be backfilled and a building exclusion for founding imposed, such that no building loading is placed directly on the cap.

It is also recommended that a 45 degree angle extending from the edge of the cap, in cross section, is used to define the depth of any foundations. It is recommended that the depths of the foundations are extended below the confining 45 degree line so that no residual strain is transferred onto the cap.

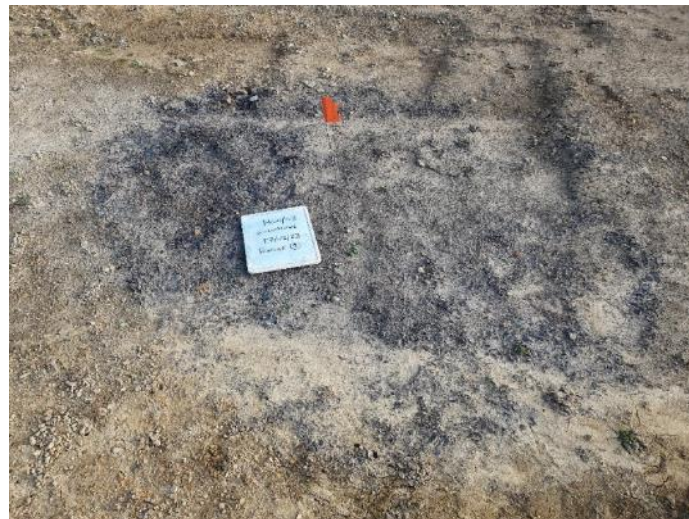
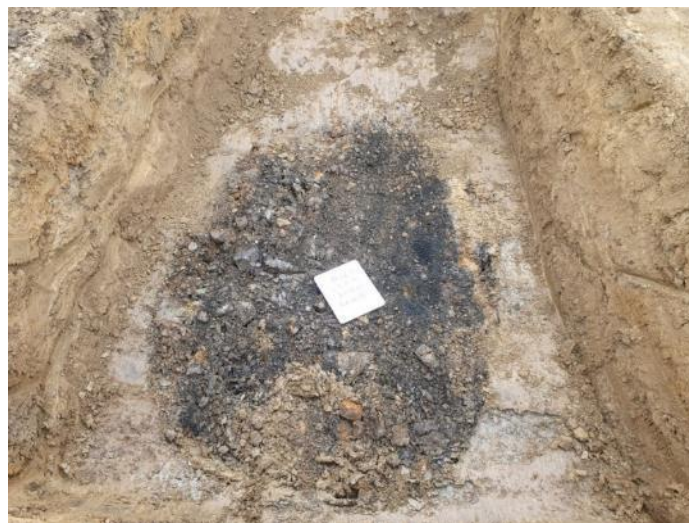
**Photo 3 and 4:** Mine entry F2 at surface (Top) and at rockhead (Bottom)

Mine Entry 'F2' (445030.83, 404259.73)

At surface, the expression of the anomaly was oval in shape and comprised densely compacted made ground. The anomaly was visible due to a colour variation between the natural strata (Dark grey in colour) compared to a light greyish brown colour.

Excavation and stripping of the surface revealed an oval patch backfilled with made ground, easily distinguished by a colour variation from the natural greyish brown coloured siltstone to a dark grey colour. The made ground was predominantly reworked natural materials such as mudstone, coal and clay. The depth to competent rock head was approximately 1.2m BGL, at a level of 36.5m AOD. The aperture at rock head was measured to be 2.5m by 1.6m. The excavation into the middle of the feature, indicated that the feature extended at least a further 2.5m, 3.7m bgl in total. From this, it is concluded that this feature is a mine shaft. The excavation was taken to 1.2m depth to assess the quality of the rock for founding a cap. This showed that the rockhead comprised siltstone, suitable for cap founding.

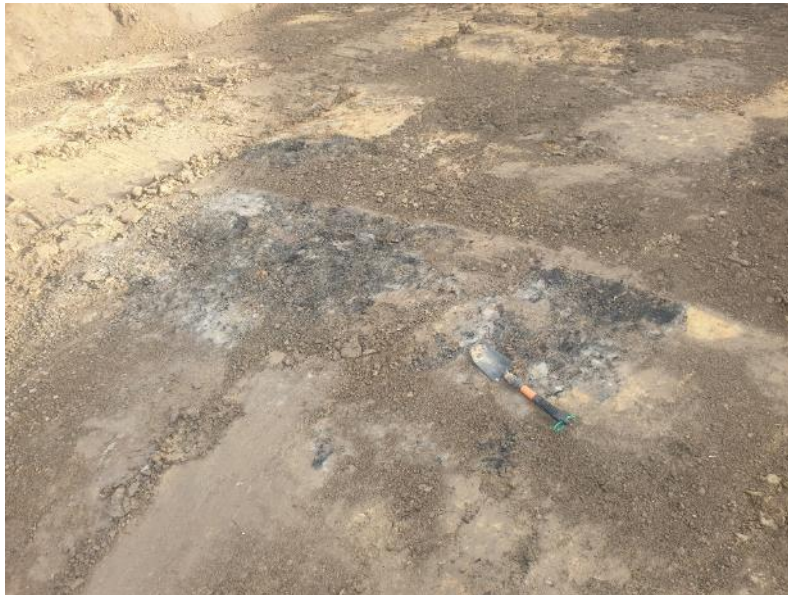
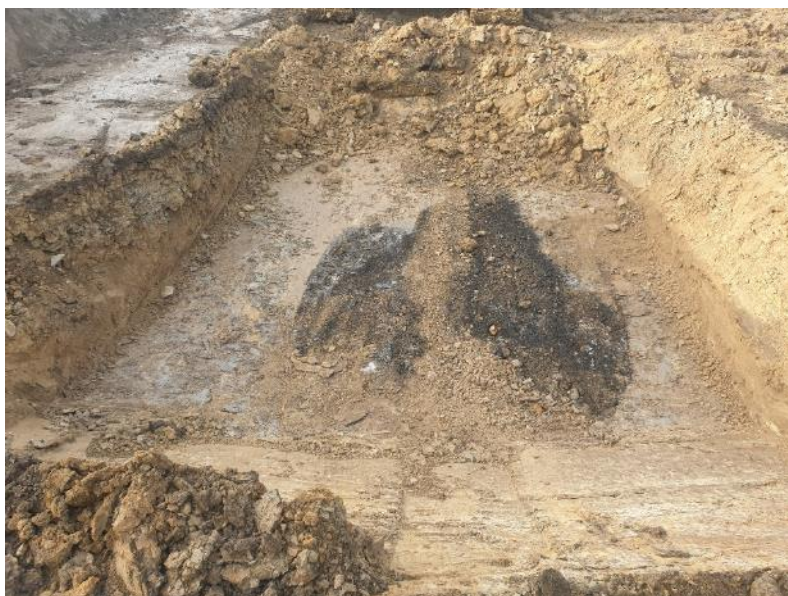
**Photo 5 and 6:** Mine entry F3 at surface (Top) and at rockhead (Bottom)

Mine Entry 'F3' (445066.09, 404232.54)

At surface, the expression of the anomaly was circular in shape, and comprised densely compacted and backfilled mine spoil.

Excavation and stripping of the surface revealed a circular patch, backfilled with made ground, easily distinguished by a colour variation from the natural greyish brown coloured siltstone to a dark grey colour. The made ground was predominantly backfilled mine spoil such as mudstone, coal and clay. The depth to competent rock head was approximately 1.2m BGL, at a level of 38.5m AOD. The aperture at rock head was measured to be 2.5m by 2.1m. The excavation into the middle of the feature, indicated that the feature extended at least a further 1.5m, 2.7m bgl in total. From this, it is concluded that this feature is a mine shaft. The excavation was taken to 1.2m depth to assess the quality of the rock for founding a cap. This showed that the rockhead comprised siltstone, suitable for cap founding.

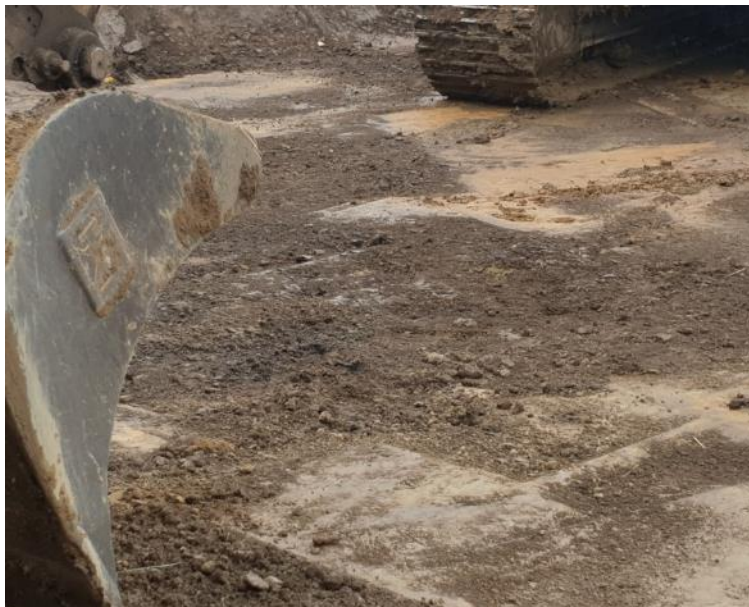
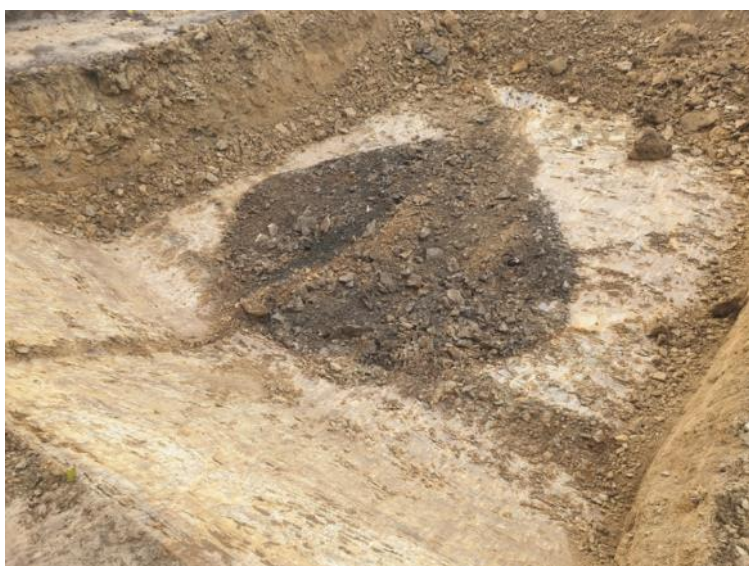
**Photo 7 and 8:** Mine entry F4 at surface (Top) and at rockhead (Bottom)

Mine Entry 'F4' (445069.36, 404276.69)

At surface, the expression of the anomaly was circular in shape, and comprised densely compacted and backfilled mine spoil.

Excavation and stripping of the surface revealed a circular patch, backfilled with made ground, easily distinguished by a colour variation from the natural greyish brown coloured siltstone to a dark grey colour. The made ground was predominantly backfilled mine spoil such as mudstone, coal and clay. The depth to competent rock head was approximately 0.8m BGL, at a level of 37.9m AOD. The aperture at rock head was measured to be a maximum of 2.4m in diameter. The excavation into the middle of the feature, indicated that the feature extended at least a further 2.0m, 2.8m bgl in total. From this, it is concluded that this feature is a mine shaft. The excavation was taken to 0.8m depth to assess the quality of the rock for founding a cap. This showed that the rockhead comprised siltstone, suitable for cap founding.
