BS 5837 Arboricultural Survey & Impact Assessment

Site Address:	Hawshaw Bank, Barnsley, South Yorkshire S74 9ND	Client:	A.N.S Construction Ltd. F.A.O Matt Thistlewood
Report Ref:	HSBB01-24	Report Date & Revision:	8th May 2024 Original
Author:	Laurence Smith BSc (Hons) Arb, M Arbor A	Signed:	<i>Laurence Smith</i>

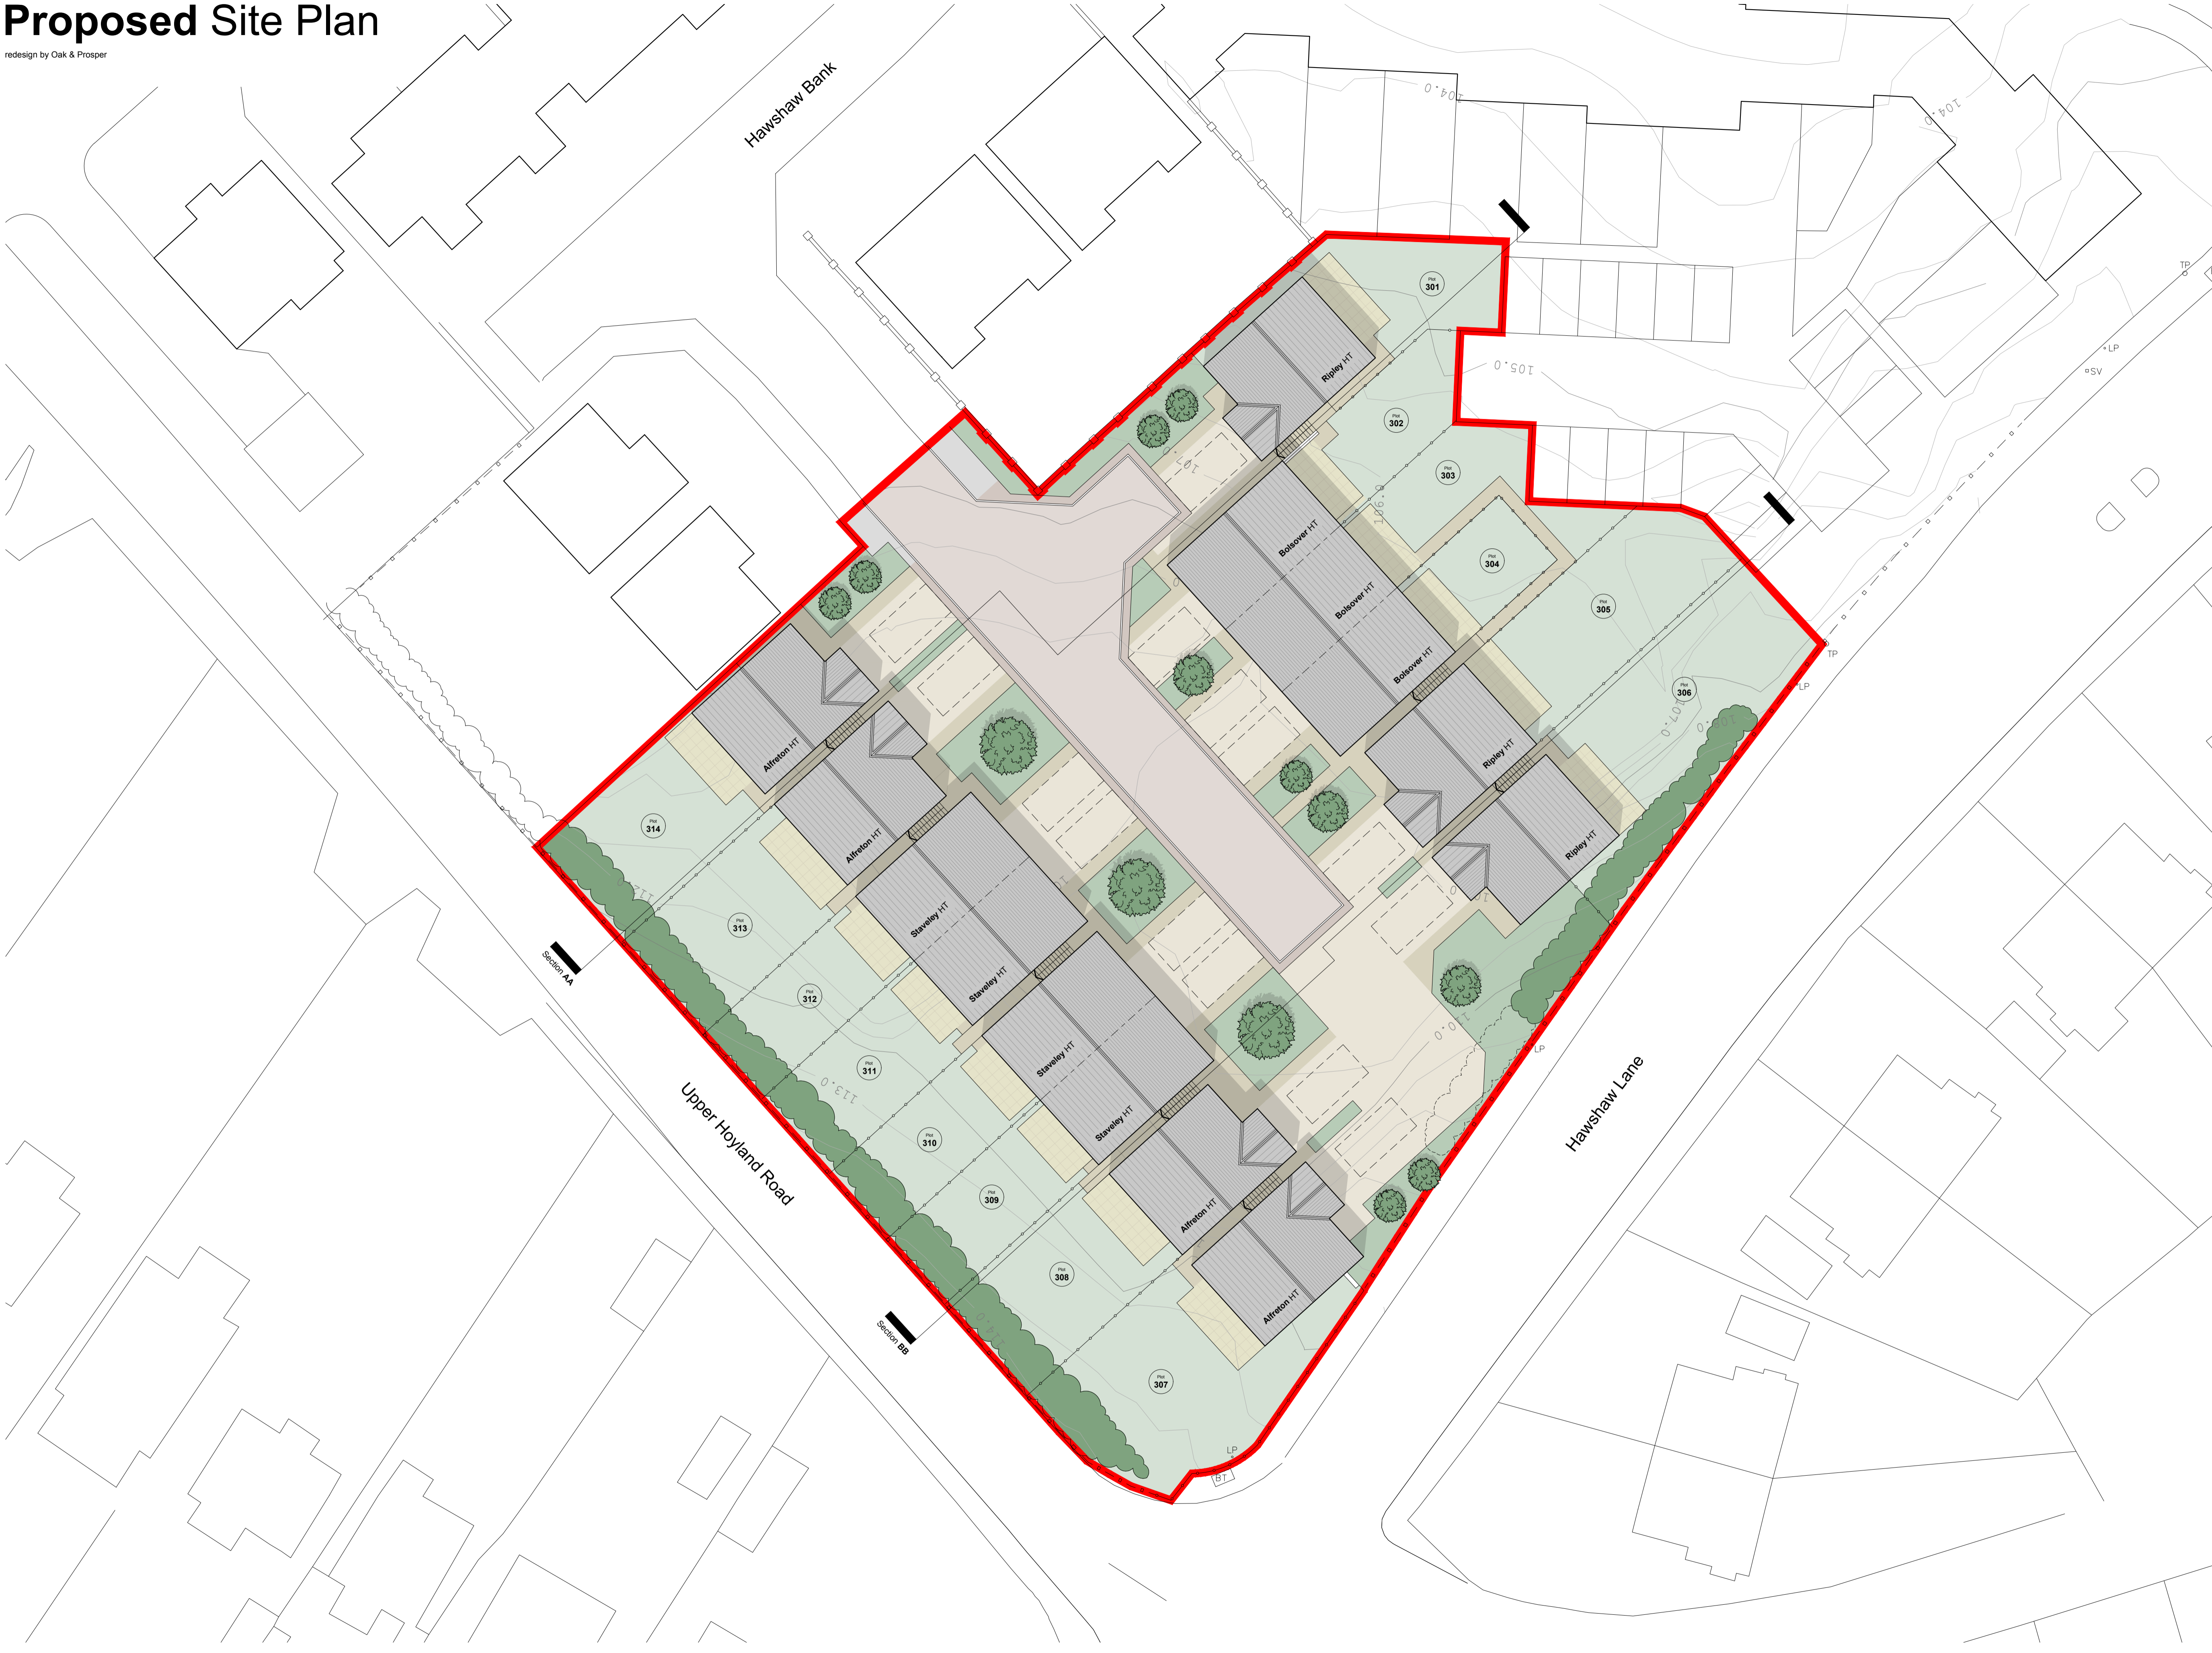
Drawing Title
 Proposed Site Layout

A hard and soft landscaping strategy has been identified across the proposed site plan to indicate how both the public and private spaces will be provided. Hard standing has been kept to a minimum where possible to allow additional grassed area and planting to be provided. Additionally, tree planting has been proposed where possible to soften the new build street scenes.

- Materials proposed to be used consist of the following:
- Tarmacadam surface to adopted roads and footpaths
 - Tarmacadam surface to private driveways
 - Concrete paving slabs to footpaths and private patios (to rear)
 - Rear gardens are to be provided with lawn turf
 - Front gardens will be provided as grass and low level shrubbery

Mitigation for the partial loss of the hedge element should be conducted by planting new trees within the development proposal. The proposed site plan shows 13 potential new planting locations which is considered to be ample mitigation for the partial loss of the hedge feature.

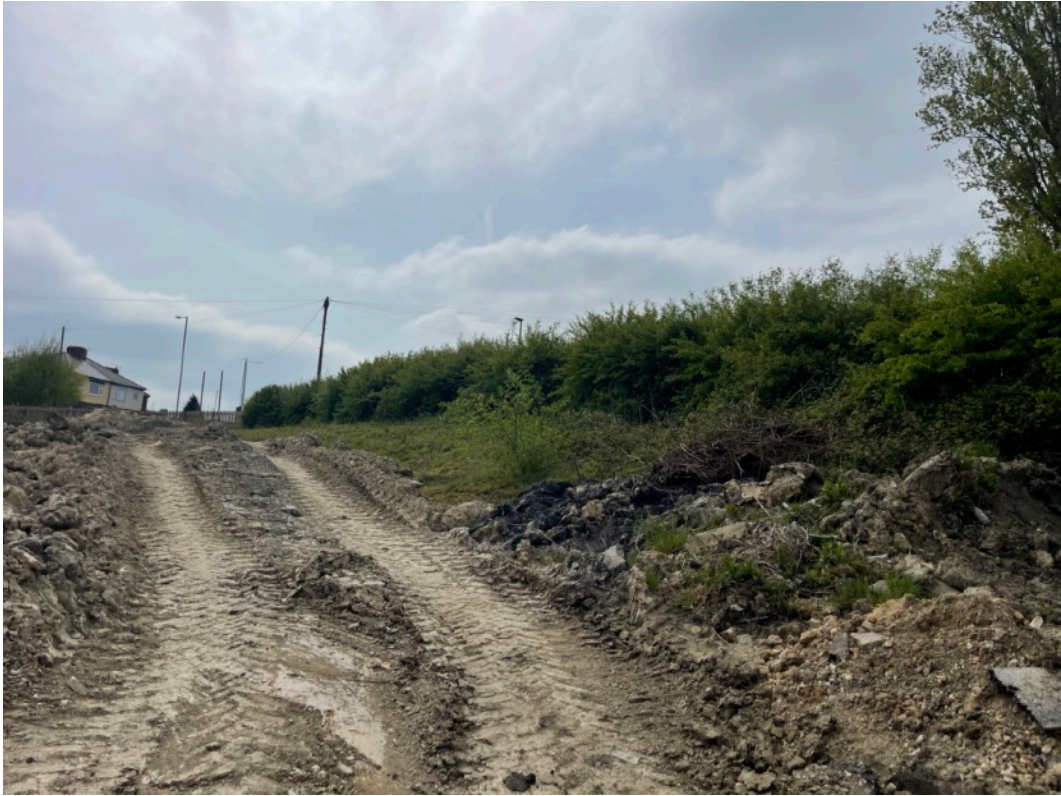
FIGURE 1. H1 running along the southwestern boundary.

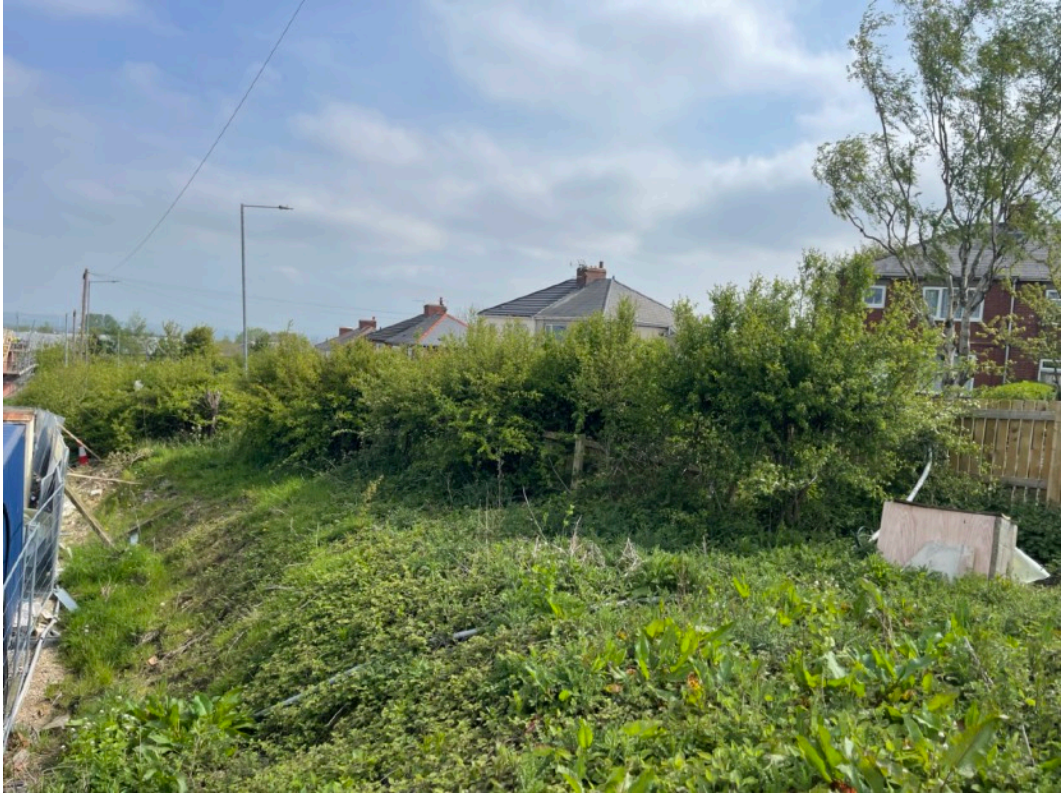
To achieve this approximately 50% of the hedge element H2 (Cat. C) will need to be removed as its location conflicts with the proposal.

FIGURE 2. H2 running along part of the southeastern boundary.

The development proposal would require the removal of the southern aspect of H2 a category C element.
