## Land Parcel H59 Monk Bretton

# Preliminary Land Contamination and Geotechnical Risk Assessment

On behalf of Barnsley Metropolitan  
Borough Council

Report 23-24-18-1-6013/DSR1  
December 2017

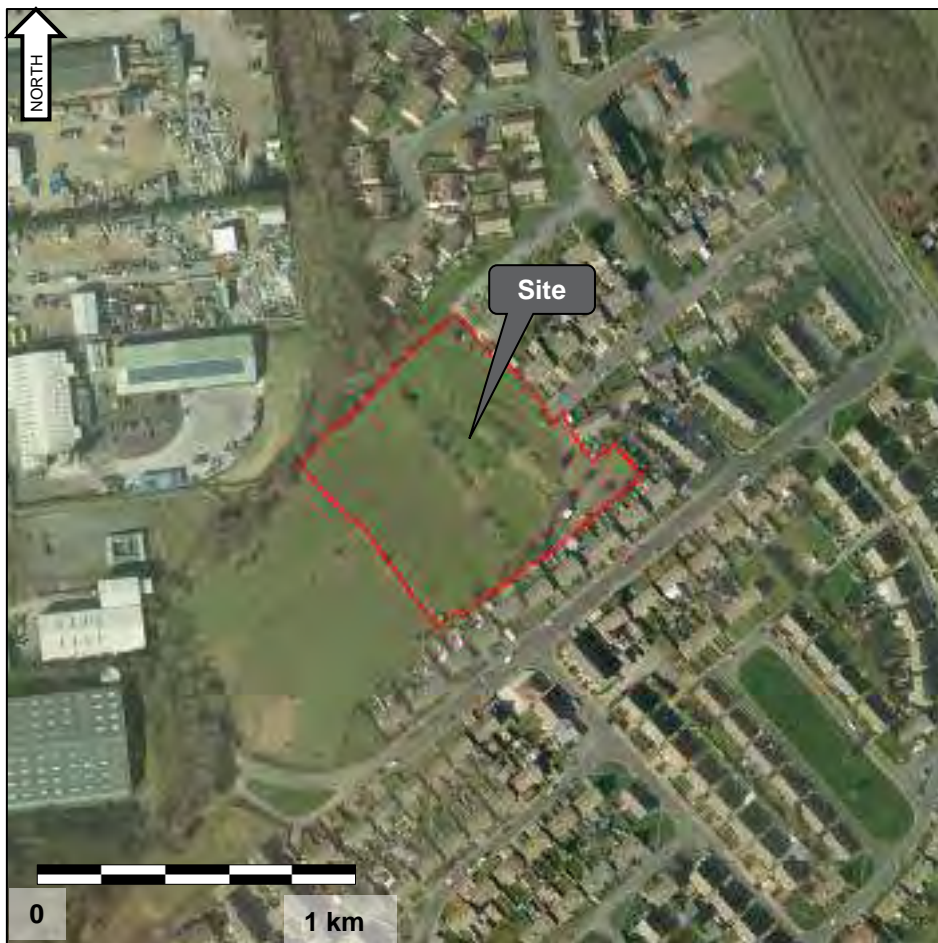
Figure 1 Site location plan

The site location is shown on Figure 1 and a more detailed plan on Figure 2.

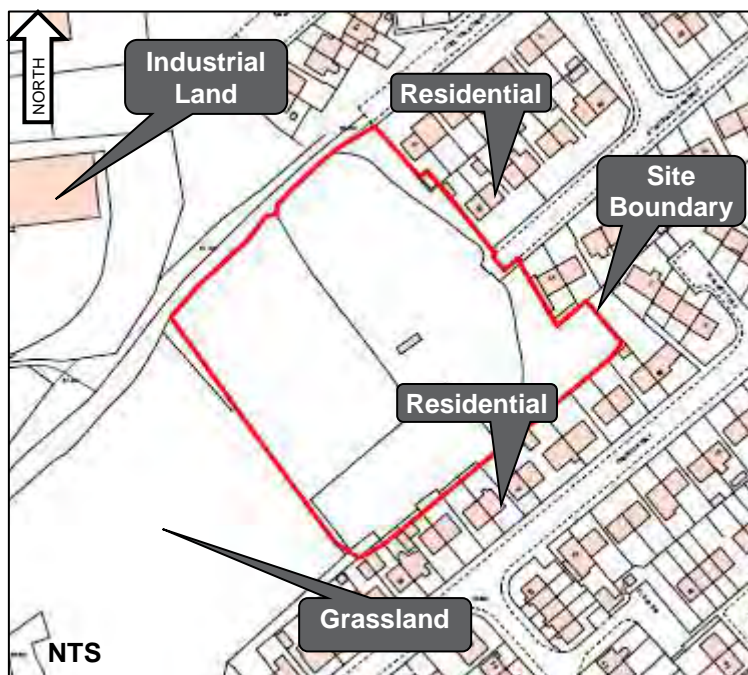
Figure 2 Site layout

Access to the site is via St Michaels Avenue to the north east of the site. At this entrance an earthworks bund has been constructed to stop vehicle access into the site. In the south of the site, behind Nos 30 to 42 Preston Way a break in slope was noted. This break in slope is circa 0.5m high and would appear to manmade feature.

The site is bound to the north, north east, south east and south by residential premises. Grassed open land lies to the south west, beyond which are industrial units.

Figure 2 shows the site setting.
