Design Development

05: Design Development Eldon Street Elevation

Eldon Street facade

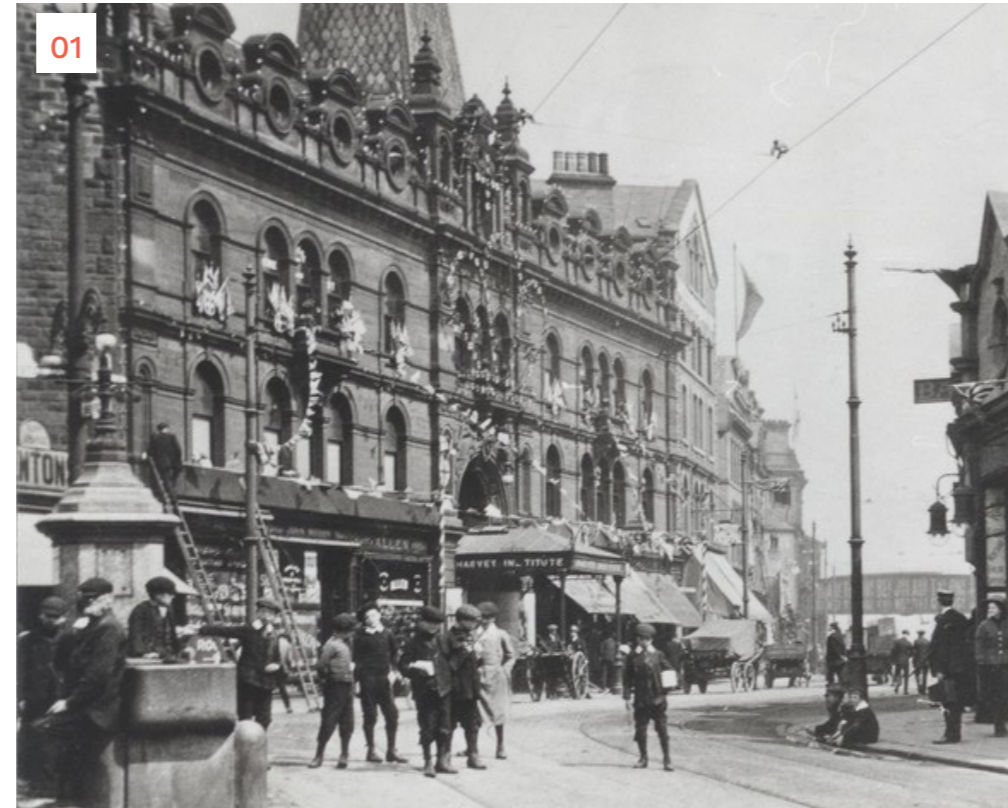
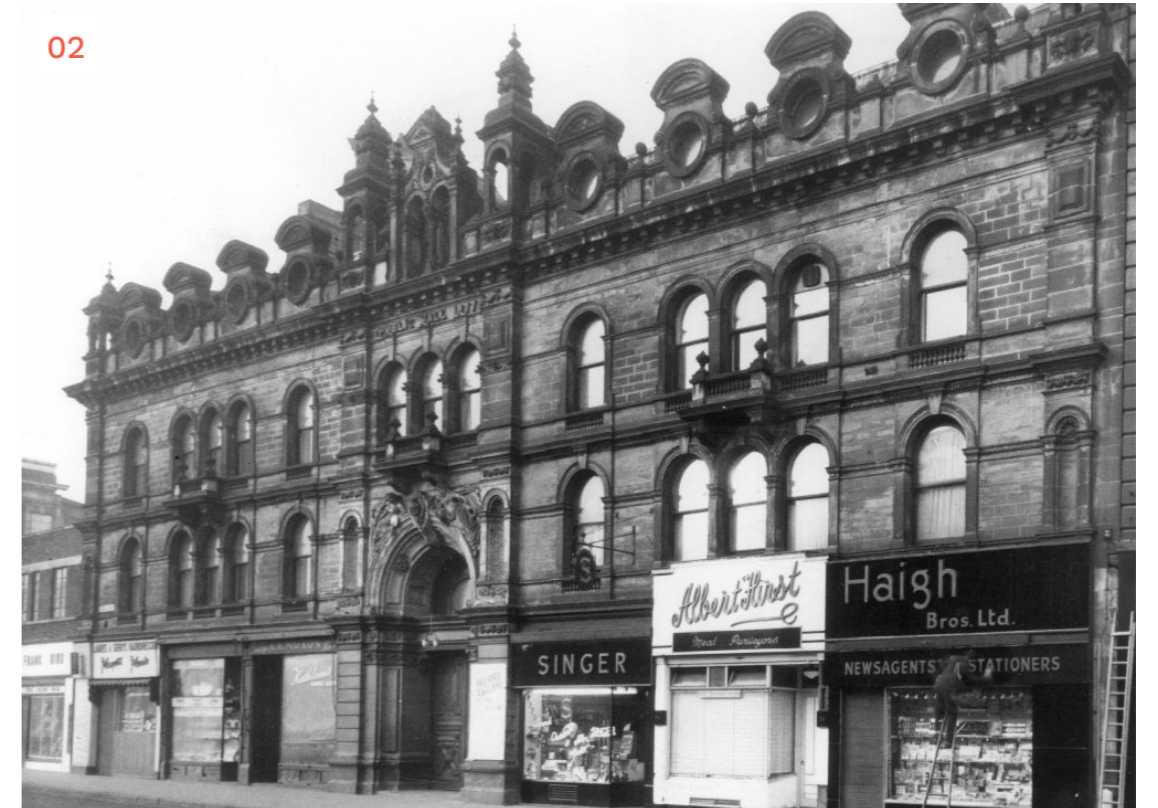
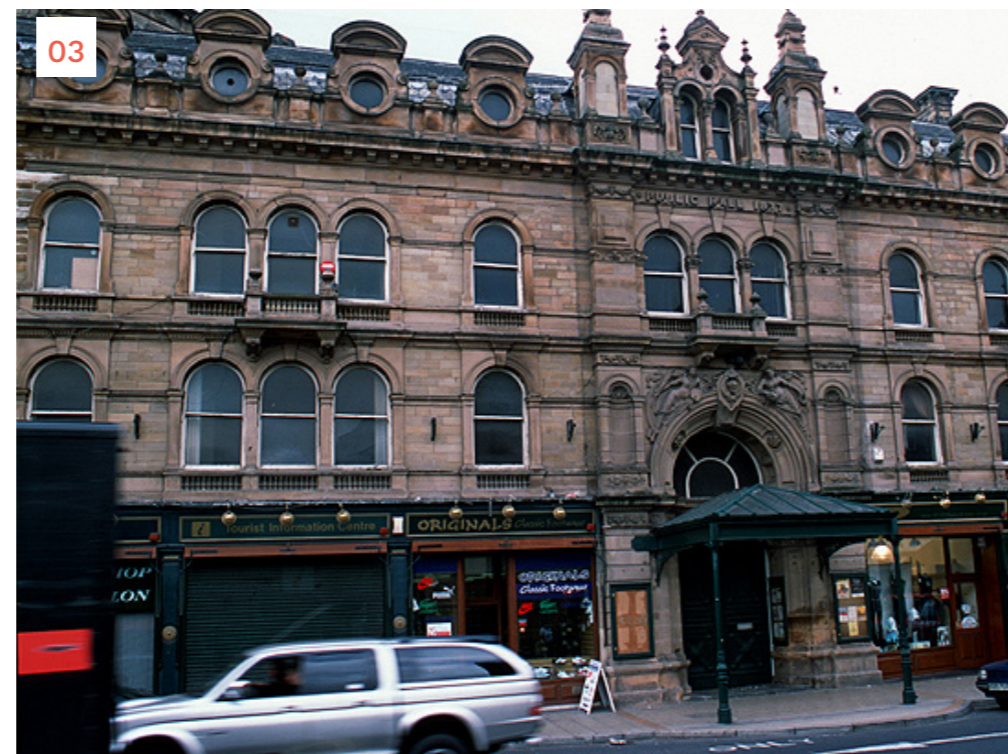
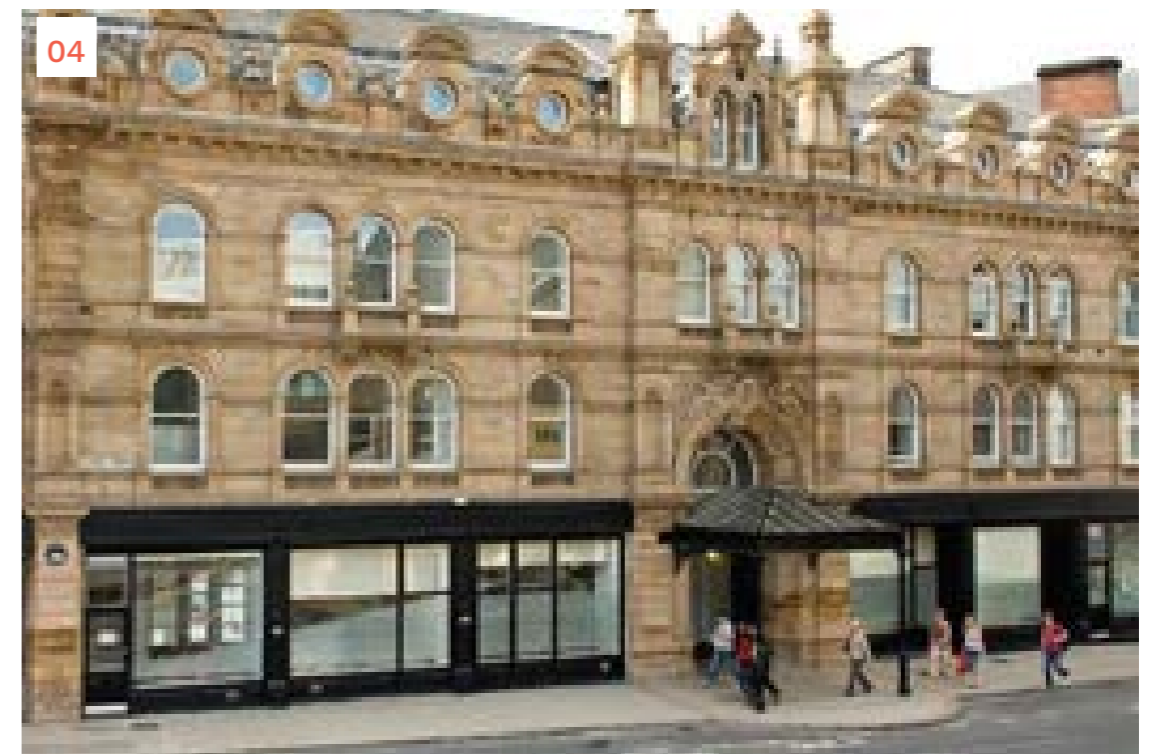
The images adjacent from 01 - 04 show the evolution of the Eldon Street facade. Much of the existing elevation has remained the same, however the shopfronts and canopy have changed throughout the building's history to accommodate the variety of uses on the ground floor.

The Eldon street frontage is an area of high significance (refer to Heritage Statement section 2.5.3 for more details). As the images adjacent demonstrate much of the facade has remained the same or similar. The shopfronts remained a fluid feature as the nature and need of the spaces on the ground floor change over time. The entrance canopy seen in image 01 is believed to be the original built in the early 1900's. This canopy was removed and reinstated as a replica of the original in the 1960's and therefore the canopy we see today bears no heritage significance.

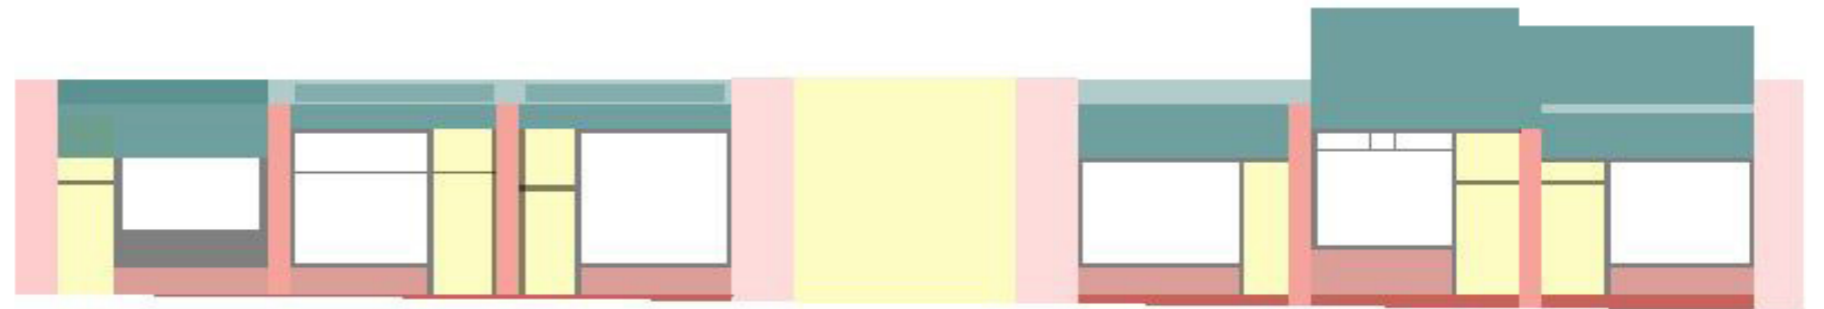
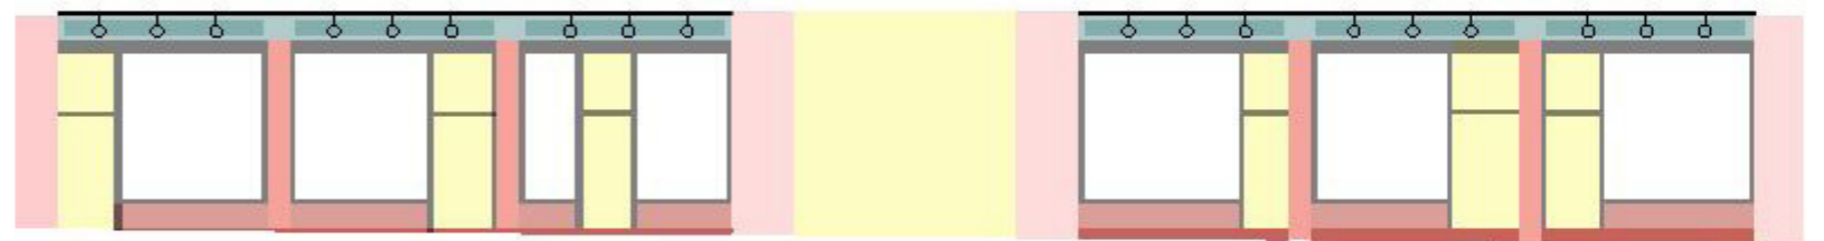
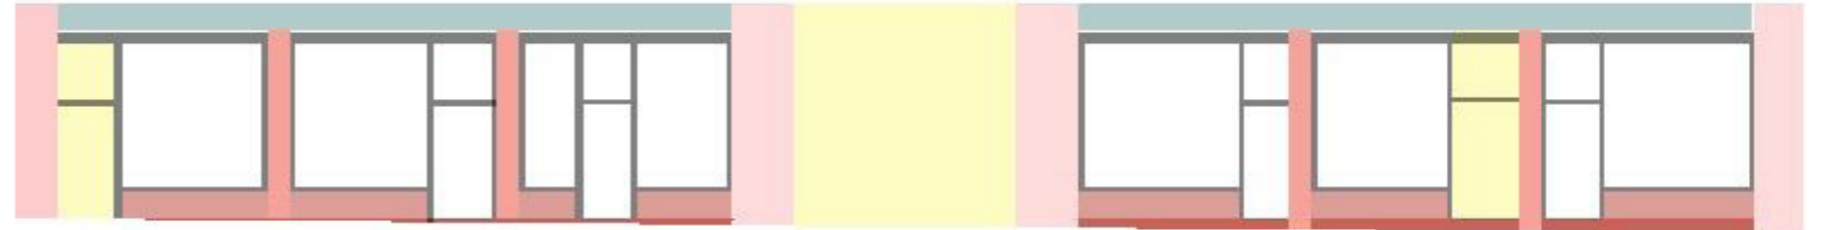
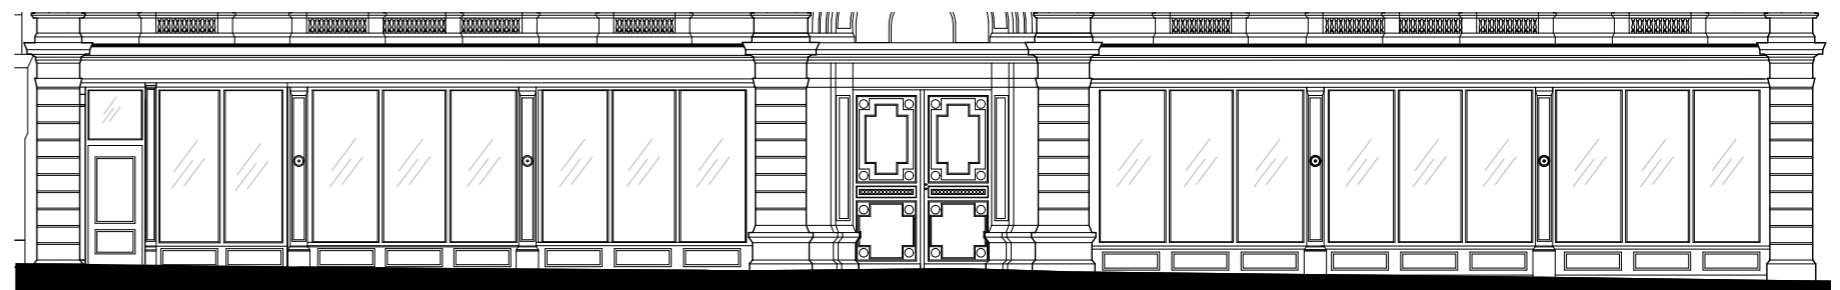
Facade Components

This demonstrates a block colour analysis of the shopfront components dating from 1963 to present day demonstrating the evolution of the facade design. It is clear to see that they have evolved to accommodate the change of uses on the ground floor. This went from individual shopfronts and stores requiring individual entrances, signage and glazed displays to present day where access points have been reduced to suit a single space behind on the ground floor.

The design proposal aims to take this one step further and retain access to the left as the residential access and retain the main entrance as single access to the large, single lettable space behind. This will provide a unified frontage, meet the security issues by reducing access points, removing the roller shutters and introducing security through the glazing.

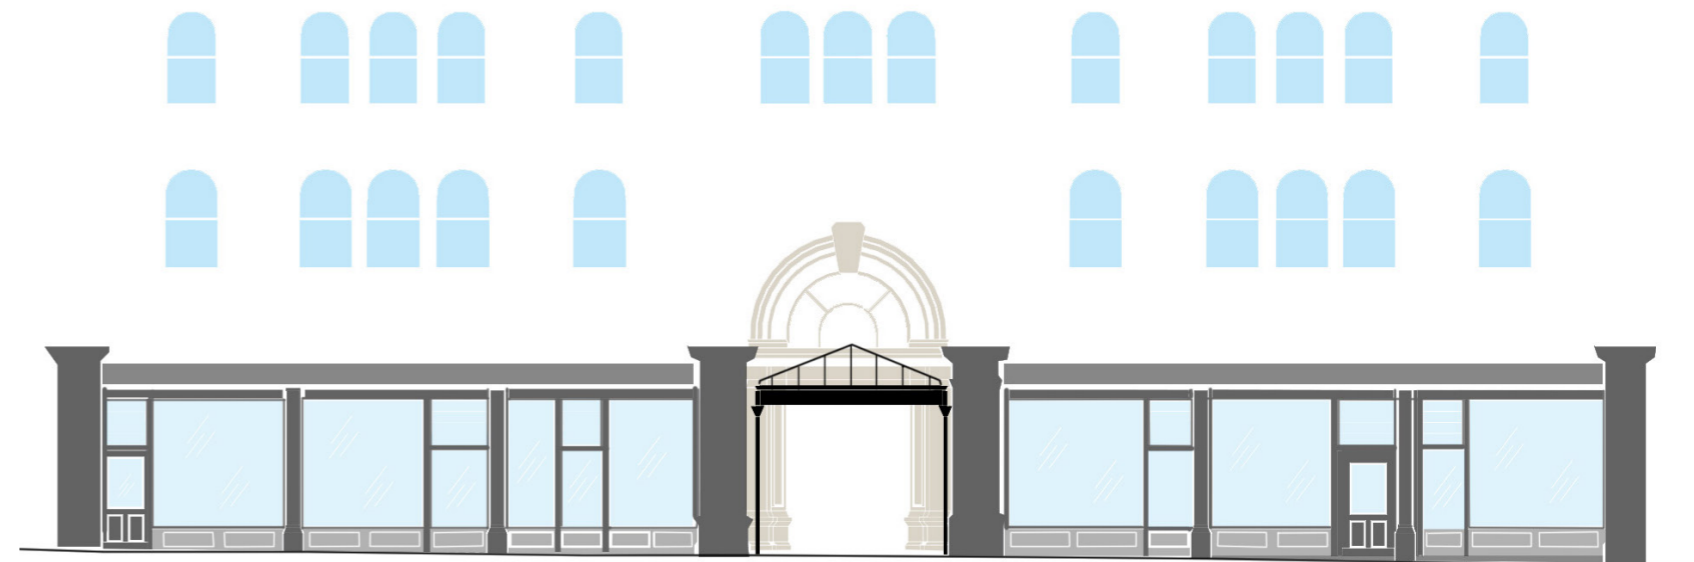
Existing Facade Analysis

The existing shopfronts are formed of:

- + Iron pilasters
- + Stall risers
- + Differing window frames and proportions
- + Canopy
- + Two entrance doors

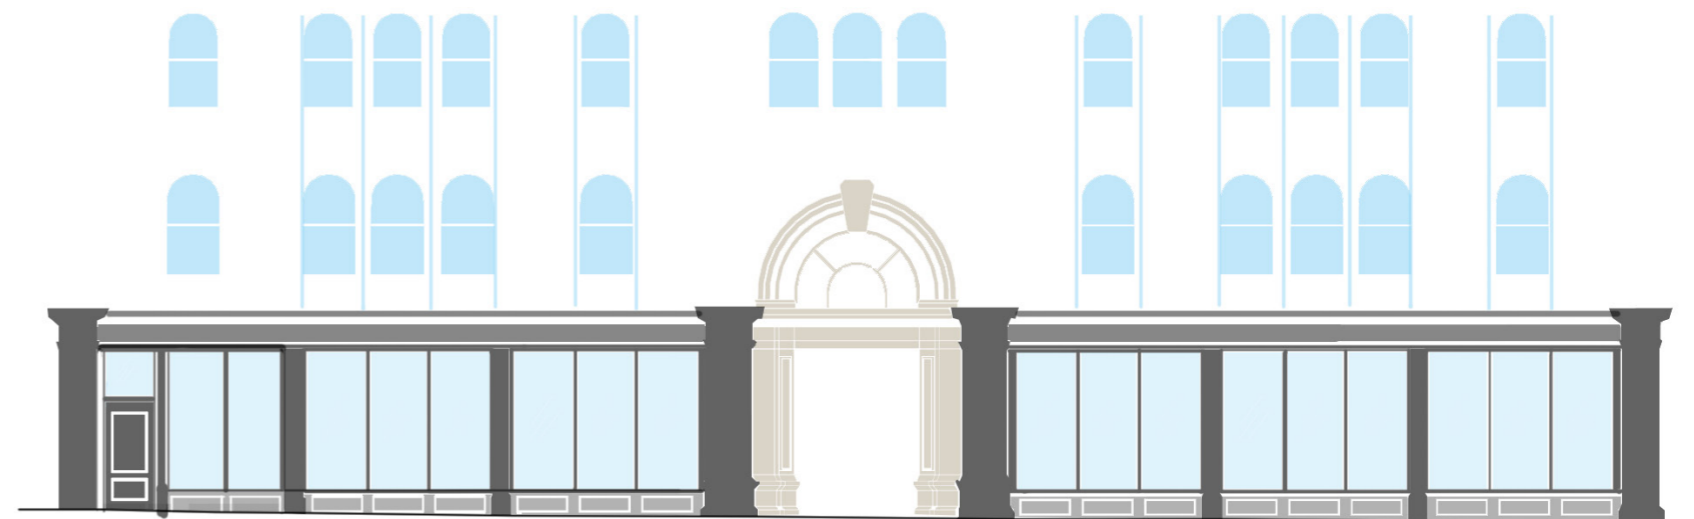
Proposed Facade Analysis

The proposed shopfronts have been designed to retain and enhance existing features and characteristics on Eldon Street.

- + Canopy
The current canopy has attracted undesirable behaviour and loitering due to the shelter it provides and has a poor relationship with the entrance stonework. The Heritage Statement section 2.5.4 refers to the canopy of having limited benefit of removing the canopy and replacing it with another replica canopy. By removing the canopy, it provides an opportunity to repair the decorative stonework around the entrance and reveal the detailed and original entrance. Along with the lighting this will re-emphasise the main entrance to The Civic.

- + Window / Glazing
Doors to the shopfronts are removed and the proposed fenestration follows the patterns and rhythm of the existing upper floors of the Eldon Street facade. The proposals create a single space use showcasing a revived active frontage with simple large panes of glass set within timber framing between the existing cast iron pilasters with a slight recessed jamb. The new shopfronts have been designed respecting the rhythm and proportions of the existing buildings as seen in the diagrams adjacent.

- + Fascia
The removal of the existing security shutters will enable a new fascia to fit more sympathetically and improve its relationship between the fascia and the existing decorative stonework. The removal of the roller shutters will also create a more welcoming and transparent environment with the glazing providing the required security.

- + Doors / Access
Currently modern doorways conflict with the proposed use of a single lettable space and therefore the access points have been reconsidered. A separate resident's entrance is required to ensure the security and provide a prestigious

presence and entrance from Eldon Street to the new high quality apartments on the first, second and third floors. The entrance resembles the existing door in this location but with solid panelling to provide privacy and security.

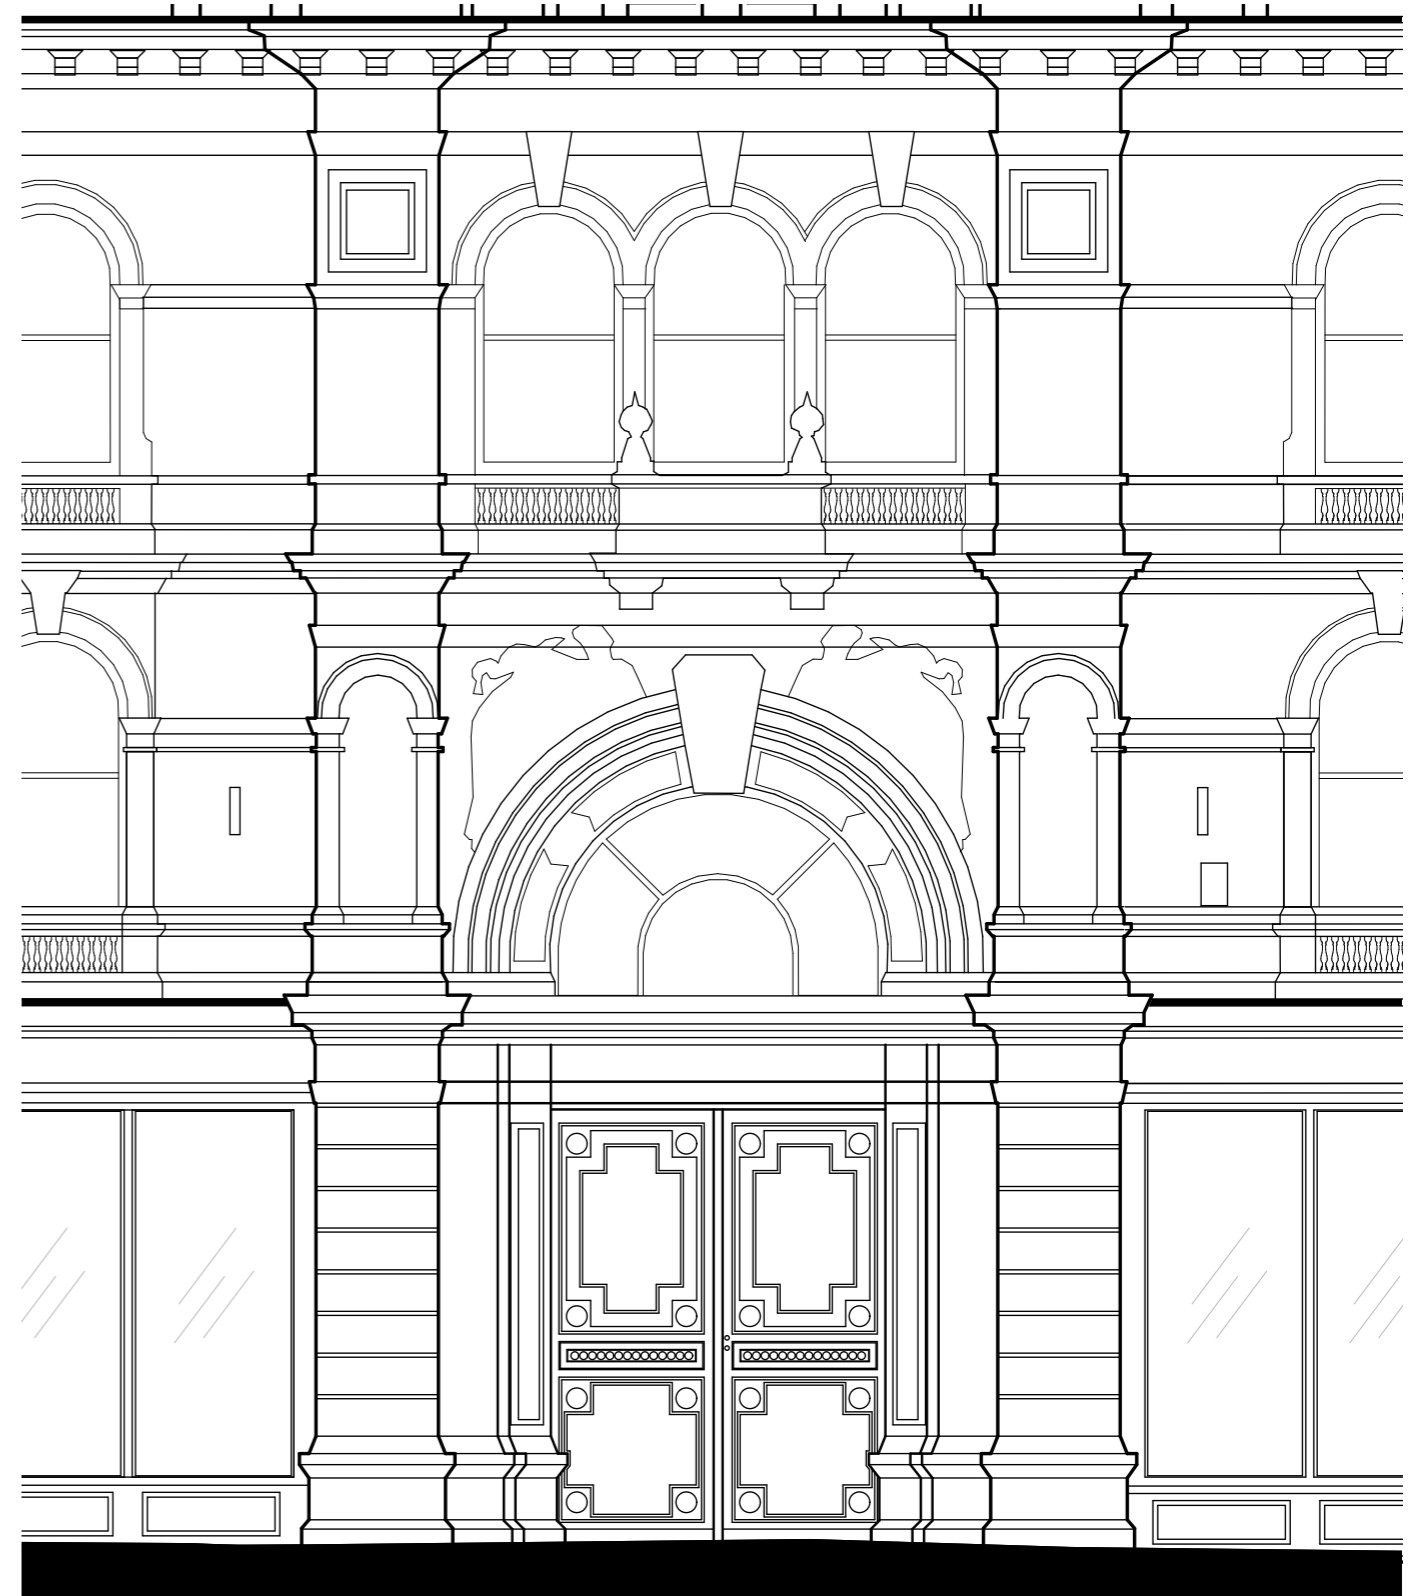
[1]. Ashlar and decorative sandstone to receive a gentle cleaning with DOFF system to remove algae & paint staining particularly to areas of water runoff. Cleaning to focus on the moulded details where the staining is the most significant and will be subject to a trial sample area to ensure that it is a suitable method, particularly to the areas of stone erosion. Following cleaning the sandstone will be brush / dress back to remove any loose and decaying masonry and a management & maintenance plan will be recommend along with a quinquennial survey routine.

[2]. To the entrance area at low level stone indents to areas to prevent significant ongoing erosion and create a strong visual impact to welcome visitors to the building. Extent indicated in blue opposite.

[3]. Areas of previous render repairs will require a high-level inspection and hammer test to determine the extent of any loose render repairs which will be removed. Minor repairs will be carried out to fix holes, some poorly patch repairs and open mortar joints. Allowance for repairs to stone surround on removal of shutter guides.

[4]. The current signage fascia with integral roller shutters will be carefully removed to determine if any parts of the historic signage fascia are to be retained. Following inspection, a replacement painted soft wood timber fascia will be provided to follow the historic profile.

[5]. The existing decorative timber main entrance door will be redecorated following a paint analysis.

[6]. The existing shopfronts will be carefully removed retaining the cast iron pilasters. A paint analysis will be carried out before the cast iron pilasters are repaired and redecorated. Open joint to the masonry to be closed off with burnt sand mastic.

[7]. New shopfronts, proposed between the pilasters, will be timber frames with double glazed units. Windows will be slightly recessed behind the existing pilasters and stonework and reflect the proportions of the building. Timber mullions and glazing bars will be used to break up the window into smaller compartments as indicated.

[8]. New stall riser will be provided as a visual and structural base for the shopfront with a moulded projecting cill. The panelled timber riser will be sat on the existing plinth and finished with a sacrificial skirting detail.

[9]. New painted timber doors and slim timber pilaster divider to create a new residential access.

[10]. The replacement of early 1900's canopy as part of the 2006-2009 works will be removed to expose the building's round-arched centrepiece. This is topped by a carved keystone depicting Henry Harvey and two figures representing art and science in the spandrels to either side. The centrepiece will have external lighting to enhance the appearance of the building.

[11]. The existing bird protection netting across the façade will be removed. Alternative, less visible deterrents and a pigeon deterrent system will be installed.

[12]. The sash windows at 1st and 2nd floor and the circular casement windows / smaller sashes at 3rd floor will be redecorated and sealed with new burnt sand mastic.

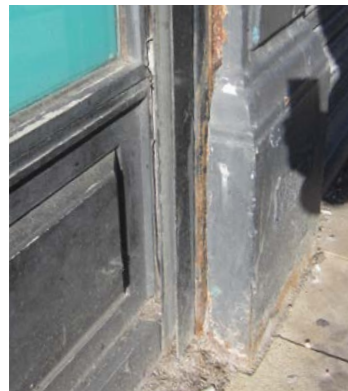
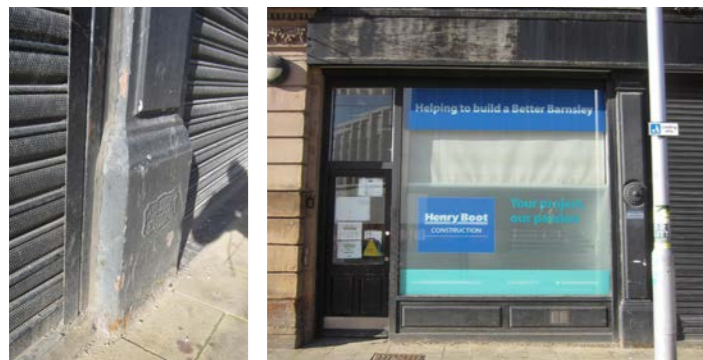
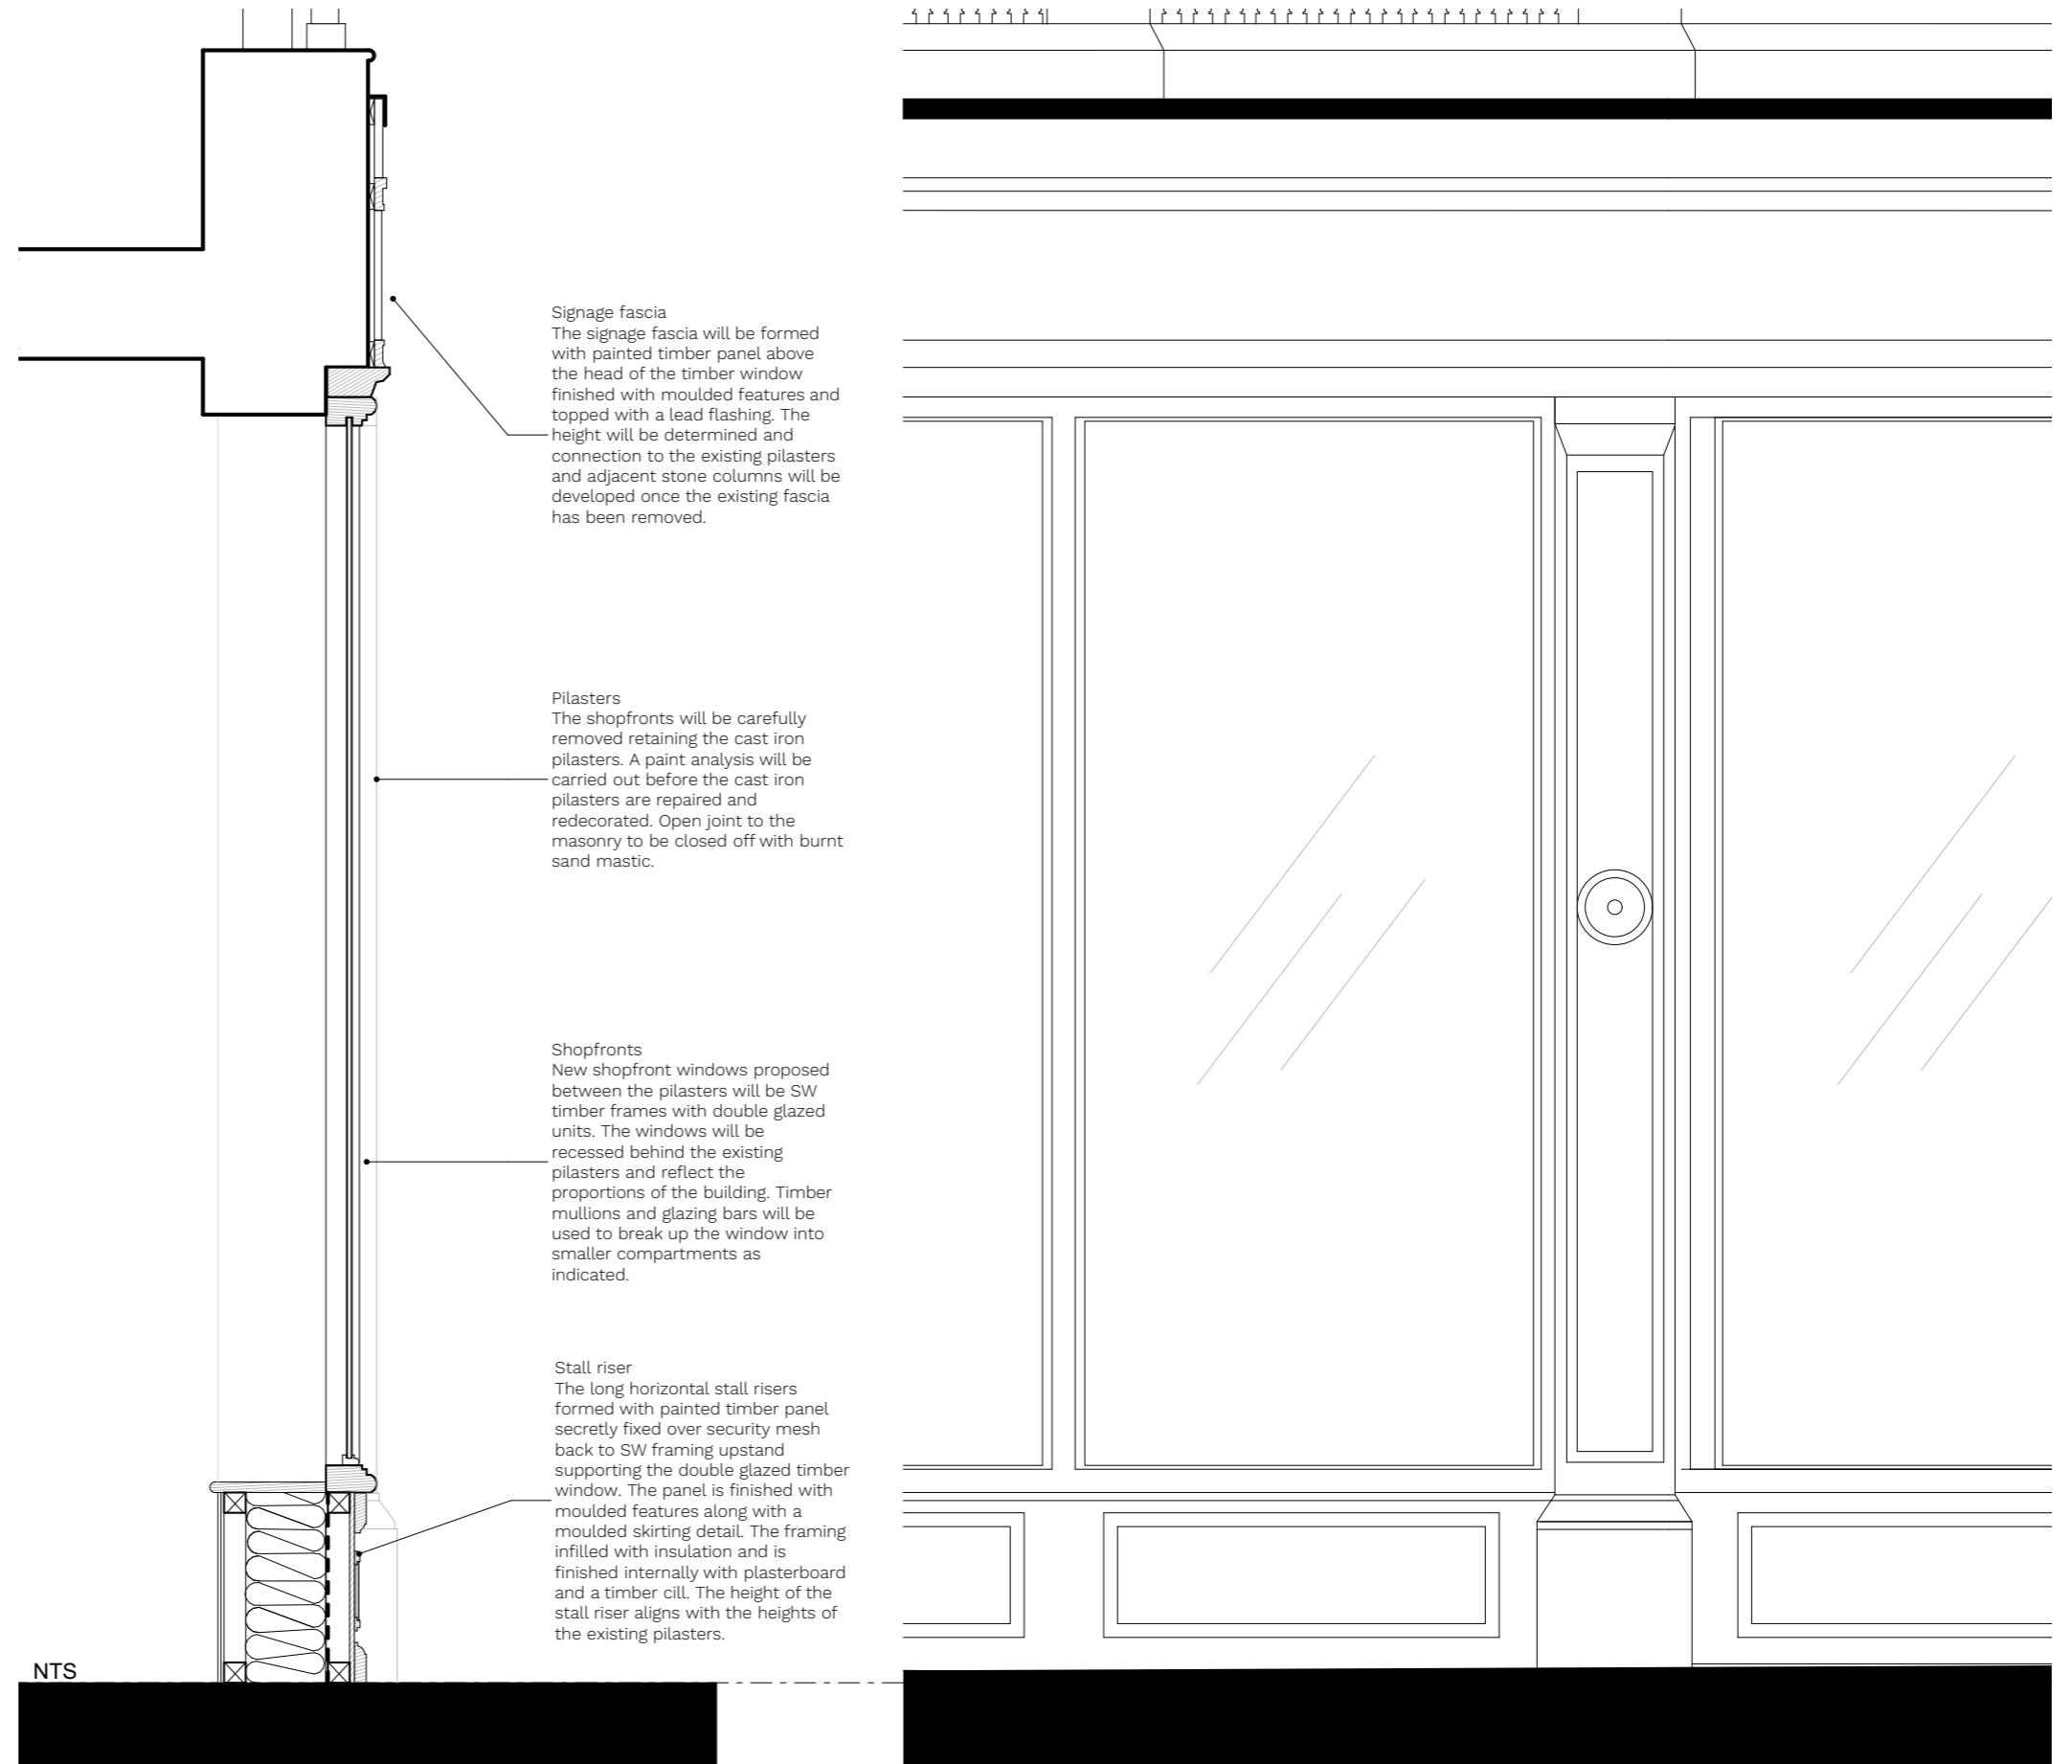
Indicative Section of the shopfronts

The new glazing units will fit neatly behind the existing pilasters and the stonework. This will mimick the existing features and the timber frames and mullions will reflect the existing proportions of Eldon Street Elevation.

Please note this is an indicative section awaiting further site investigations.

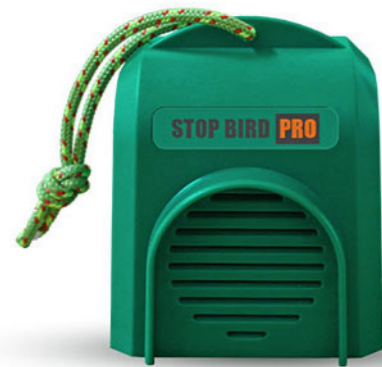
The existing pigeon netting and fixings are to be removed and a new pigeon deterrent to be added. From advice from the ecologist they recommend using a transmitter to replace the netting as they are much less intrusive and remove the need for multiple fixing other options would require.

The system is efficient and the number of transmitters as recommended by manufacturer will be spaced appropriately on the eldon street facade (potential locations indicated). They don't require intrusive fixing and are securely fixed to facade and discreetly placed adjacent the windows so the batteries can easily be maintained.

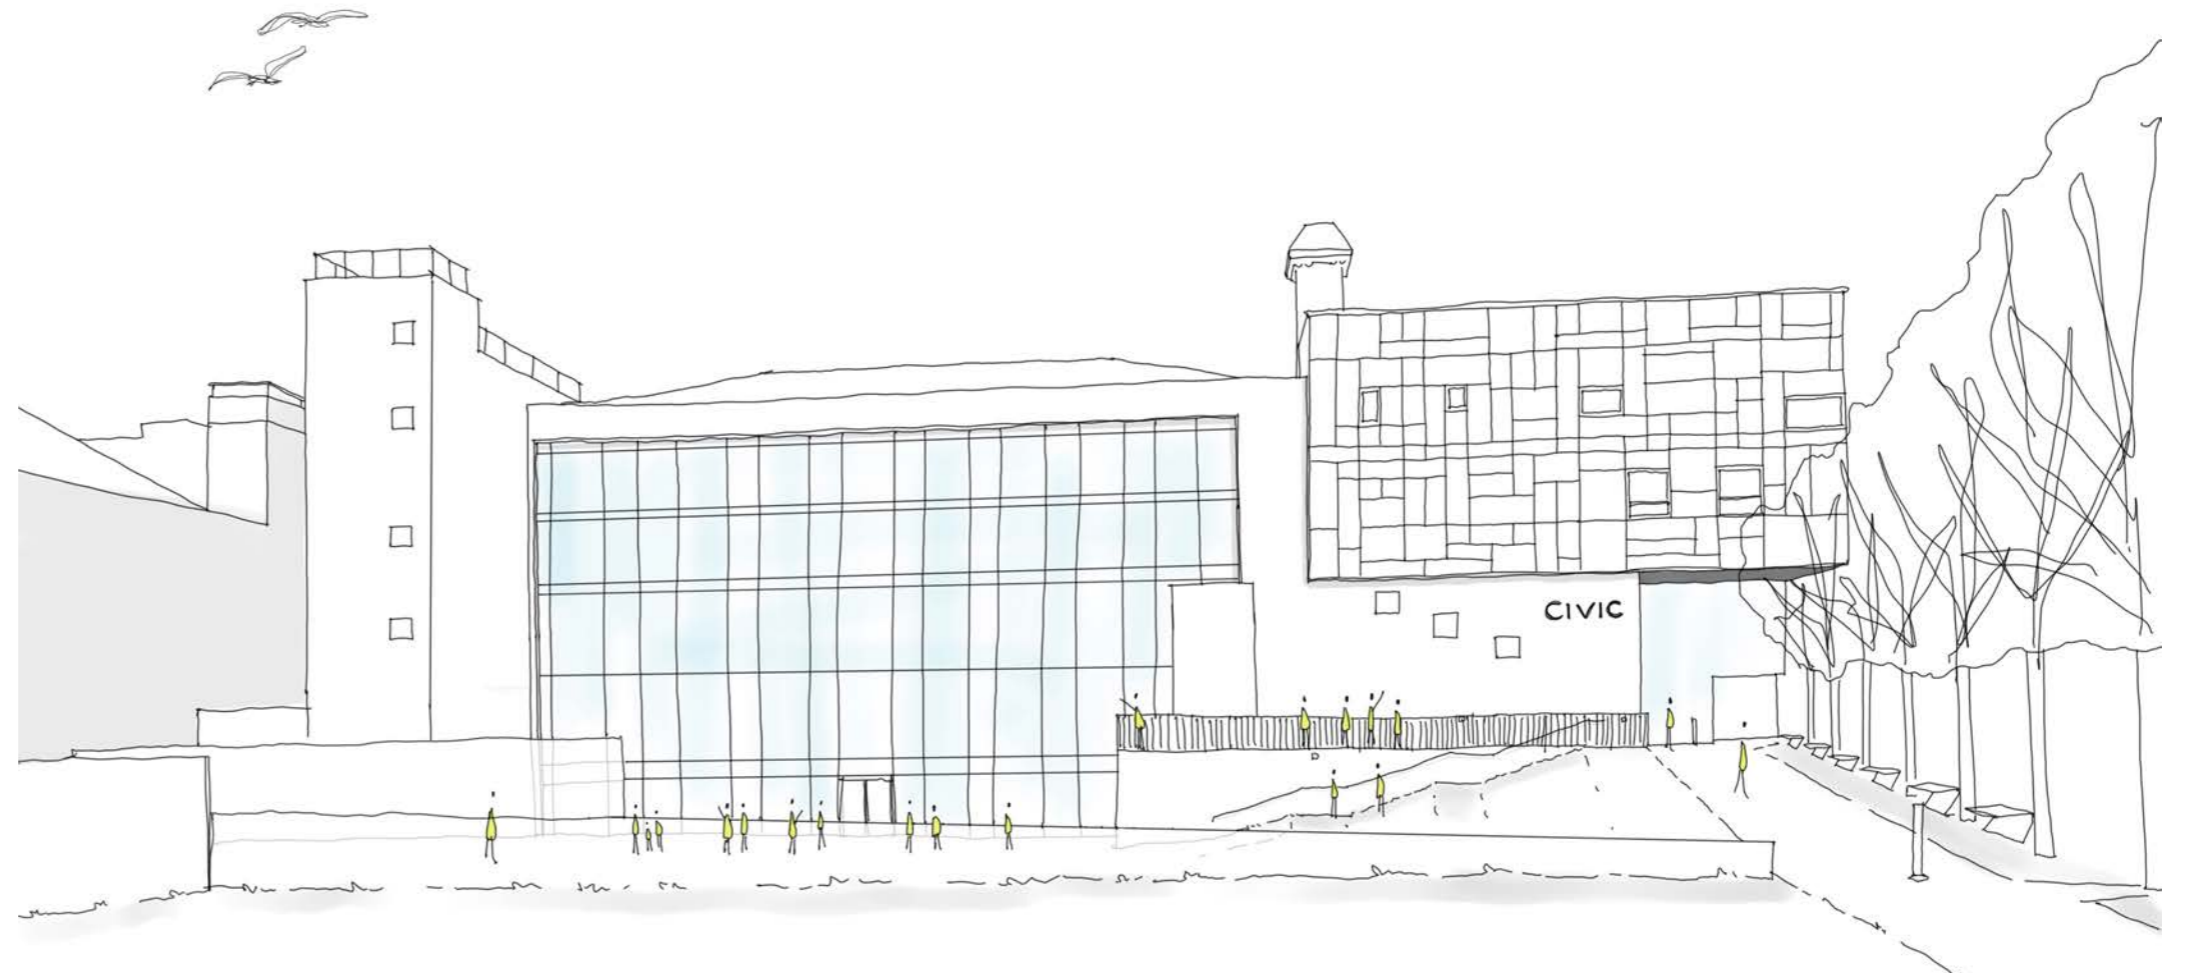
Stage 2 sketch proposing removal of the balconies

The stage 2 designs (see right) proposed removing the existing balconies and staircase to both remove the temptation for undesirable behaviour and to expose the existing brick wall behind the curtain walling. Concerns over this proposal were raised by the Local Planning Authority (LPA) at a pre-application meeting. It was felt that removing the balcony would not entirely resolve the lack of natural surveillance and, coupled with reservations about the buildability and cost of the proposals, HLM undertook a review of the Mandela Gardens elevations.

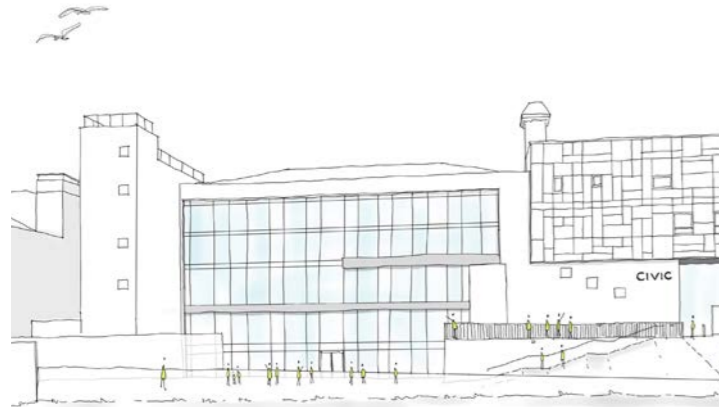
Updated sketch shows the retained floor slab elements breaking up the facade.

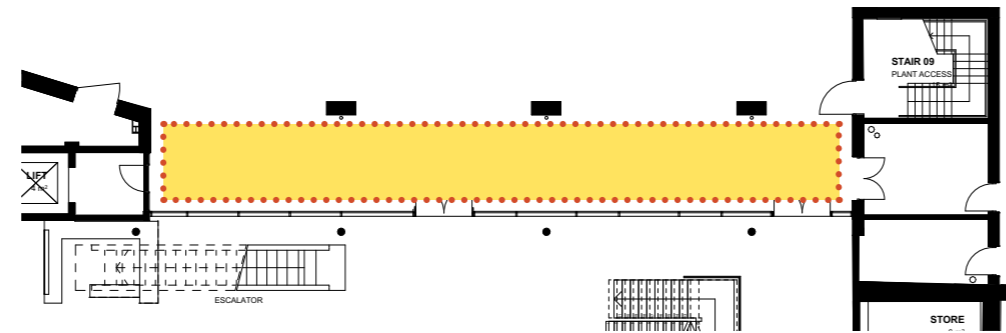
As Existing

The covered colonnade has created a shelter space for undesirable behaviour.

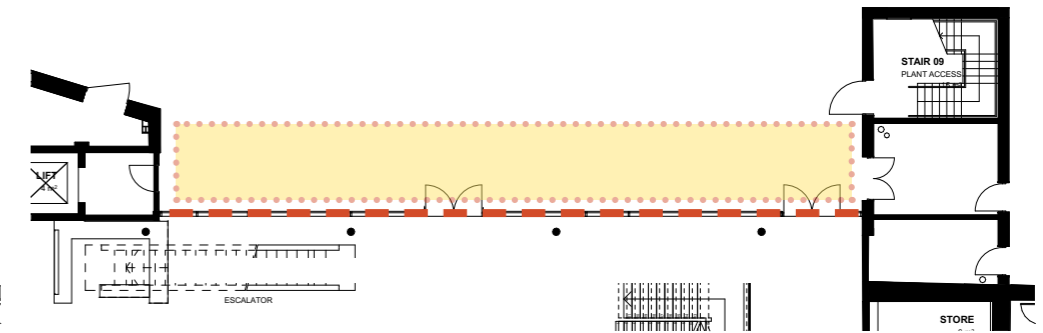
Stage 2 Proposal

Removing the colonnade, stairs and balconies solves part of the problem by removing a sheltered space for undesirable behaviour. However it pushes the building line back which limits visibility from Hanson Street, which still may encourage bad behaviour.

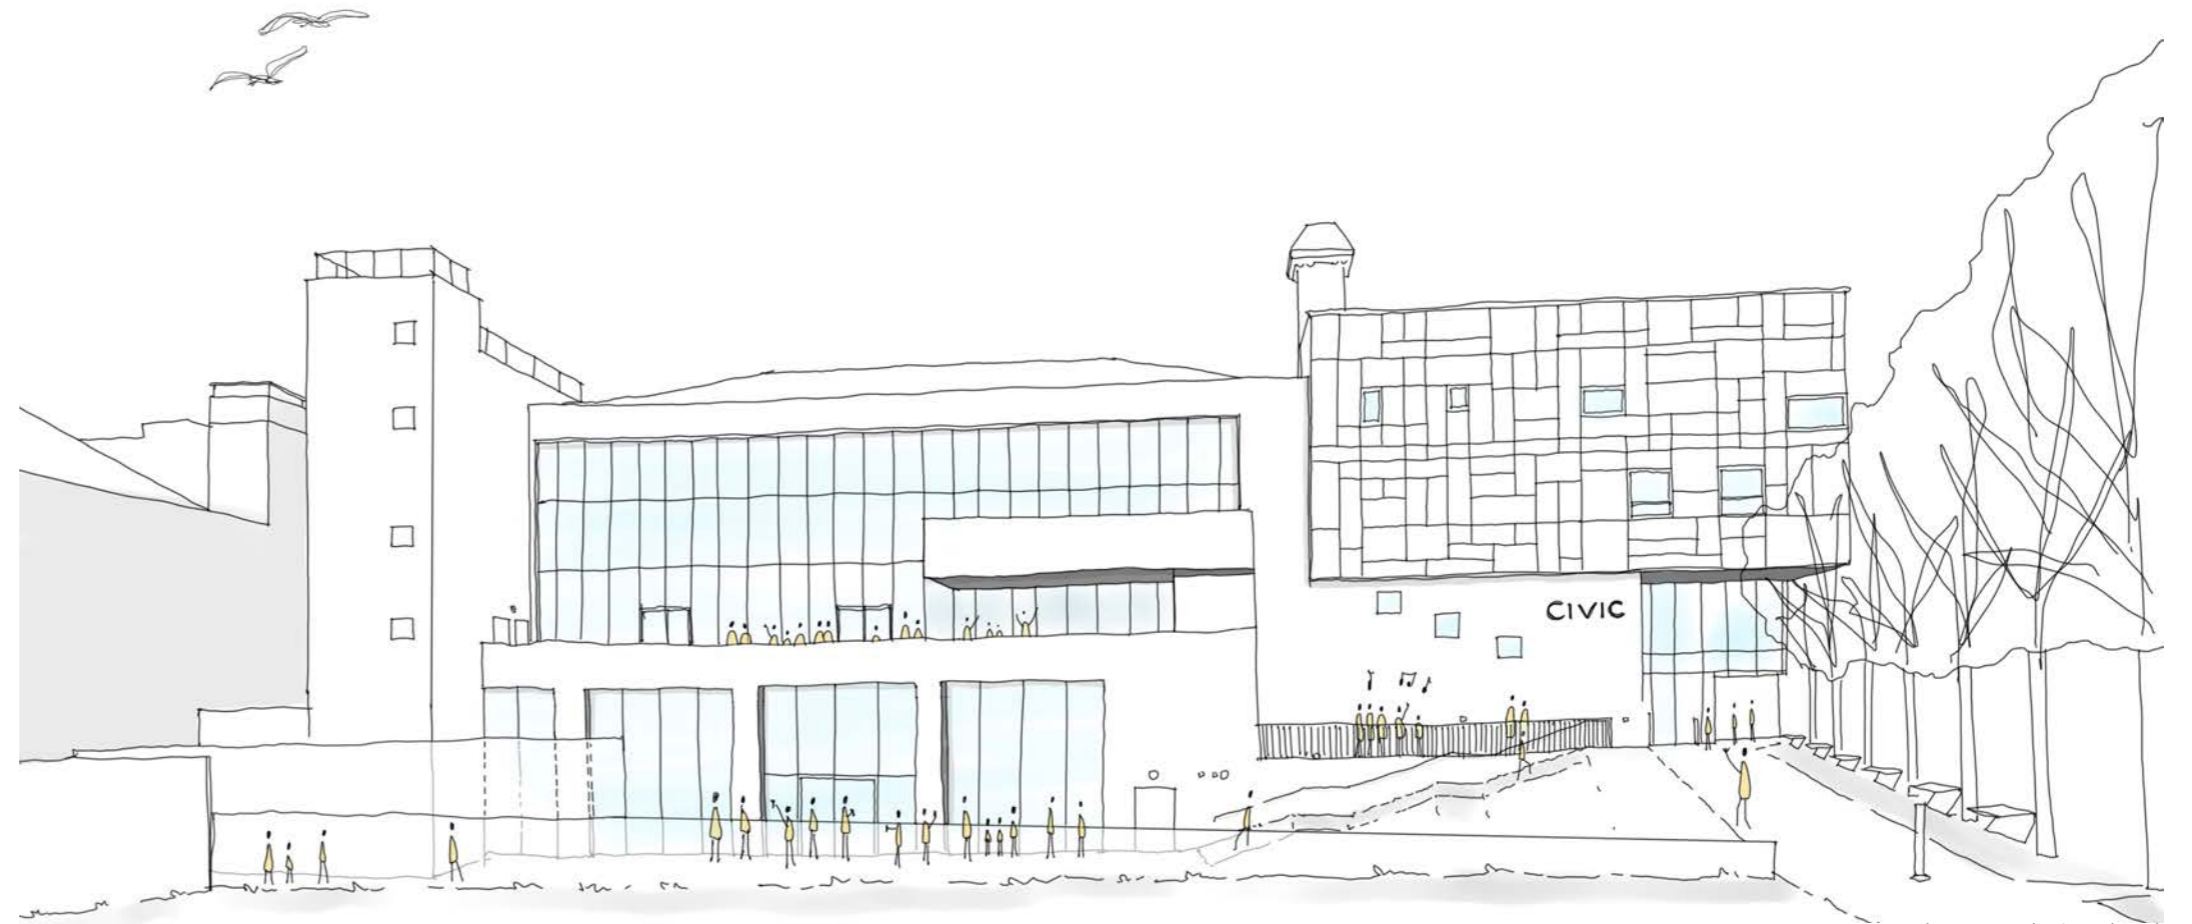
Proposed Stage 3 design sketch

Following this review it is now proposed that the existing balconies are to be retained and only the external staircase is to be removed.

This pushes the building line forward by adding new curtain wall to the colonnade, creating a new double height internal space under the balcony. The revised proposals create additional space to the bar and foyer area in front of the Studio Theatre and the new double height space provides a bright, active new frontage to Mandela Gardens. The new frontage provides natural surveillance outwards, helping to resolve the issue with antisocial behaviour and potential for a new lettable space.

The retained second floor balcony provides outdoor space for the gallery floor and the third floor balcony remains as existing, providing external space linked to the assembly rooms.

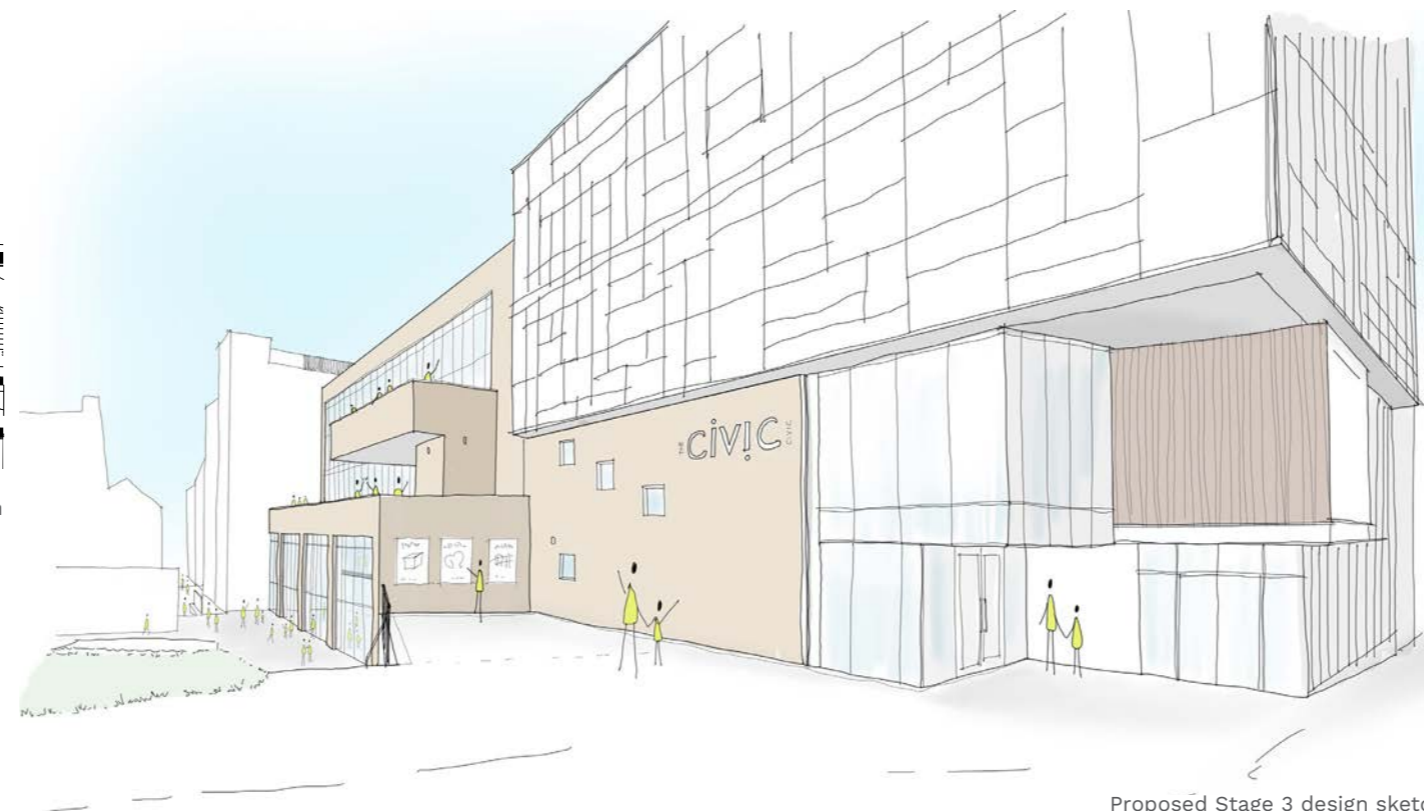
Proposed Stage 3 design sketch

This sketch adjacent demonstrates the visibility down to the colonnade and to the alley connecting back to Eldon Street and the station. The removal of the external stair opens up this space to the wider site, creating an active, visible frontage to Mandela Gardens.
