Design Development

05: Design Development Eldon Street Elevation

Eldon Street facade

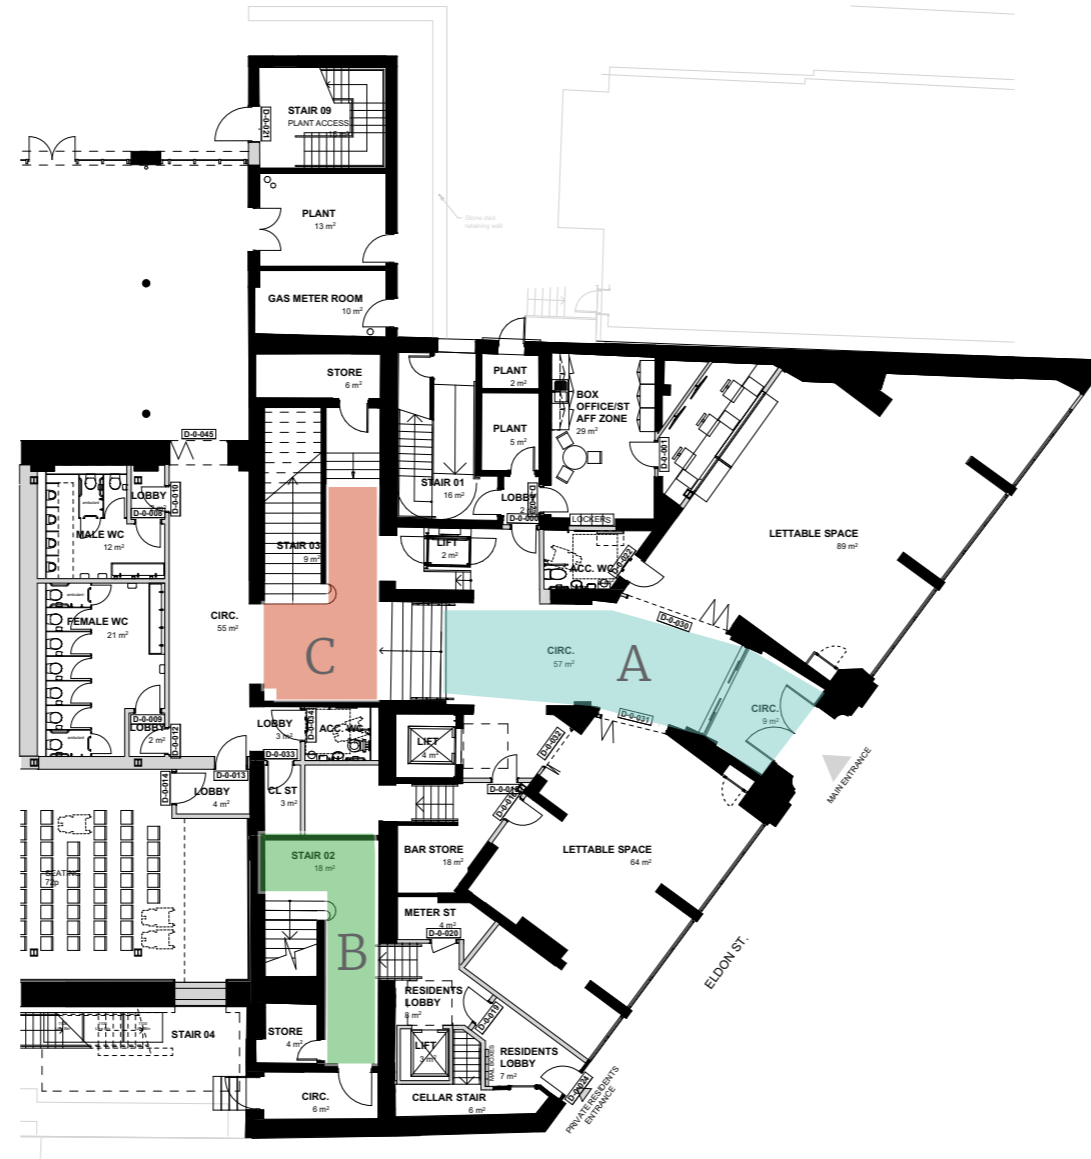
1878 Encaustic Tiles – Site Photographs

There is existing 1878 encaustic tiles and 1910 mosaic tiles of heritage significance in the circulation hallways and entrance on the ground floor which provide an opportunity to repair for the projected footfall when the building re-opens to optimise the heritage value of the building.

A – The mosaic tiles to the entrance and hallway are in good condition and we will clean and carry out minor repairs to conserve the tiles

B – The encaustic tiles to the Minton’s floor in the south side of the grand staircase are in good condition and we will clean and carry out minor repairs to conserve the tiles.

C – Unfortunately the flooring on the north side of the grand staircase has been removed previously and we propose to reinstate a Minton’s floor with similar encaustic tiles and patterning for the public access into the Civic’s facilities.

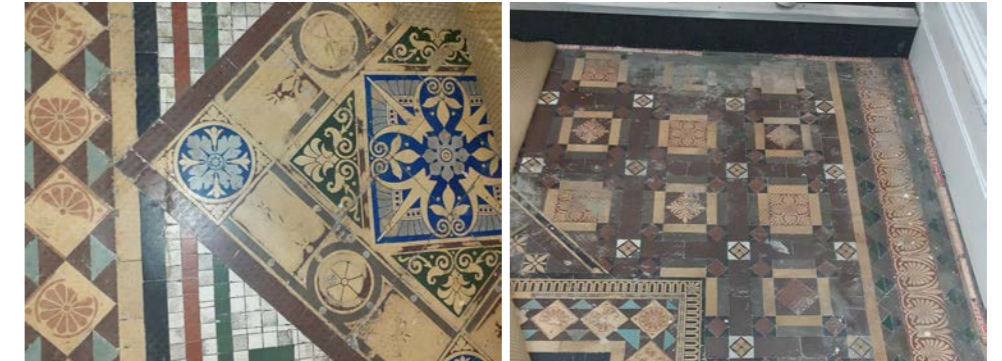
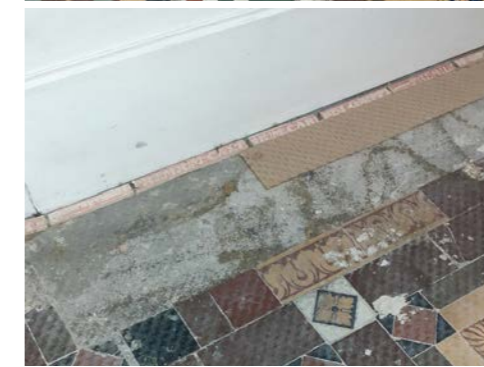
1878 Encaustic Tiles – Reconstruction of original

The area outside the north stair and entrance into the studio theatre is to be provided with new tiles to match the historic pattern of the tiles in the south passage.

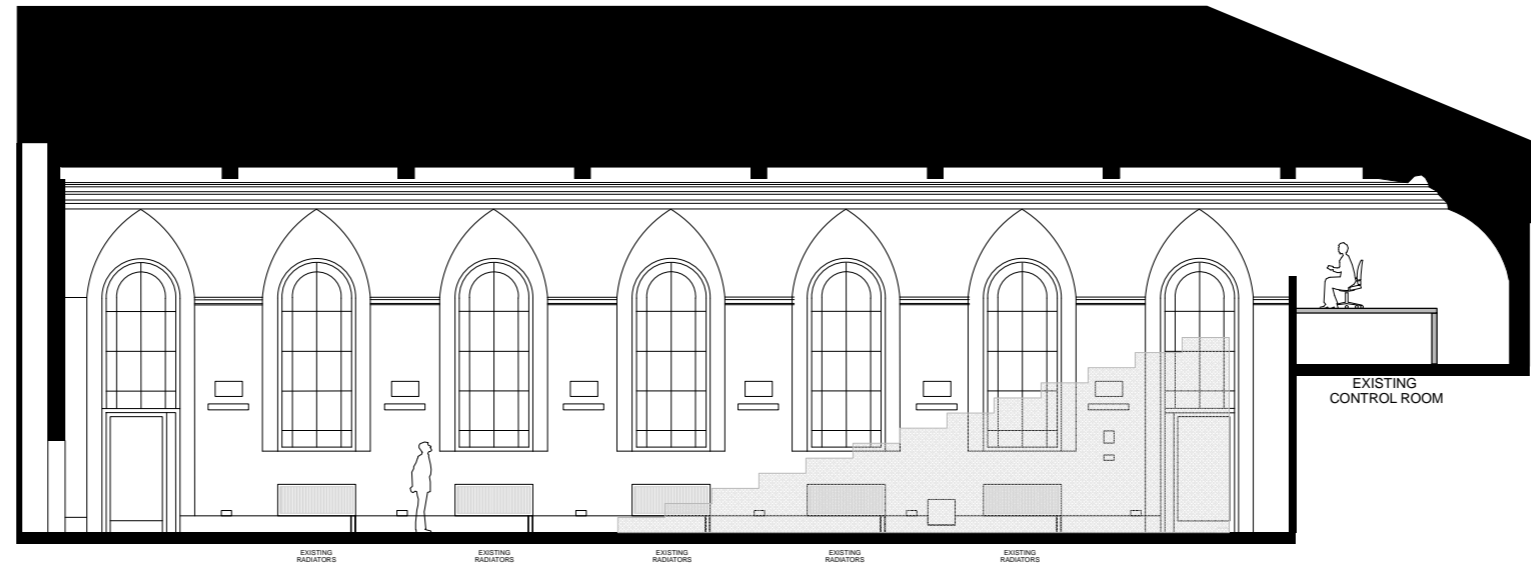
EXISTING ASSEMBLY ROOM ELEVATION

IN ABSENCE OF A BUILDING SURVEY - THIS ELEVATION HAS BEEN CREATED USING EXISTING DRAWINGS AND SITE PHOTOGRAPHS

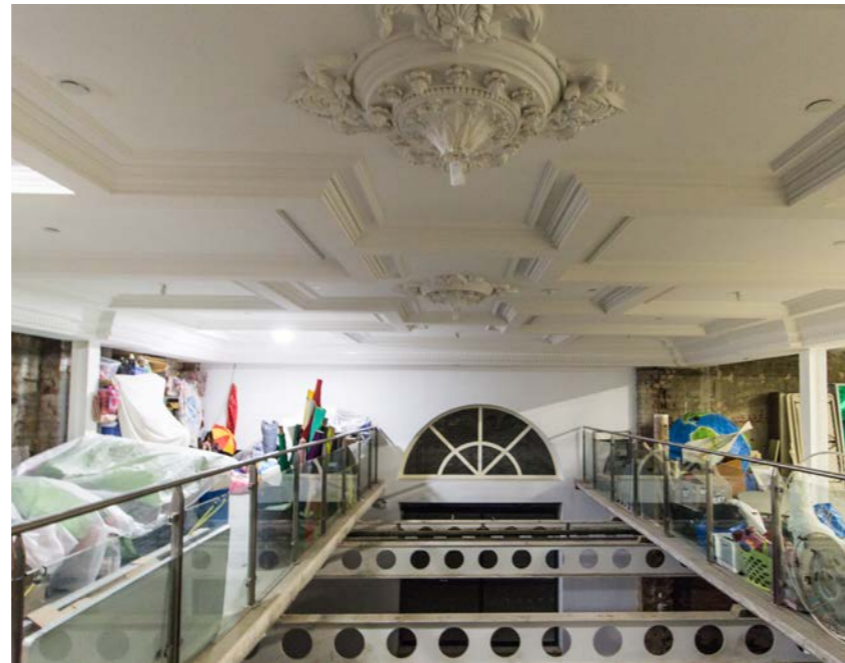
[01] CURRENT PHOTOGRAPH OF REPLICA CEILING

The decorative plaster ceiling which is currently located to the underside of the second floor is a replica as the original was removed as part of the works circa 2008. The replica ceiling has been located on plan to the original location of the reading room but on section in a different location. This has provided a significant constraint to the use of the space below. The design team have given this very careful consideration but advice from the acoustic specialist alongside the other design constraints has determined that this ceiling cannot be retained. Although this ceiling is a replica it is considered to hold some heritage value as it provides evidence of the former reading room ceiling and former use of the space.

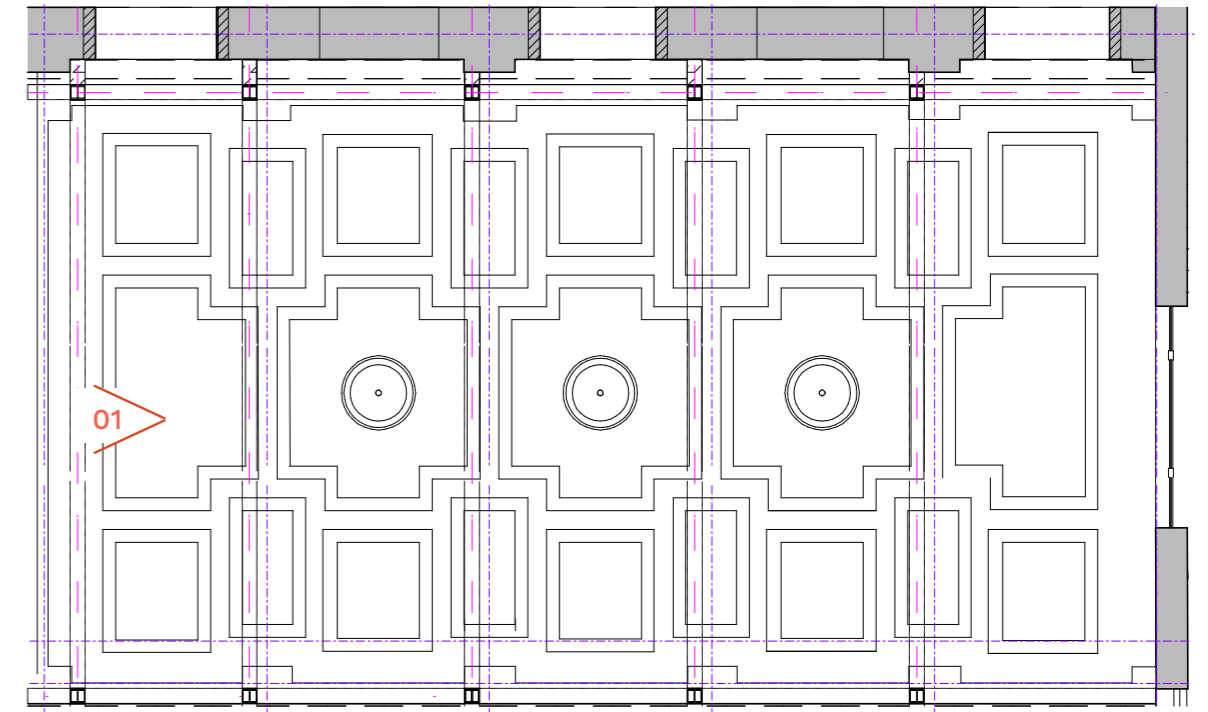
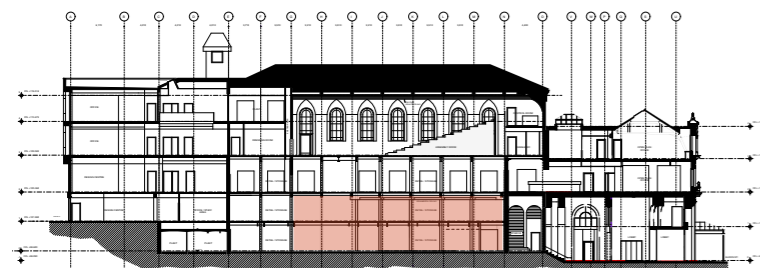
EXISTING SECTION

BLUE - Represents the ornate ceiling
