ARBORICULTURAL REPORT

to BS 5837:2012 at:

***Springhill Road
Grimethorpe,
Barnsley
S72 7BQ***

Reference: *AWA7294*

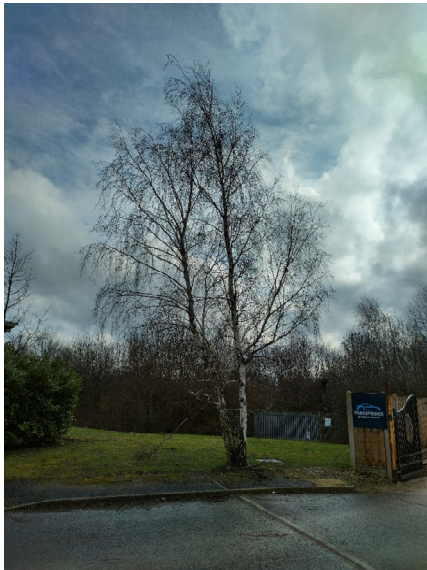
Photo 1: T1 from north west

- 3.2.2 T1 is an adjacent individual semi mature Birch situated bordering Springhill Road beyond the site's north eastern corner.
- 3.2.3 G2 and G3 are young and semi mature tree groups bordering the site's eastern boundary, G4, T5, T6, T7, T9, T10, G11 and T14 are young to semi mature trees and tree groups bordering the site's southern boundary, and G8 is a young to semi mature tree group bordering the site's western boundary.

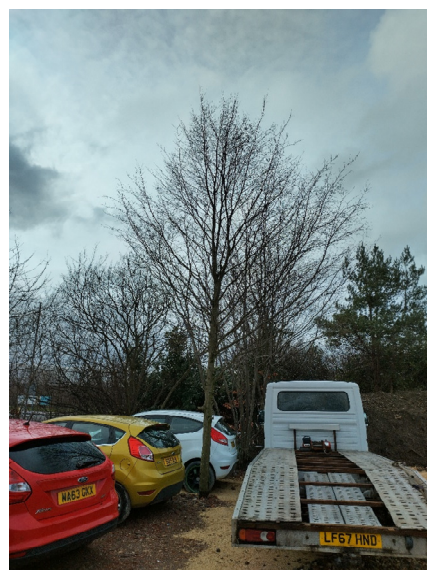
Photo 6: T7 from east

Tree ID	Tree Species		Maturity	Measurements				Crown (m)				Tree Condition						Category	Management Works		
	Common Name	Latin Name		Height (m)	Stems	Stem Diameter (mm)	Estimated	Crown height	N	E	S	W	Roots	Stem	Crown	Comments	Physiological			Structural	Life Expectancy
T7	Hornbeam	<i>Carpinus betulus</i>	Young	9	1	150	No	2.5	3	2.5	2.5	2	Increase in ground level	Single stemmed. Vertical. Old pruning wounds. Stubs	Minor deadwood	Increase in ground level around base of stem. Pruning wounds and stubs to stem from crown lifting works.	Good	Good	10 to 20 yrs	C	No works required in current site context
G8	Cherry Laurel. Willow. Beech. Birch. Hornbeam. Pine.	<i>Prunus sp. Salix sp. Fagus sp. Betula sp. Carpinus sp. Pinus sp.</i>	Semi-mature	10	10	100	Yes	1	See plan				Young to semi mature boundary group. Cherry Laurel, Willow, Beech, Birch, Hornbeam and occasional Pine. Piled soil along eastern edge. Limited access.				Good	Good	20 to 40 yrs	C	No works required in current site context

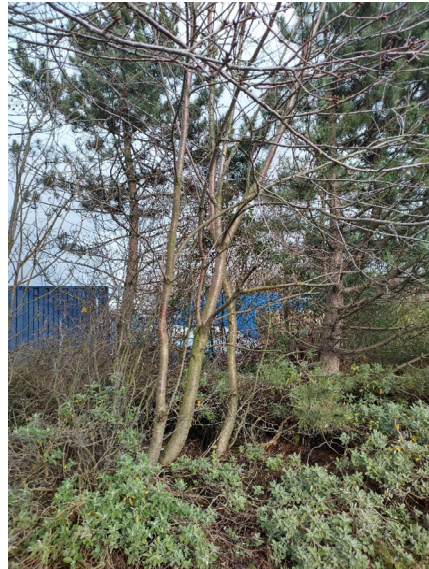
Photo 8: T9, T10 and G11 from south west

T9	Pine	<i>Pinus sp.</i>	Semi-mature	9	1	220	No	2	2.5	2.5	1.5	2	Limited access around base	Single stemmed. Slight lean north east. Stubs	Minor deadwood	Limited access. Stake at base to south east but not attached.	Good	Good	20 to 40 yrs	C	No works required in current site context
T10	Pine	<i>Pinus sp.</i>	Semi-mature	8	1	280	No	1.5	2	3	3	1.5	No visual defects	Single stemmed. Vertical	Minor deadwood. Old pruning wounds		Good	Good	20 to 40 yrs	C	No works required in current site context
G11	Cherry	<i>Prunus sp.</i>	Semi-mature	10	3	80, 130, 110	No	2	See plan				Three Cherries forming one crown. Slight lean south east. Pruning wounds to stems.				Good	Good	10 to 20 yrs	C	No works required in current site context
T12	Cherry	<i>Prunus sp.</i>	Early mature	12	1	300	No	2.5	2.5	4.5	5	4	Exposed roots. Mower damage	Single stemmed. Slight lean south east	Minor deadwood. Old pruning wounds	Exposed roots with mower damage	Good	Good	20 to 40 yrs	B	No works required in current site context

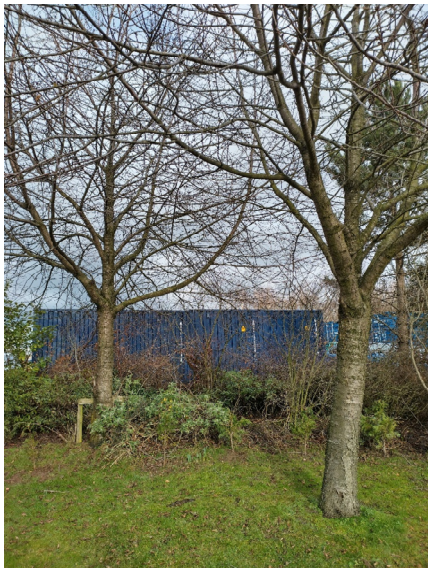
Photo 9: T12 and T13 from south west

- 3.2.4 T12, T13, T15 and T16 are early mature Cherries of moderate value situated bordering the roundabout beyond the site's southern western boundary.

Tree Species		Maturity	Measurements				Crown (m)				Tree Condition							Category	Management		
Tree ID	Common Name		Latin Name	Height (m)	Stems	Stem Diameter (mm)	Estimated	Crown height	N	E	S	W	Roots	Stem	Crown	Comments	Physiological		Structural	Life Expectancy	Works
T13	Cherry	<i>Prunus sp.</i>	Early mature	12	1	280	No	3	5	5	4.5	4.5	No visual defects	Single stemmed. Vertical. Stubs	Minor deadwood. Old pruning wounds	Stake at base to north but not attached	Good	Good	20 to 40 yrs	B	No works required in current site context
T14	Cherry	<i>Prunus sp.</i>	Young	4.5	1	80	No	2	2	2	2	1.5	No visual defects	Single stemmed. Vertical. Old pruning wounds. Stubs. Bark damage. bleeds	Minor deadwood	Stake and tie attached. Tie significantly girdling stem.	Good	Good	10 to 20 yrs	C	Recommended to remove stake and tie regardless of development
T15	Cherry	<i>Prunus sp.</i>	Early mature	12	1	280	No	3	4	5	5	4	Exposed roots. Mower damage. Girdled roots	Single stemmed. Vertical	Minor deadwood. Old pruning wounds	Exposed roots with mower damage. Stake at base to north west but not attached.	Good	Good	20 to 40 yrs	B	No works required in current site context

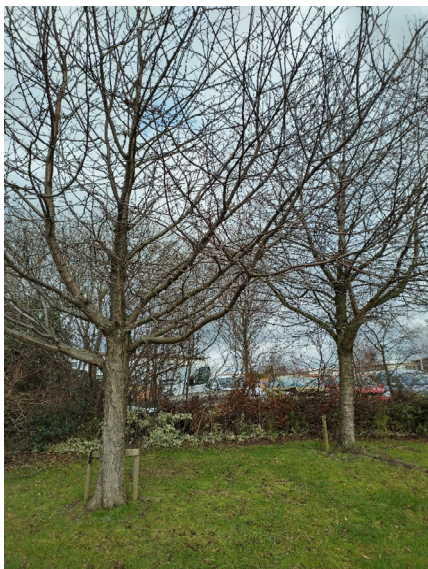
Photo 11: T15 and T16 from south west

T16	Cherry	<i>Prunus sp.</i>	Early mature	11	1	310	No	2.5	4	4.5	4	4.5	No visual defects	Single stemmed. Vertical	Minor deadwood. Old pruning wounds	Stakes at base to north but not attached	Good	Good	20 to 40 yrs	B	No works required in current site context
