## ASOS CAR PARK EXTENSION

LAND WEST OF, PARK SPRING ROAD, LITTLE HOUGHTON,  
BARNSELEY, S72 7GX

### PHASE 1: GEO-ENVIRONMENTAL RISK ASSESSMENT

**ASOS**

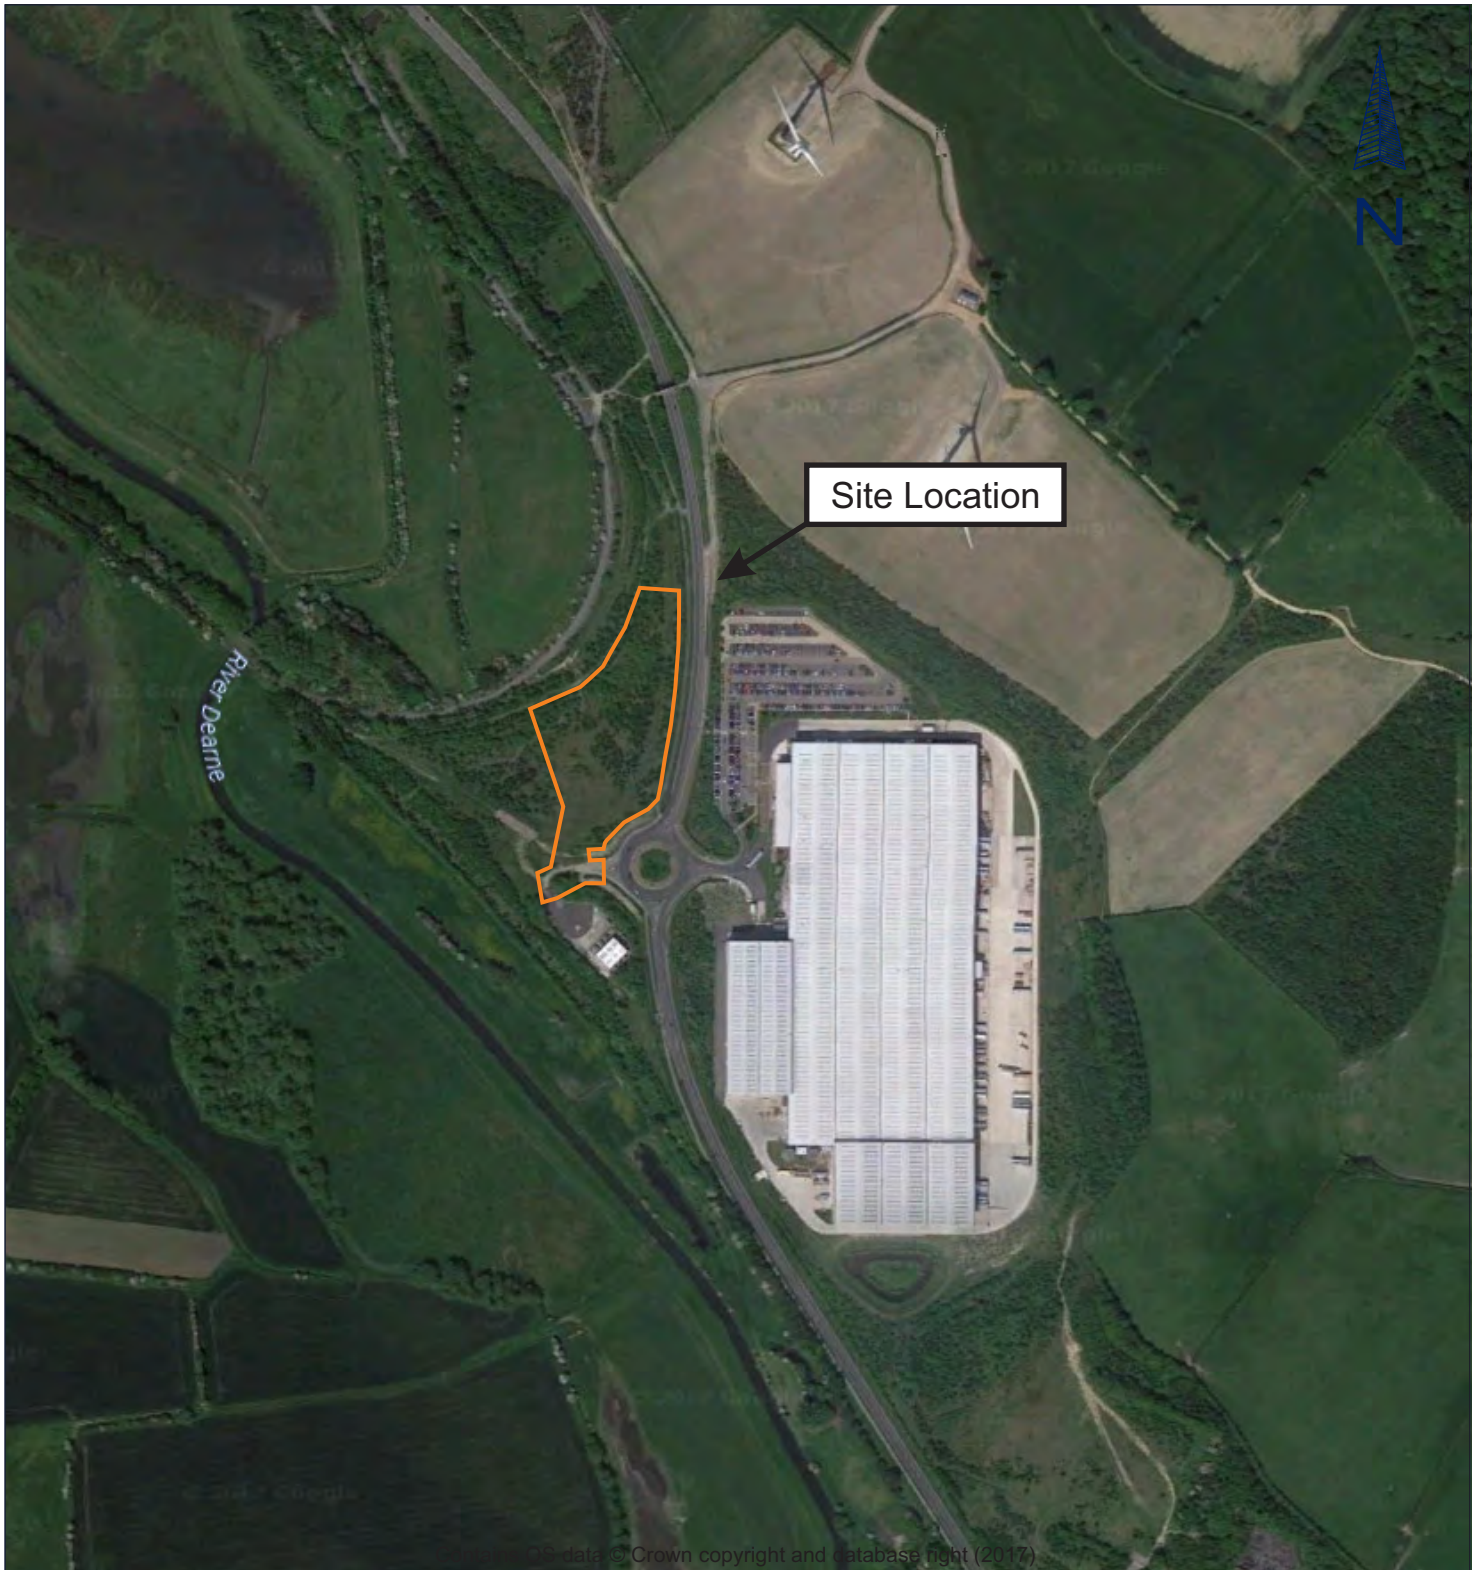
Figure 2

Site Plan

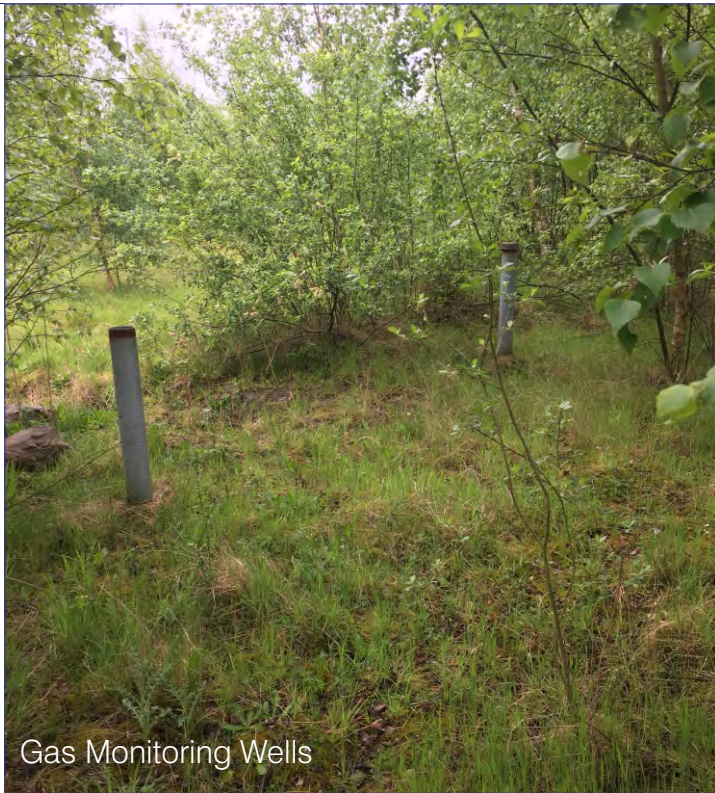
Gas Monitoring Wells

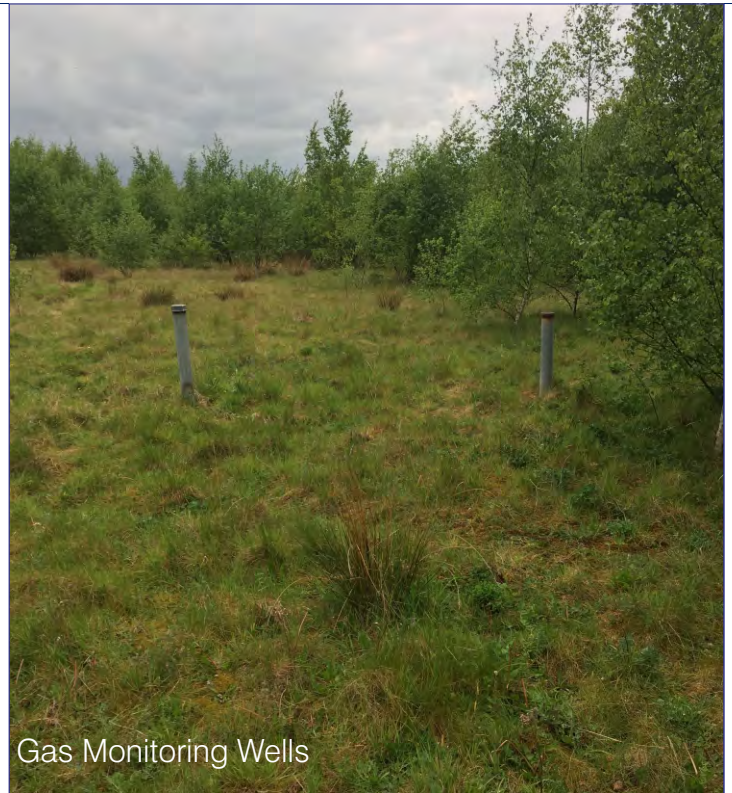
Gas Monitoring Wells

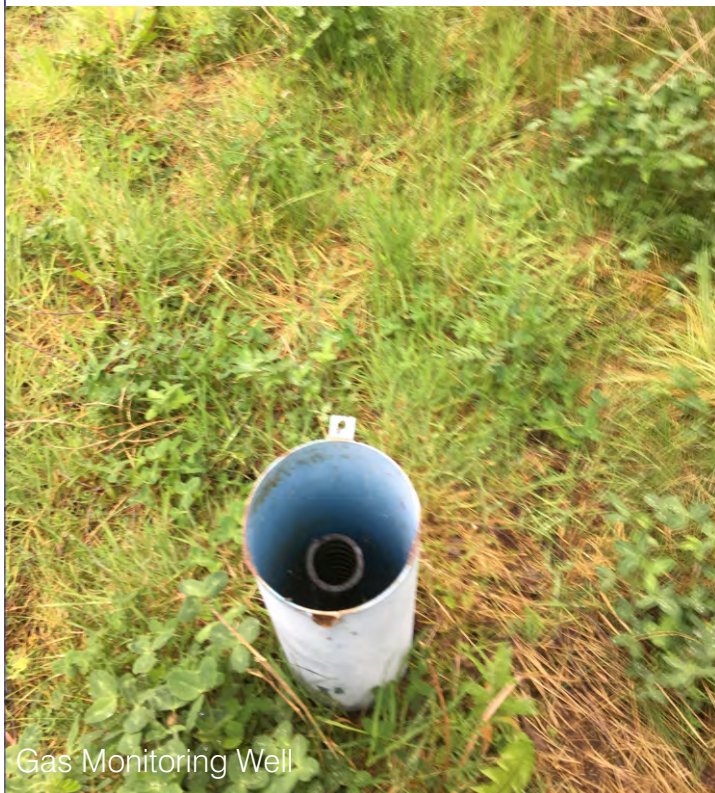
Gas Monitoring Well

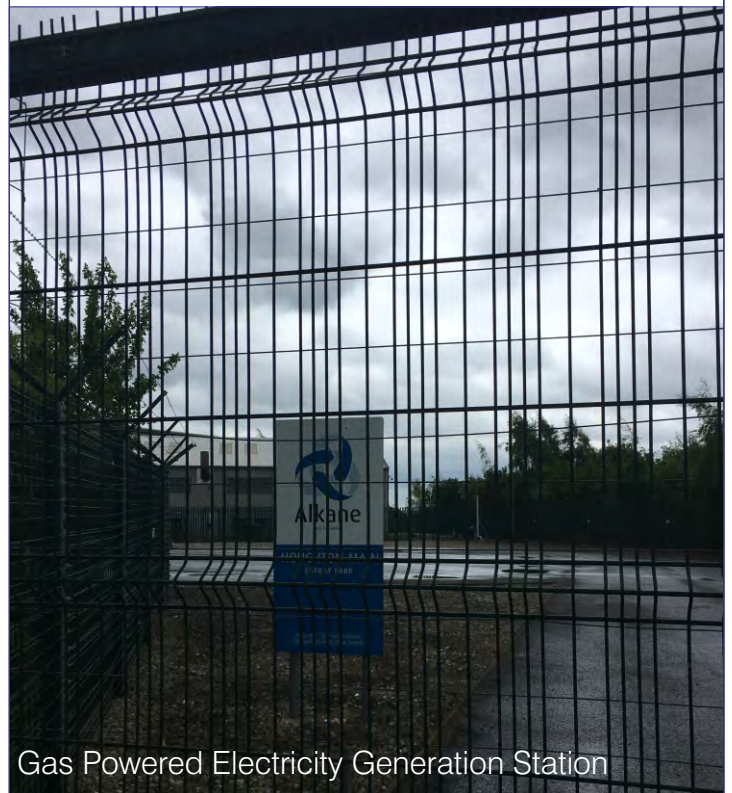
Gas Powered Electricity Generation Station
