**Developments  
Kendray  
Barnsley**

**Clayfield Construction Ltd**

**Ground/Geoenvironmental  
Investigation Report**

October 2008

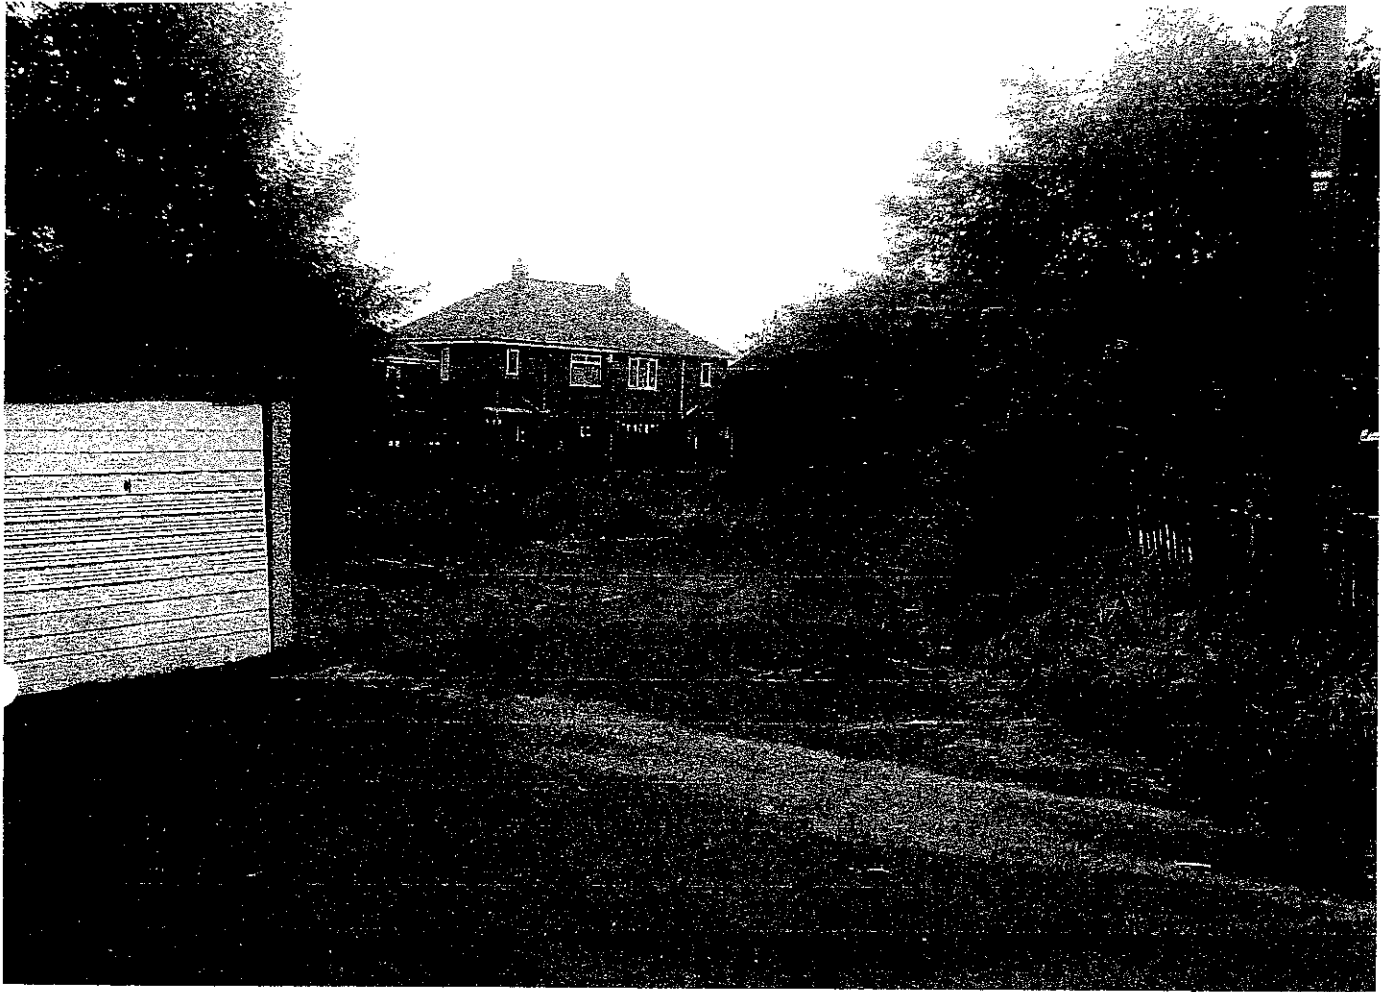
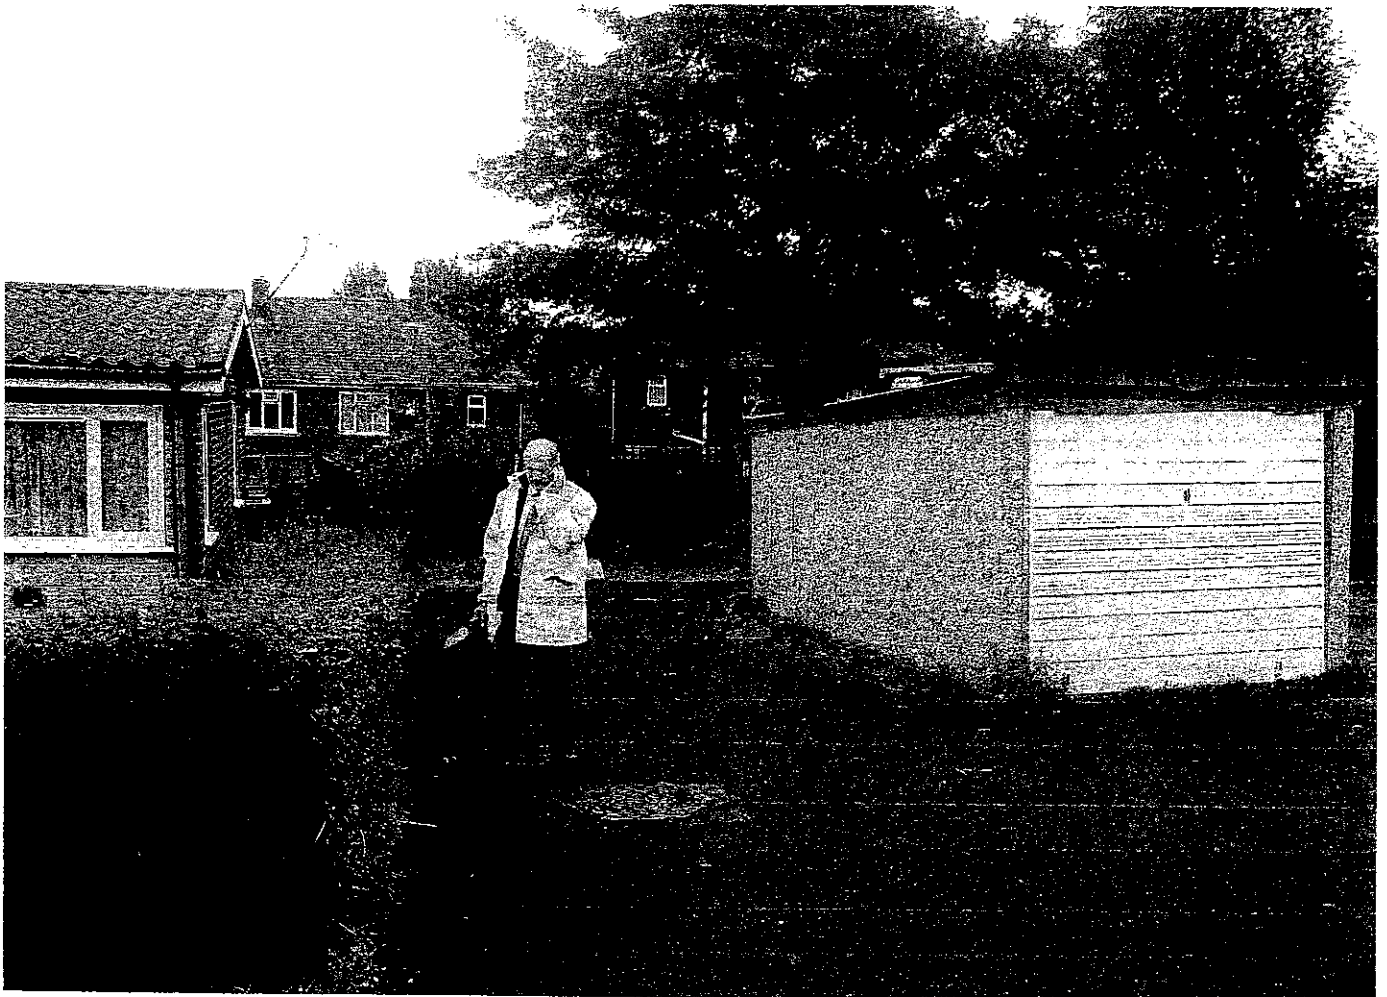
GILBERT GROVE

- 1 Gilbert Grove. The National Grid Reference is 436677, 405549. Figure 2017/1 in Appendix 7 shows the site in detail. The site is a flat area at approximately 70m AOD and currently consists of the base of a demolished domestic garage, tarmac hardstanding and landscaped areas containing trees. The site is surrounded by housing.

Gilbert Grove- topsoil over stiff clay with sandstone at 1.8m deep.

Gilbert Grove. The clay has a safe bearing pressure of 100kN/sq m and therefore 600mm wide footings will be satisfactory for normal domestic construction. The footings should be a minimum of 900mm below ground level but will require localised deepening near the trees in accordance with the NHBC Guideline 'Building Near Trees'. The clay has a medium shrinkage potential. The maximum depth required would be 1.8m below ground level as at this level sandstone will probably be encountered. However if any part of the foundation is sat on the sandstone it will be necessary to deepen all foundations to the sandstone level to avoid differential movement.

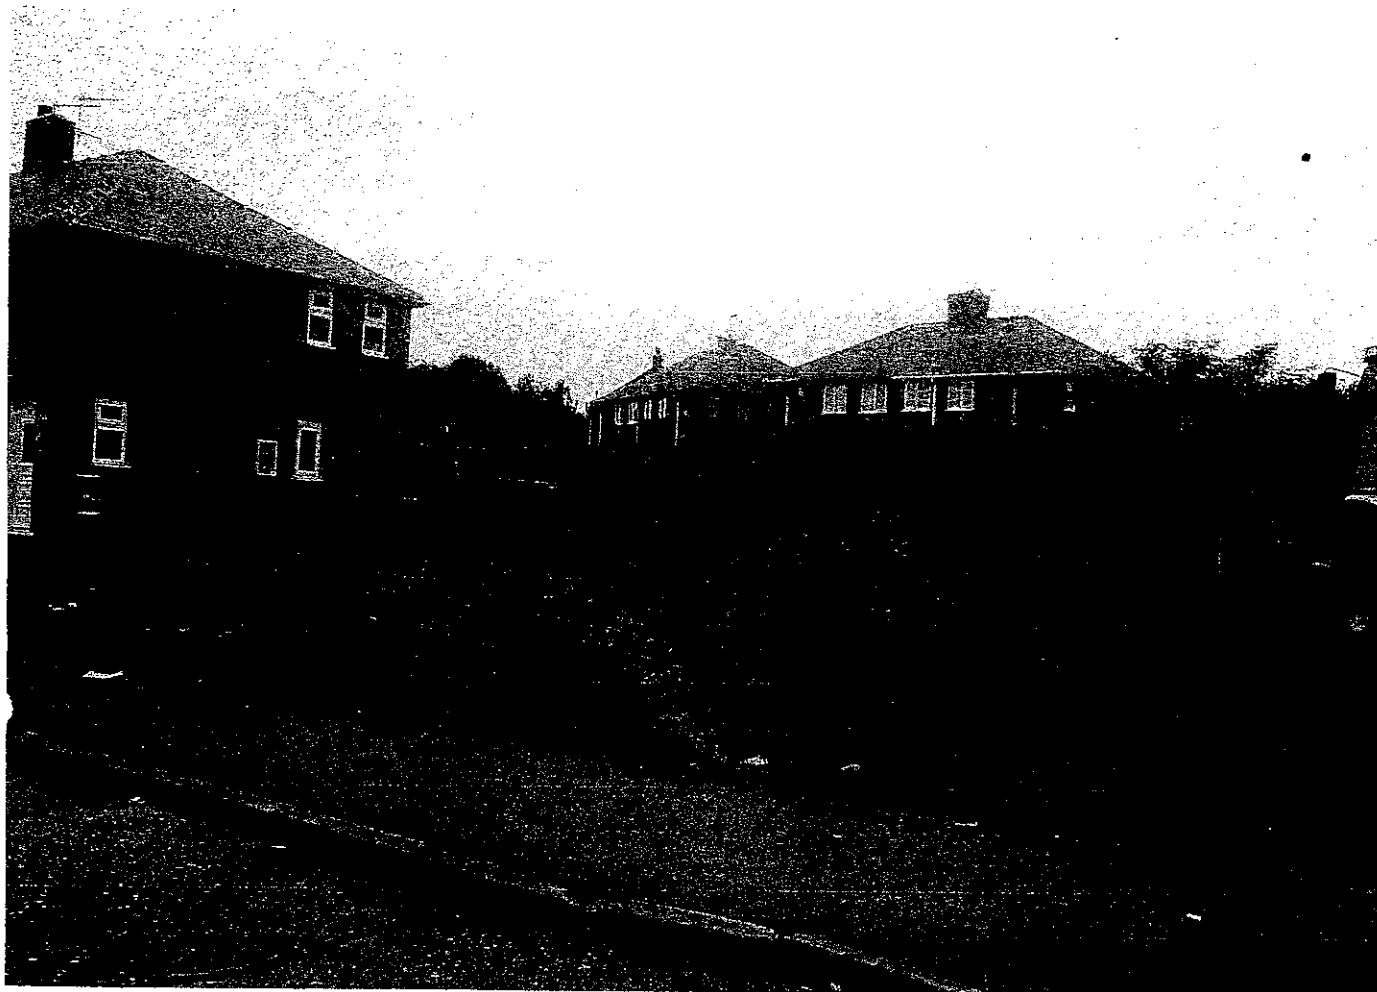
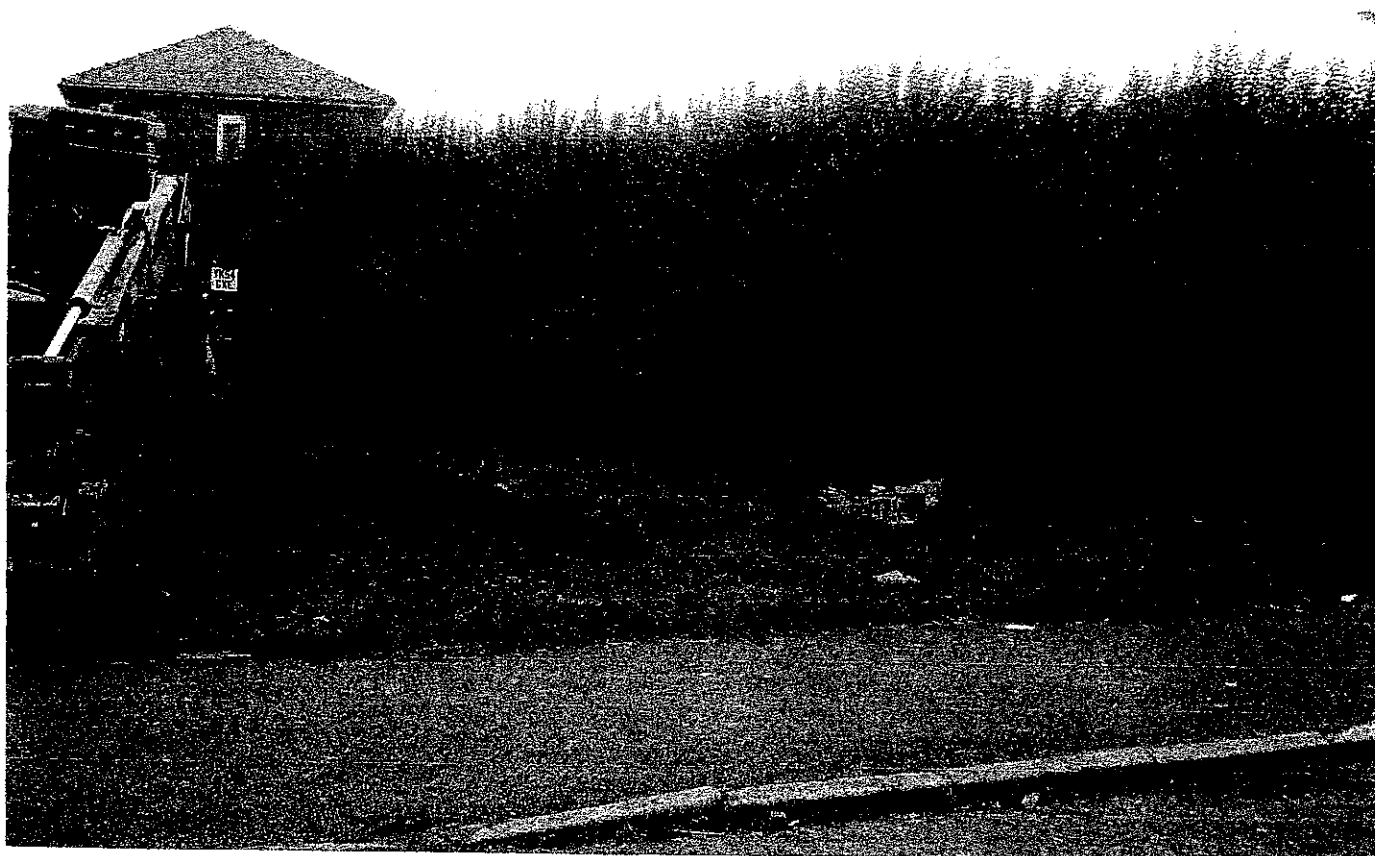
GERALD ROAD

- 2 Gerald Road. The National Grid Reference is 436447, 405266. Figure 2017/2 in Appendix 7 shows the site in detail. The site is a flat grassed area at approximately 90m AOD and is surrounded by housing.

Gerald Road-topsoil over medium dense sand becoming weathered sandstone with depth.

Gerald Road. The sand has a safe bearing pressure of 100kN/sq m and therefore 600mm wide footings will be satisfactory for normal domestic construction. The footings should be a minimum of 600mm below ground level

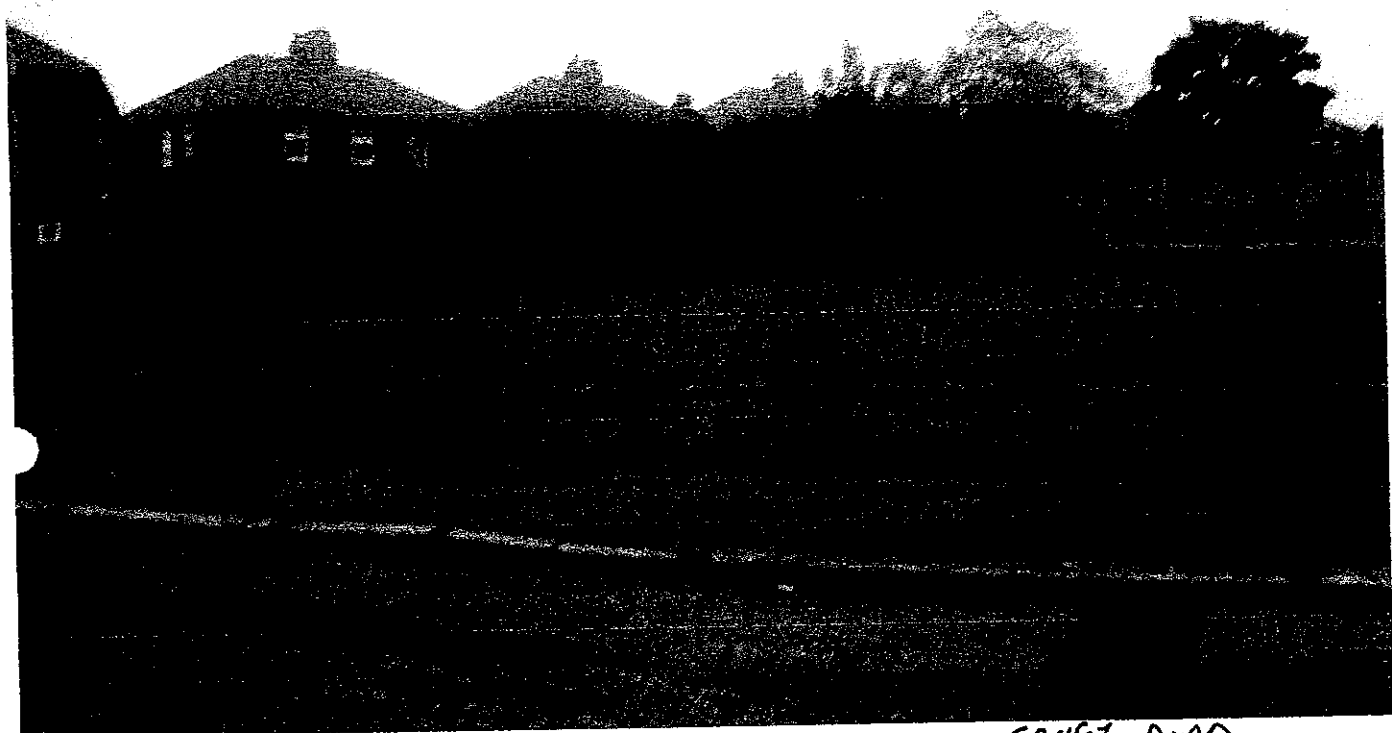
CRAFT ROAD

- 3 Croft Road. The National Grid Reference is 436496, 405048. Figure 2017/3 in Appendix 7 shows the site in detail. The site is a flat grassed area at approximately 98m AOD and is surrounded by housing.

Croft Road-topsoil/demolition rubble over medium dense sand becoming weathered sandstone with depth.

Croft Road. The sand has a safe bearing pressure of 100kN/sq m and therefore 600mm wide footings will be satisfactory for normal domestic construction. The footings should be a minimum of 600mm below ground level

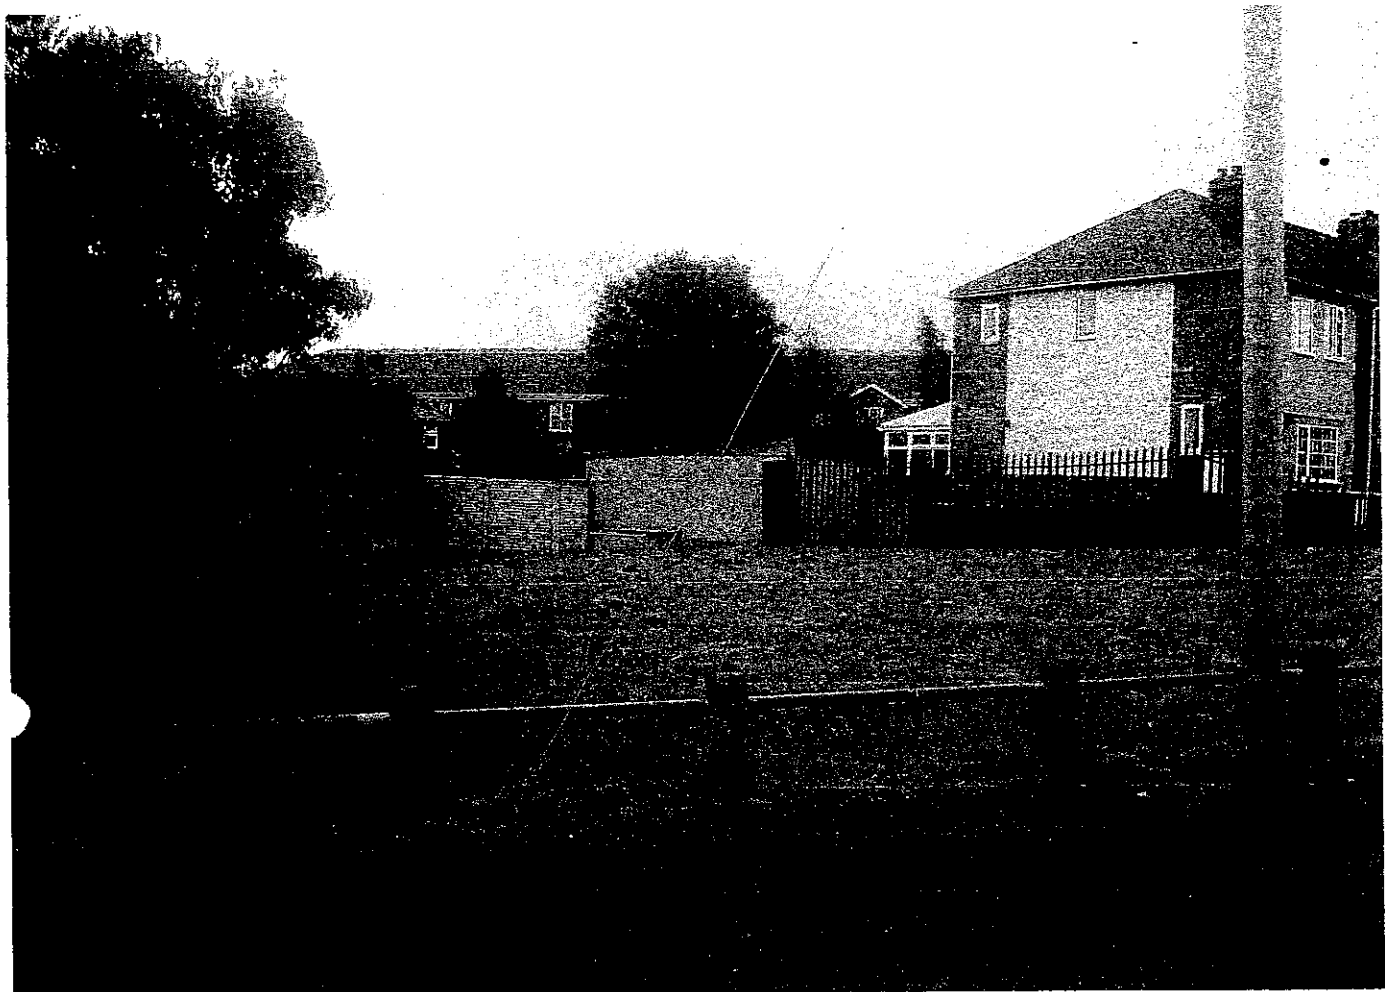
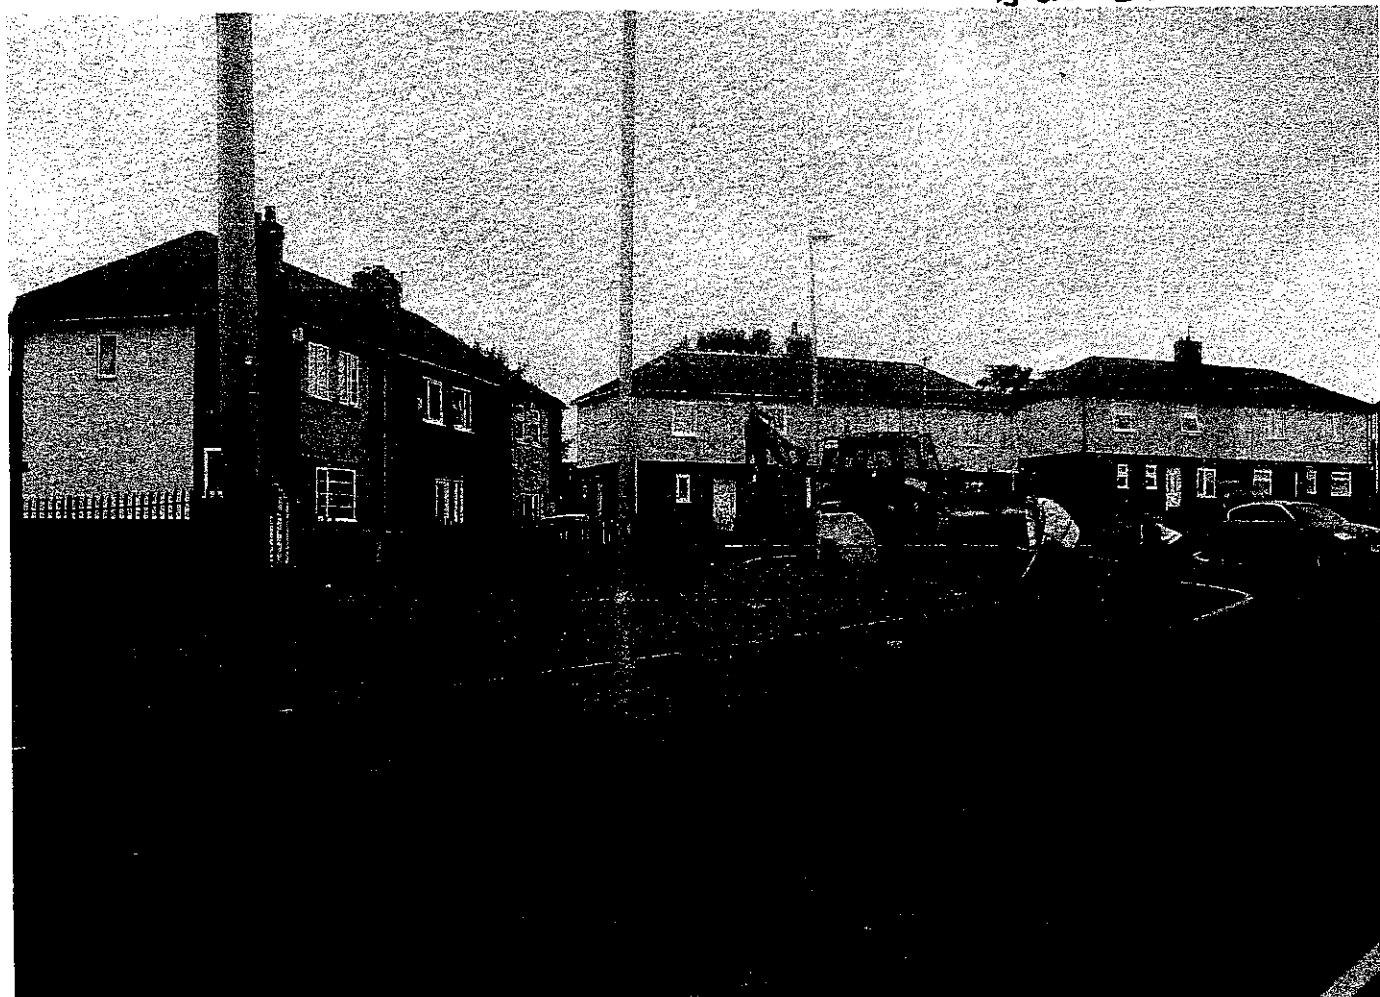
BIRK CRESCENT

- 4 Birk Crescent. The National Grid Reference is 436397, 405192. Figure 2017/4 in Appendix 7 shows the site in detail. The site is a flat grassed area at approximately 100m AOD and is surrounded by housing and public open space.

Birk Crescent-topsoil/demolition rubble up to 1.4m deep over medium dense sand becoming weathered sandstone with depth.

Therefore no values exceed the relevant guide levels except arsenic at Birk Crescent..

Birk Crescent. The sand has a safe bearing pressure of 100kN/sq m and therefore 600mm wide footings will be satisfactory for normal domestic construction. The footings should be a minimum of 600mm below ground level however the trial pits indicate that the fill material is up to 1.4m deep and therefore it is probable that some deepening of the footings will be required.

No special measures with regard to contamination are considered to be necessary except at Birk Crescent where additional testing of the soil will be required to confirm whether there is a high arsenic content or whether the result was an anomaly. If the soil has a high arsenic content then it is recommended that all garden and landscaped areas are covered with 400mm of clean topsoil/subsoil as a capping layer.

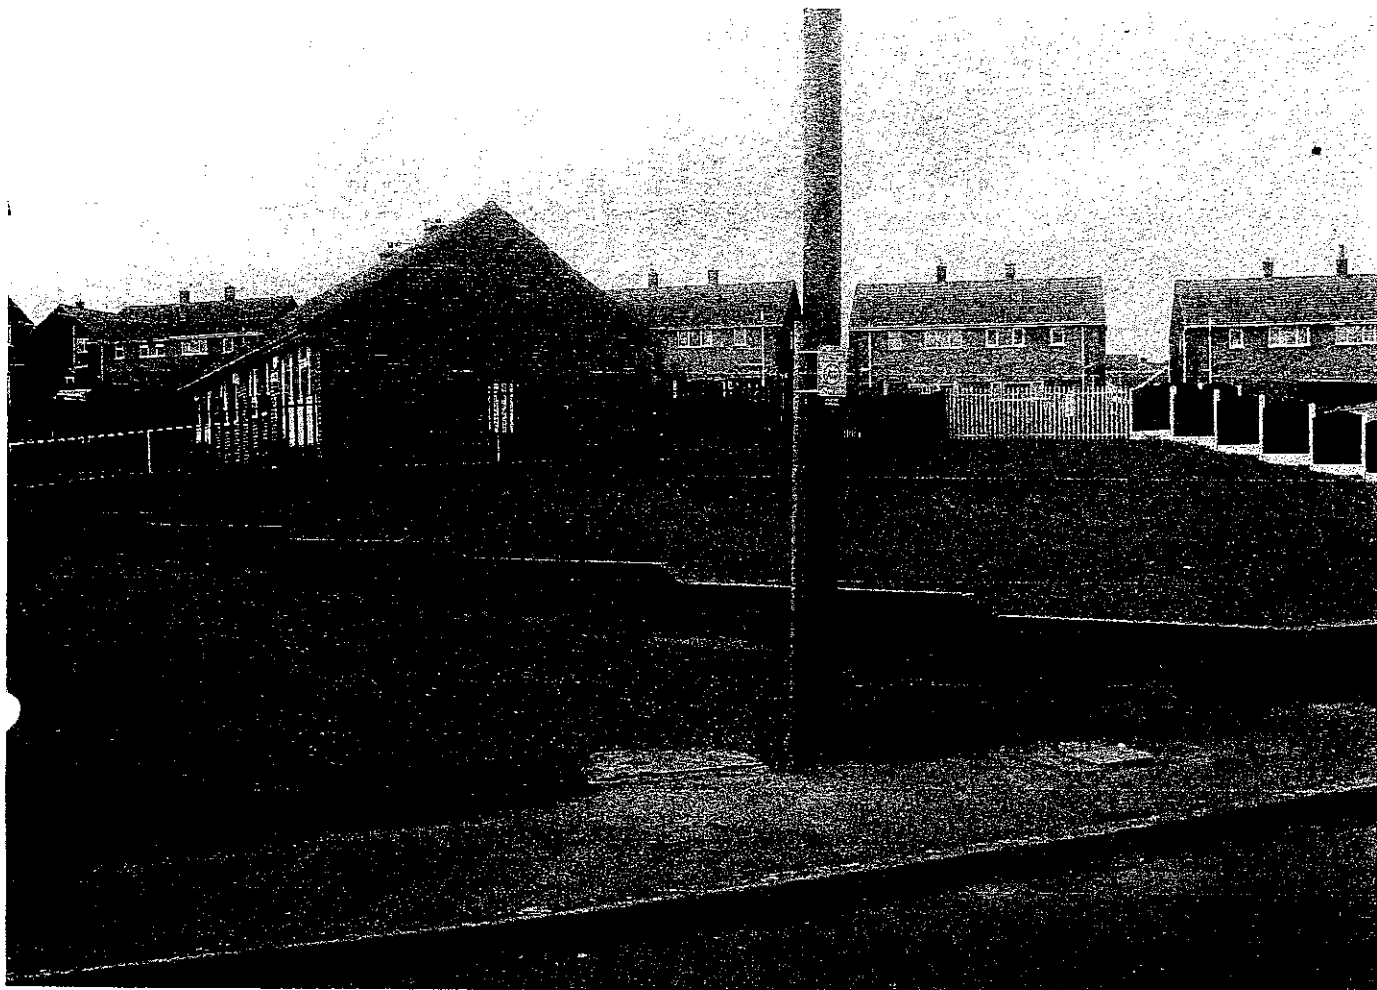
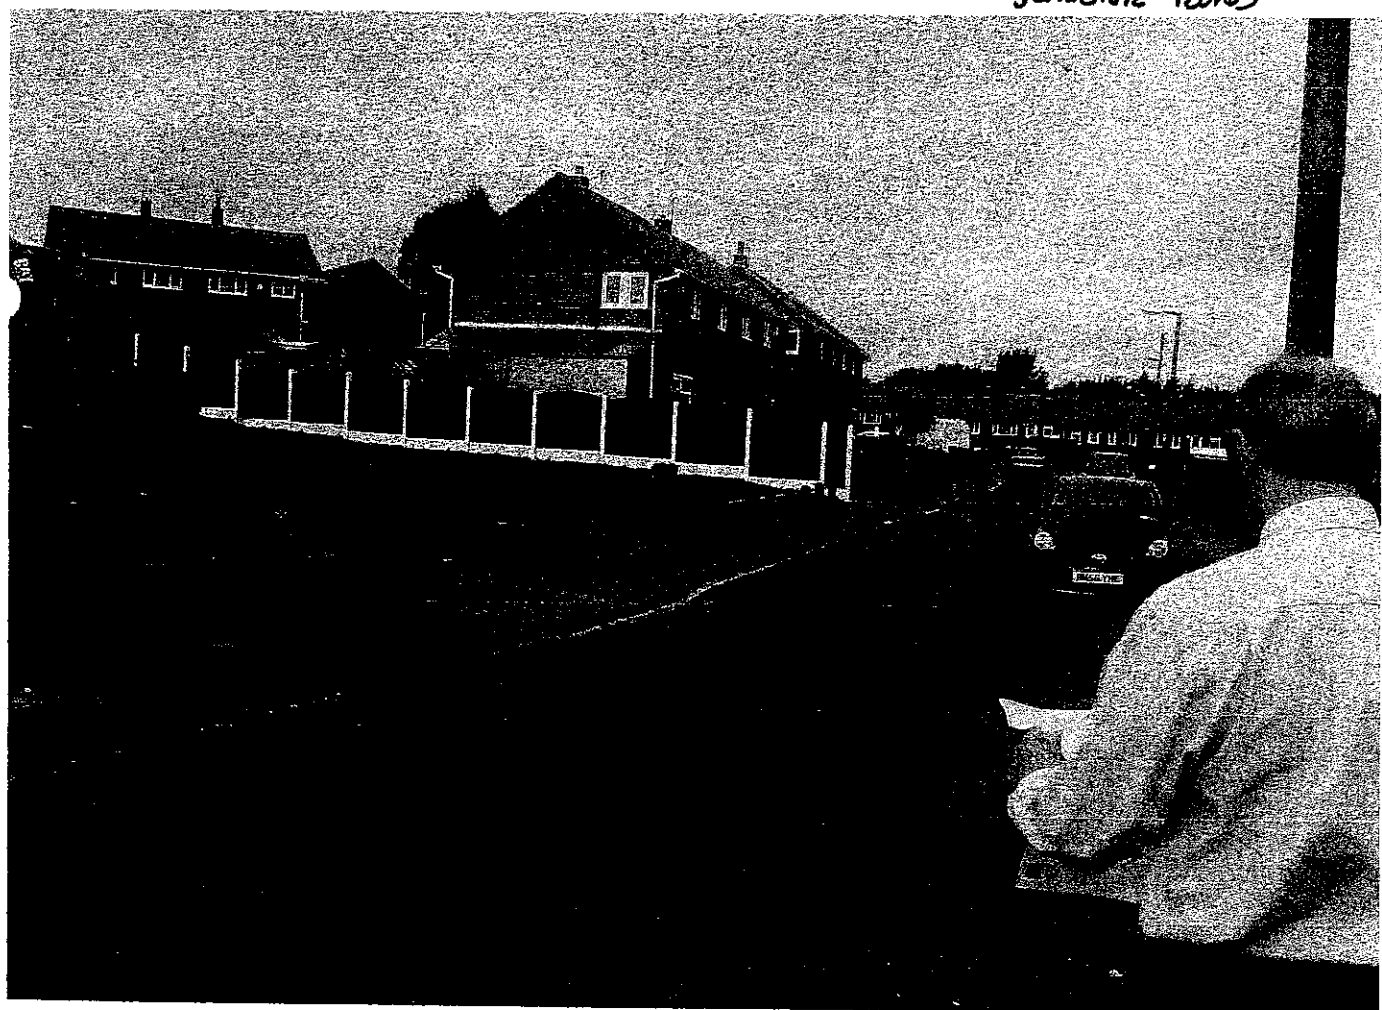
SWANKE ROAD

- 5 Swanee Road. The National Grid Reference is 436239, 404968. Figure 2017/5 in Appendix 7 shows the site in detail. The site is a slightly sloping grassed area at approximately 95m AOD and is surrounded by housing and public open space.

Swanee Road-topsoil over medium dense sand becoming weathered sandstone with depth.

Swanee Road. The sand has a safe bearing pressure of 100kN/sq m and therefore 600mm wide footings will be satisfactory for normal domestic construction. The footings should be a minimum of 600mm below ground level

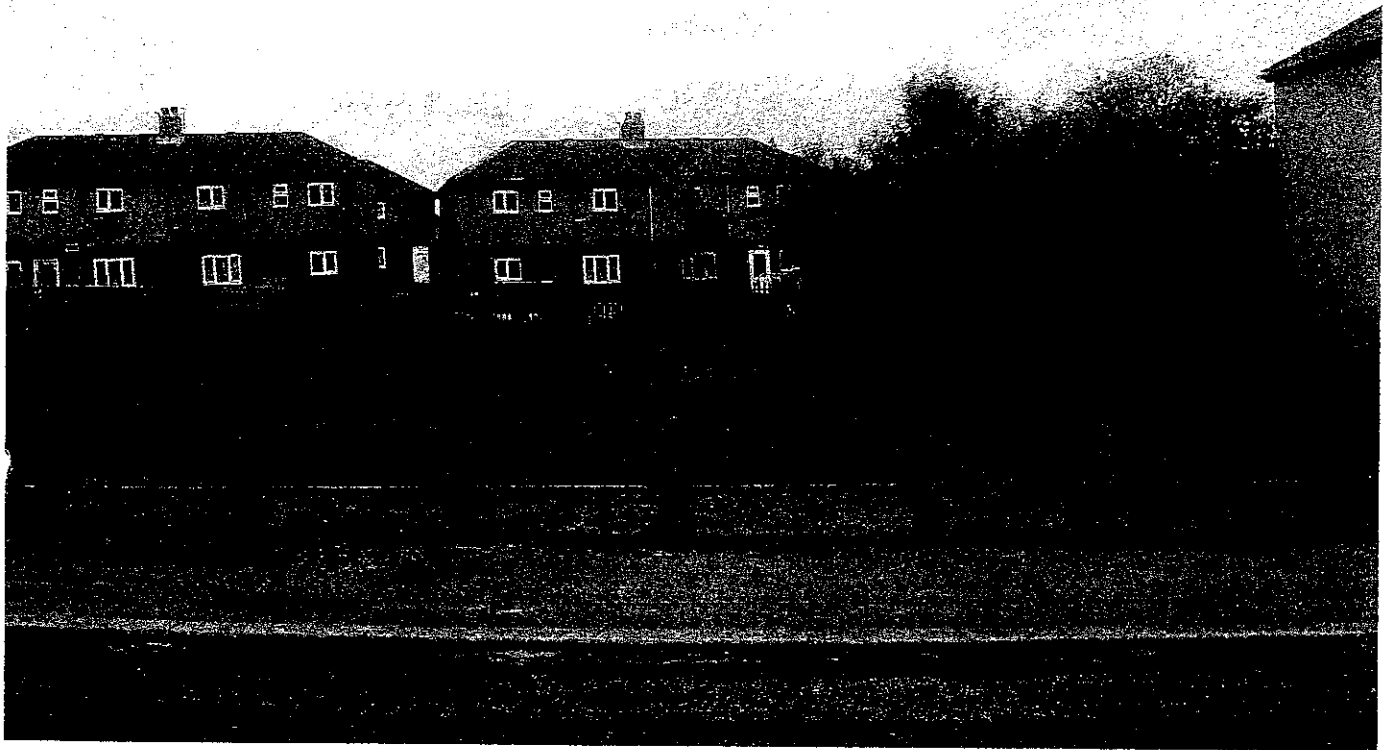
COLLEY CRESCENT

- 6 Colley Crescent. The National Grid Reference is 436373, 404928. Figure 2017/6 in Appendix 7 shows the site in detail. The site is a flat grassed area at approximately 100m AOD and is surrounded by housing. There are barriers to the site which prevented access and therefore the trial pits were excavated from the public highway.

Colley Crescent-topsoil/demolition rubble over firm sandy clay becoming mudstone with depth. (Access was restricted to this site)

Colley Crescent. The clay has a safe bearing pressure of 100kN/sq m and therefore 600mm wide footings will be satisfactory for normal domestic construction. The footings should be a minimum of 900mm below ground level but will require localised deepening near the trees in accordance with the NHBC Guideline 'Building Near Trees'. The clay has a medium shrinkage potential and the mudstone will have a low shrinkage potential. However if any part of the foundation is sat in the mudstone it will be necessary to deepen all foundations of that particular plot to the mudstone level to avoid differential movement. The investigation of this site was limited due to problems with access and therefore it is not known if the soil varies across the site.

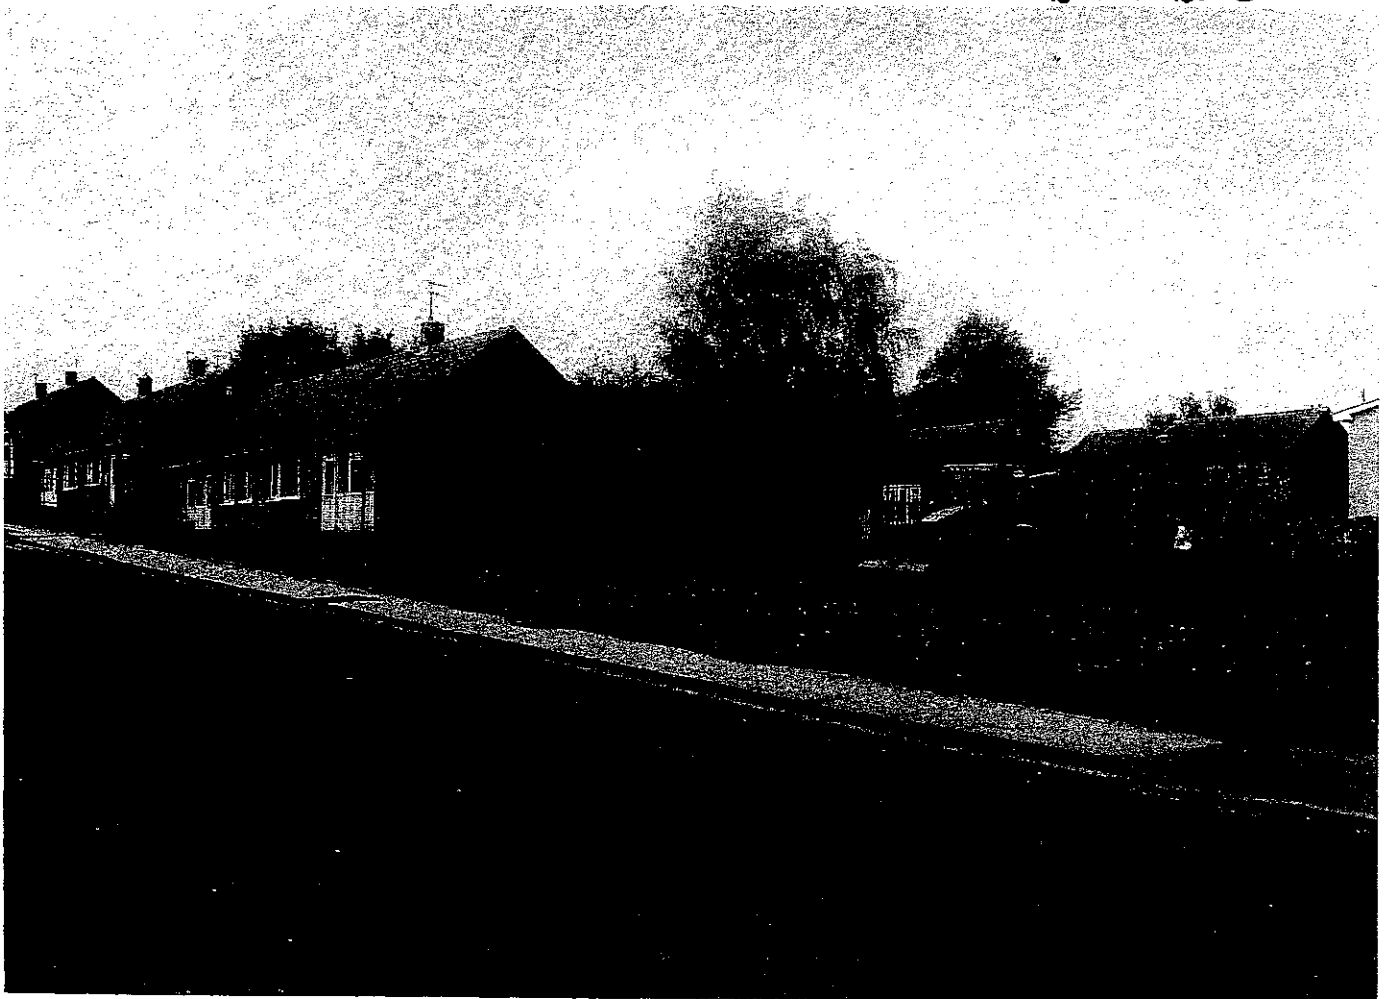
BIRCH ROAD

- 7 Birch Road. The National Grid Reference is 436724, 405270. Figure 2017/7 in Appendix 7 shows the site in detail. The site is a flat grassed area at approximately 90m AOD and is surrounded by housing and public open space.

Birch Road-topsoil/demolition rubble up to 1.0m thick over either soft blue/grey clay or firm brown clay becoming mudstone with depth.

Birch Road. The firm brown clay has a safe bearing pressure of 100kN/sq m and therefore 600mm wide footings will be satisfactory for normal domestic construction. The footings should be a minimum of 900mm below ground level but will require localised deepening near the trees in accordance with the NHBC Guideline 'Building Near Trees'. The clay has a medium shrinkage potential and the mudstone has a low shrinkage potential. However if any part of the foundation is sat in the mudstone it will be necessary to deepen all foundations to the mudstone level to avoid differential movement. The soft blue clay encountered in part of the site is probably from the former pond that occupied part of the site. If this is encountered during excavation it will be necessary to deepen the footings to the firm brown clay below. This may result in some water ingress and temporary pumping of the excavations may be required.

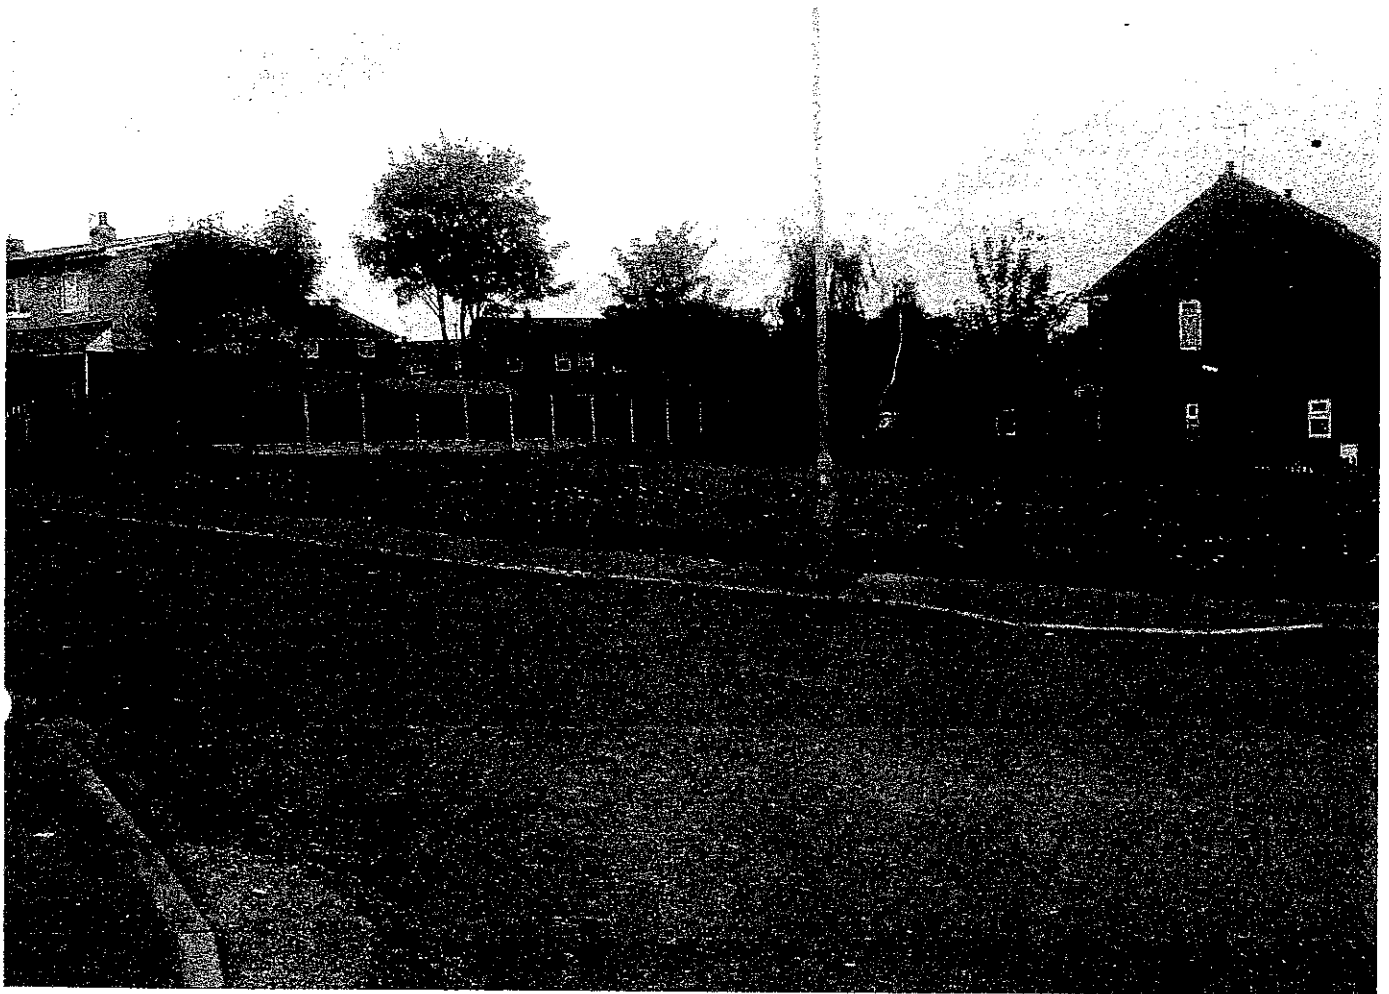
REGINALD ROAD

- 8 Reginald Road. The National Grid Reference is 436726, 405406. Figure 2017/8 in Appendix 7 shows the site in detail. The site is a flat grassed area at approximately 90m AOD and is surrounded by housing and public open space.

Reginald Road-topsoil over clay becoming weathered sandstone with depth.

Reginald Road. The clay has a safe bearing pressure of 100kN/sq m and therefore 600mm wide footings will be satisfactory for normal domestic construction. The footings should be a minimum of 900mm below ground level but will require localised deepening near the trees in accordance with the NHBC Guideline 'Building Near Trees'. The clay has a medium shrinkage potential. The maximum depth required would be 2.2m below ground level as at this level sandstone will probably be encountered. However if any part of the foundation is sat on the sandstone it will be necessary to deepen all foundations to the sandstone level to avoid differential movement
