Penistone Library

Preliminary Roost Assessment

Report Ref. ER-7396-01

Barnsley Metropolitan Borough Council

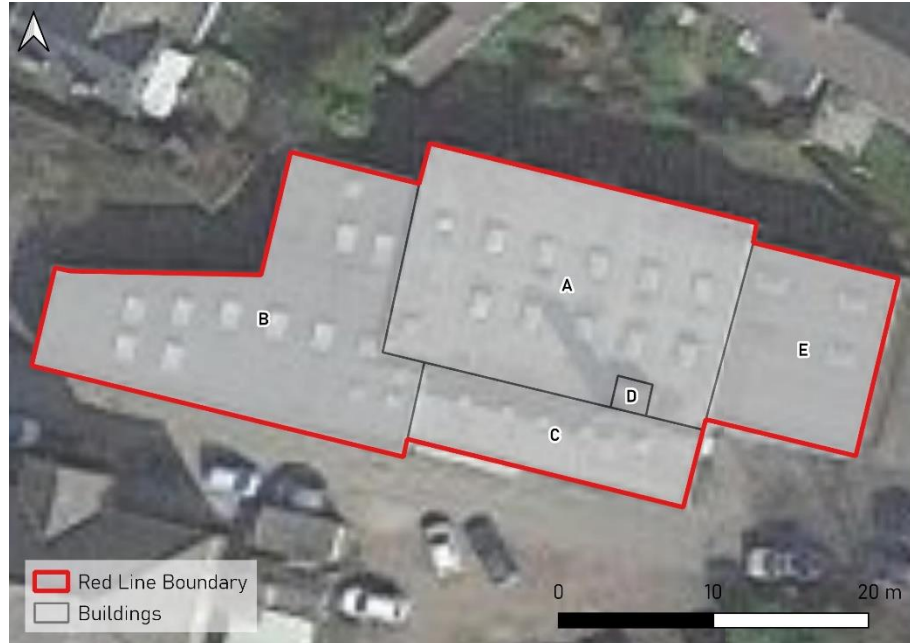
16. The Site comprises a single main building separated externally into sections based on the levels of their roofs, plus a chimney stack and a garage extension on the eastern end.

Figure 3 Location of buildings on-Site.

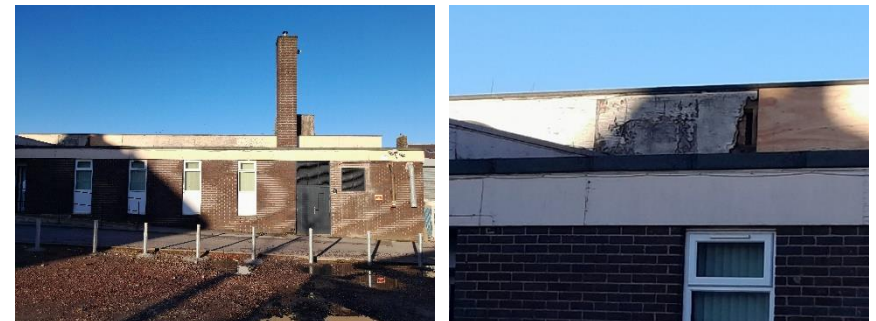
17. Building A is the main body of the library, a single-storey building of brown brick construction, well-mortared, with no gaps in the masonry noted. The windows are set within uPVC frames which are well-sealed, offering no potential roost features (PRFs).
18. The building has a flat roof consisting of a concrete deck, a layer of cork insulation, and a double layer of bitumen felt, offering no roof void (and the associated PRF) which a timber-framed flat roof might support.
19. Part of the fascia boarding on the building's southern elevation was damaged at time of survey, likely by a recent storm, revealing an internal wall cavity. Due to the recency and severity of the damage, permitting draughts and water ingress, this cavity is unlikely to be used by bats, and forms a PRF of negligible roost suitability.

Figure 4 Typical view of Building A (rear), D (middle), and C (fore) (left); damaged fascia board on Building A (right).

28. No further survey work is recommended in support of this conclusion.
29. It is recommended that features of negligible suitability (i.e., any damaged fascia boards) should be subject to endoscope inspection by a licensed ecologist prior to replacement. This is in lieu of a dusk emergence survey, which would be disproportionate to the level of bat roost potential identified.
