## **Dick Royd Farm, Carlecotes Barnsley**

### **Bat Survey**

June 2010.

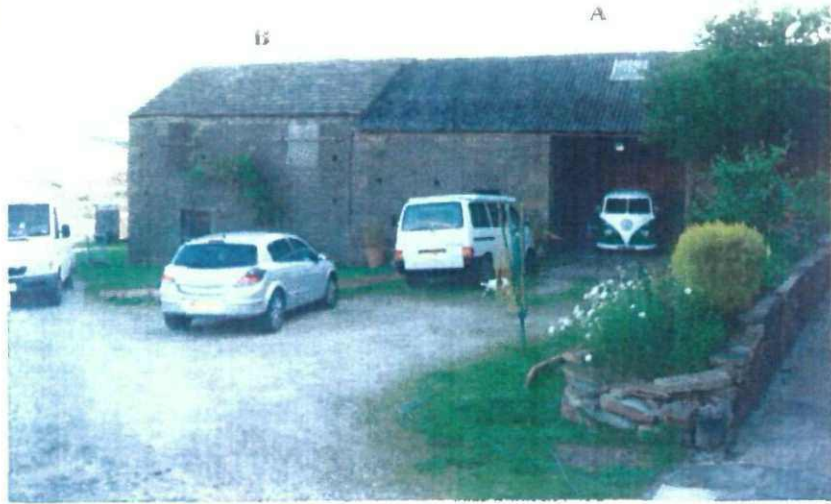
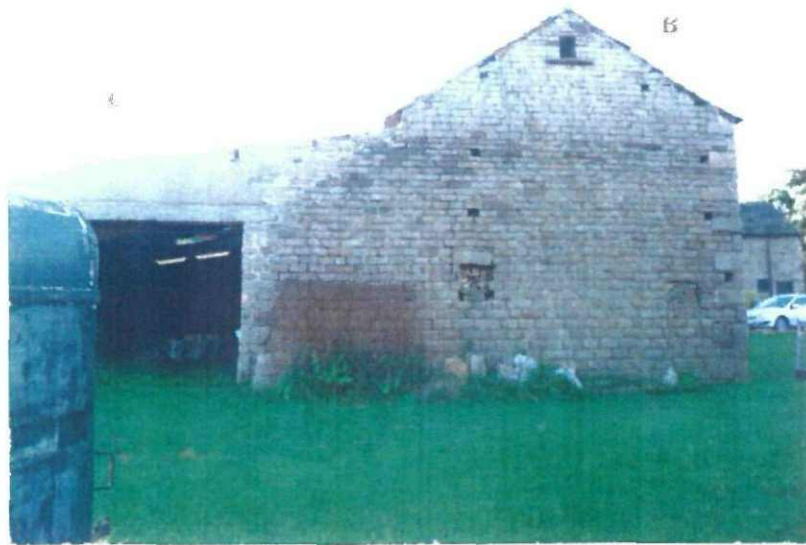
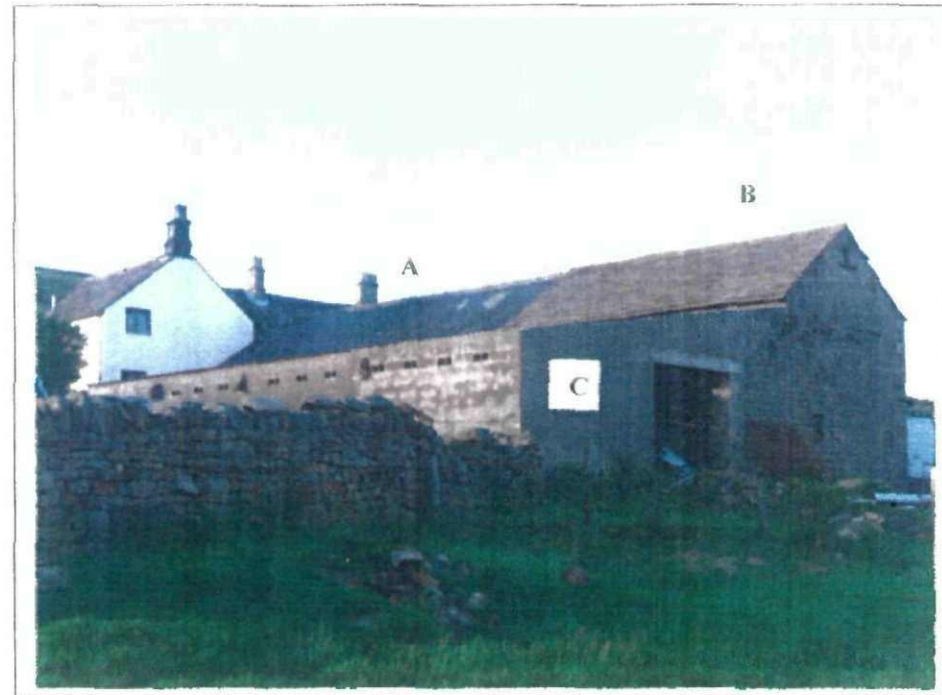
FIG 1

| Key | Description |
|---|---|
| A | <p>Two-storey height stone barn with corrugated asbestos cement roof sheets. The northern gable was partially covered by an attached porch connected to the house. The apex of the barn was quite low above the porch roof and unlikely to be attractive to bats. The eaves corner of the barn at this point was approx. 1.8 metres above the path level, too low for bats.</p> <p>The walls on the east (yard) side contained a full height uncovered door opening and a ground floor window opening. The walls contained ventilation slots and abundant open joints. The west wall contained a full height covered door opening and much of the rest of the wall was covered by Barn C.</p> <p>Internally the barn was open to the underside of the roof which was supported on simple 'A' frame trusses. The apex had two close fitting purlins rather than a traditional ridge board leaving no suitable enclosed crevices under ridge tiles which are favoured by bats. The large timbers did not contain any suitable mortise or socket holes. The internal walls also contained abundant crevices. There were no signs of droppings, urine spotting or discarded insect remains on the inner gable walls, floor or the many surfaces of materials stored within the barn including the roof of a van parked inside.</p> |
| B | <p>Two-storey height stone barn with stone slate roof. The southern gable contained an 'Owl' window in the apex with vent slots and abundant joint crevices in the wall face. The slate verge pointing also contained numerous gaps. The walls on the east (yard) side contained two ground floor windows and a door all closely covered. The west wall was contained within barn C.</p> <p>Internally the barn was open to the underside of the roof which was supported on Queen-post trusses. The large timbers did not contain any suitable mortise or socket holes. The ridge board was quite clean and not covered by cobwebs. There was a half loft at the western end with an enclosed store room below accessed from the yard. The barn was partially filled with old hay bales. There were no signs of droppings, urine spotting or discarded insect remains on the inner gable walls, floor or the many surfaces of materials stored within the barn.</p> |
| C | <p>Lean-to barn with concrete block outer walls and a mono-pitch asbestos sheet roof. There was a large door opening in the southern end.</p> <p>The external walls of barn B contained joint crevices. There were no signs of droppings, urine spotting or discarded insect remains on the inner gable walls, floor or the many surfaces of materials stored within the barn.</p> |
