Bat Survey to
The Old Bakery
Carlton Street
Cudworth

Barnsley
S72 8ST

3rd November 2022

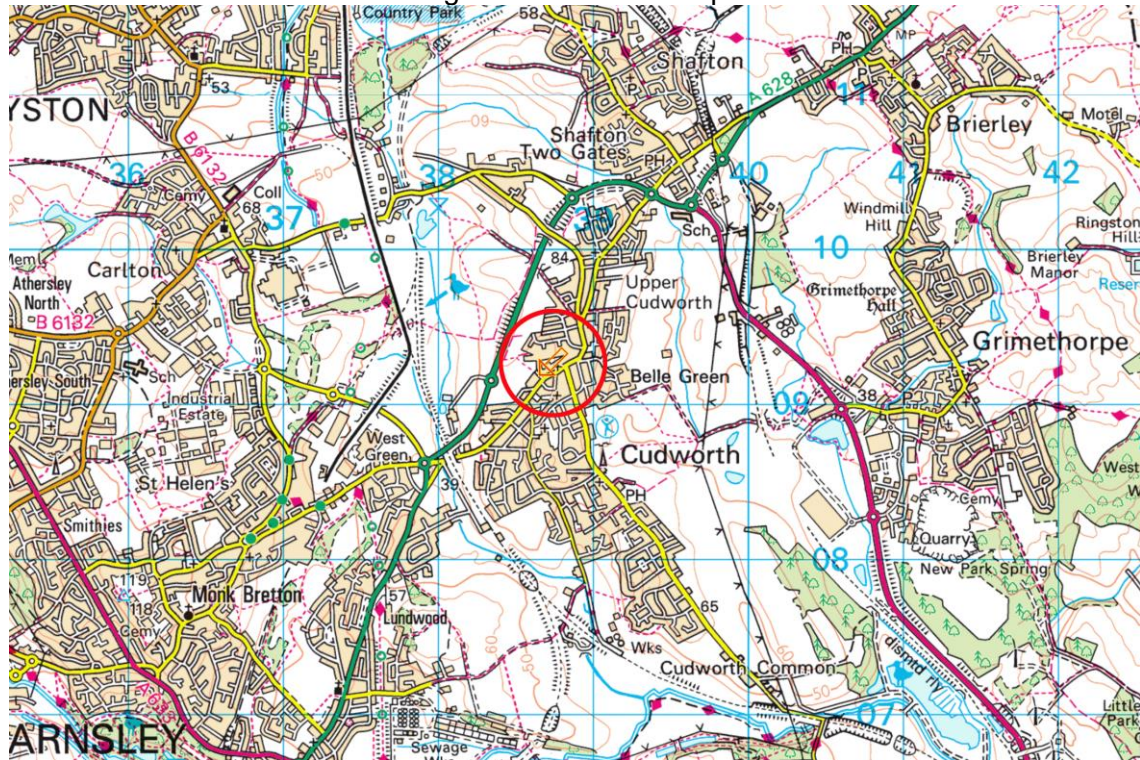
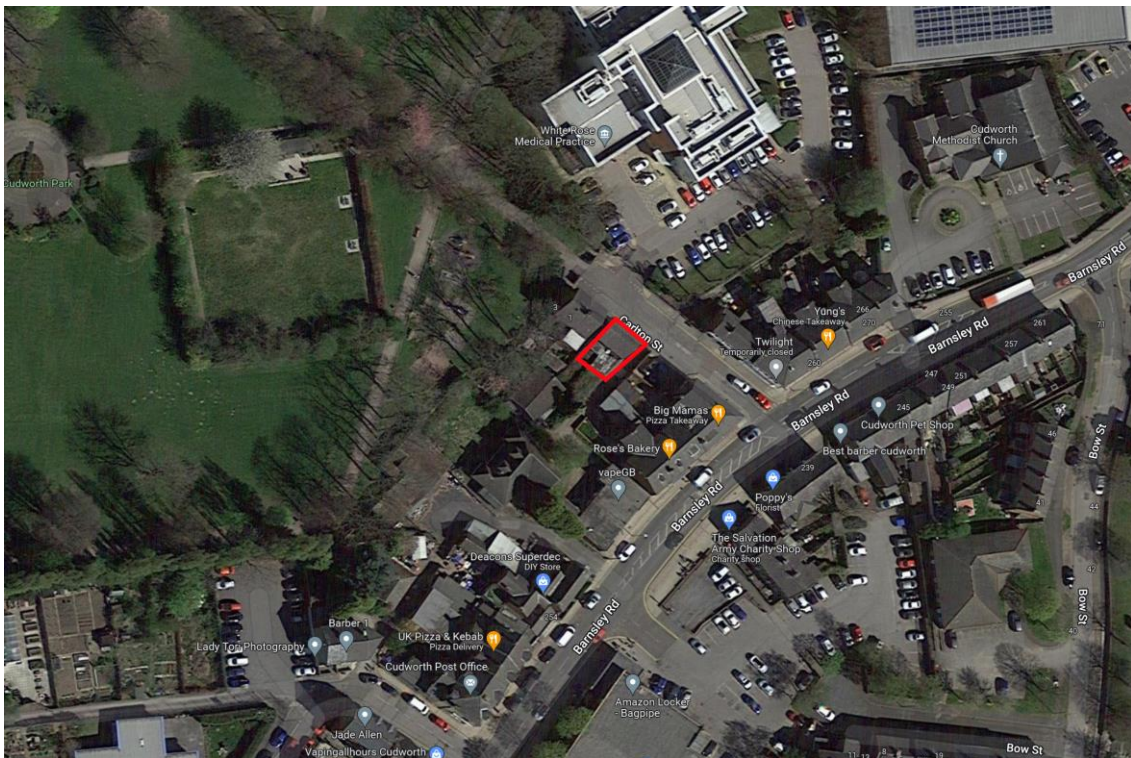
Figure 2 Aerial view of the site, surrounds and specific buildings surveyed

5.1 The site consists of a two-storey brick building in an urban area close to other buildings and residential dwellings. Moderate foraging habitat occurs adjacent to the site, but the habitat suggest only commoner species are likely to be present and in low numbers. The site is connected to the wider landscape by a series of linear features.

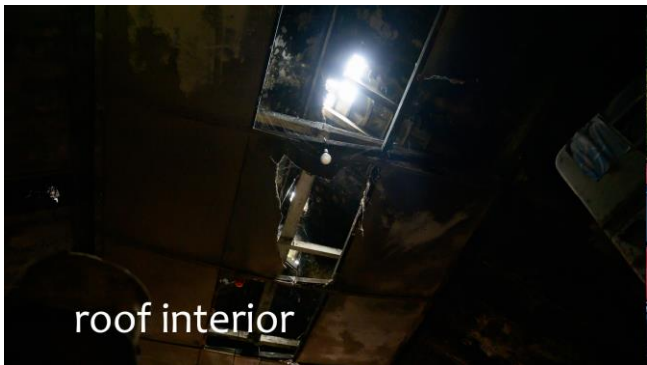
The building is a two-storey former bakery built from brick with a blue slate roof. The building is beginning to deteriorate and is subject to regular vandalism and trespass despite its unsafe nature. The roof has a covering of blue slate and has both missing and slipped tiles with some large holes close to the ridge section. All ridge tiles are present but there is failed mortar along the length of the ridge. Internally, the roof is mostly unlined with remnants of MDF fastened to the roof timbers, but this is very wet and is mostly falling away. The upper floor is littered with old contents and bits of bakery machinery and has a covering of general detritus that prevents easy inspection, but there does not appear to be any scattered prey remains. The ridge beam is heavily covered with cobwebs and do not appear to be used by bats. As well as no evidence of bats, the roof does not have the 'feel' of being used by bats.

roof interior

- If possible, the roof should be stripped by hand during the winter period October-March inclusive.

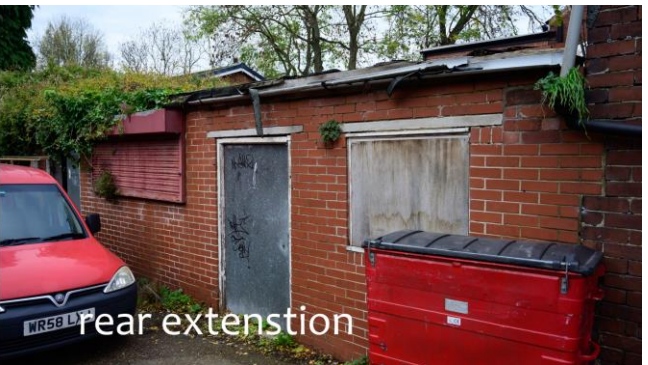
There is a single-storey, flat roofed extension to the rear of the building which is considered to have negligible roosting potential and is in an advance state of disrepair due to vandalism.

rear extension

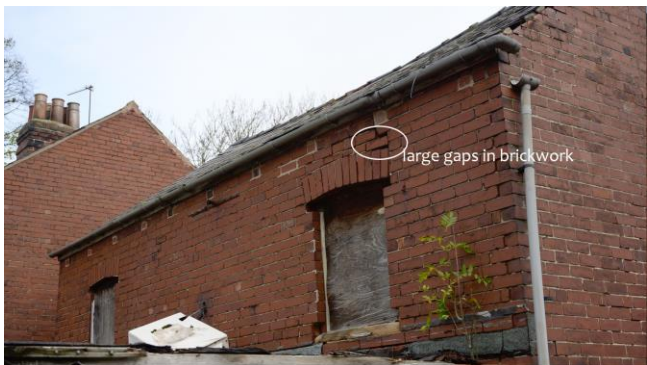
The walls are constructed from brick arranged in a header and stretcher style and therefore, there is no wall cavity restricting use by bats to the wall tops. There are some structural cracks over one of the upper floor windows on the rear of the building, but these were difficult to inspect from the flat roof below due to the unsafe nature of the roofing. The cracks are larger than the typical crevices used by bats, particularly for hibernation and are likely to not be used. Most of the mortar has failed on both dry verges leaving large and exposed gaps. These gaps are used by house sparrow which usually suggests they are not used by bats as sparrows are very territorial and likely to attack bats if they were present. The gutters are fixed to the walls on flat boards, but these sit tight to the brickwork and do not offer the gaps that bats require. There is also a build up of cobwebs along the length of the wood.

large gaps in brickwork

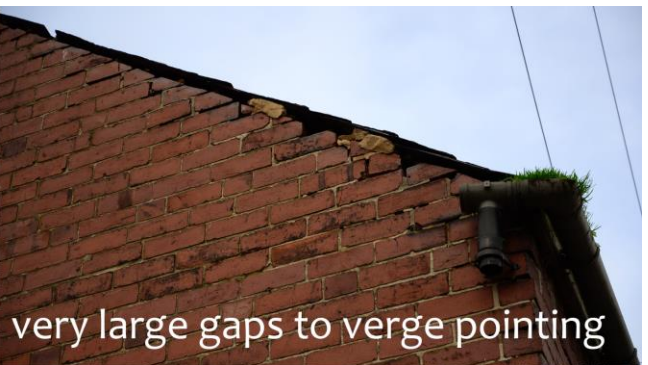
very large gaps to verge pointing

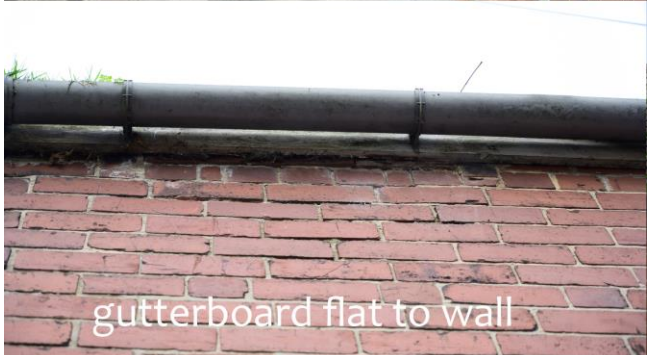
gutterboard flat to wall

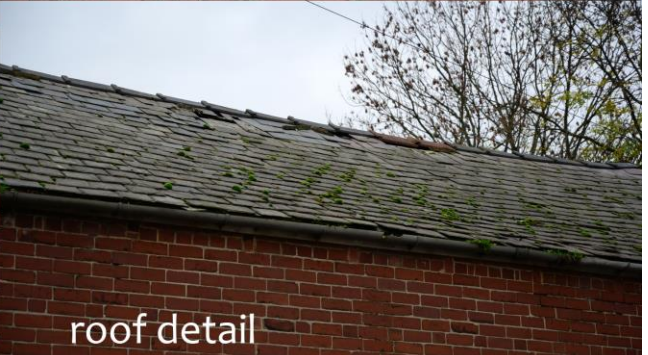
roof detail
