# NPG Clearance Report

**Circuit Name: -** WOOLLEY  
**Network Name: -** WOOLLEY - WOOLLEY GRANGE 11KV  
**Pole Ref Number :-** 142508367  
**Voltage: -** LV  
**Inspection Date: -** 21/08/2015

Title NPG ESQCR Building Services for SS: - WOOLLEY  
WOOLLEY - WOOLLEY GRANGE 11KV 142507892  
Reconductoring Plan

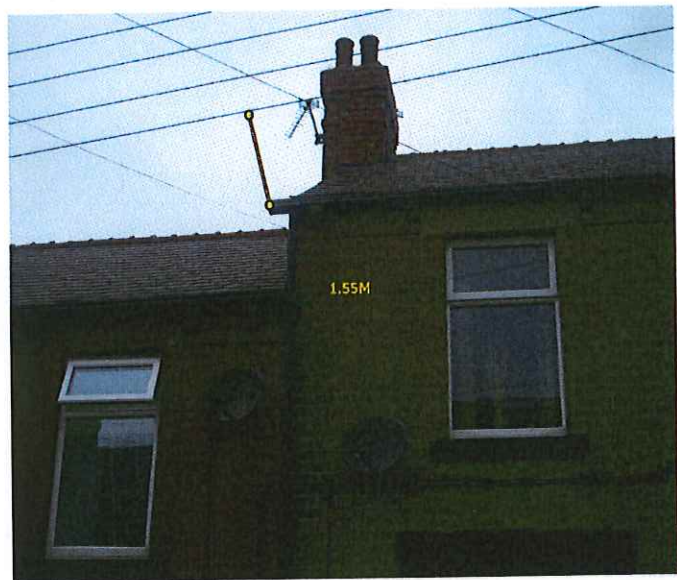
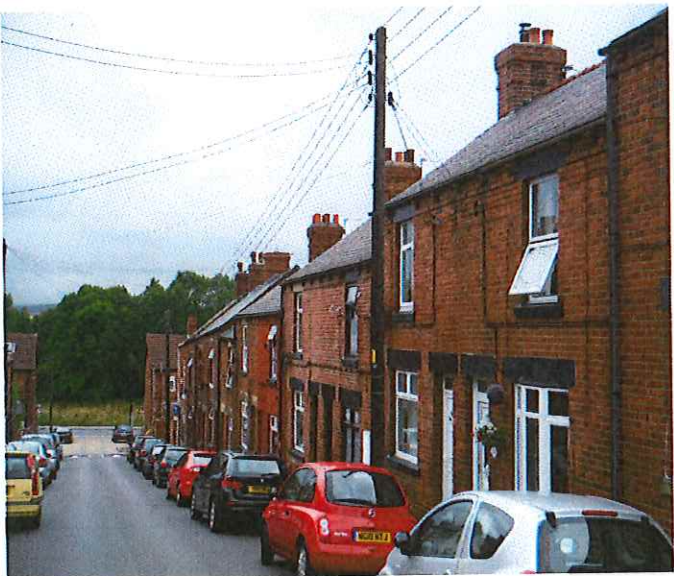
There is a Building or Object Present at this Site and it has been inspected

**Conductor Location Relative to the object: -** To the side and above the object  
**Solution for this clearance issue: -** Overhead line conductors can be changed to effectively insulated type  
**Closest approach of conductor to object: -** 1.55 mtrs

This clearance is less than or equal to 3.0 mts so has "FAILED"

This non conformance will form part of a network solution as other spans have been identified with clearance issues

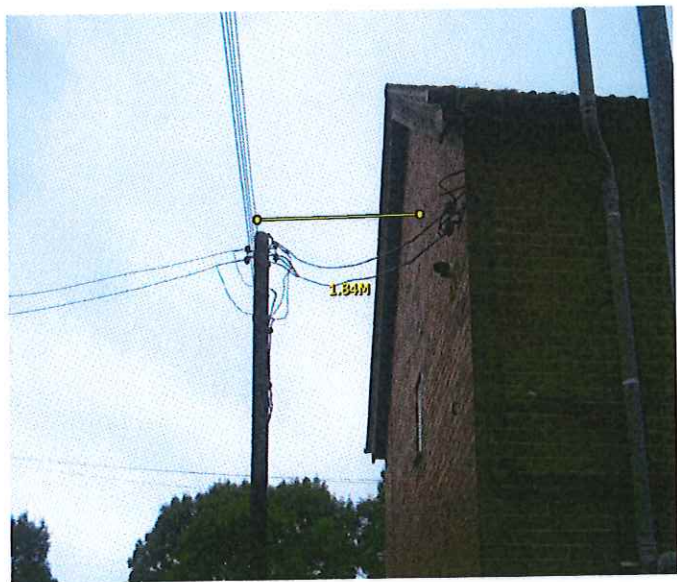
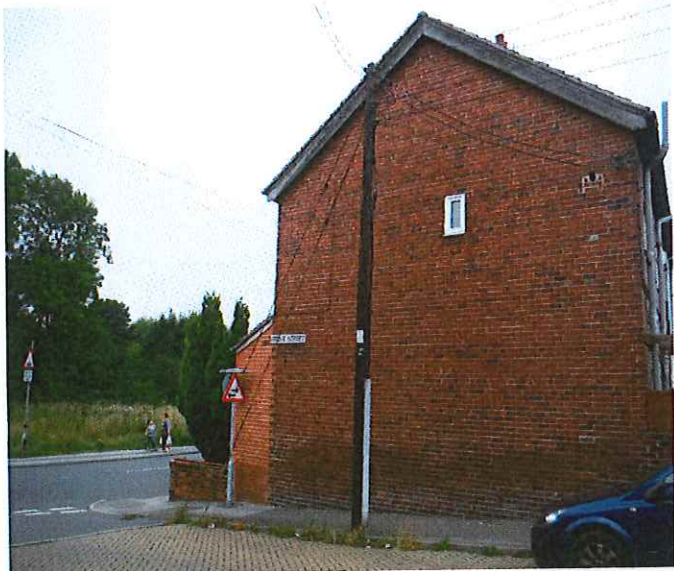
There is a Building or Object Present at this Site and it has been inspected

**Conductor Location Relative to the object: -** To the side of object

**Closest approach of conductor to object: -** 1.84 mtrs

This clearance is less than or equal to 3.0 mts so has "FAILED"

No Solution Required - No span attached to pole

**Solution for this clearance issue: -** Overhead line conductors can be changed to effectively insulated type

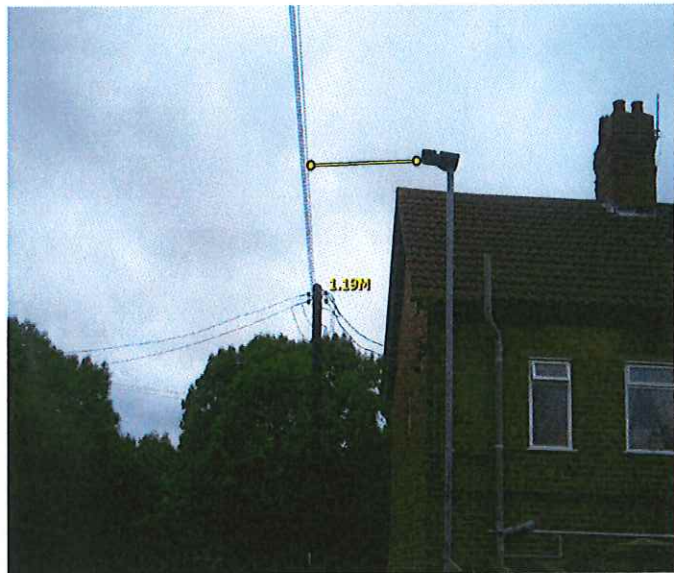
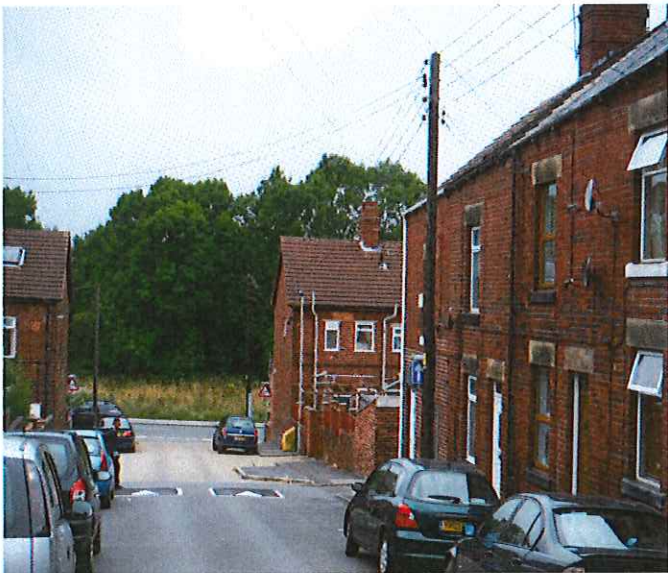
**There is a Building or Object Present at this Site and it has been inspected**

**Conductor Location Relative to the object: -** To the side of object

**Closest approach of conductor to object: -** 1.19 mtrs

**This clearance is less than or equal to 3.0 mts so has "FAILED"**

This non conformance will form part of a network solution as other spans have been identified with clearance issues

**Solution for this clearance issue: -** Overhead line conductors can be changed to effectively insulated type

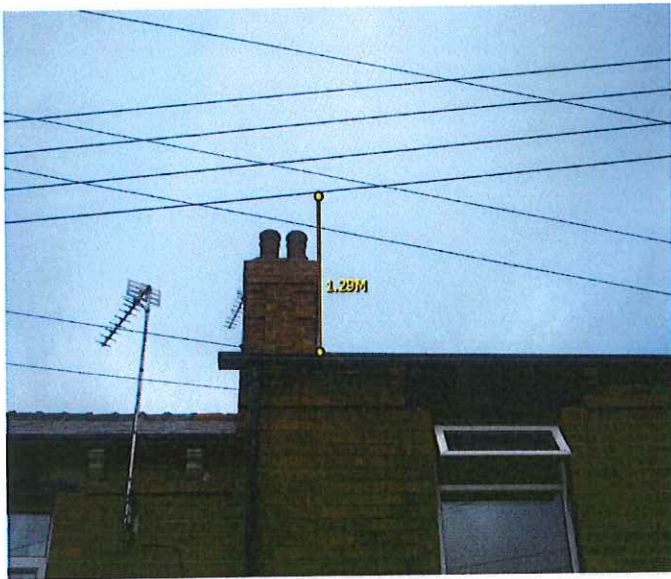
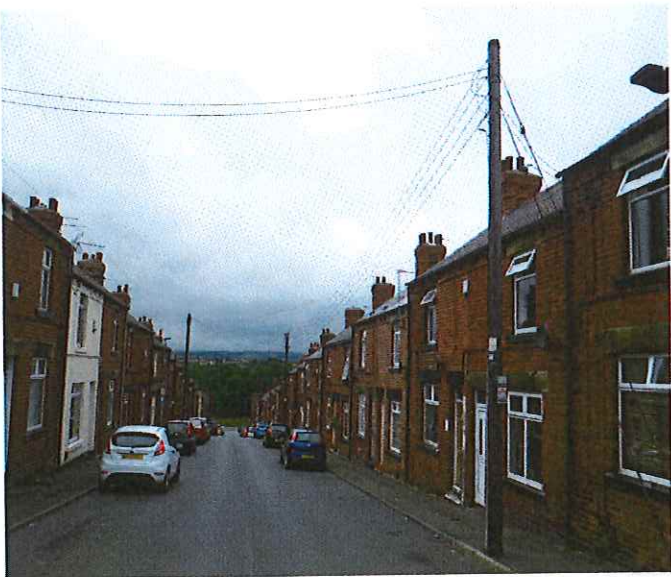
There is a Building or Object Present at this Site and it has been inspected

**Conductor Location Relative to the object: -** To the side of object

**Closest approach of conductor to object: -** 1.29 mtrs

This clearance is less than or equal to 3.0 mts so has "FAILED"

This non conformance will form part of a network solution as other spans have been identified with clearance issues

**Solution for this clearance issue: -** Overhead line conductors can be changed to effectively insulated type

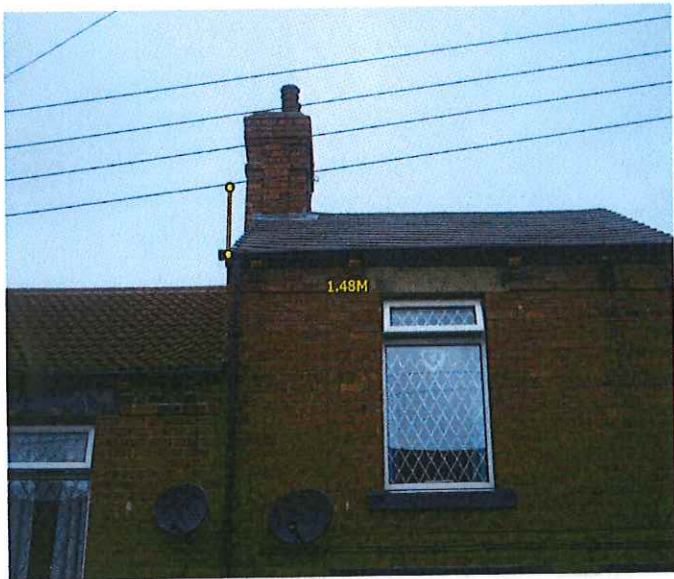
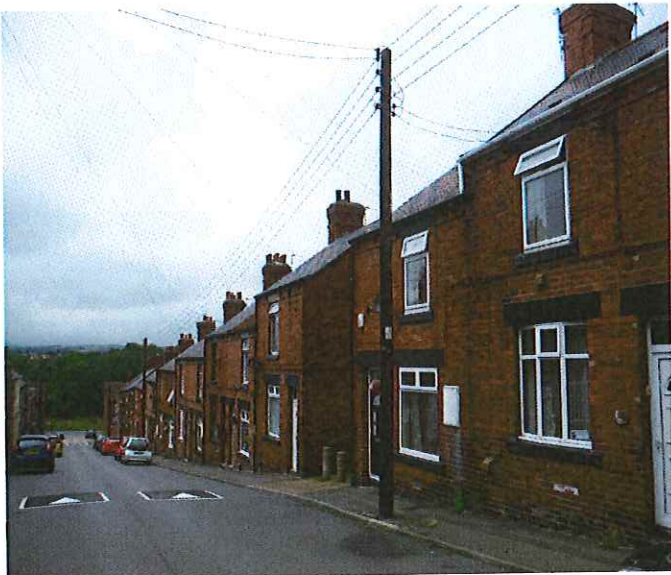
**There is a Building or Object Present at this Site and it has been inspected**

**Conductor Location Relative to the object: -** To the side of object

**Closest approach of conductor to object: -** 1.48 mtrs

**This clearance is less than or equal to 3.0 mts so has "FAILED"**

This non conformance will form part of a network solution as other spans have been identified with clearance issues

**Solution for this clearance issue: -** Overhead line conductors can be changed to effectively insulated type
