Interpretative Geotechnical Investigation Report

Parkside, Hoyland Common, Barnsley

February 2024

Client Name: Barnsley Metropolitan Borough Council
Document Reference: WIE20198-100-WAT-EGT-RP-N-70-001
Project Number: WIE20198

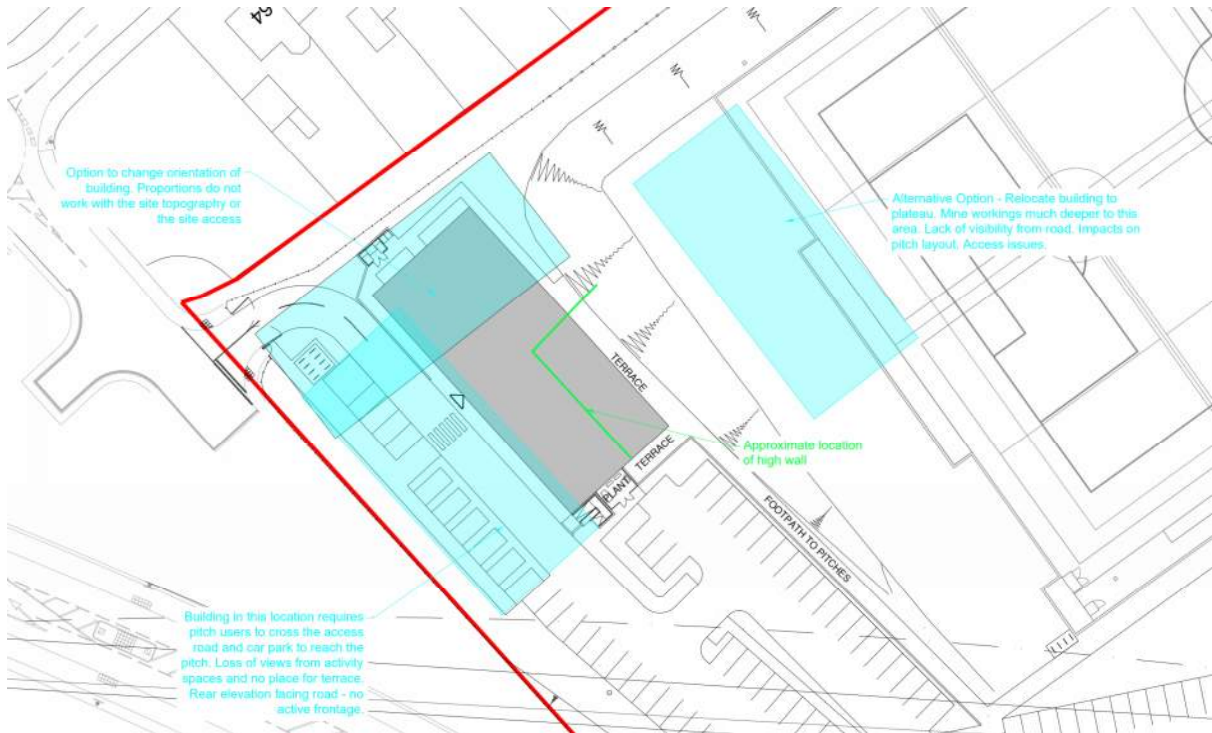
Figure 1: Initial Design Proposals

The final option was to relocate the building further north, wholly onto the opencast backfill deposits where the mine workings are known to be at a greater depth. This would also create issues with regard to pitch layout and restrict visibility from the access road.

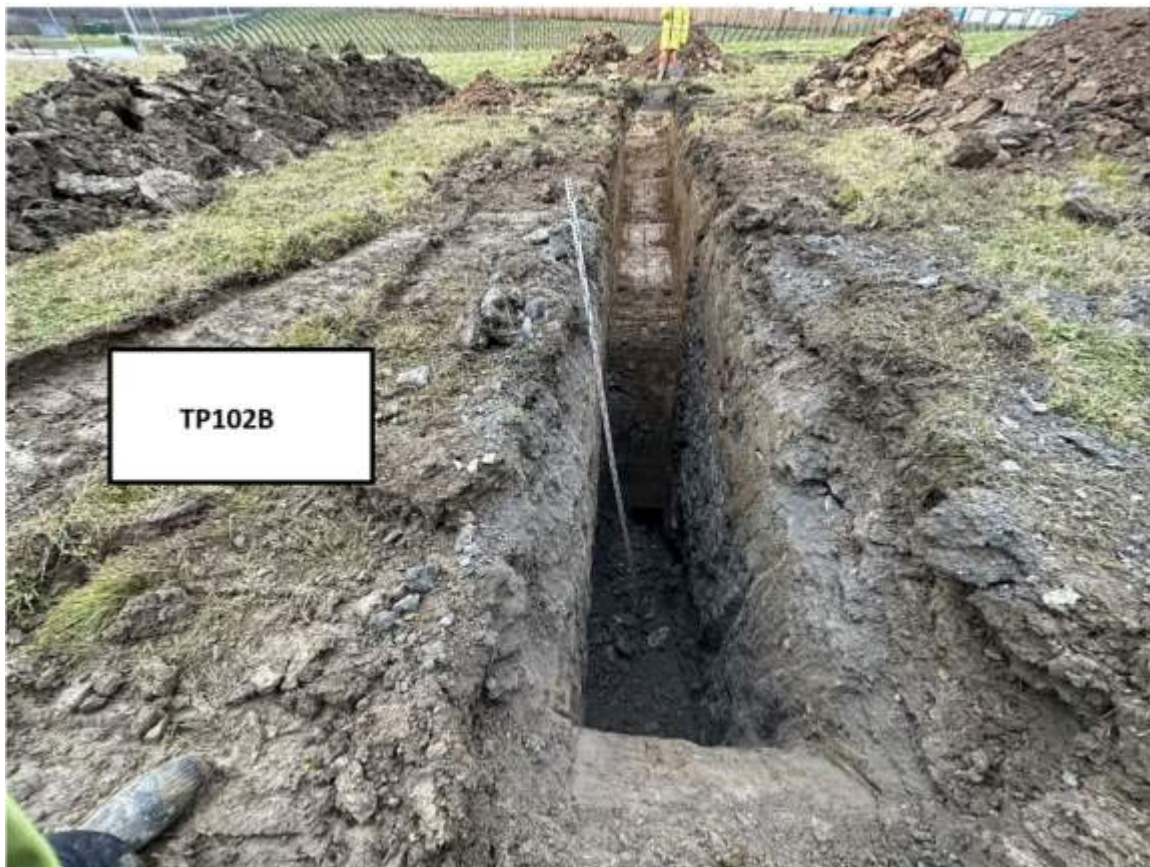
Figure 4: Photograph of TP-102b showing a vertical face into the opencast material.

It is noted that the trial pitting potentially identified a stepped edge to the highwall within two trial pits at depths of 1.20mbgl and 3.00mbgl.

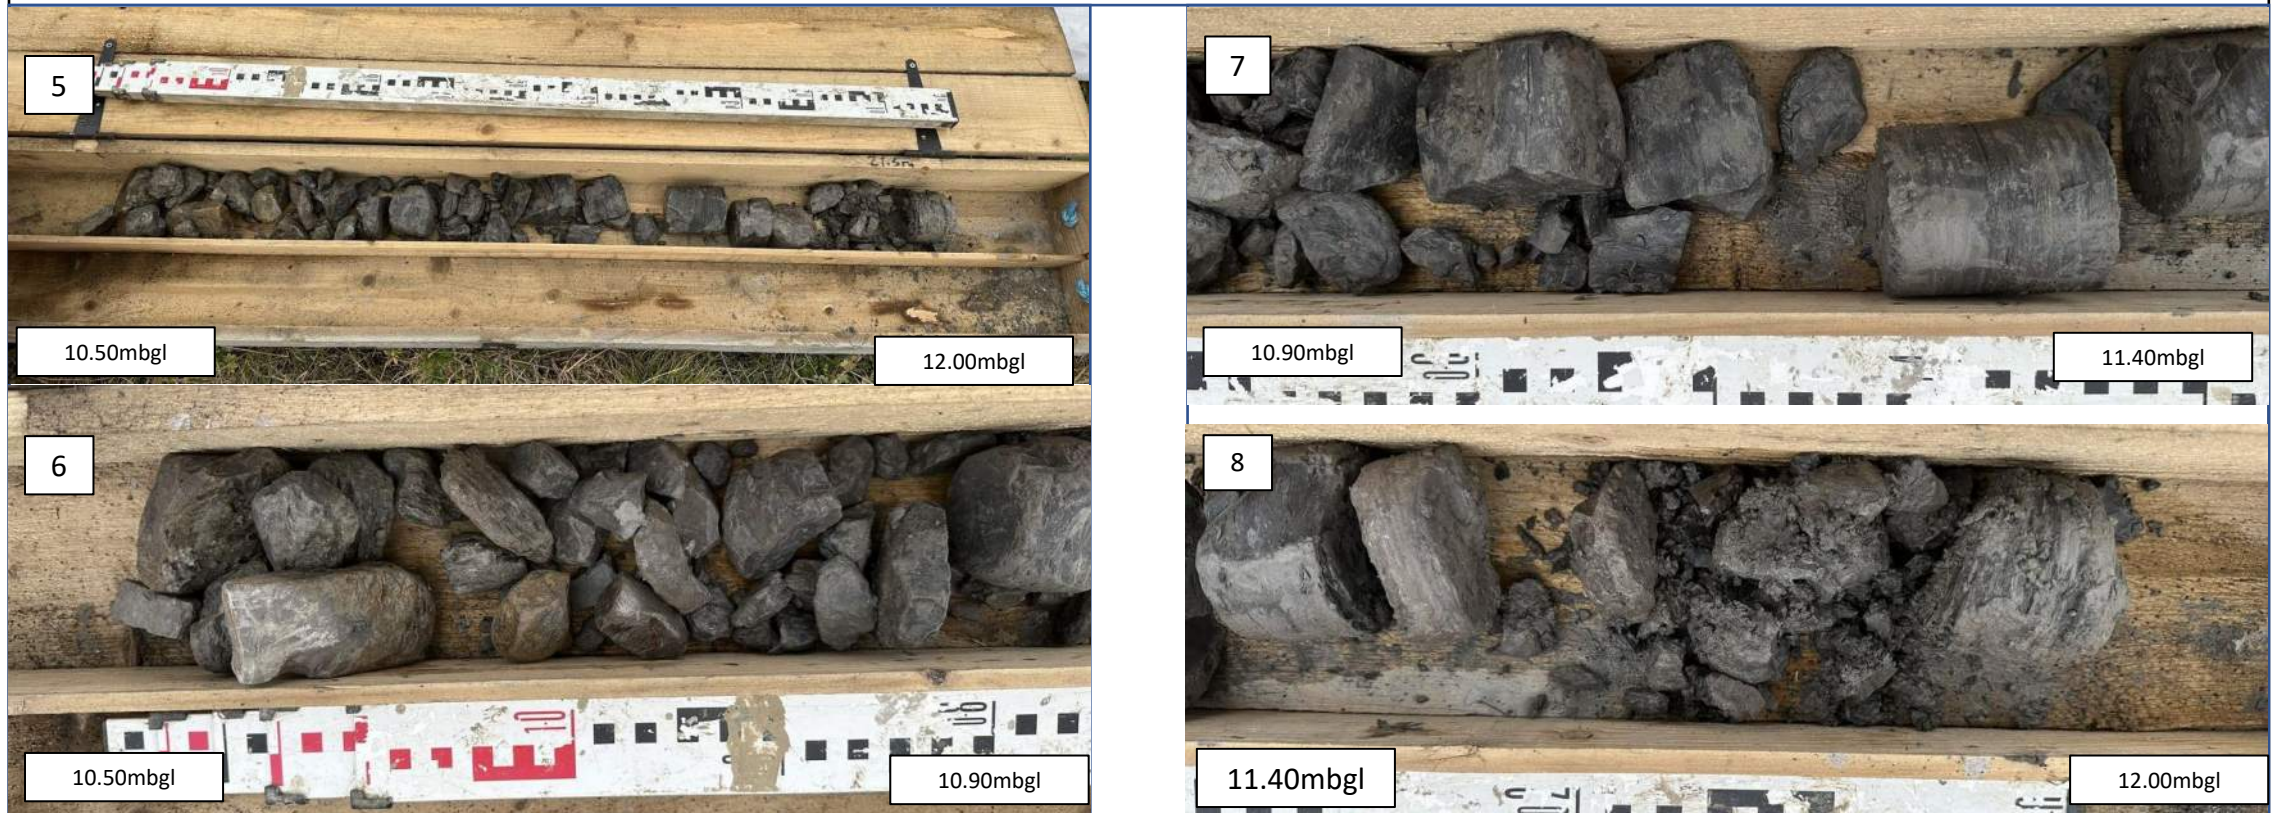
RO03 CORE 10.50-12.00mbgl

Photograph 5: Wide angle view of RO03 core 10.50-12.00mbgl.

Photograph 7: View of RO03 core approximate depth of 10.90-11.40mbgl.

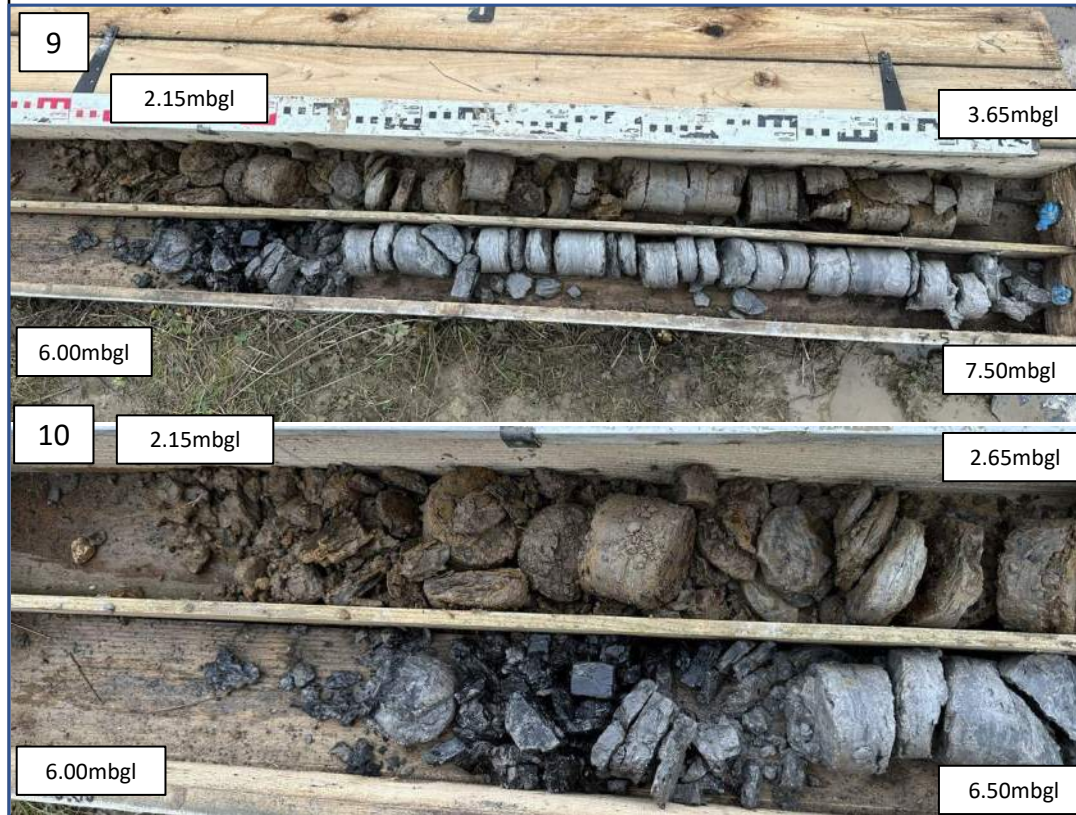
RO04 CORES 2.15-3.65mbgl and 6.00-7.50mbgl

Photograph 9: Wide angle view of RO04 cores 2.15-3.65mbgl (top) and 6.00-7.50mbgl (bottom).

Photograph 10: View of RO04 cores approximate depths of 2.15-2.65mbgl (top) and 6.00-6.50mbgl (bottom). Coal noted within bottom core

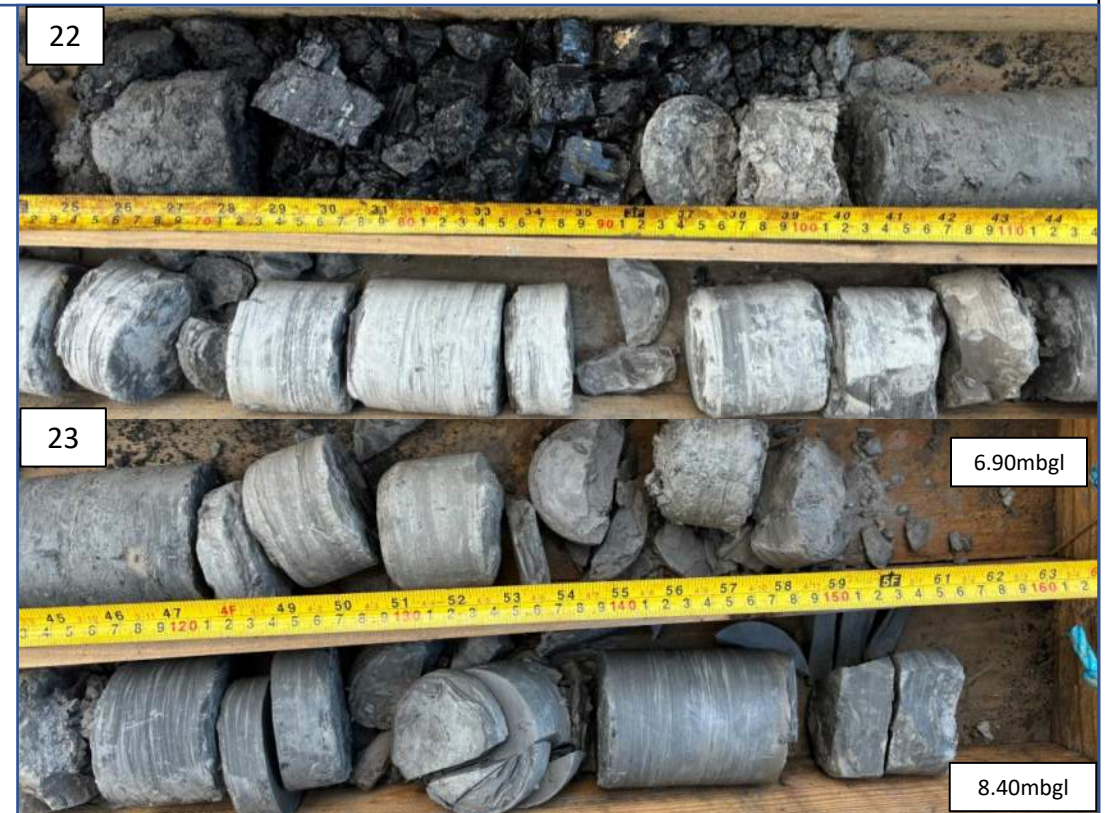
Photograph 22: View of middle third of RC01 cores. 0.20m thick coal seam noted at approximate top depth of 5.80mbgl.

Photograph 23: View of RC01 cores of last third of core runs with bottom depths of 6.90mbgl (top) and 8.40mbgl (bottom).

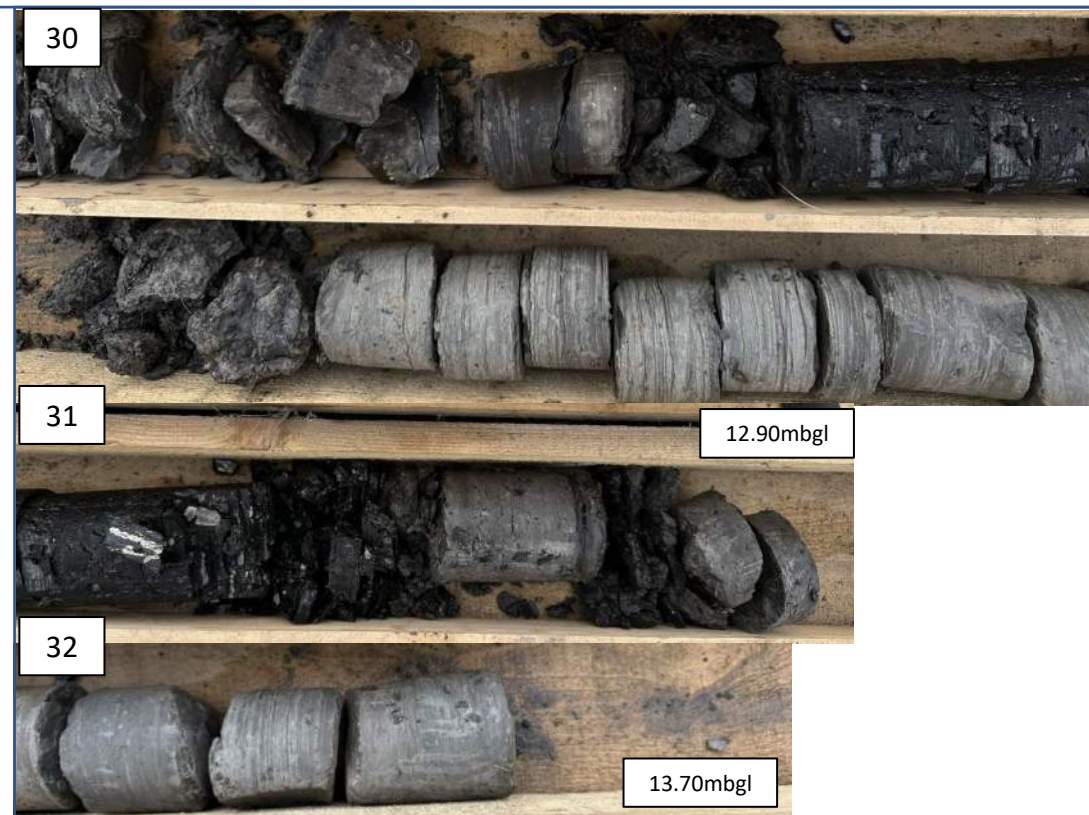
Photograph 30: View of approximate middle section of RC01 core runs. Coal seam noted in core run (top) at approximate top depth of 12.00mbgl

Photograph 31: View of RC01 core at bottom depth of 12.90mbgl. Coal gravels noted in core run at approximate top depth of 12.50mbgl.

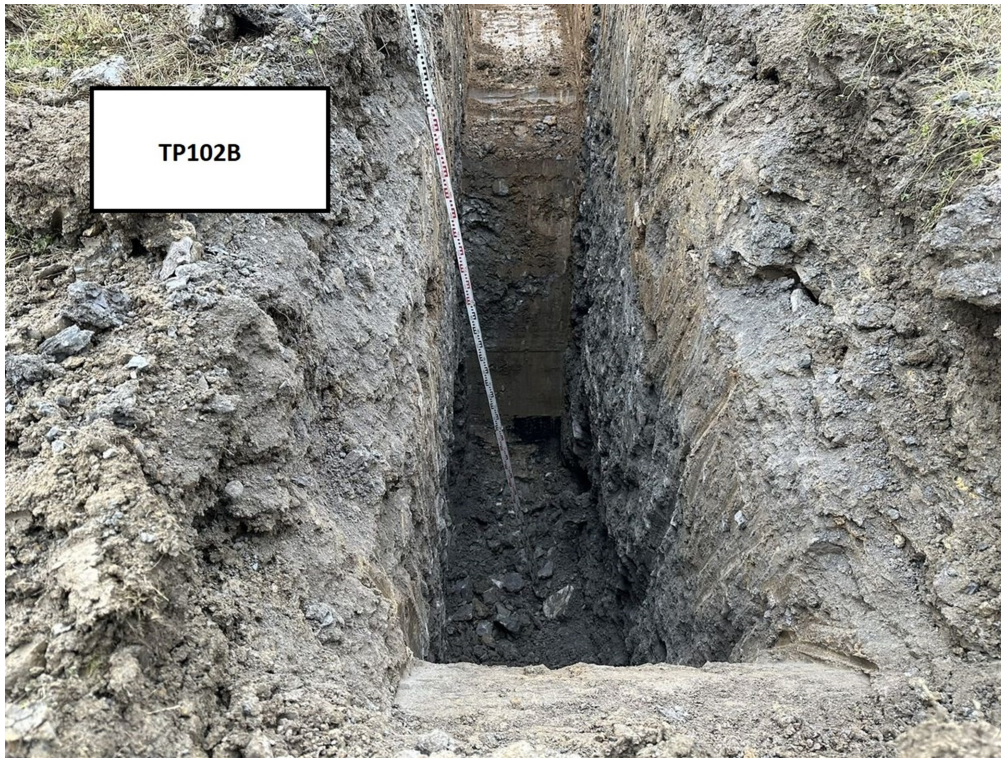
Photograph 13: Trial pit TP102B. High wall of opencast mine workings identified in the central pit area. View from north east to south west.

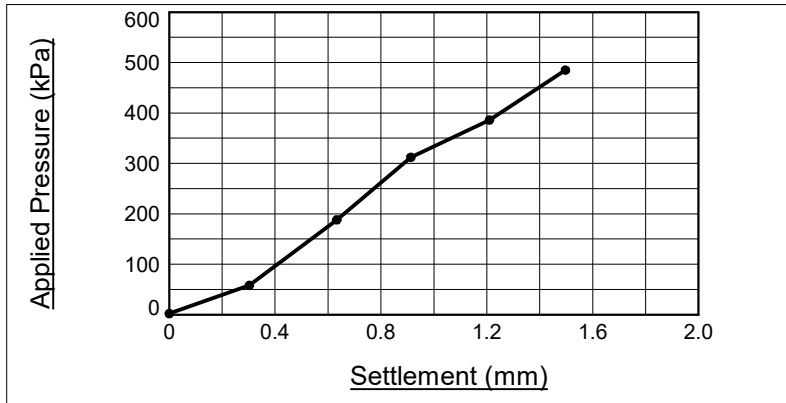
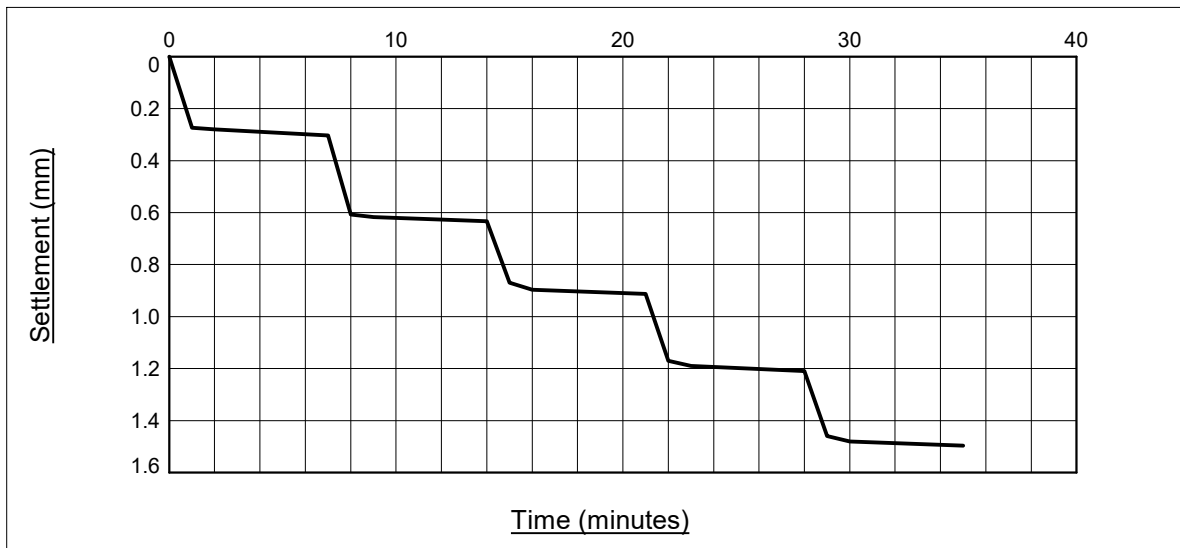
Position ID: **PBCBR01** Depth (m) : **0.50** Date of Test : **18/12/23**

Applied Pressure (kPa)	Average Settlement (mm)
2	0.000
58	0.303
188	0.633
312	0.913
386	1.210
485	1.497

Plate Diameter (mm):	455	Reaction Load :	13T
Maximum Applied Pressure (kPa):	485	Maximum Applied Deformation (mm) :	1.497

Modulus of Subgrade Reaction at 1.25mm			
Applied Pressure:	400 kPa	Conversion to k_{762} :	$k_{455} \times 0.6273$
k_{455} :	320000 kN/m ² /m	k_{762} :	200736 kN/m ² /m
Approximate Equivalent CBR Value (%): 94			
Calculations derived from section 7.14 of Department of Transport, Interim Advice Note 73/06 (Draft HD25) February 2009 Design Guidance for Road Pavement Foundations

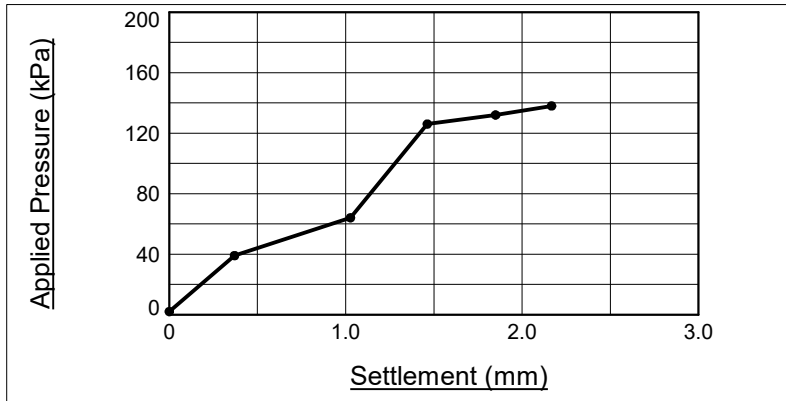
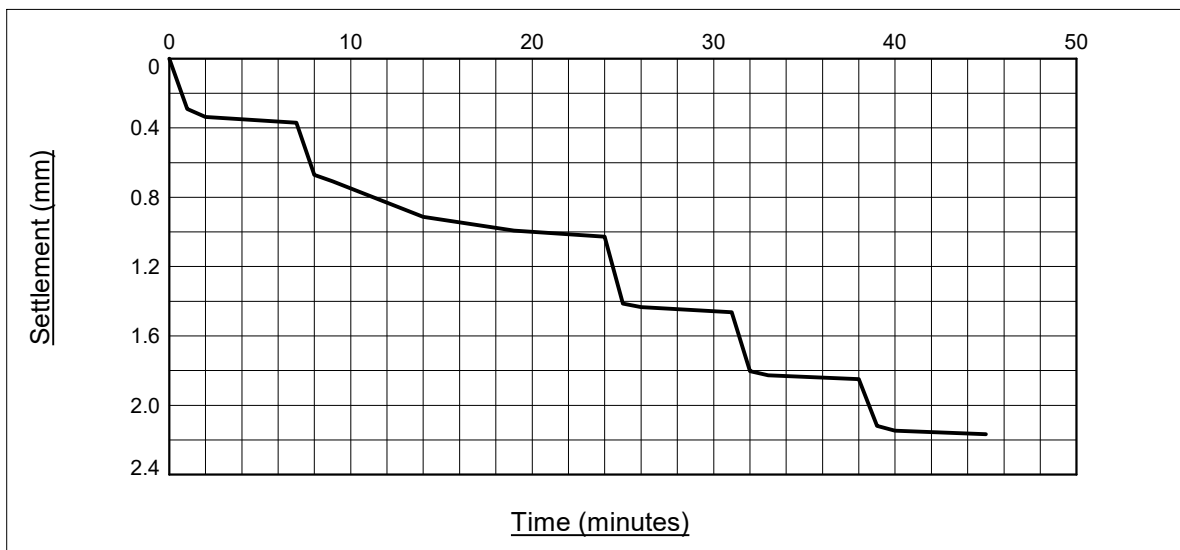
Position ID: **PBCBR02** Depth (m) : **0.50** Date of Test : **18/12/23**

Applied Pressure (kPa)	Average Settlement (mm)
2	0.000
39	0.370
64	1.027
126	1.463
132	1.850
138	2.167

Plate Diameter (mm):	455	Reaction Load :	13T
Maximum Applied Pressure (kPa):	138	Maximum Applied Deformation (mm) :	2.167

Modulus of Subgrade Reaction at 1.25mm			
Applied Pressure:	96 kPa	Conversion to k_{762} :	$k_{455} \times 0.6273$
k_{455} :	76800 kN/m ² /m	k_{762} :	48177 kN/m ² /m
Approximate Equivalent CBR Value (%): 8.0			
Calculations derived from section 7.14 of Department of Transport, Interim Advice Note 73/06 (Draft HD25) February 2009 Design Guidance for Road Pavement Foundations

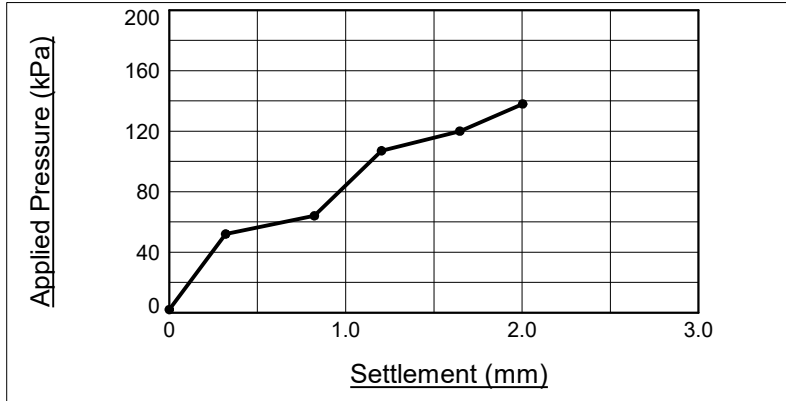
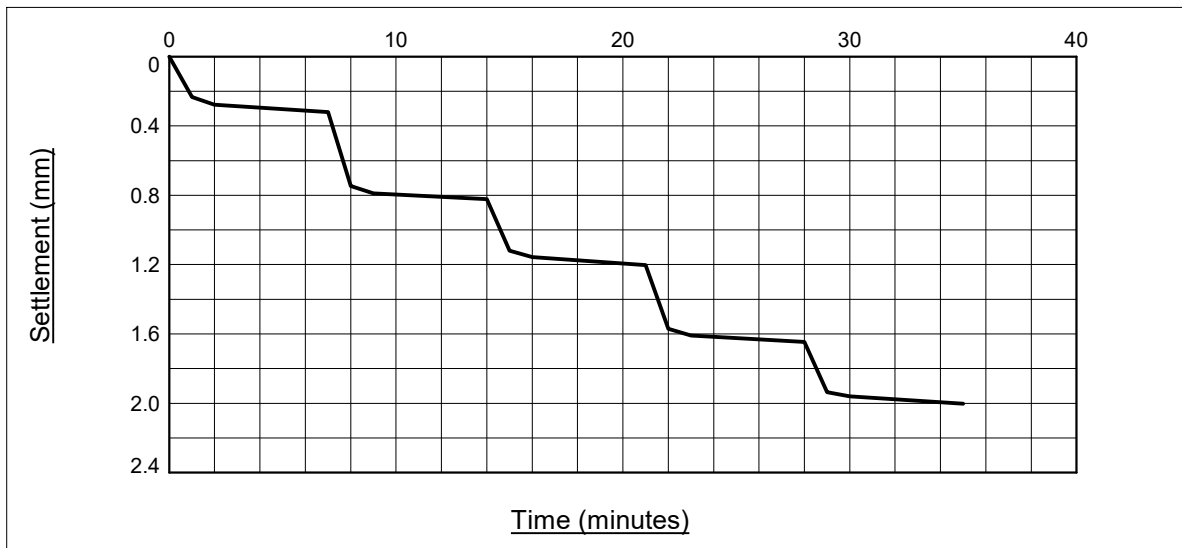
Position ID: **PBCBR03** Depth (m) : **0.50** Date of Test : **18/12/23**

Applied Pressure (kPa)	Average Settlement (mm)
2	0.000
52	0.320
64	0.823
107	1.203
120	1.647
138	2.003

Plate Diameter (mm):	455	Reaction Load :	13T
Maximum Applied Pressure (kPa):	138	Maximum Applied Deformation (mm) :	2.003

Modulus of Subgrade Reaction at 1.25mm			
Applied Pressure:	108	kPa	Conversion to k_{762} :
k_{455} :	86400	kN/m ² /m	$k_{455} \times 0.6273$
			54199 kN/m ² /m
Approximate Equivalent CBR Value (%): 9.8			
Calculations derived from section 7.14 of Department of Transport, Interim Advice Note 73/06 (Draft HD25) February 2009 Design Guidance for Road Pavement Foundations

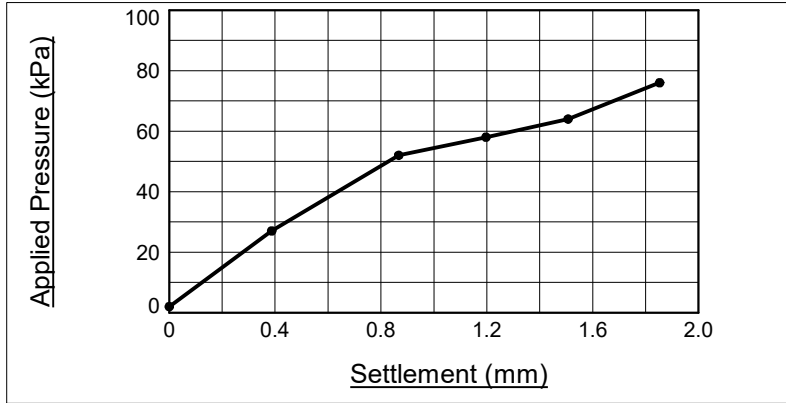
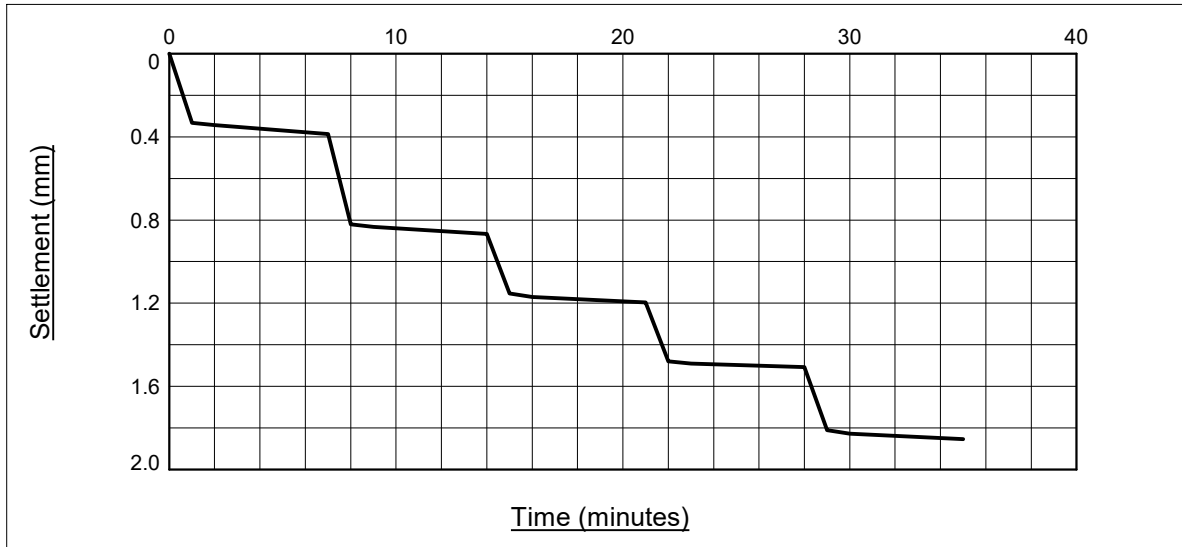
Position ID: **PBCBR04** Depth (m) : **0.40** Date of Test : **18/12/23**

Applied Pressure (kPa)	Average Settlement (mm)
2	0.000
27	0.387
52	0.867
58	1.197
64	1.507
76	1.853

Plate Diameter (mm):	455	Reaction Load :	13T
Maximum Applied Pressure (kPa):	76	Maximum Applied Deformation (mm) :	1.853

Modulus of Subgrade Reaction at 1.25mm			
Applied Pressure:	59 kPa	Conversion to k_{762} :	$k_{455} \times 0.6273$
k_{455} :	47200 kN/m ² /m	k_{762} :	29609 kN/m ² /m
Approximate Equivalent CBR Value (%): 3.4			
Calculations derived from section 7.14 of Department of Transport, Interim Advice Note 73/06 (Draft HD25) February 2009 Design Guidance for Road Pavement Foundations
