Manor Farm, Hood Green
Bat Survey Report
23rd September 2021

Document ref: MBE/BAT/2021/84/01				
Purpose and Description	Originated	Checked	Reviewed	Date
For Planning	R Bell MCIEEM <i>R Bell</i>	P Middleton MCIEEM <i>P Middleton</i>	R Bell MCIEEM <i>R Bell</i>	23/09/2021

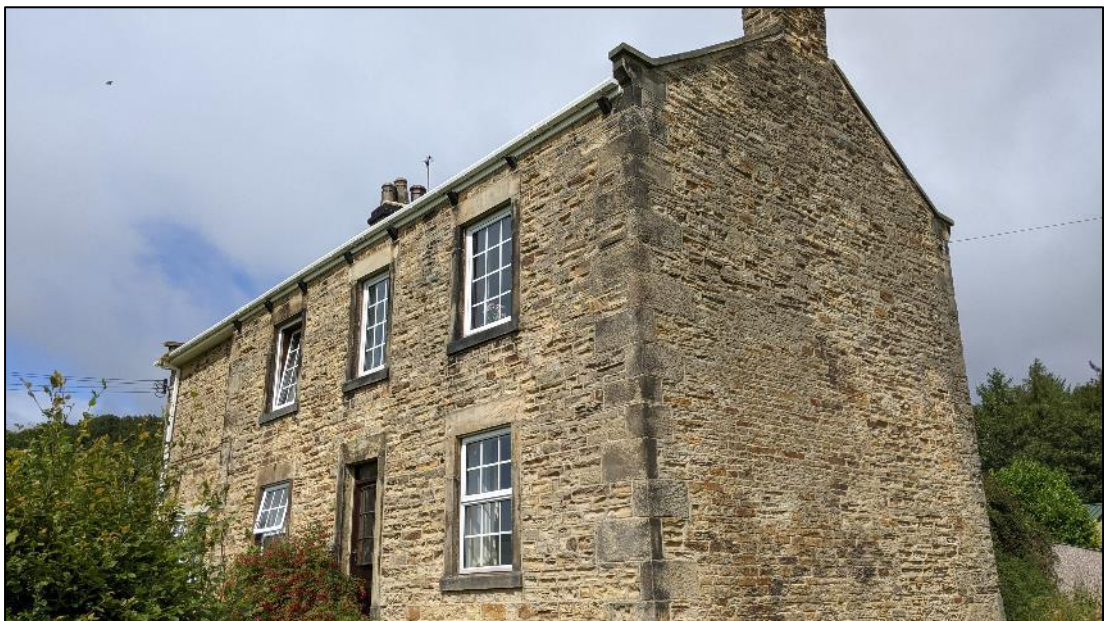
Plate 1. Southeast corner of farmhouse (B1)

- 5.2.2 The two-storey stone farmhouse has a single storey extension on the north elevation, a two storey extension on the western end of the building and a lean-to porch at the western end of the north elevation. Anecdotal evidence from the resident reveal the

farmhouse to date from the 1500s, however, it appears to have been largely rebuilt/constructed in the 1800s. The dwelling mainly has pitched roofs with imitation stone (concrete) roof and ridge tiles, whilst the porch has Welsh slates on a single pitch roof. The two storey section of the dwelling has stone copings and lead flashing is present at the base of two stone chimneys. The walls are rendered on the north and west elevations. The dwelling has a mixture of uPVC and wood fascia boards with a section of soffit on the south elevation. Windows are uPVC framed and double-glazed. Dense clematis *Clematis* is present on the north gable of the single storey extension.

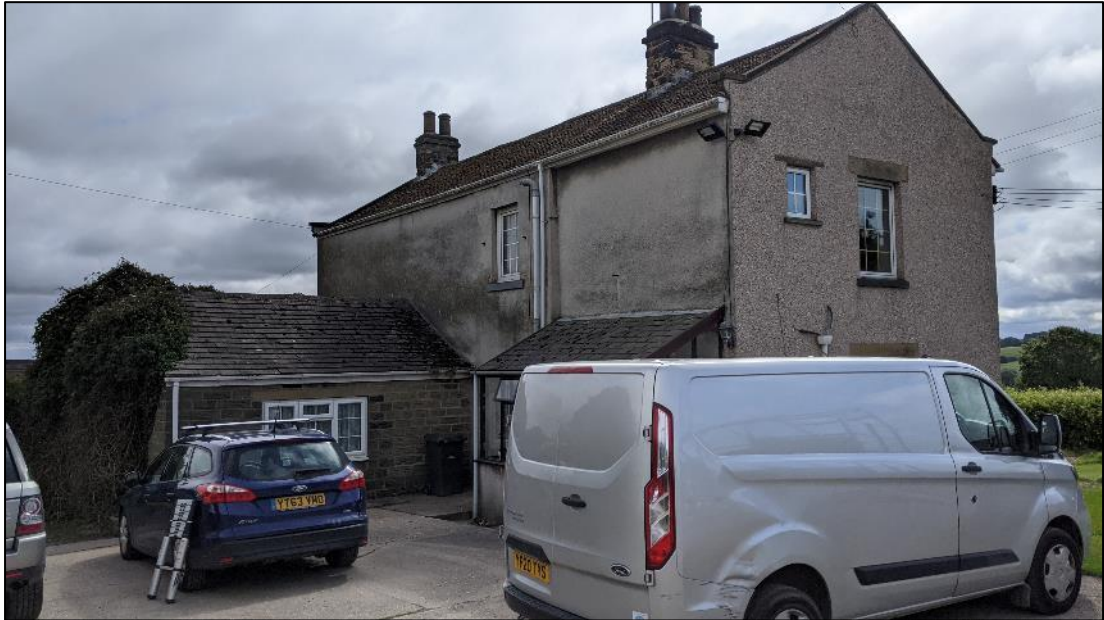
Plate 2. Northwest corner of farmhouse

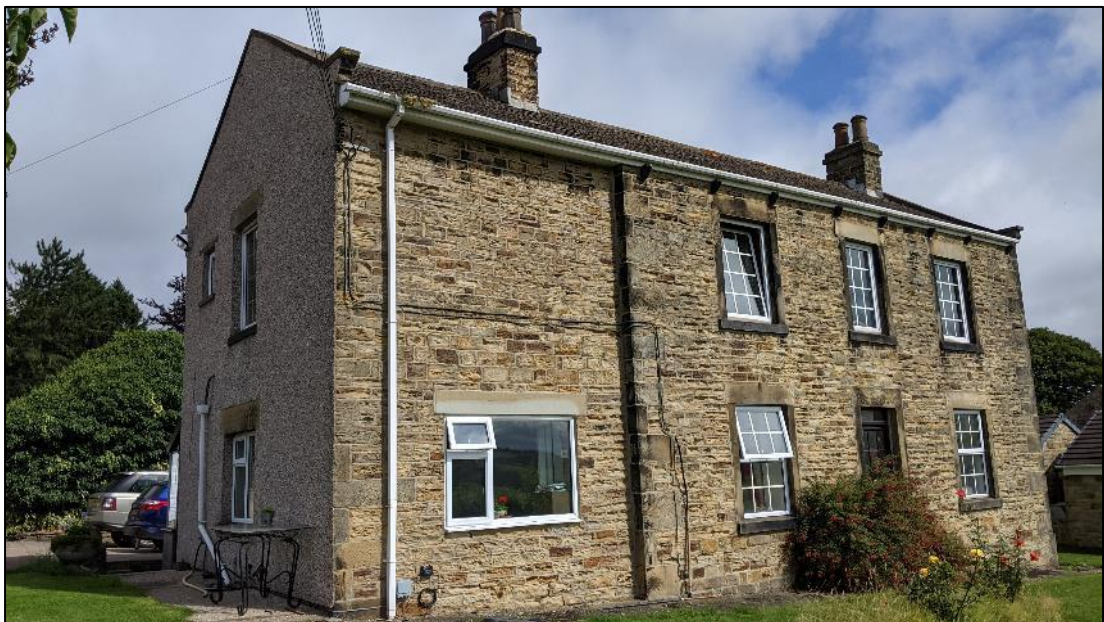
Plate 3. Southwest corner of farmhouse

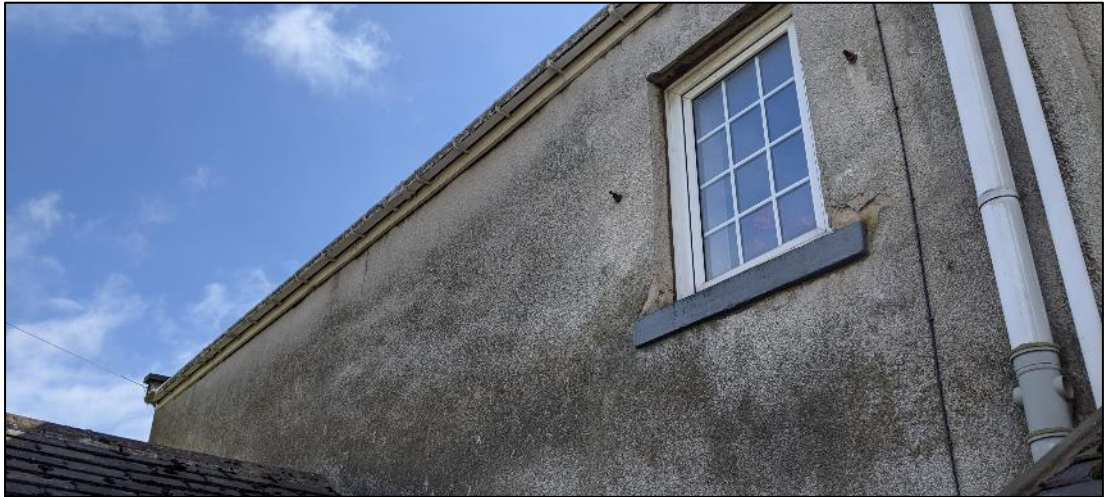
- 5.2.3 The walls are well pointed, and the roof tiles largely lack crevice spaces between tiles. Potential roost features on the exterior are largely limited to occasional gaps in bedding mortar on ridge tiles, crevices behind fascia boards (Plate 4) and some lifted sections of lead flashing associated with chimneys.

Plate 4. Crevice visible between fascia board and rendered wall on north elevation of farmhouse

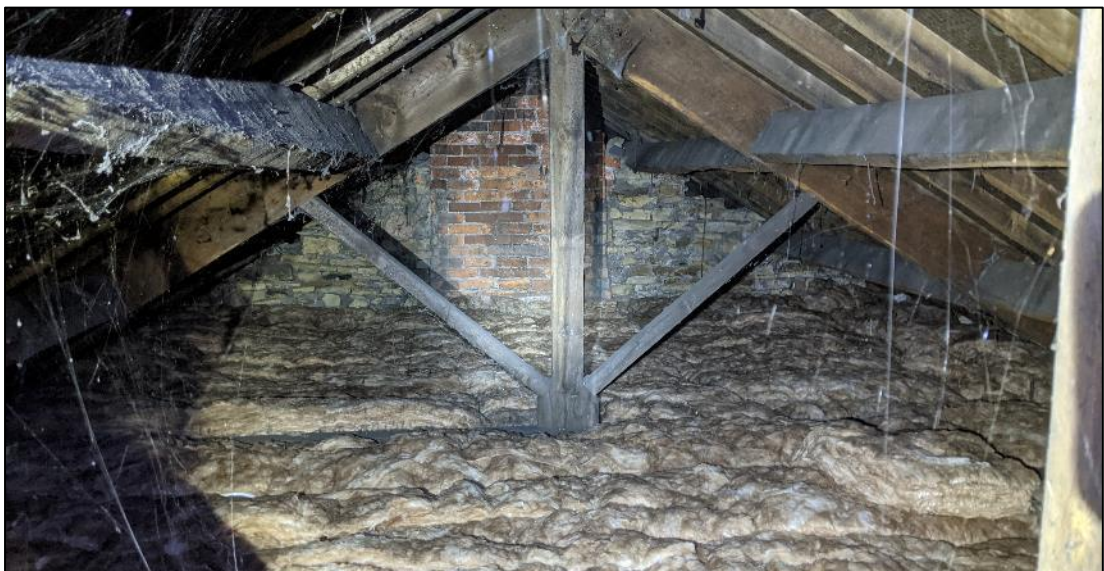
- 5.2.4 The main farmhouse roof is lined with Type 1F felt and suspended on king-post trusses, with a ridge beam, purlins, rafters and battens. A 2m high void is formed with c.200mm of glass fibre insulation on the ceiling. No signs of bat presence or potential access points were noted, however, rat *Rattus norvegicus* droppings were noted and the space was found to be very cobwebby. The single storey extension has a 1m high roof void, which is similarly lacking in any signs of bat presence.

Plate 5. Roof void of farmhouse

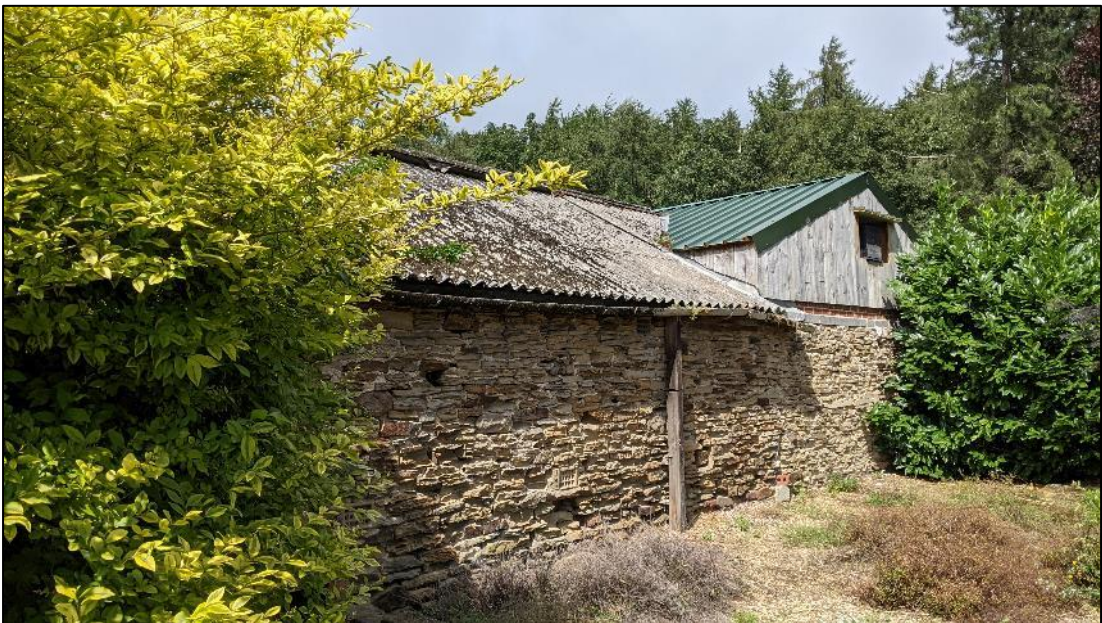
5.2.5 Sections of the single storey outbuilding have been constructed differently. The central section of B2 is constructed of stone and brick with a pitched concrete-asbestos corrugated sheet covered roof with a wooden fascia board (Plate 6). A mix of wooden and metals doors are present in the west elevation with very thick ivy *Hedera helix* cover on the south gable. The northern section of B2 has walls comprising a mixture of stone, concrete block and brick, with wood cladding in places above (Plates 6 & 7). This section of the building has a pitched roof covered in corrugated metal sheeting with a metal ridge and verge capping. This section of the building is in active use as a meat processing area, with double steel doors in the east gable. Adjoining the south end of B2 is a garage constructed from prefabricated concrete panels with a gently sloping corrugated concrete-asbestos sheet roof (Plate 8). This section of the building has an up-and-over door and a missing rear window.

Plate 6. East elevation of outbuilding (B2)

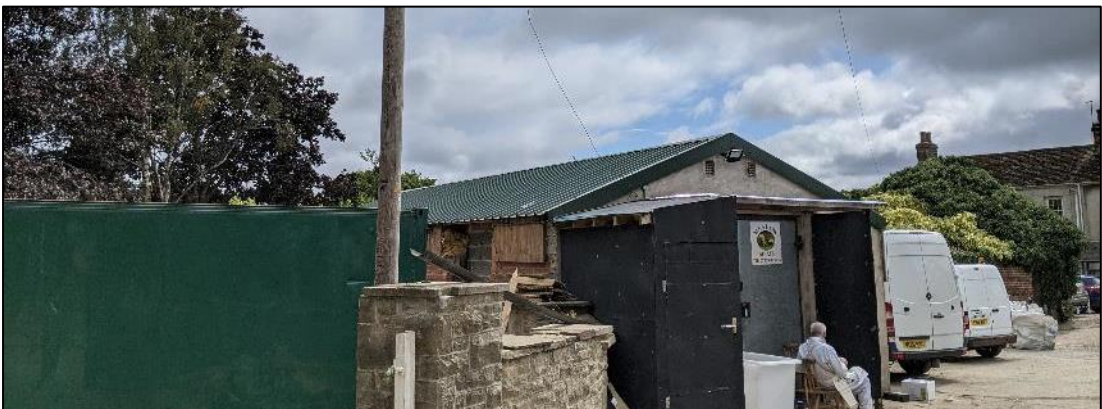
Plate 7. Northwest corner of outbuilding

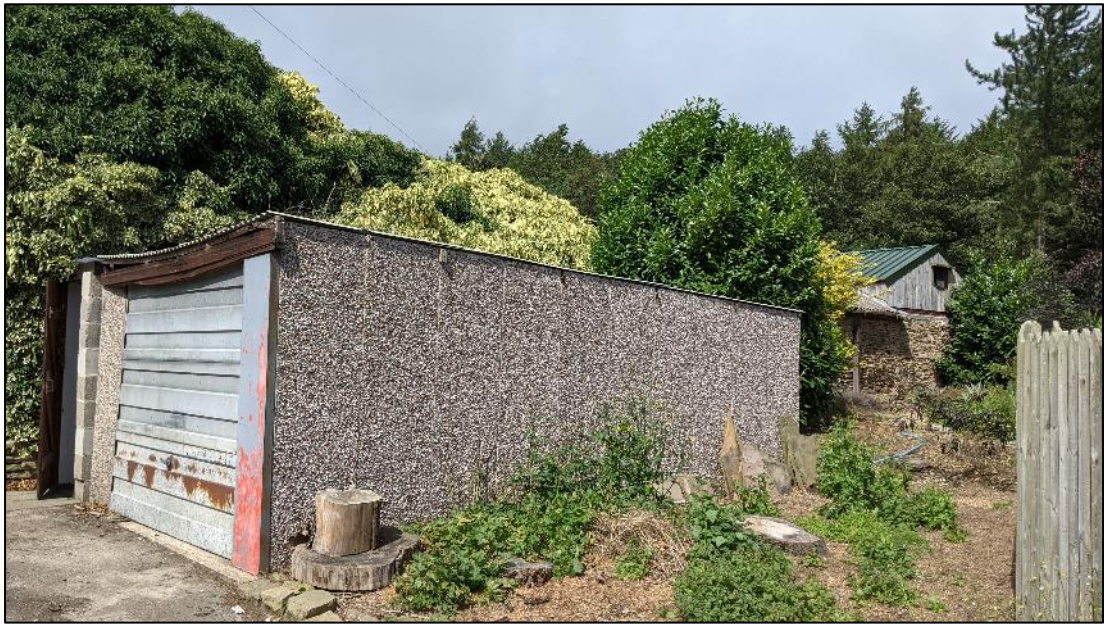
Plate 8. Garage at southeast corner of outbuilding

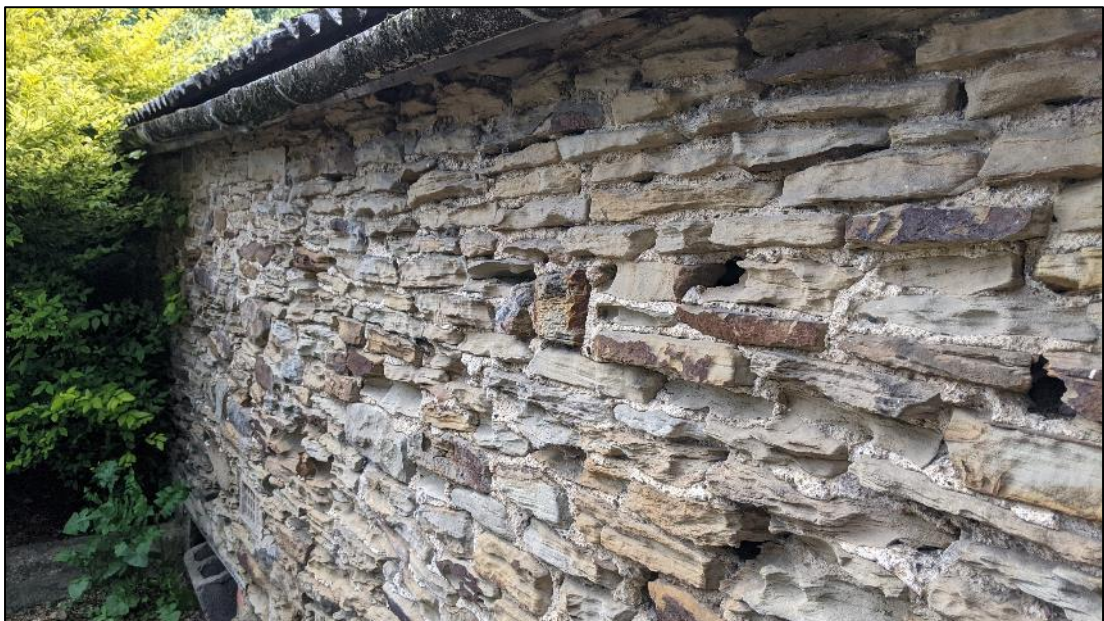
- 5.2.6 The stone wall on the east elevation is eroded and includes a number of voids which were found to be dry and dusty internally (Plate 9). There was also a fairly superficial crevice behind the fascia board on the west elevation. Similar narrow and fully inspected crevices are present behind metal verge capping at the northern end of the building, with a collapsed section of brickwork on the north elevation, exposing a crevice behind the outer brick skin (Plate 10).

Plate 9. Dry and dusty hollows in stone wall on east elevation

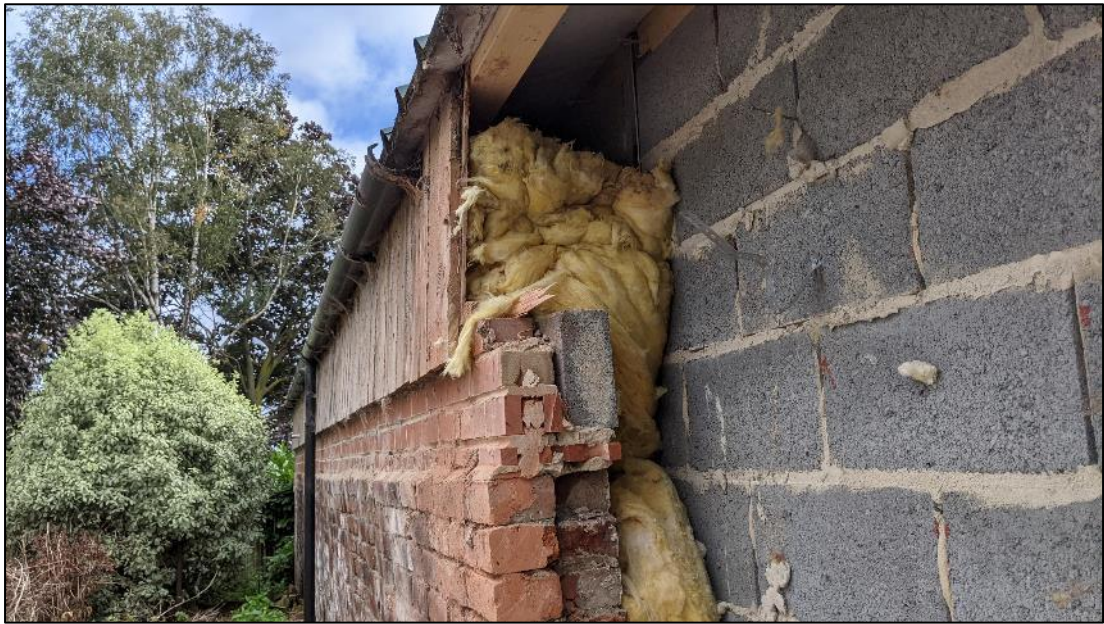
Plate 10. Collapsed section of brickwork on north elevation of outbuilding

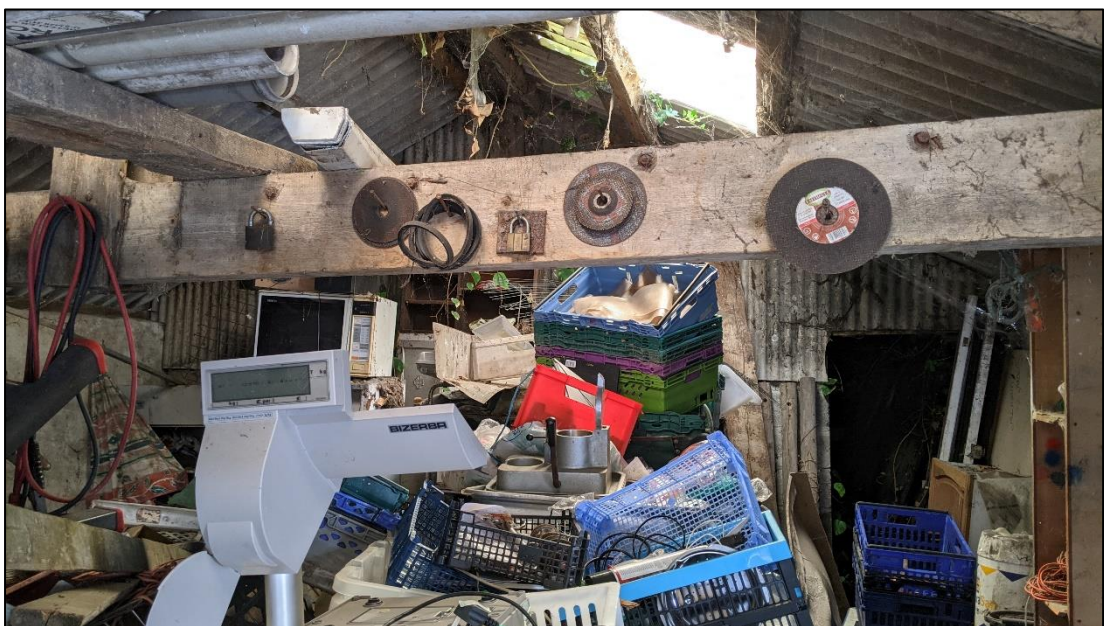
- 5.2.7 The central section of the outbuilding interior is open to the underside of the roof sheeting with no roof void present and the space used for storage (Plate 11). At the north end of the building is a 1m high roof-void with 100mm of glassfibre insulation on the ceiling (Plate 12). No signs of bat presence were noted from any area section of the interior.

Plate 11. Interior of central section of outbuilding
