## **Landscape Assessment**

Rabbit Ings Regeneration Scheme near Royston,  
Barnsley

On behalf of the City of Wakefield Metropolitan District  
Council and Yorkshire Forward

October 2008

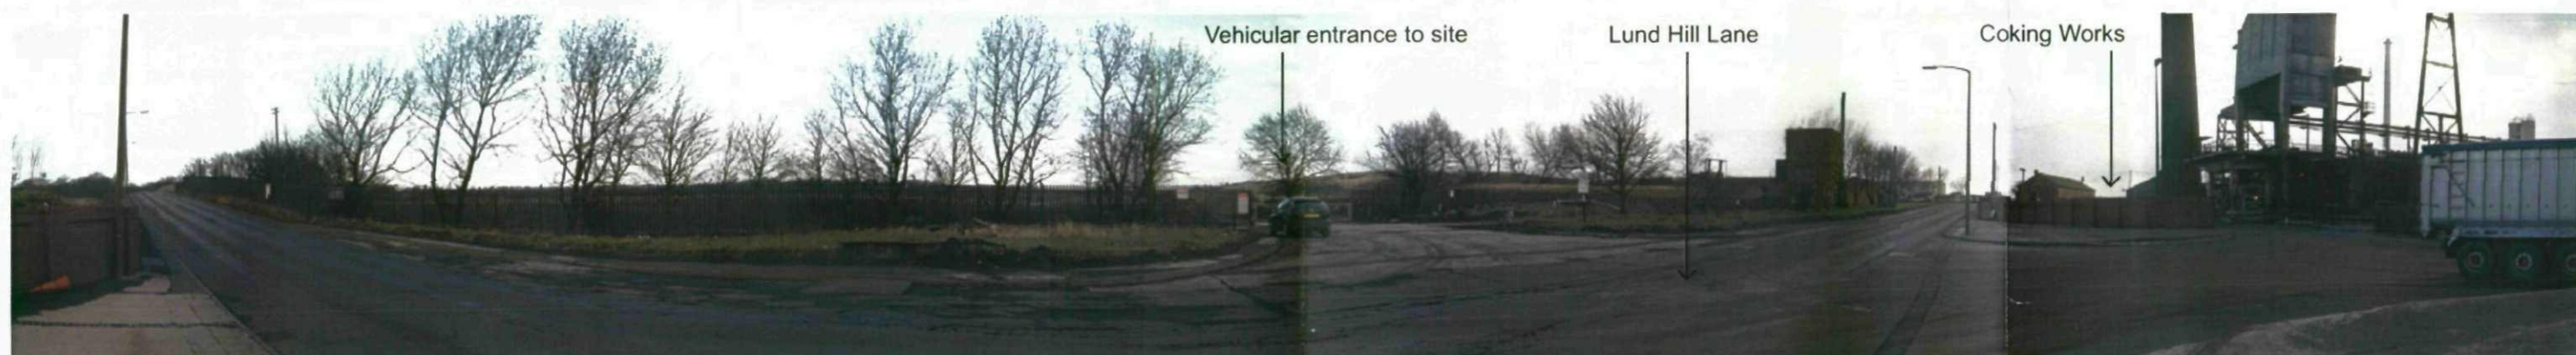
**Viewpoint 2:** View looking east towards the site from Lund Hill Lane from the northern entrance into the coking works (which is visible to the right of the view). The metal palisade security fencing, which extends around much of the western site boundary, is visible on the far side of the road.

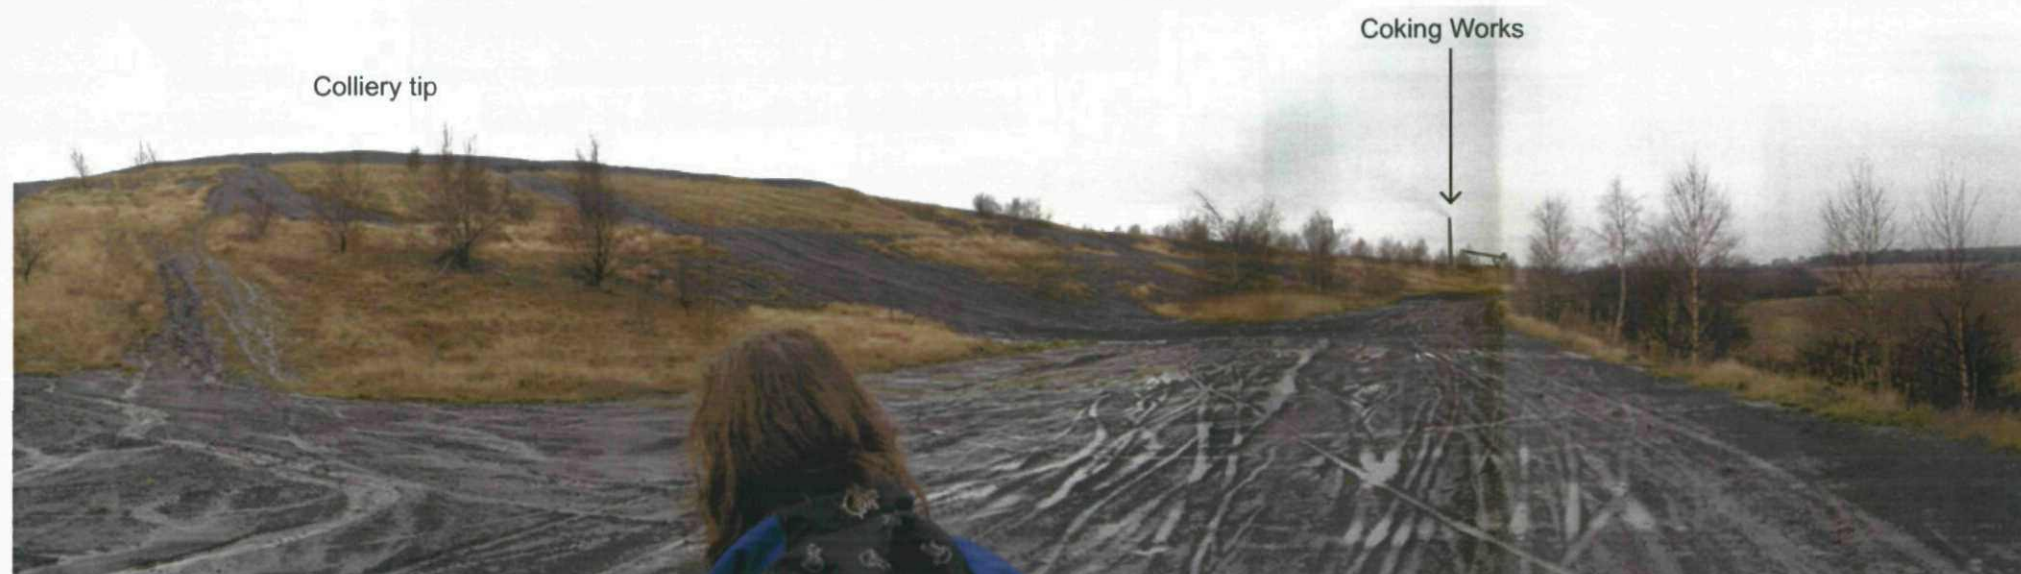
**Viewpoint 3:** Internal view looking south west from the northern edge of the site. The sparsely vegetated northern slopes of the colliery tip are prominent to the left of the view, whilst the patchy woodland planting, which has established along the northern boundary, is visible to the right of the view.

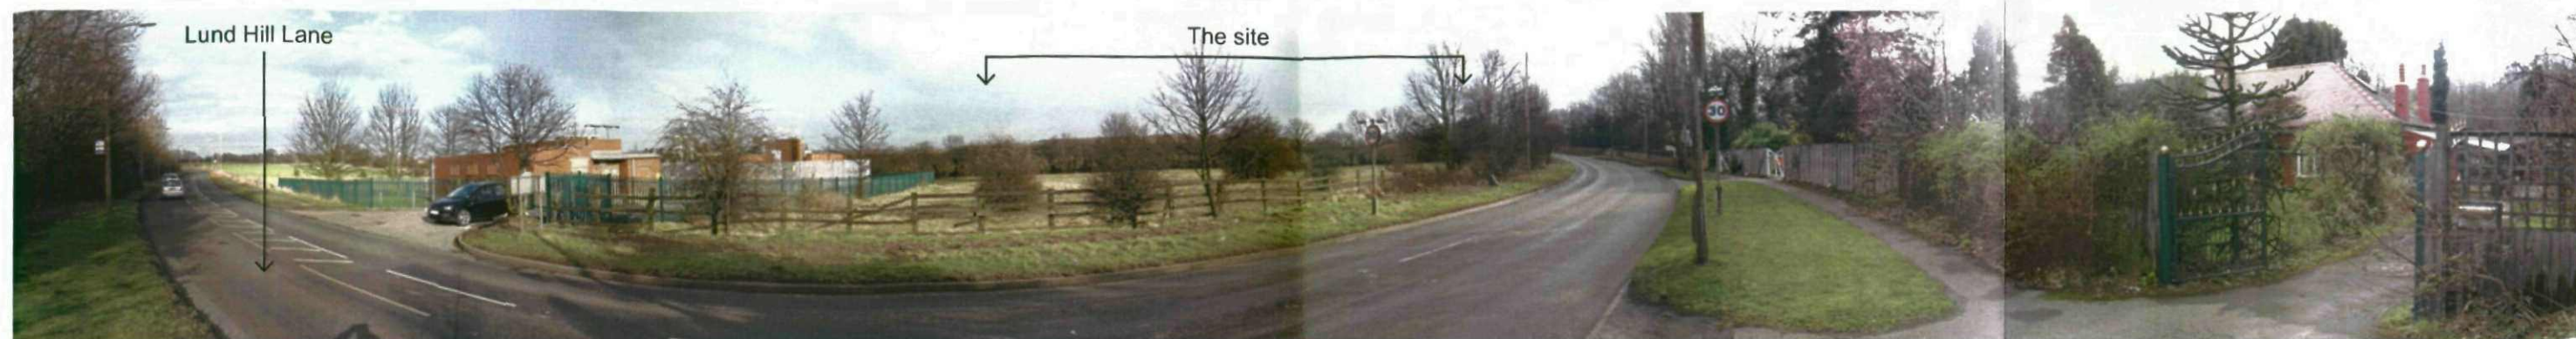
**Viewpoint 4:** View looking south east towards the site from Lund Hill Lane. The upper slopes of the colliery tip are visible on the skyline beyond the tree line in the centre of the view.

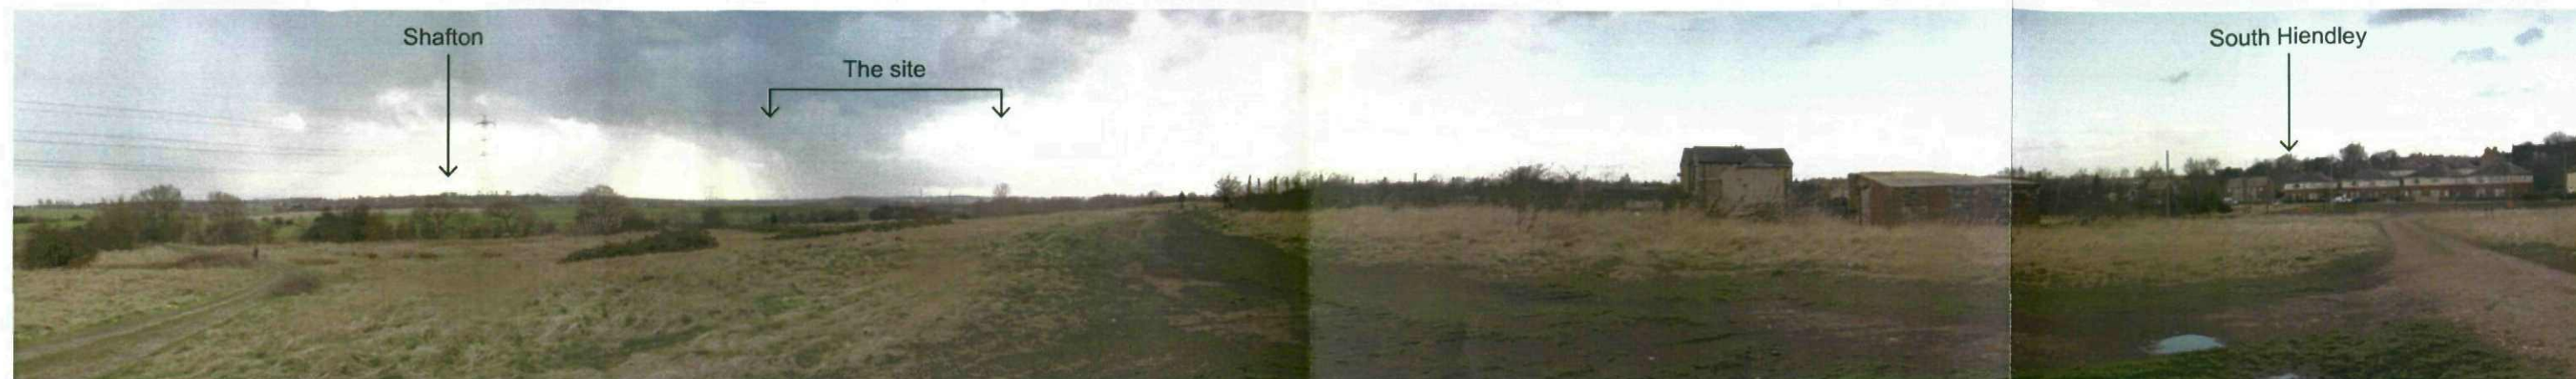
**Viewpoint 7:** View looking west towards the site from the Low Common, at the south western edge of South Hiendley. The edge of the settlement is visible to the right of the view, whilst the upper slopes of the colliery tip at Rabbit Ings is visible on the skyline.

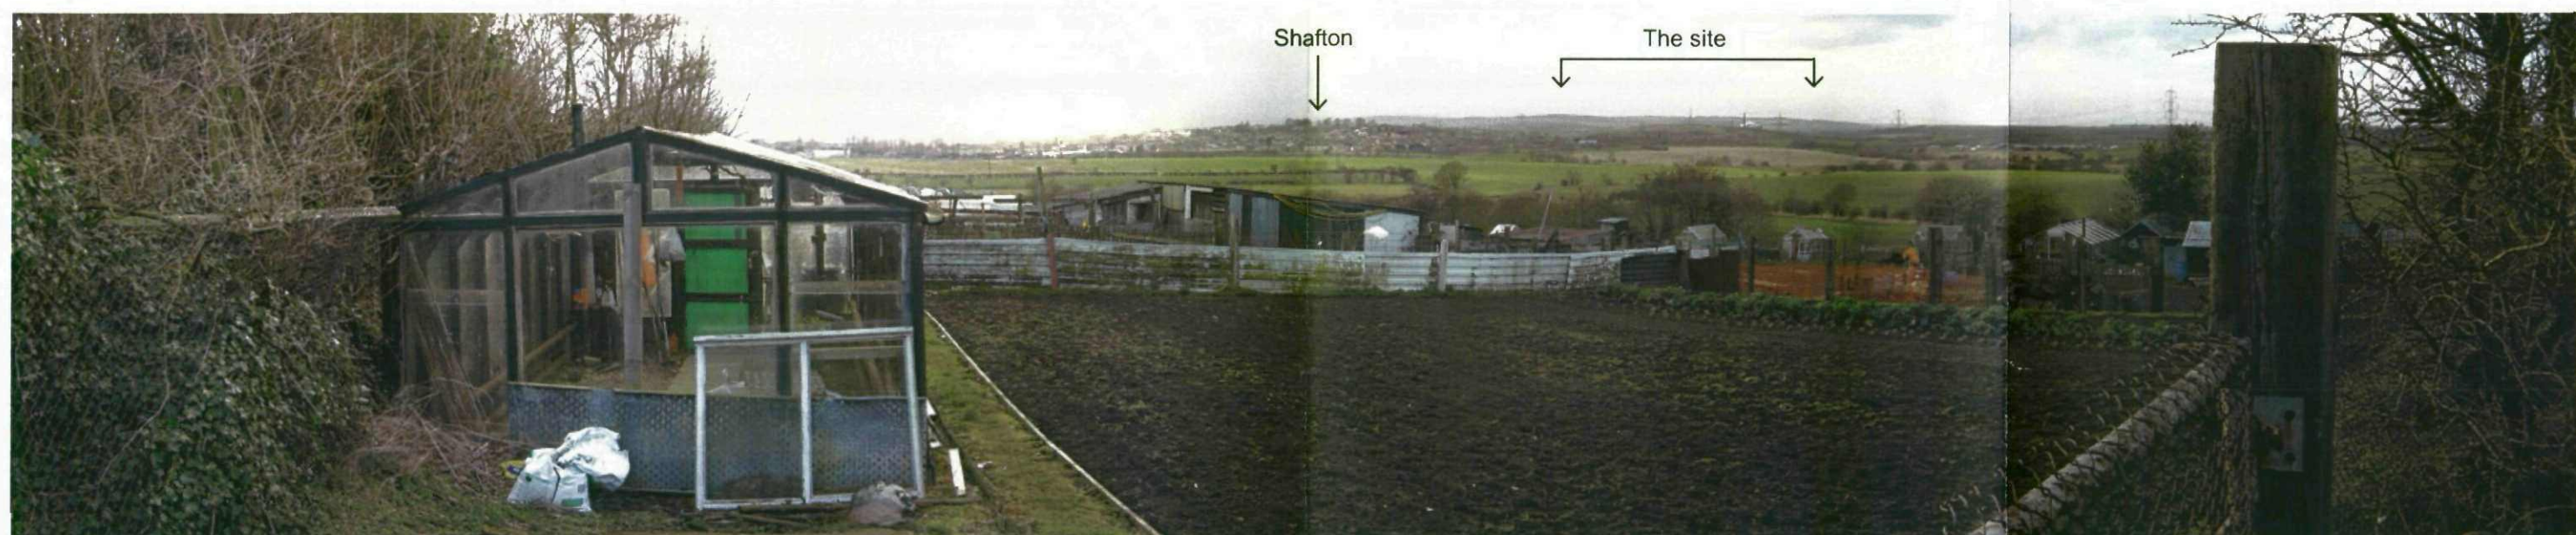
**Viewpoint 8:** View looking west towards the site from the western edge of Brierley. The colliery tip is visible in the mid ground of the view, immediately to the north west of Shafton.

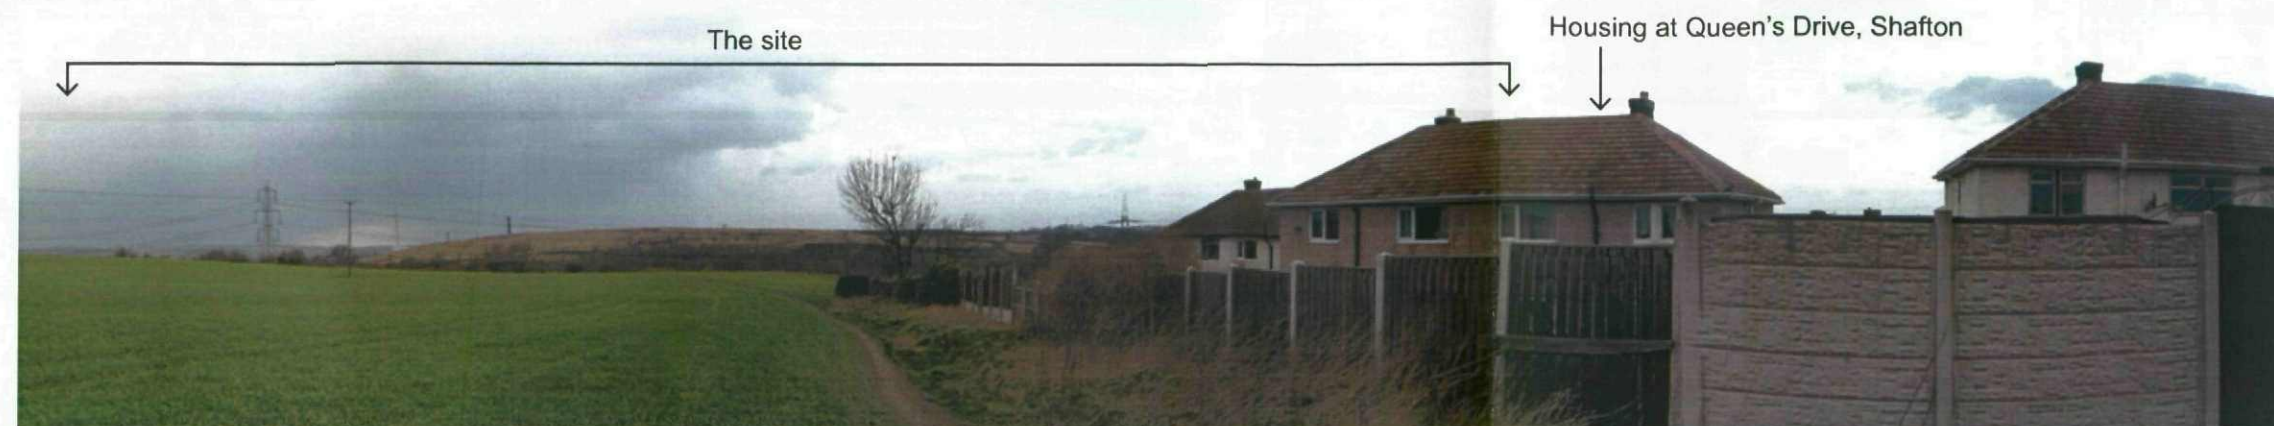
**Viewpoint 9:** View looking north west towards the site from the north western edge of Shafton. The houses at Queen's Drive are visible to the right of the view, whilst the upper slopes of the colliery tip is visible on the skyline.

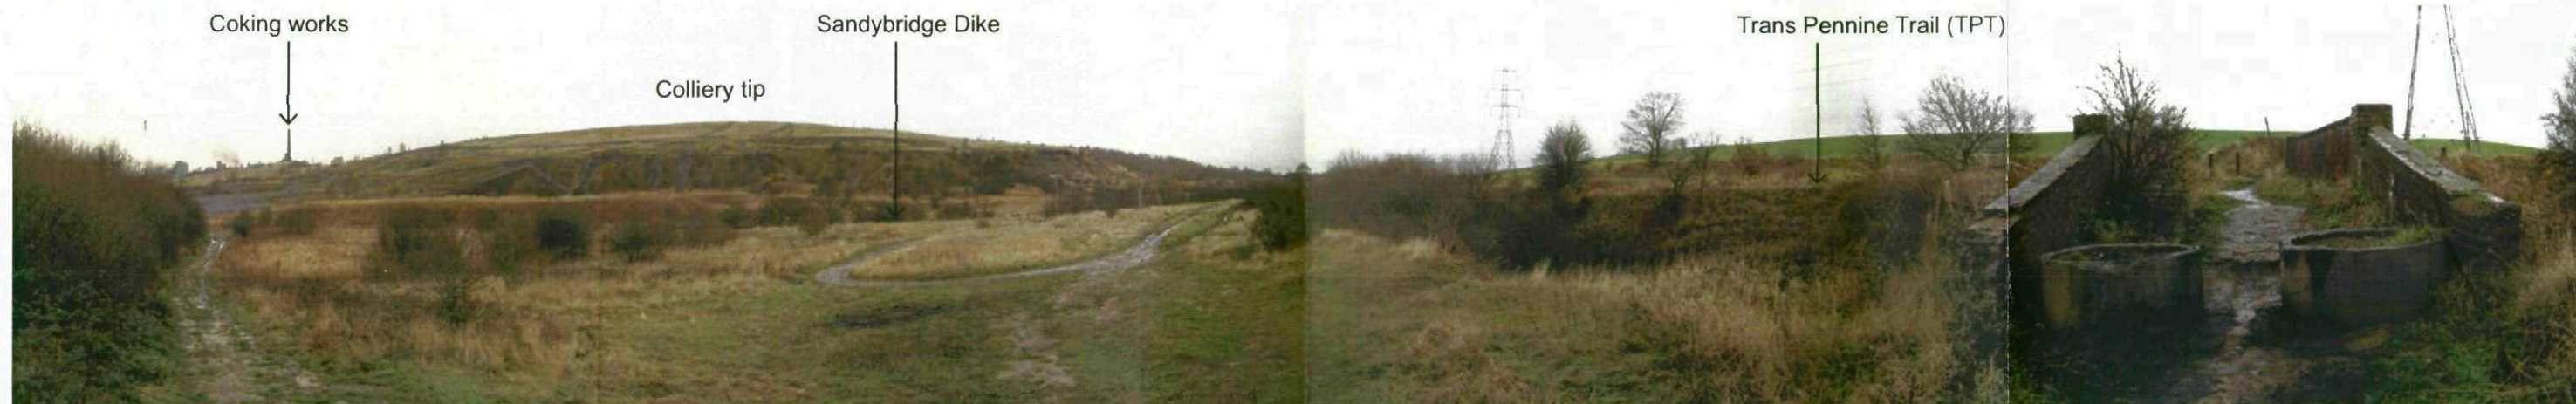
**Viewpoint 11:** View looking north from the footpath (Right of Way) which extends between Sandybridge Dyke and the Trans Peninne Trail. The steep southern slopes of the colliery tip are prominent in the centre of the view.

- 5.22 Views towards the southern flanks of the colliery tip, the reed beds and the Sandybridge Dike are available from the Trans Pennine Trail (TPT) as the route extends between the woodland at Pools Ings and Sandybridge Lane. The steep southern flank of the colliery tip, which is scarred with drainage runoff channels, benches and rough access tracks, is prominent in the view from this location, and whilst some regenerating woodland has established at the eastern end of the southern flank and along Sandybridge Dike, this degraded, post industrial landscape and colliery tip is seen as a significant visual intrusion in views from this strategic footpath & bridleway. This is illustrated in **Viewpoint 11, Figure 9.**

| Selected Photo View No. | Location | Approx. Distance from Site | Description of Existing View and Landscape Character | Sensitivity of View | Potential Impact of Development & Mitigation / Change in View | Nature of Change | Magnitude of Change | Duration of Impact | Overall Significance of Visual Impact |
|---|---|---|---|---|---|---|---|---|---|
| 11. | View from the footpath (Right of Way) which extends between Sandybridge Dike and the Trans Pennine Trail (TPT) | 100m | View from footpath / track overlooking an area of rough grassland which is interspersed by small trees and scrubby vegetation. The southern flank of the colliery tip, is prominent in the view, and is set in the context of a degraded landscape with overhead cables and pylons framing the setting to the east and industrial structures established at Royston framing the setting to the west. | Low | <p>The patchy grassland, runoff channels, access tracks and benches etc, which are all visible on the southern slopes of the tip, will be removed and replaced with a more uniform, gently sloping landform. Whilst much of the existing tree and scrub planting, which has established on the lower slopes, will be lost due to the necessary re-profiling works (to achieve a stable 1:3 slope), significant areas of new 'native' species based structure planting will be introduced along the lower slopes of the tip. These new planting areas will, once established, soften views towards the lower slopes whilst also significantly enhancing the existing woodland resource within the site and the local context.</p> <p>During the construction stage the earthworks and engineering works being carried out on the tip slopes will be visible from the footpath and the Trans Pennine Trail (TPT) however, this adverse impact will be short term and the longer term impact will be substantial beneficial.</p> | <p>Adverse (Short Term / Construction)</p> <p>Beneficial (Long Term)</p> | <p>Minor</p> <p>Substantial</p> | <p>Short Term</p> <p>Permanent</p> | <p>Minor adverse to Substantial Beneficial</p> |
