**PHASE 1 ENVIRONMENTAL SITE  
ASSESSMENT REPORT**

**210 CARLTON ROAD,  
ATHERSLEY SOUTH, BARNSELY,  
S17 2AP**

| <b>Report Title</b> | Phase 1 Environmental Site Assessment Report | | |

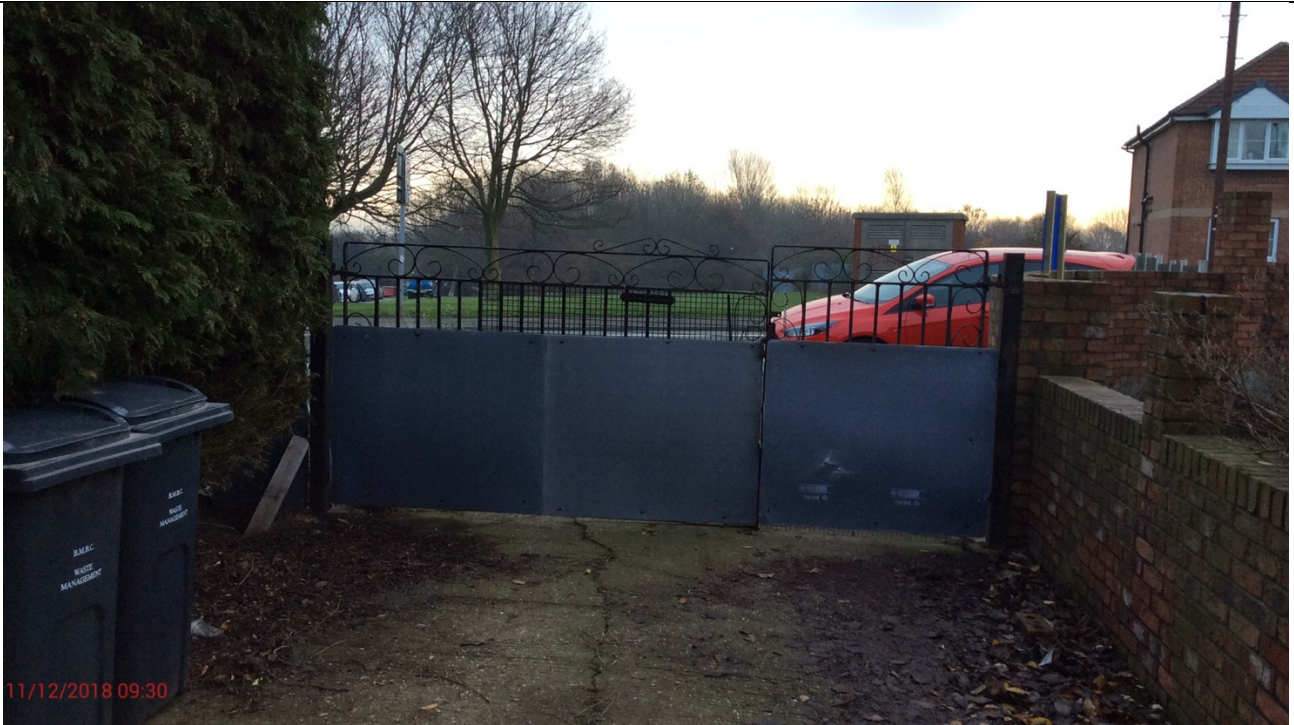
The site is accessed via a 1.5m tall metal gate along Carlton Road. A small concreted track runs adjacent to no. 210 Carlton Road towards the site. The gate was unlocked at the time of the walkover.

1.5m tall access gate

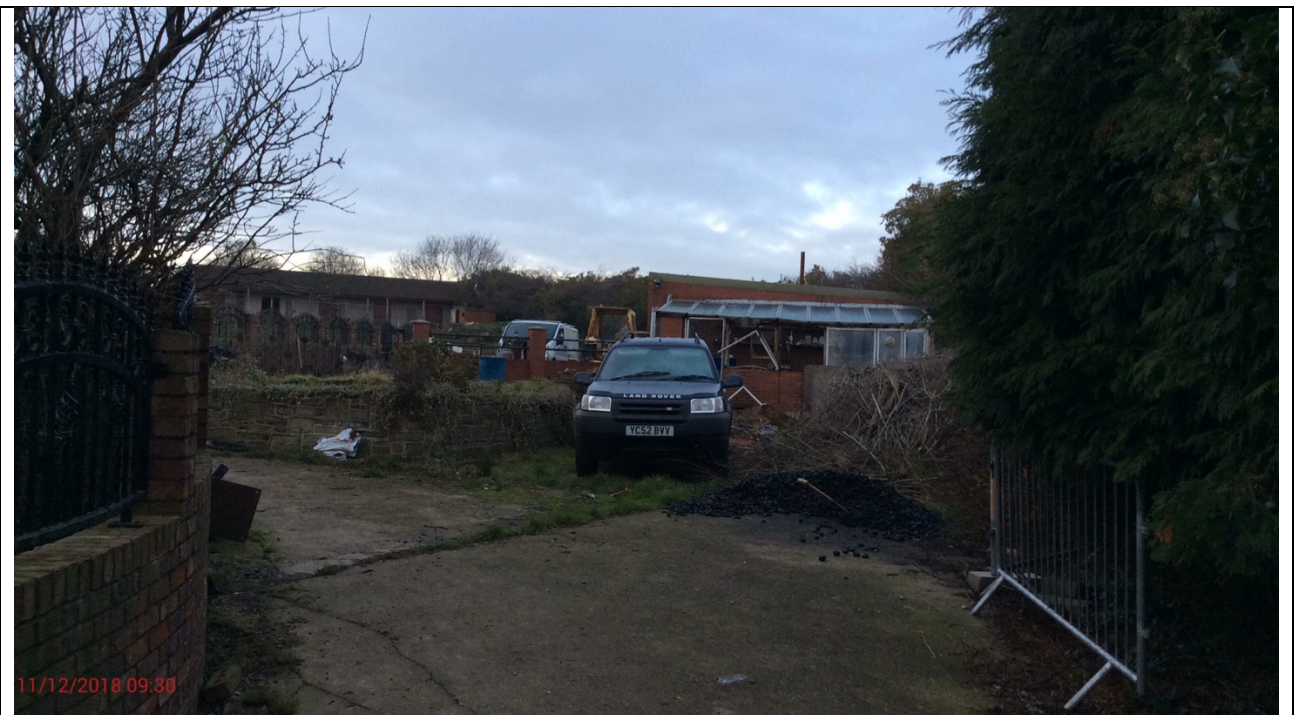
The site is irregular in shape and has an approximate area of 0.43 hectares. The site is largely open green space currently occupied by several small outbuildings and structures. The outbuildings are used for storage including vehicle parts, gas canisters and materials. All areas around the buildings and vehicles is covered in hardstanding which is in good condition.

View of the site looking west showing concrete hardstanding

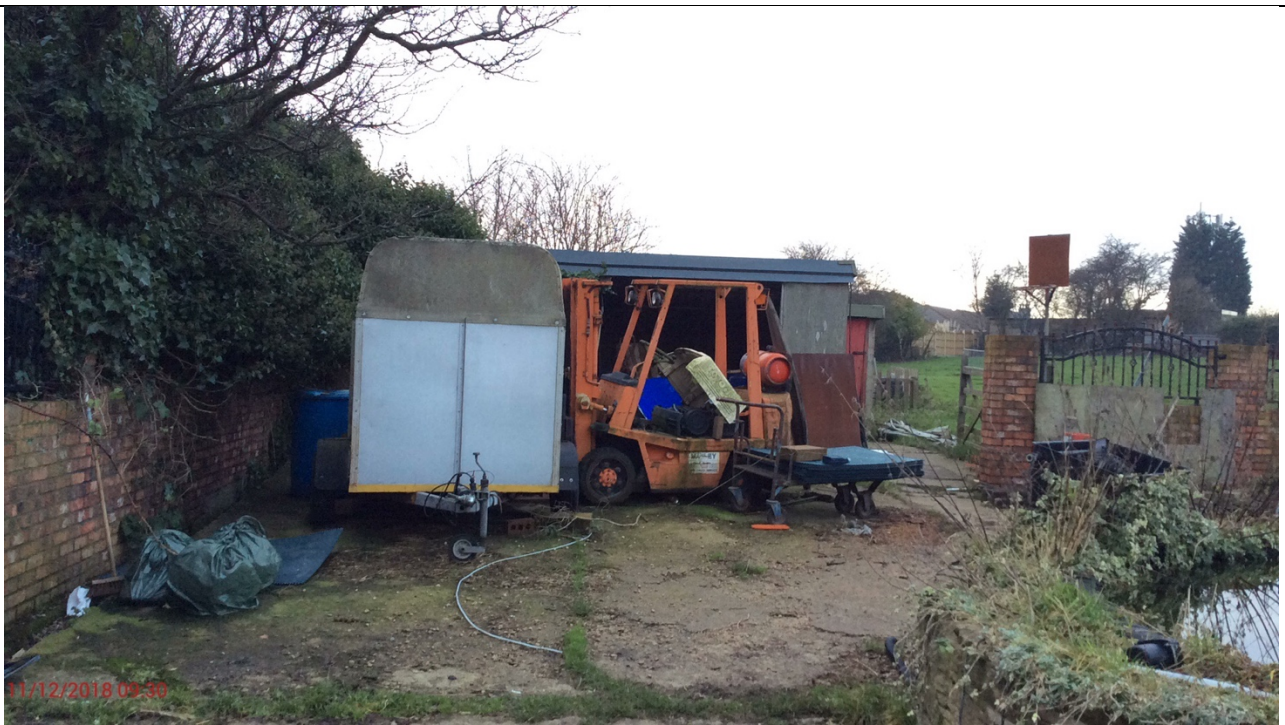
Storage of trailers and machinery on site

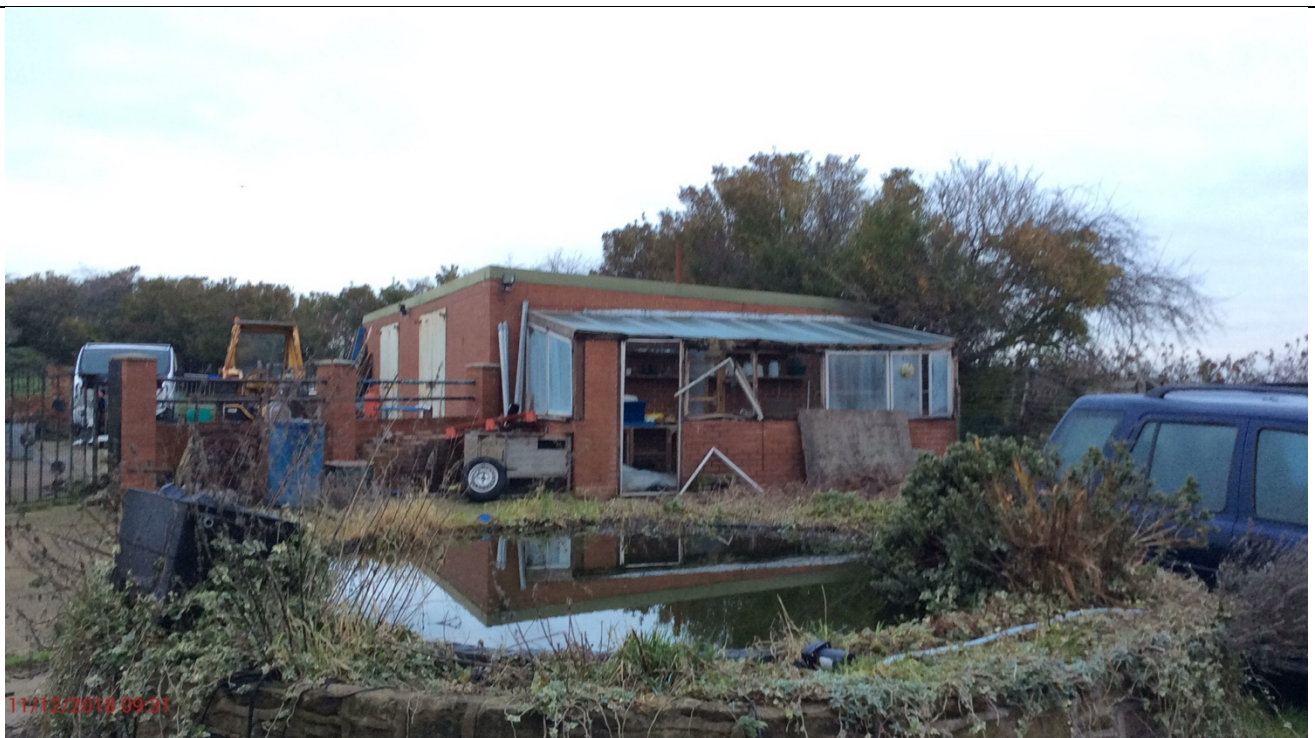
Should materials have been spilled or stored incorrectly in the garage, they could impact on the shallow soils. Upon the walkover survey it was noted that all areas around the garage and areas accessed by vehicles was covered in concrete hardstanding. It is considered unlikely that any minor contaminants will have infiltrated to the natural soils.

Outbuilding used as small garage

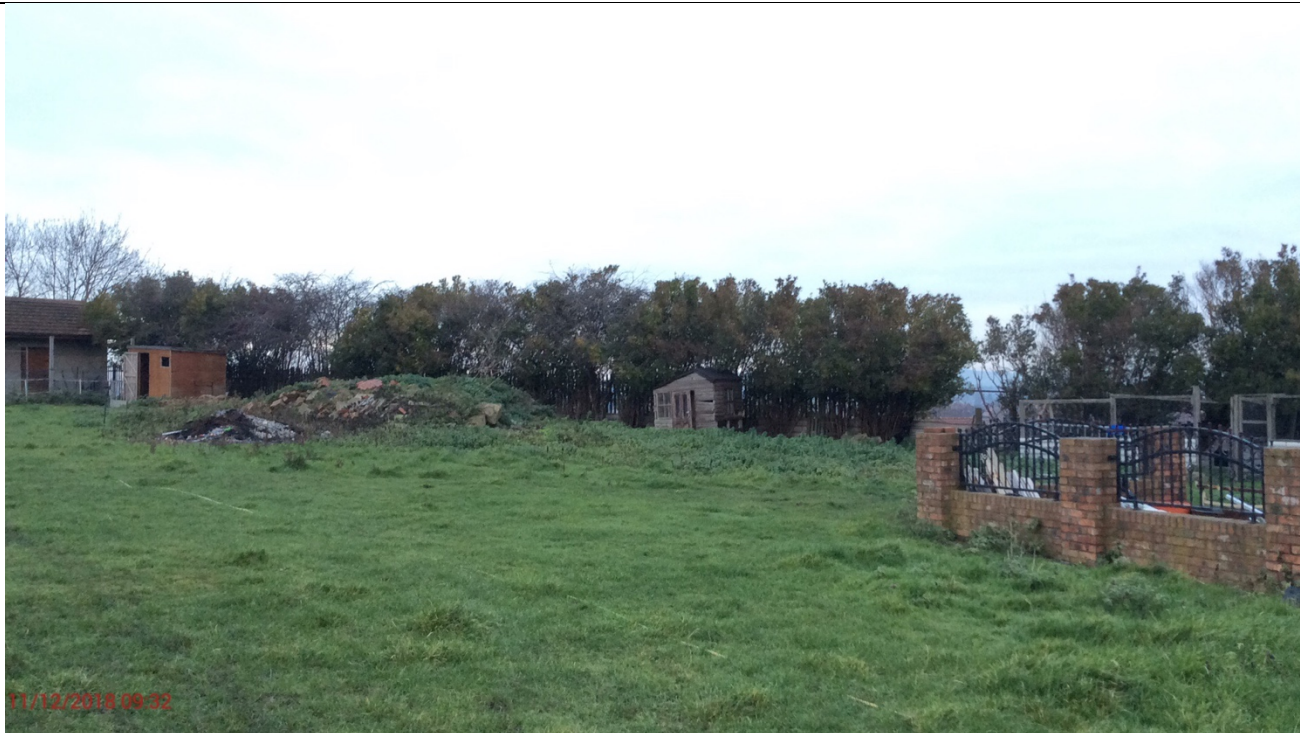
Open green space on the western side of the site

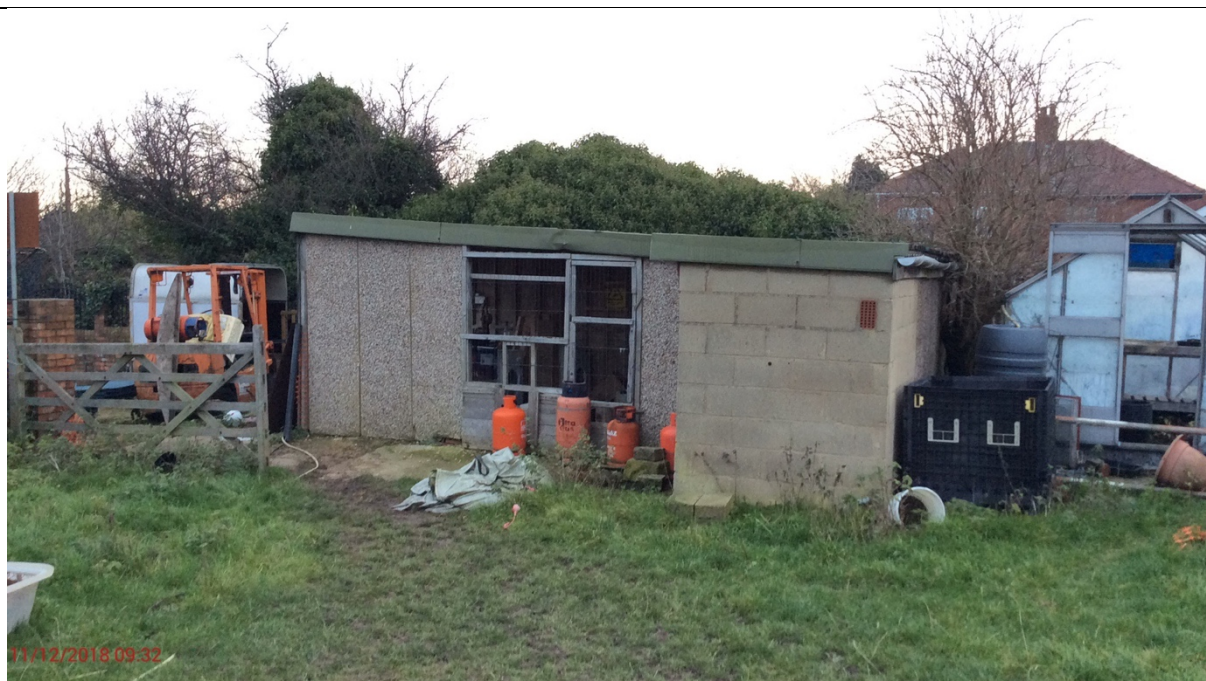
Small concrete outbuilding with gas canisters

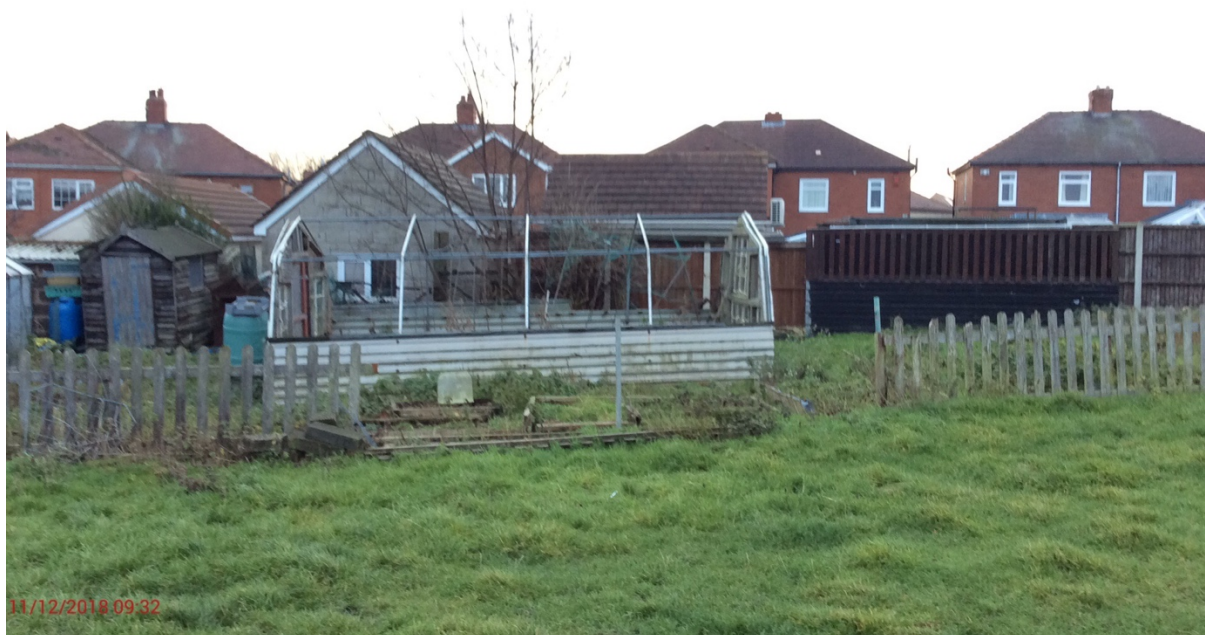
Small greenhouse type building on the eastern boundary

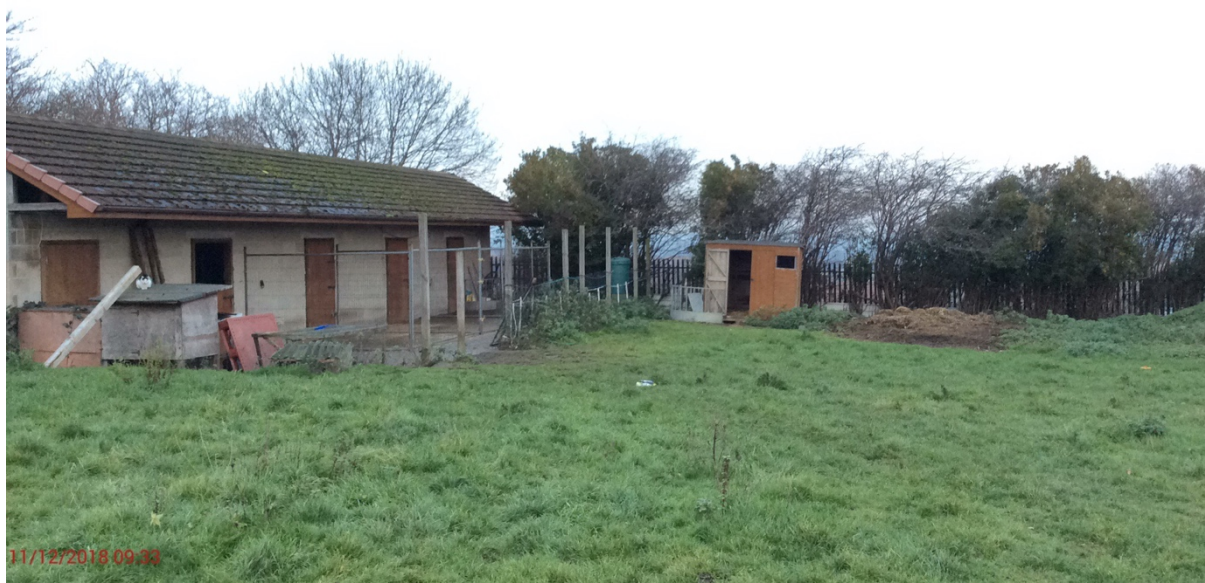
Concrete outbuilding on the western boundary
