## Phase 1: Desk Study

**Trinity Academy, Barnsley**

**S230406**

# PHASE 1 DESK STUDY

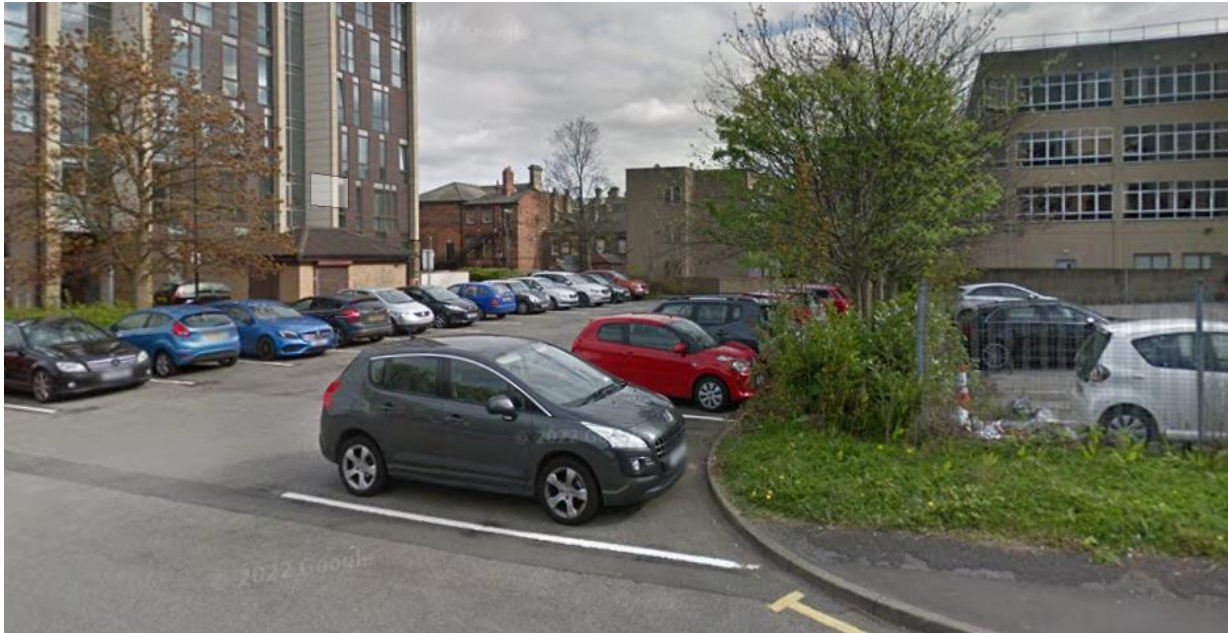
Photo 1: Photo taken looking south east across site.

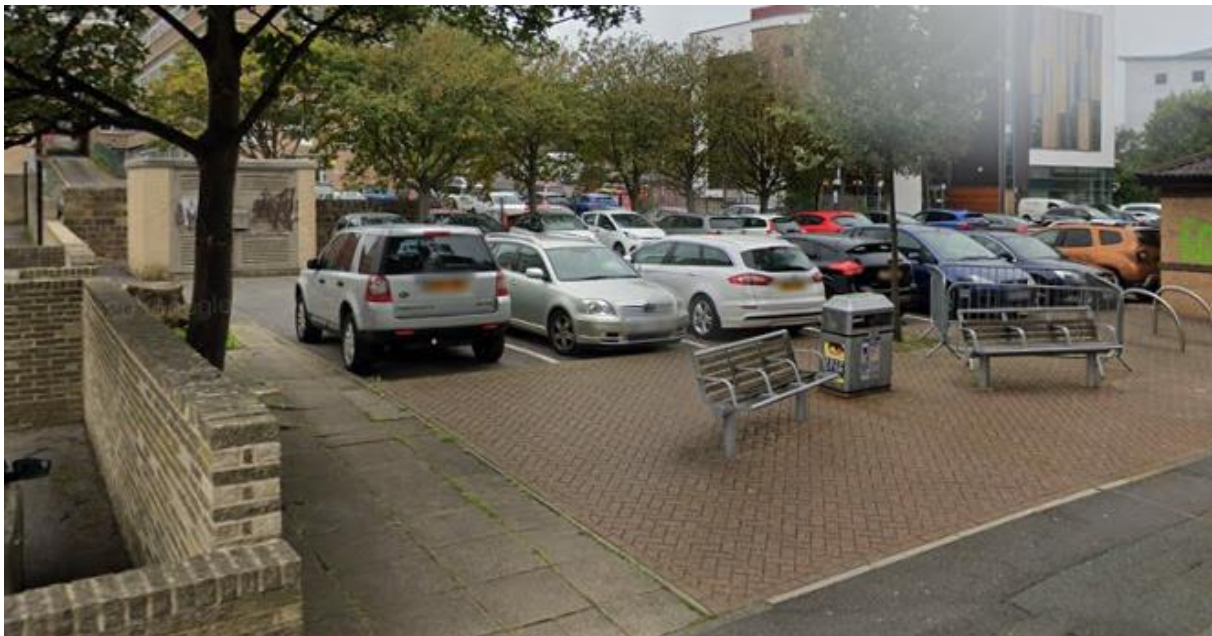
Photo 2: Photo taken looking north west across site.

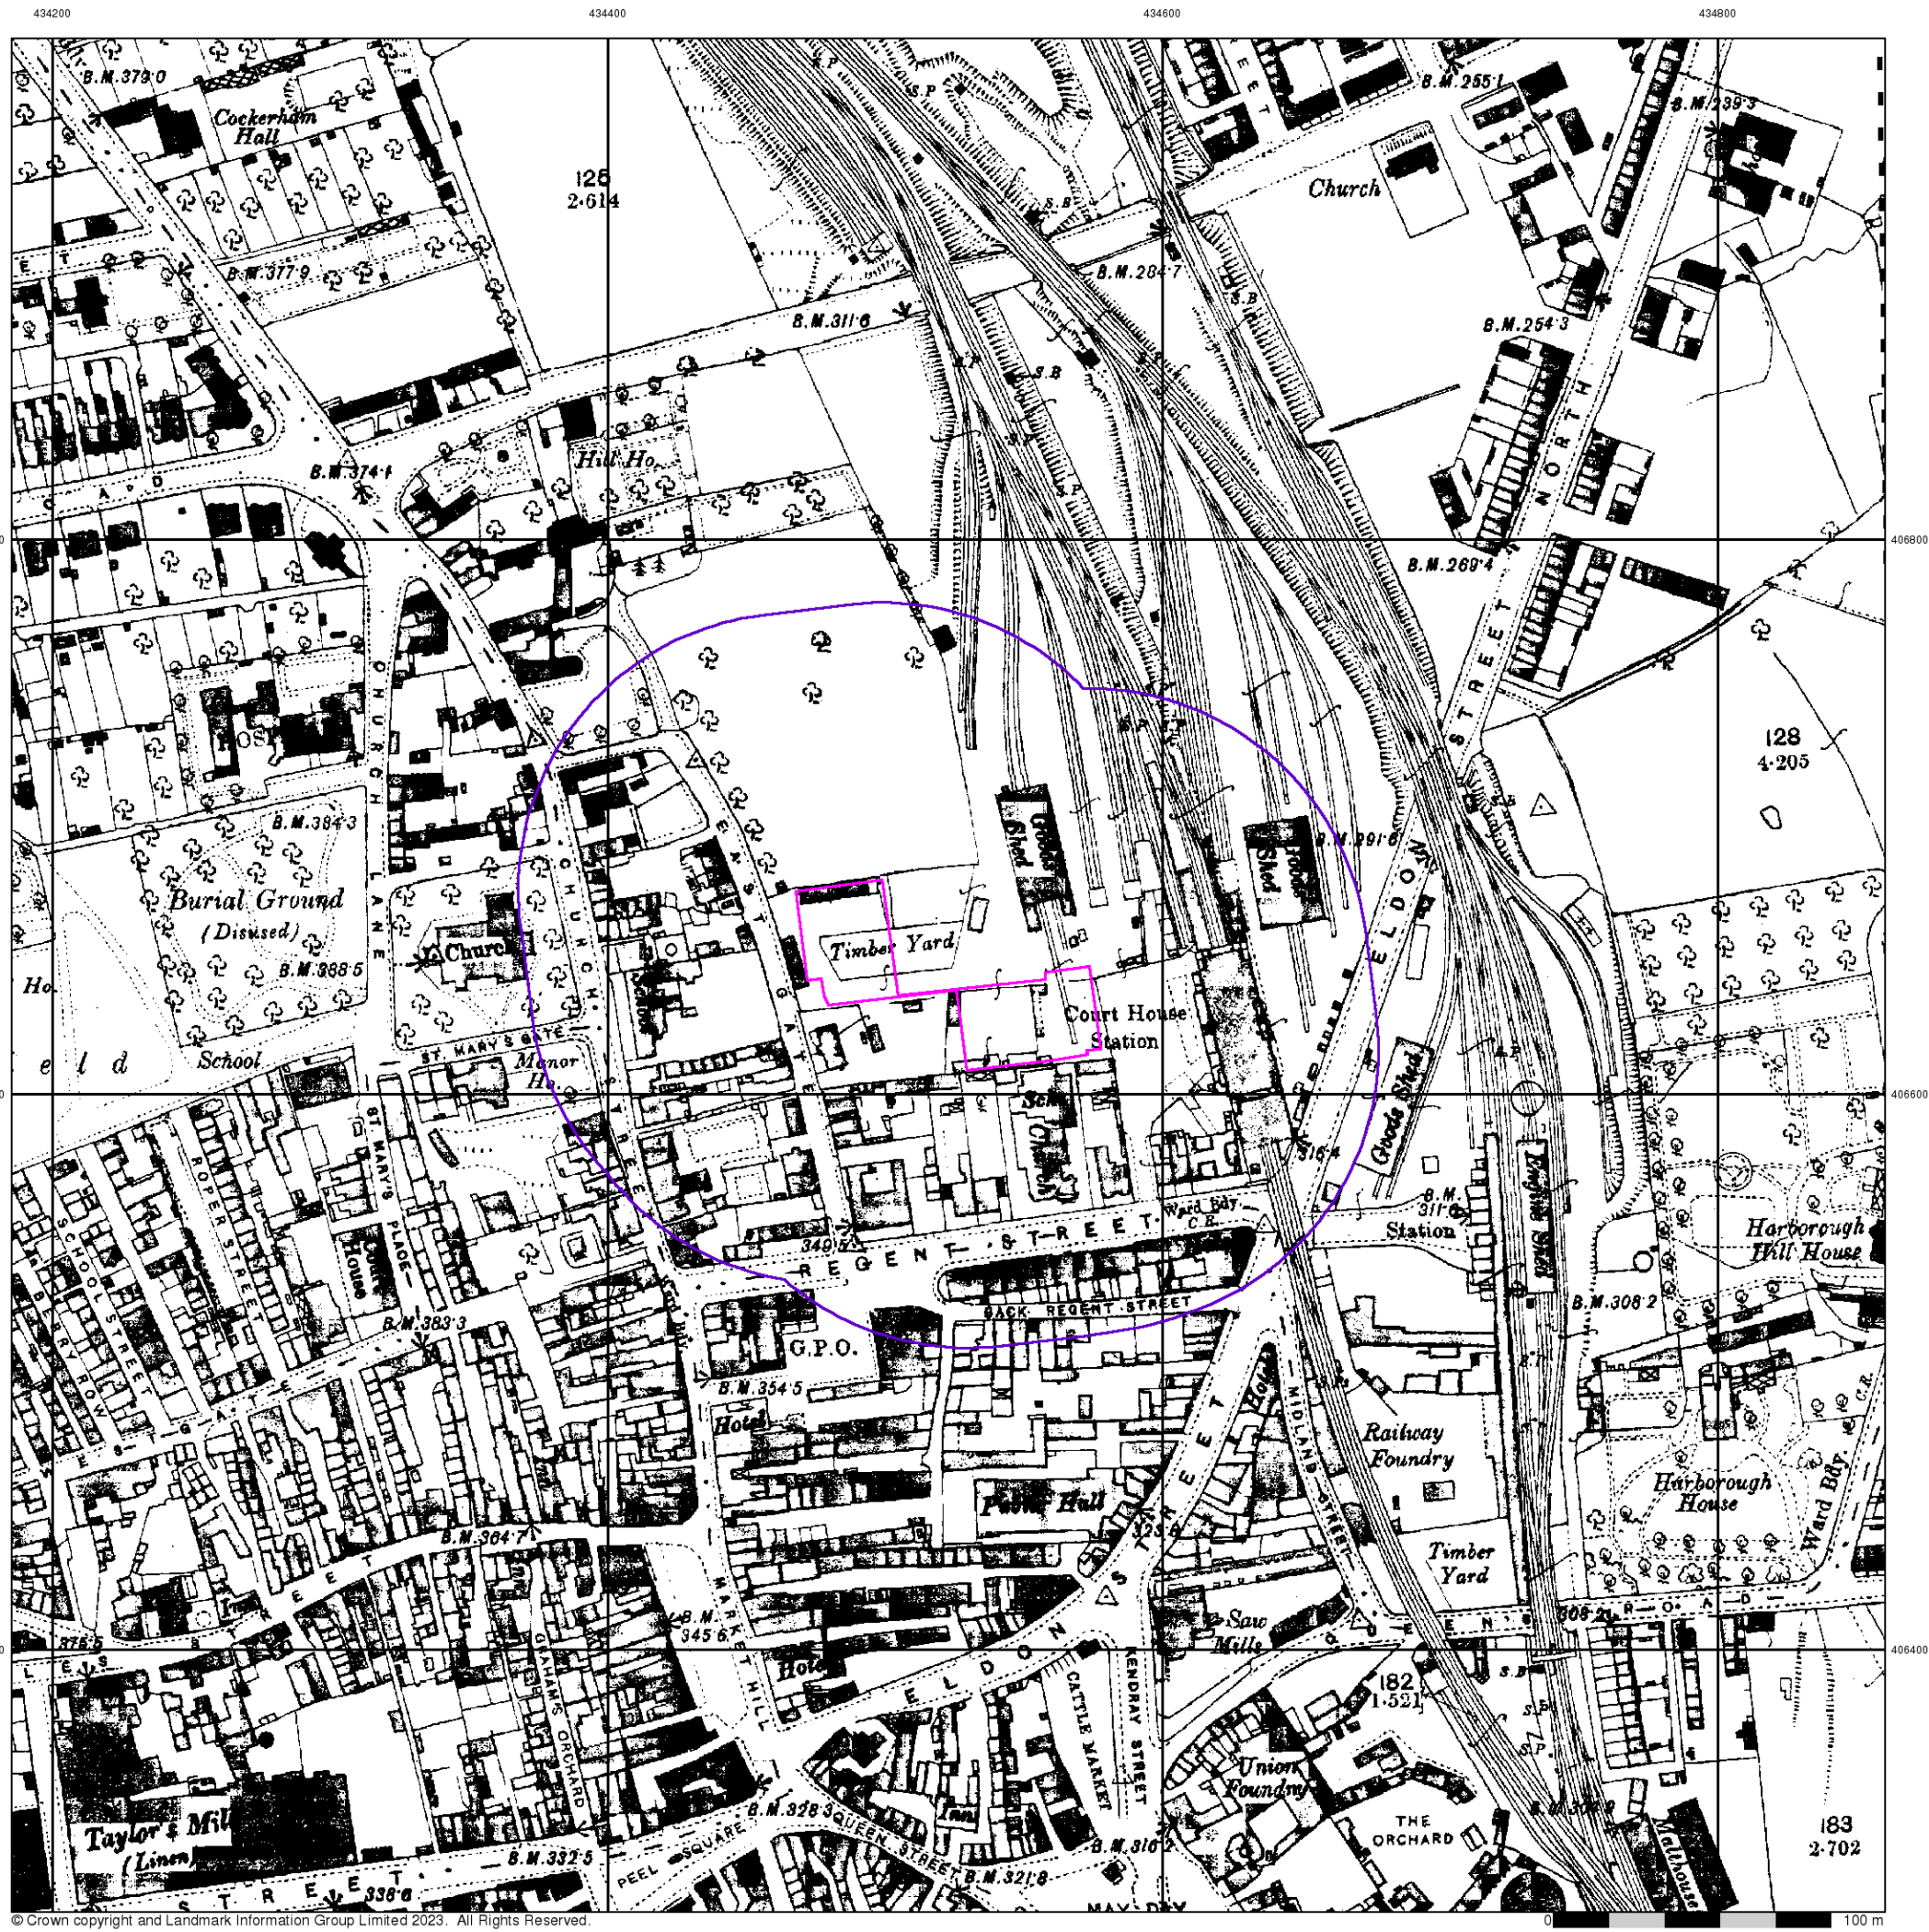
Published 1892 - 1893

| OS Map Edition | On-site Features | Off-site Features |
|---|---|---|
| <b>1892 – 1893</b><br><b>1:2,500</b><br><b>&amp;</b><br><b>1894</b><br><b>1:10,560</b> | The site is now within the grounds of the railway, with a line running through the centre of the site orientated approximately N-S. An area of hardstanding is located along the eastern boundary of the site.<br>A small building has been constructed in the north western corner of the site.<br>A timber yard is present in the north-western portion of the site. | Goods Sheds are located 25m to the north and north east of the site.<br>A Railway Foundry is located 125m to the south east of the site.<br>A Saw Mill is located 150m to the south of the site.<br>A Burial ground is located 150m to the west of the site.<br>A Tannery is located 650m to the north east of the site,<br>A Colliery is located 900m to the south of the site. |
