*Greencroft, Hood Green*

*20220014-Bat*

*Bat Survey*

*27<sup>th</sup> May 2022*

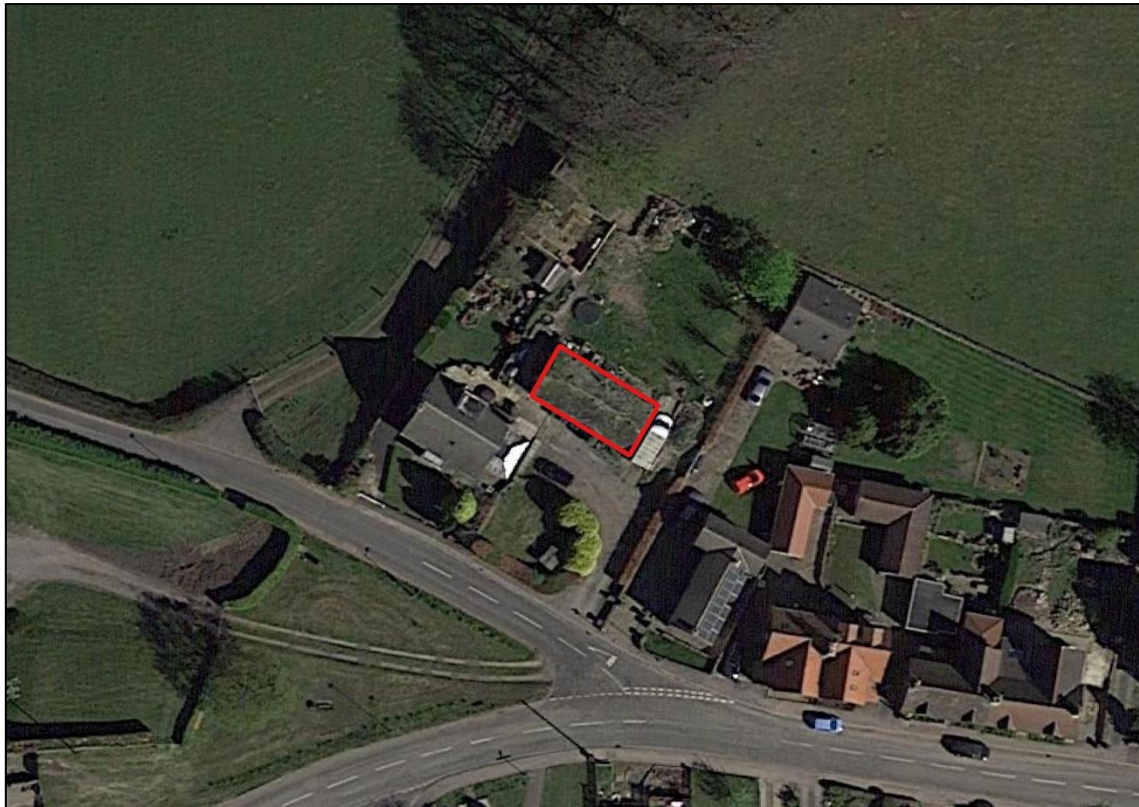
*Figure 1: Showing the location of the building covered by this survey.*

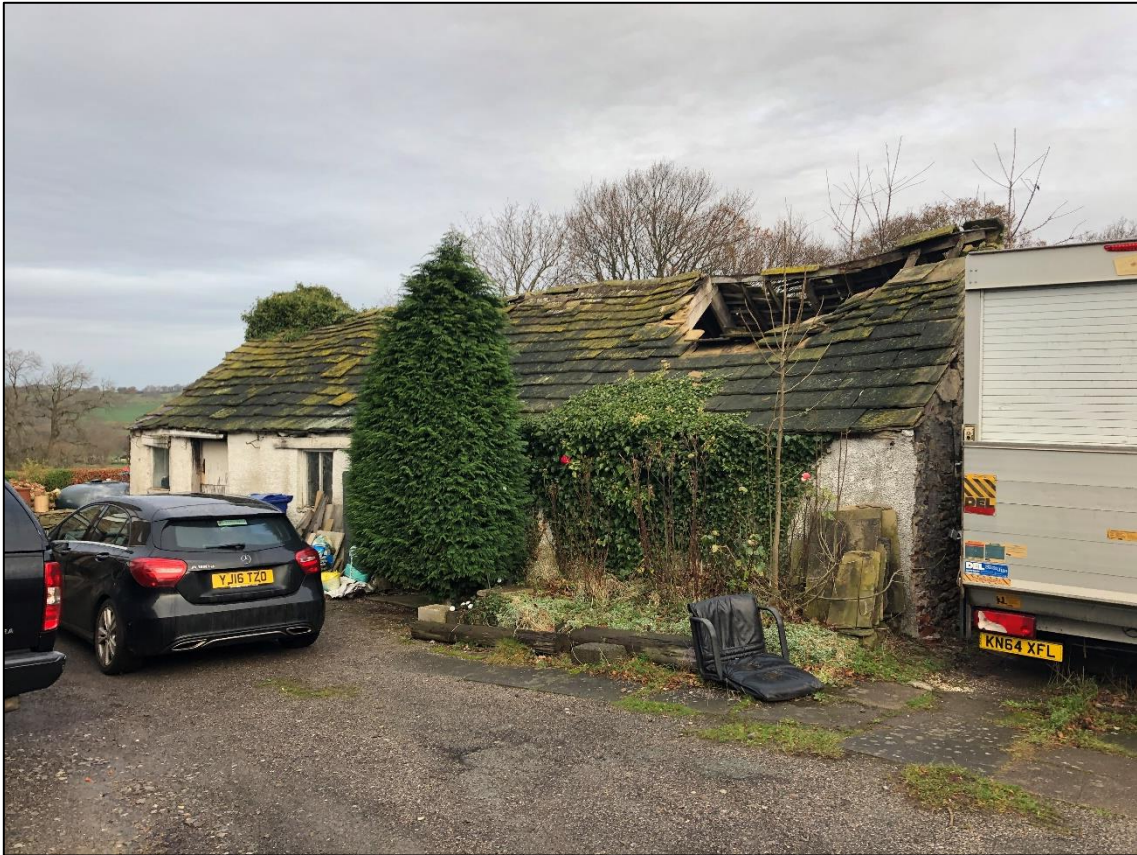
2.2.3. The walls of the building comprise rubble filled stone walls that are rendered on the southern and western elevations of the building. The windows and doors around the building comprise a mixture of wood and uPVC frames.

Figure 2: The southern elevation of the building.

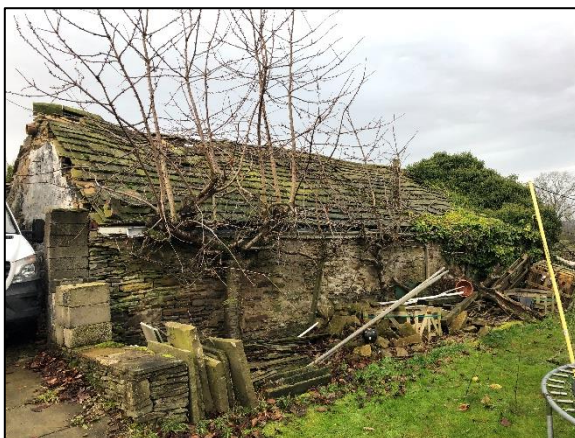
2.2.4. The building has areas of wooden fascia along its northern elevation with no fascia or guttering present to the south.

Figure 3: The northern elevation of the building.

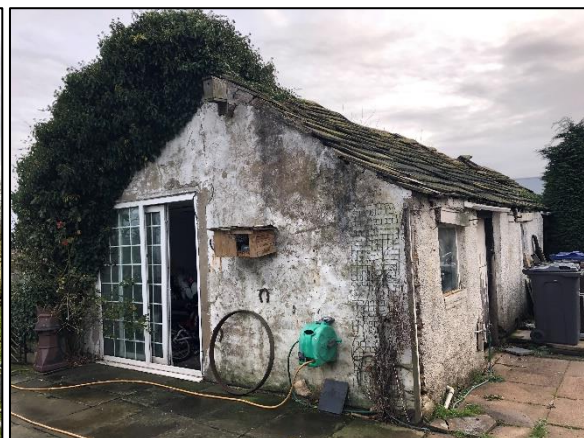
2.2.5. Dense ivy (*Hedera helix*) is growing on the western end of the building and in areas along the southern elevation.

Figure 4: The western elevation of the building.

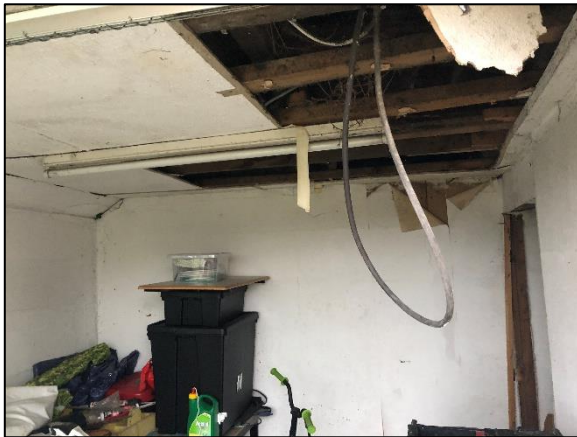
2.2.7. Internally the building is split into two rooms. At the western end of the building there is a section of the building that comprises a utility room with a loft space above. The remaining areas of the building comprise a workshop/storage area that is open to the inside of the roof with no lining present on the underside of the tiles.

Figure 5: The interior of the western end of the building.

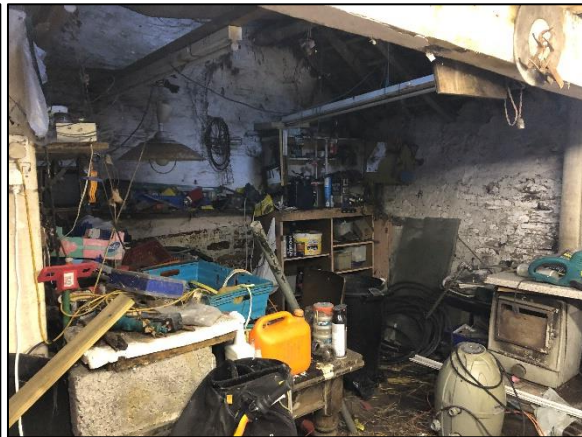
Figure 6: The interior of the workshop/storage area.

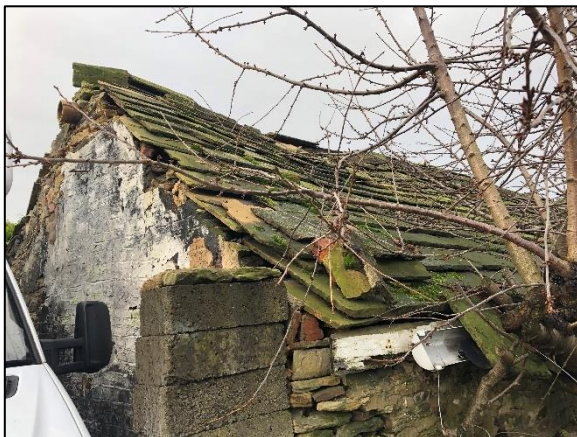
4.2.1. The external walls of the building were found to be in a generally good condition, considering the state of the building, with the render to the south and west predominantly intact. Abundant voids were identified higher in the walls of the building and around the northern and eastern elevations, which are not rendered.

Figure 8: The eastern elevation of the building.

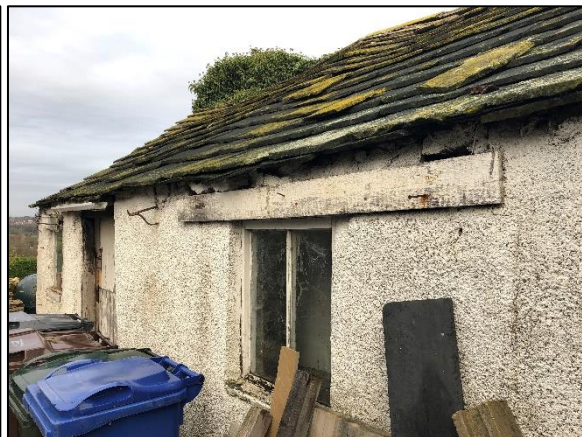
Figure 9: Rendered areas to the south of the building.

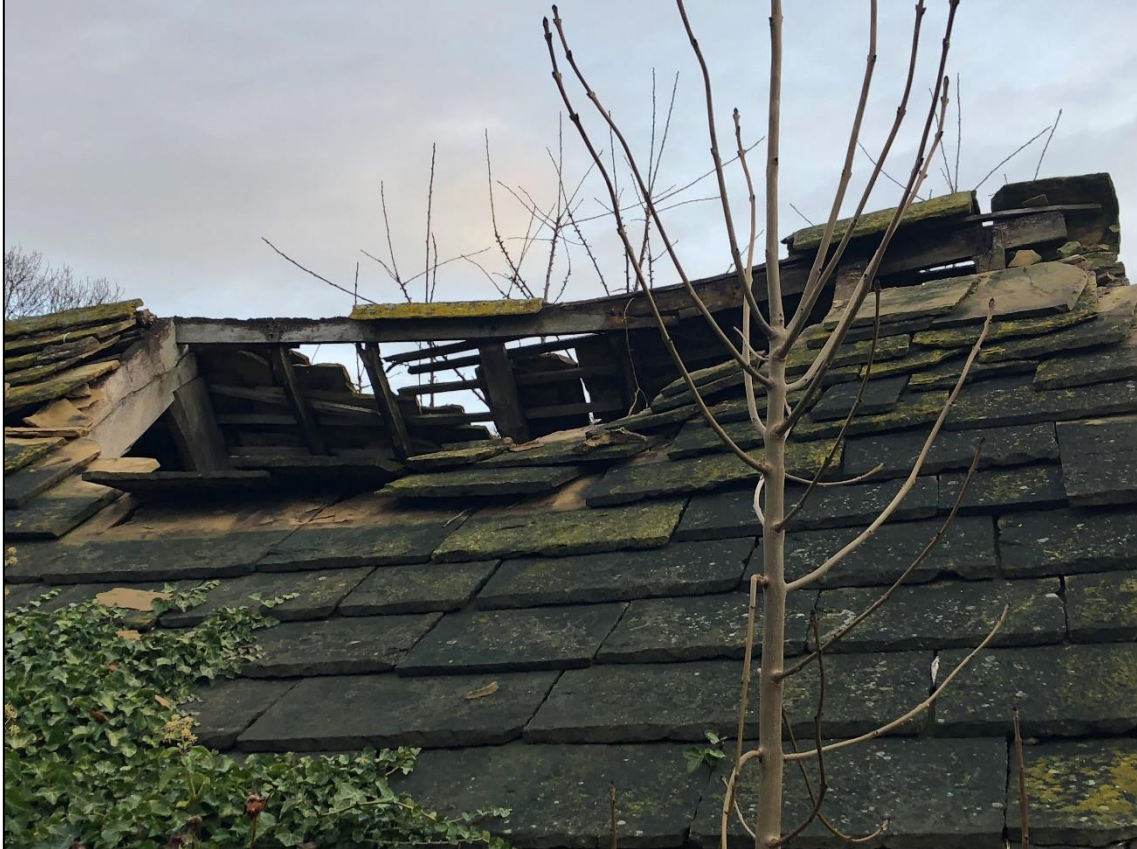
4.2.3. The roof of the building was found to be in a deteriorating and partially collapsed state with a large area of the roof to the east of the building having collapsed into the building several months before the survey and further areas of more recent collapse due to the winter weather conditions.

*Figure 10: The collapsed section of roof.*

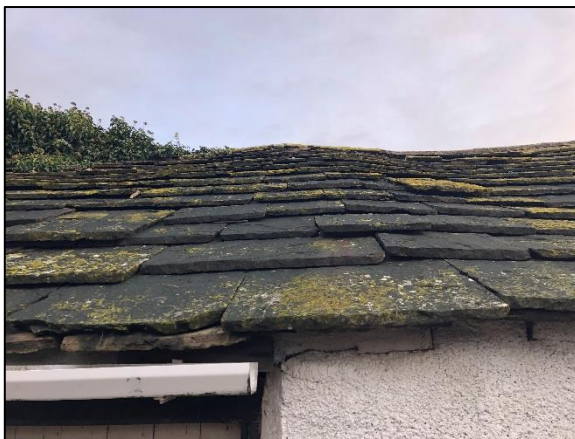
*Figure 11: The stone tiles on the roof of the building.*

4.2.4. Due to the non-uniform nature of the stone tiles and the movement in the roof of the building abundant voids were identified leading between the stone tiles and underneath the ridge tiles of the building.

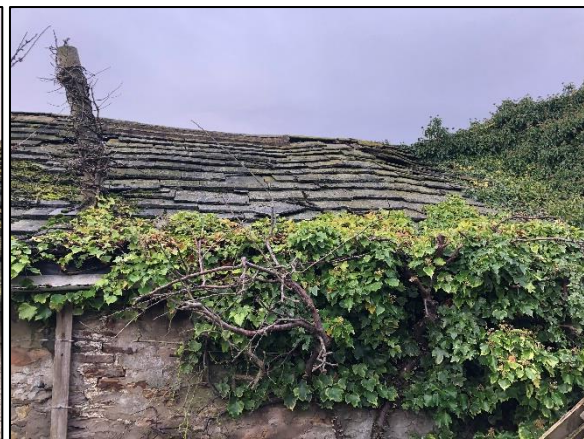
*Figure 12: Showing the poor condition of the roof.*

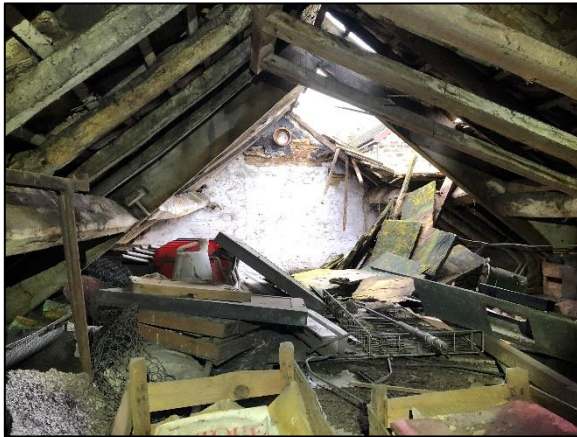
4.2.6. Internally the building was also found to be in a deteriorating state with no lining on the inside of the tiles and abundant holes of varying sizes in the roof. Ivy was also identified growing through the roof at the western end of the building leaving areas of hanging vegetation within the small loft space present with the loft floor also having collapsed into the room below.

Figure 13: Looking along the interior of the building.

4.2.8. The roof timbers, which are of a purlin and rafter design, were found to be in a very poor condition with collapsed areas of roof and an abundance of rot and movement throughout the roof.

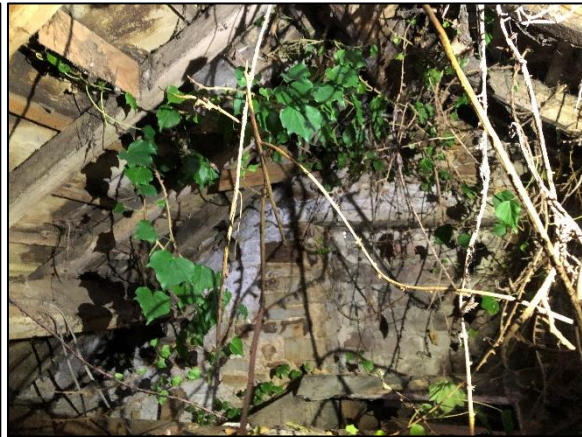
Figure 14: The loft space to the west of the building.

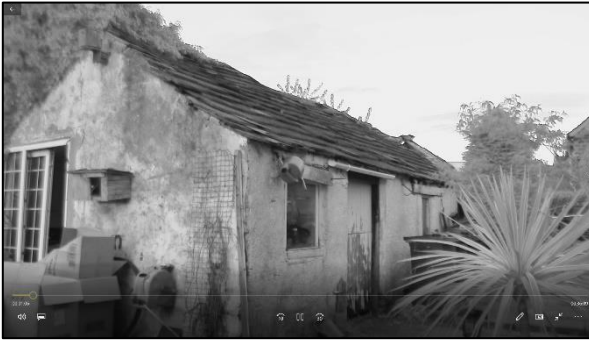
Figure 16: Video with Surveyor 1 at the start of the survey.

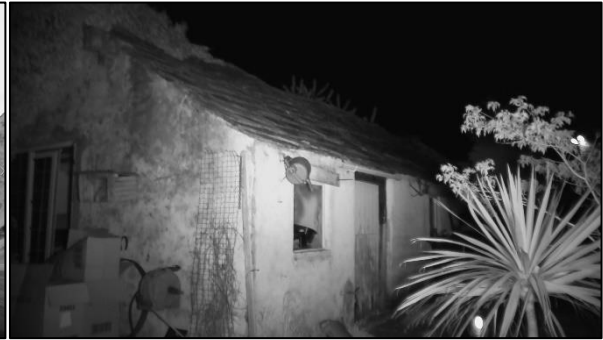
Figure 17: Video with Surveyor 1 at the end of the survey.

4.3.2. The bat activity across the site was very low throughout the survey with all activity confined to common pipistrelle (*Pipistrellus pipistrellus*). The first activity was recorded at 21:01 (19 minutes after sunset), which was distant bats heard off site but not seen. This activity continued occasional throughout the survey.

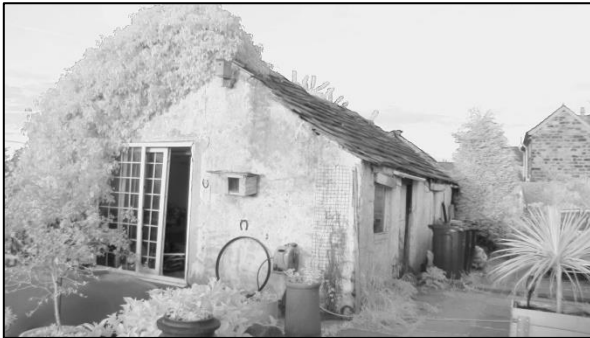
Figure 19: Video with Surveyor 1 at the start of the survey.

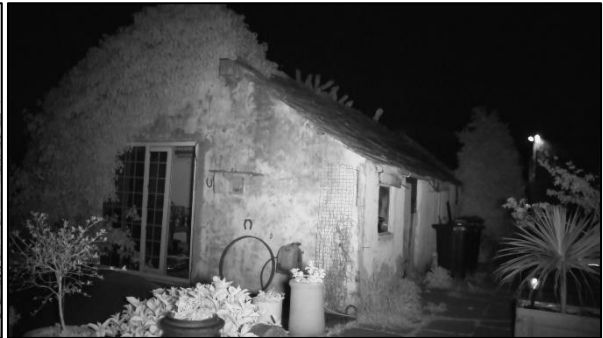
Figure 20: Video with Surveyor 1 at the end of the survey.

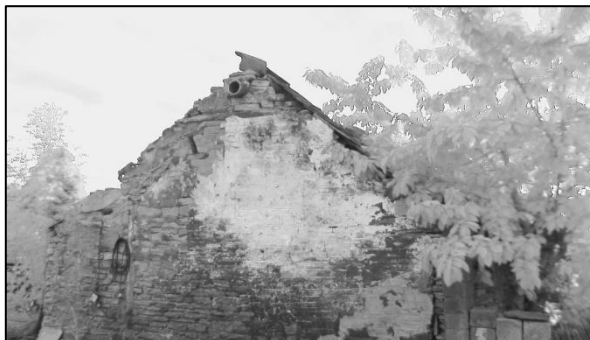
Figure 21: Video with Surveyor 2 at the start of the survey.

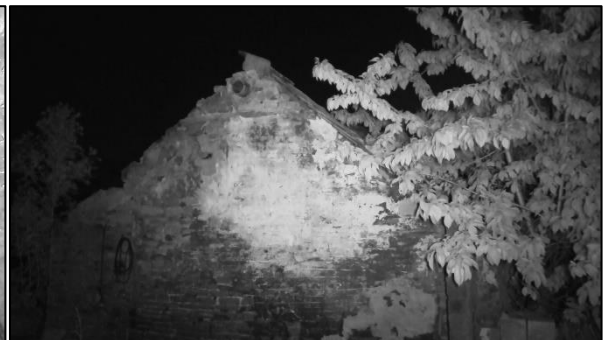
Figure 22: Video with Surveyor 2 at the end of the survey.

4.4.2. The bat activity recorded during the survey was confined to a single common pipistrelle passing over the site from south to north at 21:37 (22 minutes after sunset), a myotis (*Myotis sp.*) bat crossing the site from west to east at 22:22 and a distant noctule (*Nyctalus noctula*) that was heard but not seen at 22:30, potentially over the fields around the site.

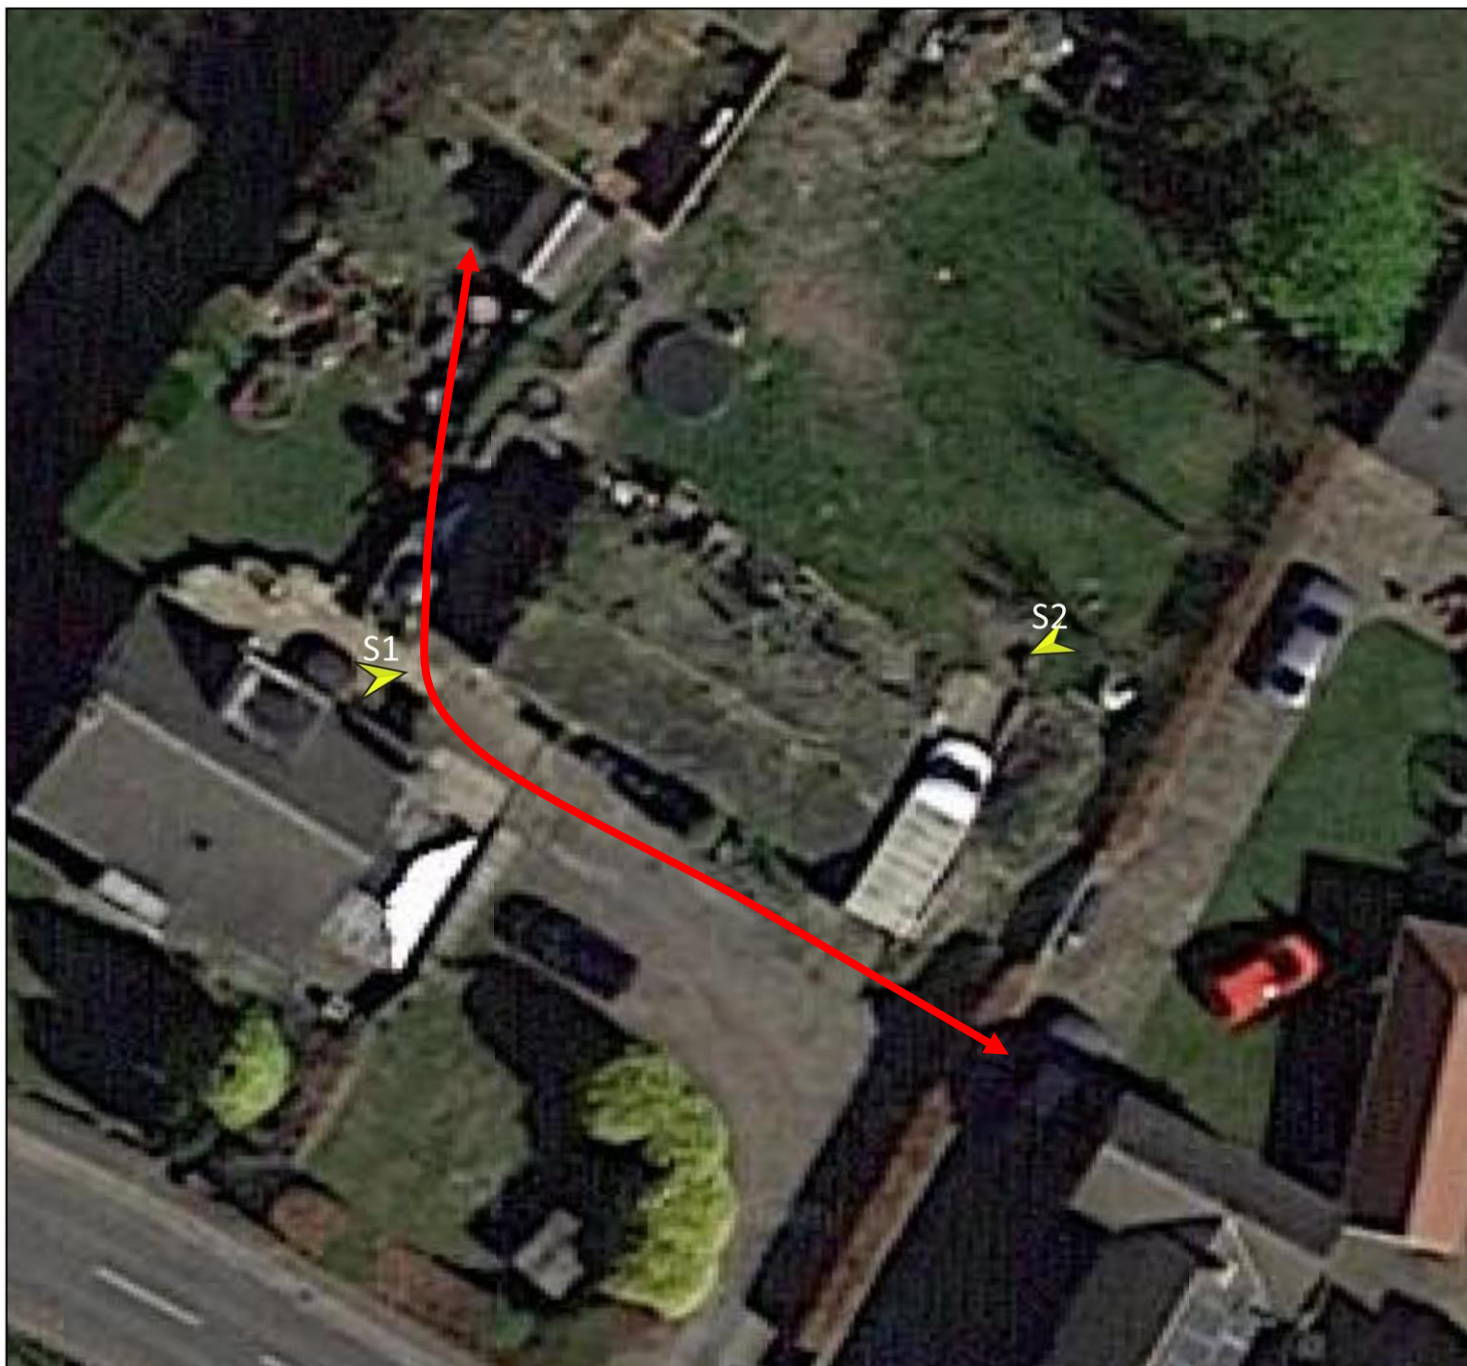
Bat Activity

4.3.1. The plan in Appendix II of this report shows the surveyor locations and bat activity recorded during the survey.

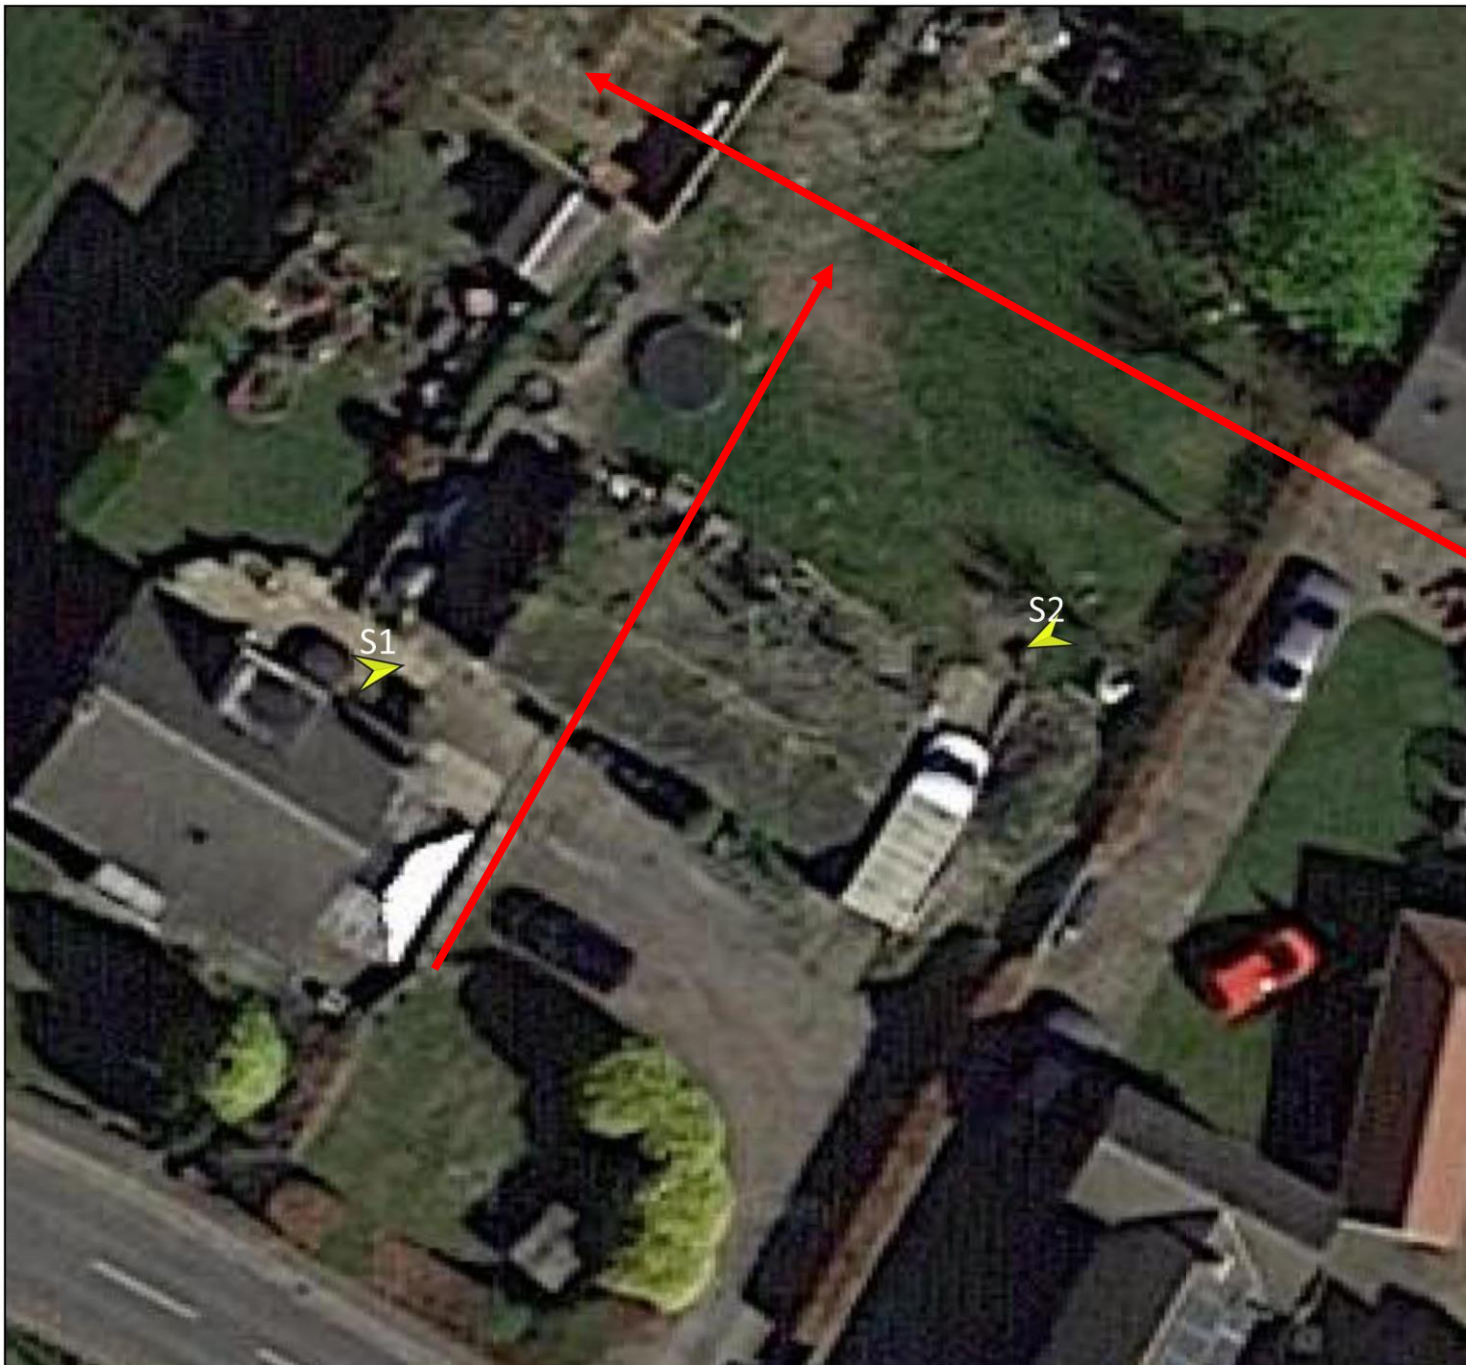
Bat Activity

4.4.1. The plan in Appendix II of this report shows the surveyor locations and bat activity recorded during the survey.
