**Ecological Assessment, Brierley Hall,
Church Street, Brierley**

Report reference: BE-R-0700-01
April 2010

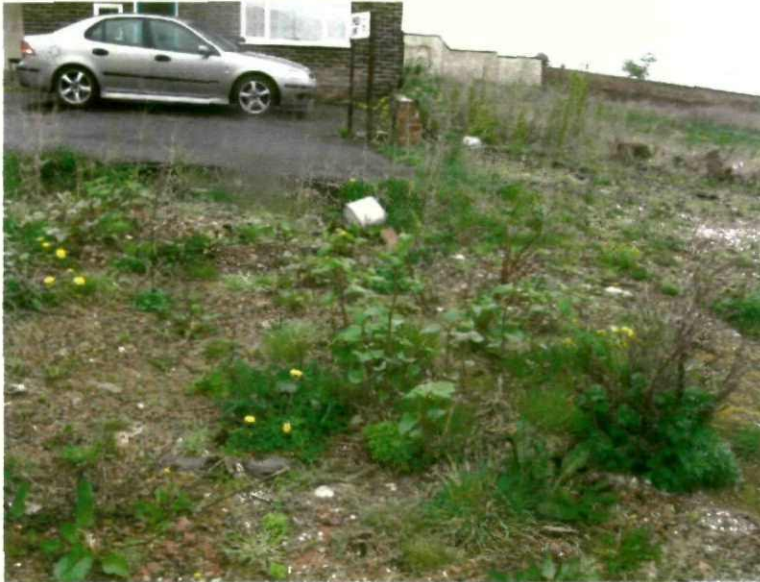
Figure 1

Large areas of the site are made up of tarmac surface surrounding the buildings which in the main support very few plant species, though in small areas, where the surface has been broken, dandelions (*Taraxacum officinale* sp.) black medick (*Medicago lupulina*) and grasses, predominantly cocksfoot (*Dactylis glomerata*), are beginning to colonise. Several sections of the original hall were demolished after a fire and the site now contains large areas of flattened rubble on the footprint of the former structures. This now supports a mosaic of ruderal plants including creeping thistle (*Cirsium arvense*), buddleia (*Buddleia davidii*), willowherbs (*Epilobium* spp.) broad leaved dock (*Rumex obtusifolius*), Oxford ragwort (*Senecio squalidus*), dandelion, white clover (*Trifolium repens*), cocksfoot, and perennial rye grass (*Lolium perenne*). There is large spoil heap containing a mixture of top soil and brick rubble which has remained largely free of vegetation apart from occasional patches of dandelion and weld (*Reseda lutea*). An emerging stand of the invasive and controlled plant Japanese Knotweed (*Fallopia japonica*) was found on an area of rubble several metres south east from the front of the modern house on the site (figure 1).

General site view looking east across area of bare ground/rubble. Small stand of Japanese knotweed emerging in the foreground.

Several stands of Japanese knotweed (*Fallopia japonica*) have been found on the site. This plant is listed under the Wildlife and Countryside Act (1981) making it an offence to plant or encourage its growth by disturbing the surrounding soils. Its removal will be required as part of the land owners duty of care and will have to be carried out using specialist contractors. For more detailed information about removal of Japanese knotweed the Environment Agency Guidelines should be consulted.

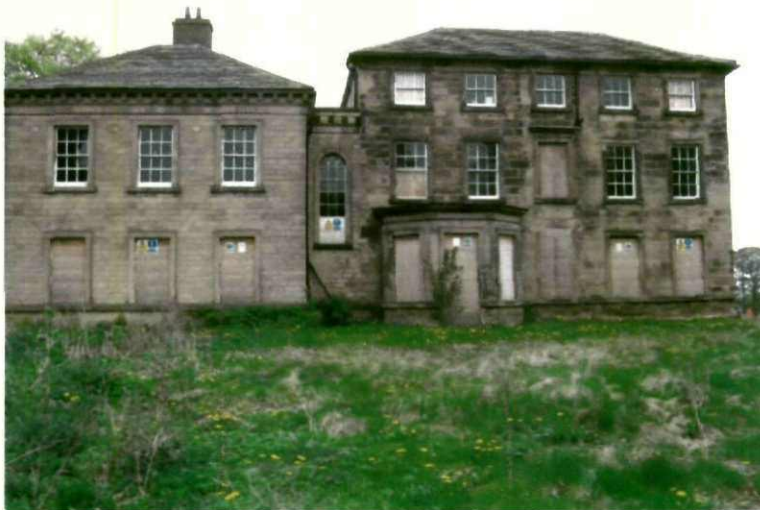
Figure 2

Brierley Hall (figure 1) is a stone three storey listed building which has had a number of extensions added to it over the years. The main section has solid brick walls faced with stone and a double pitched valley roof, hipped at both ends. A two storey extension is attached at the northern elevation, while another is located at the eastern elevation (figure 3); both these sections are of very similar construction to the original hall. Externally, the building appears to be in good repair with sound pointing, while windows and doors are well sealed to the stonework providing no suitable access points for bats. The main building has a stone cornice at the eaves, while the extensions have gutters supported by a series of stone pegs. Both these areas are in good condition with no obvious gaps or access points that could offer roosting for bats. There are some small areas on the south east elevation where missing pointing and small gaps created by the demolition of an adjoining building have created cracks that could be used by crevice dwelling bats, though given these spaces do not lead to a wall cavity, these areas are only likely to provide occasional roosts for small numbers of bats.

The roofs of all three stone built sections of the hall have grey slate (flag stone) roofs, well laid and capped by ridge stones soundly cemented in place. Although the roof is in good repair, the nature of its construction allows many minor cavities which can be used by bats as temporary roosting spaces. In addition, there are gaps under the ridge at the eastern elevation, which again could provide temporary roosting for small numbers of bats.

View of main hall viewed from the west.

Both the hall and detached house have been assessed as having limited bat roost potential as they contain features that are only likely to support small numbers of bats using the buildings on a sporadic basis. As the roof of the Hall is unlined, roosting potential is limited to crevices beneath the roof stones while the general good condition of the pointing and lack of wall cavity means that bats are unlikely to find space to roost in other parts of the building. Potential roosting in the detached house is also limited to small areas within the roof and gable ends. The flat roofed extension on the main hall has been assessed as having no roosting potential and can be demolished without further precautions in regard to bats.

Plans for the site include the renovation of the main hall including the demolition of the flat roofed extension. The detached house is also scheduled to be demolished. As the buildings are located close to good foraging habitat and bats can roost in unexpected locations it is sensible to follow a precautionary approach with regard to any renovation affecting the Hall roof and demolition of the detached house. Hence we recommend that that this work takes place when bats are inactive between November 2010 and March 2011. Should work need to be carried out before that time, it would be advisable to carry out an emergence survey to confirm absence of bats.

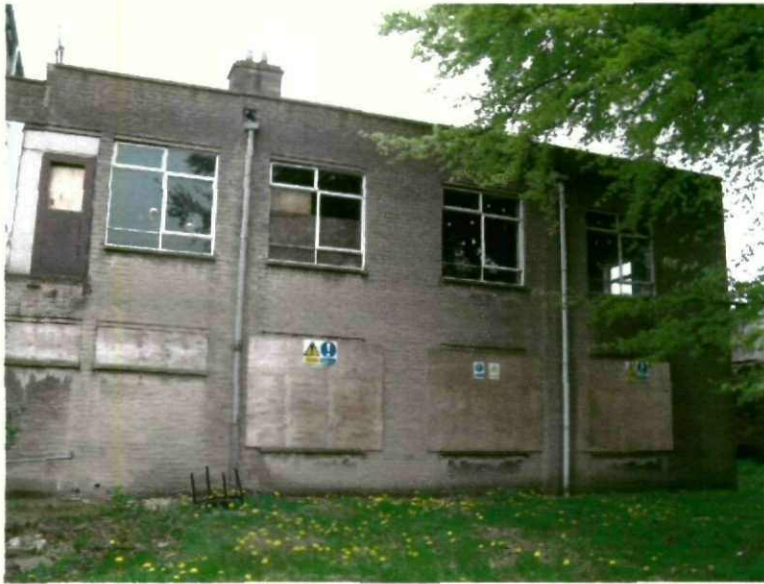
Figure 4
Brick built modern
extension at northern
elevation of Hall.

At the northern elevation of the building is a large two storey modern brick built extension (figure 4) with flat felt roof hidden behind low façade walls. This section of the hall is in good repair with sound pointing and no obvious areas which could offer roosting potential for bats.

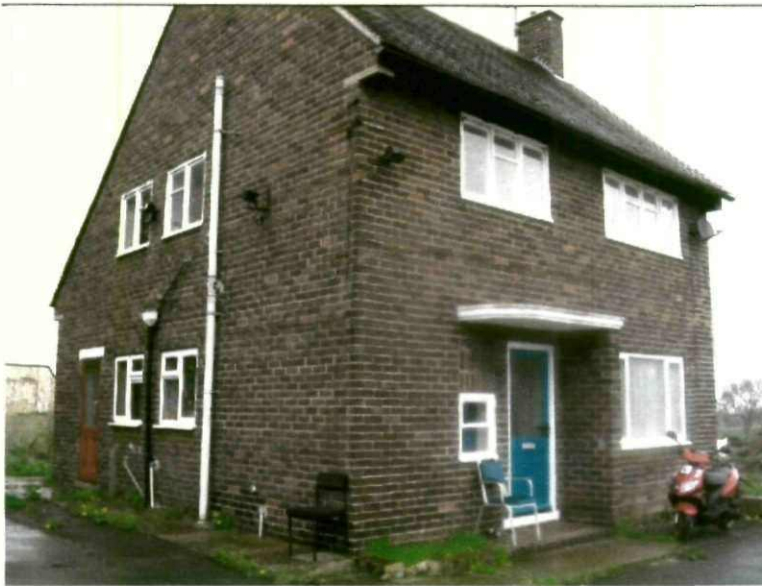
Figure 5

This is a two storey modern brick building with double pitched tile roof. All pointing is in excellent condition and the UPVC windows are well sealed to the brickwork providing no access points for bats. The roof is in reasonable condition although there are a few slipped tiles on the south east elevation creating gaps which could provide sporadic roosting for small numbers of bats. Pointing at the eastern gable end is sound, although at the western end some of the cement is

missing creating a crevice which again could provide opportunities for occasional roosts.

Detached house
viewed from the
south.
