**Manor Farm, Crane Moor**  
**Bat and Bird Survey Report**  
**5<sup>th</sup> May 2020**

| Document ref: MBE/BAT/2020/13/01 | | | | |

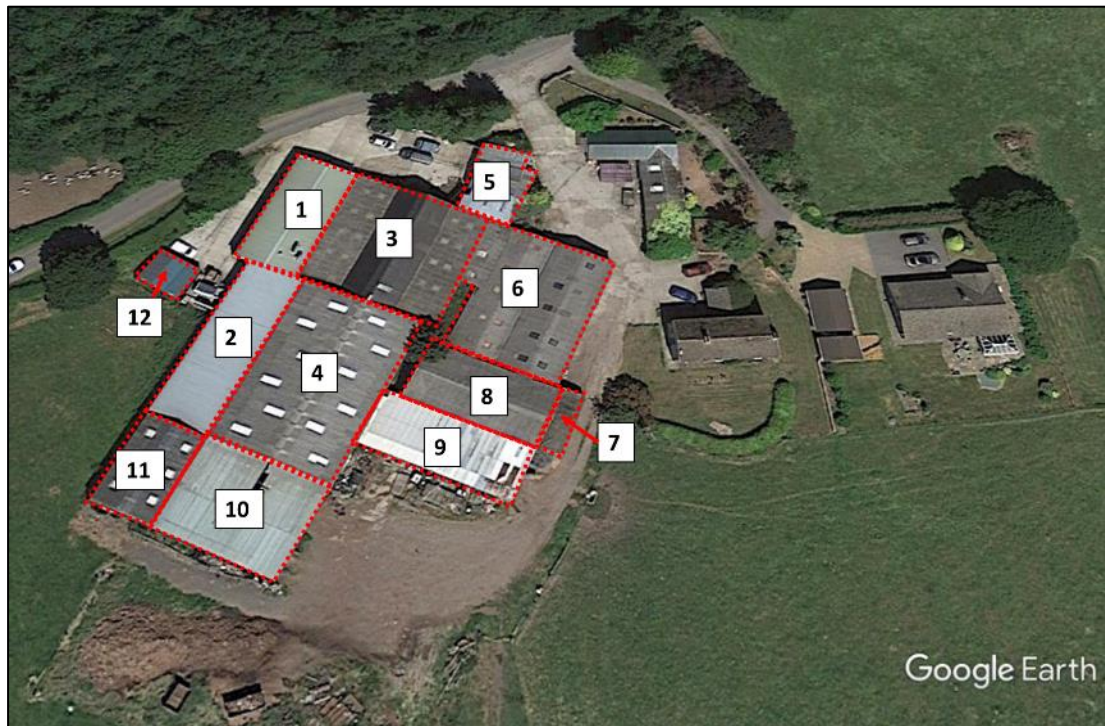
**Figure 2. Building numbering plan**

- 5.2.1 For the purpose of aiding description, the surveyed building complex has been divided into sections based on their construction, with building section numbers shown on Figure 2. All buildings were assessed as offering negligible bat roost potential, although nesting swallow *Hirundo rustica* and house sparrow *Passer domesticus* were recorded from the site. No signs of barn owl *Tyto alba* were recorded.

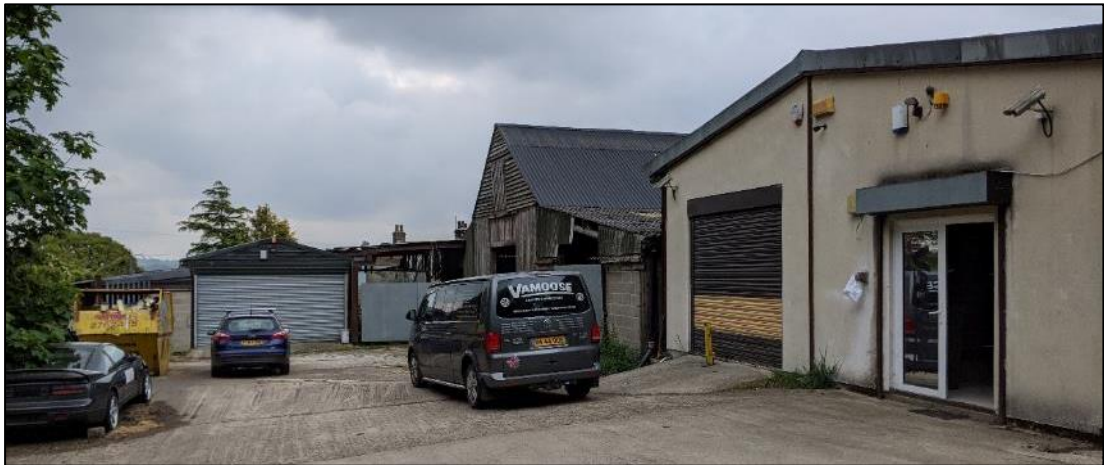
**Plate 1. Building Section 1 on right, with BS3 in centre of image and BS5 on left**

- 5.2.2 Building Section 1 comprises a relatively modern single storey concrete block built industrial buildings with a pitched roof covered by corrugated metal sheeting with metal verge capping (Plate 1). Gutter boards are present with uPVC and roller shutter doors in the northeast elevation. This building is part rendered.
- 5.2.3 No potential bat roost features were recorded from the exterior of the building, however, some crevices allow potential bat access into the roof space via the wall tops. Internally the building is used as industrial space with a false ceiling forming a roof space above. The unlined roof is suspended on a metal frame with 100mm of glass fibre laid on the false ceiling. The roof space has a height of up to 1m and is very dusty with little suitability for use by bats and no signs of bat presence recorded (Plate 2).

- 5.2.8 Building Section 5 comprises a small single storey steel framed outbuilding with a pitched corrugated sheet covered roof (Plate 1). Walls are part concrete block and part metal sheet with a metal roller shutter door. No potential roost features or bat access points into the building were noted. Internal access was not possible but was not considered necessary given the building's construction and the lack of potential access points.

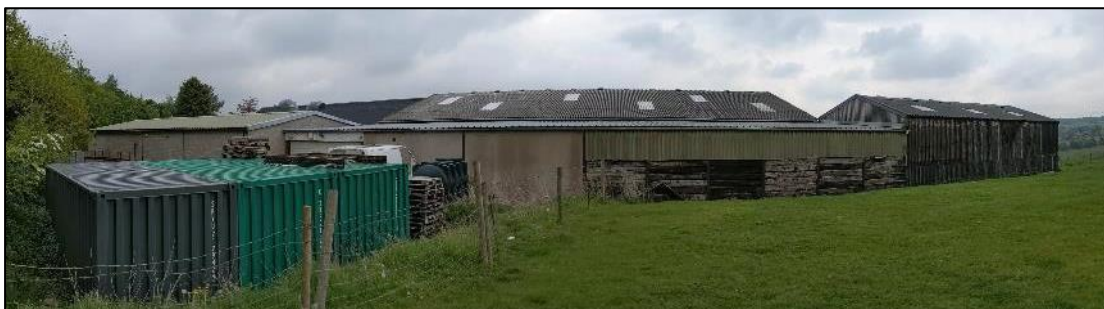
**Plate 3. Northwest side of building complex with BS12 on left of image, BS2 in centre and BS11 on right**

- 5.2.4 Building Section 2 comprises a modern single storey building with a flat corrugated metal sheet covered roof (Plate 3). The northern end is concrete block built and forms an extension to the industrial workspace in BS1, whilst the southern end has wood sleeper walls and corrugated sheet covered walls and comprises an extension to the adjacent barns. No potential bat roost locations were recorded from the exterior and this section of building lacks a roof space.

- 5.2.5 Building Section 3 comprises a single storey timber framed barn with a multi-pitched roof covered by corrugated metal sheet on the steeper central section and corrugated asbestos sheet on shallow pitched sides (Plate 3). This is likely to comprise the oldest section of building surveyed, however, it has been heavily modified over the years since construction. The building is timber cladded on the northeast elevation with partial concrete block and wood sleeper walls on northwest and southeast sides. The building is partly open on the northeast elevation, as well as the entirety of the southwest elevation, where it connects to BS10.

- 5.2.15 Building Section 12 comprises modern (built 2016) concrete block built single storey outbuilding with a shallow pitched corrugated metal sheet covered roof (Plates 3 & 10). No potential roost features or bat access points into the building were noted. Internal access was not possible but was not considered necessary given the building's construction and the lack of potential access points.

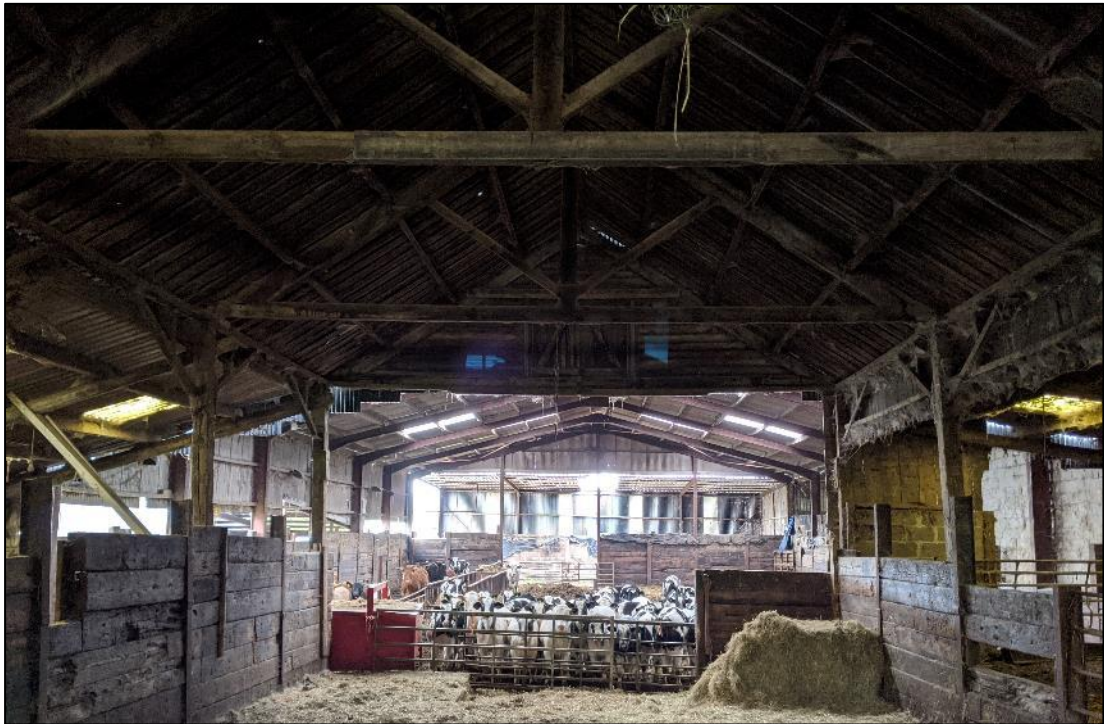
**Plate 4. Interior of BS3**

- 5.2.6 No potential bat roost features were recorded from the exterior of BS3, however, numerous potential access points to the interior are present. The roof is lined with spaced timber boards and is suspended on timber king-post trusses and purlins (Plate 4). No void is present, and no signs of bats were noted. An old swallow nest was recorded from a roof timber.

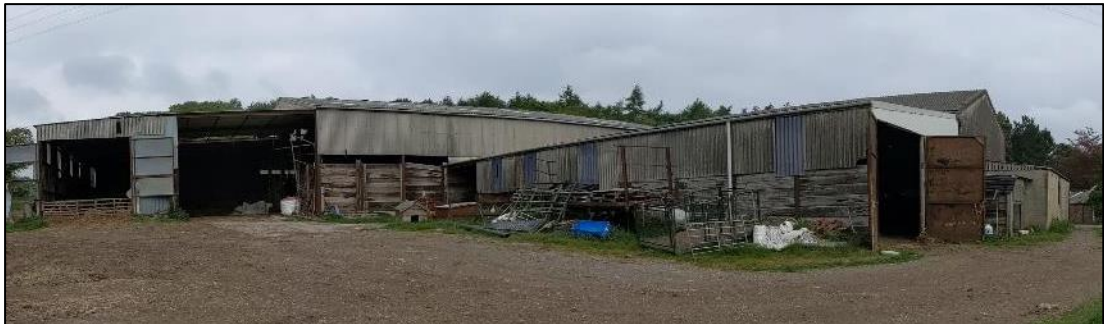
**Plate 5. Southern end of building complex with BS8 and BS9 on right of image, BS4 in centre and BS10 on left**

- 5.2.7 Building Section 4 is located centrally within the building complex and comprises a single storey metal framed barn with a pitched corrugated asbestos sheet covered roof (Plate 5). This structure is partly open sided and was being used to contain a herd of cows at the time of survey (Plate 6). Walls, where present, comprise stacked wood sleepers and corrugated sheet. No potential roost features were recorded from this building section.

- 5.2.11 Building Section 8 comprises a concrete framed single storey barn with a multi-pitched roof covered in corrugated asbestos sheet (Plate 5). This structure is part open sided with the walls partly comprising concrete block, with some corrugated asbestos sheet cladding. No potential bat roost features were recorded from BS8.

- 5.2.12 Building Section 9 comprises a metal framed single storey lean-to constructed against BS8 (Plate 5). This structure has a single-pitched corrugated metal sheet covered roof and is part open-sided with some walls comprising stacked wood sleepers and corrugated asbestos sheet cladding. No potential bat roost features were recorded from BS9.

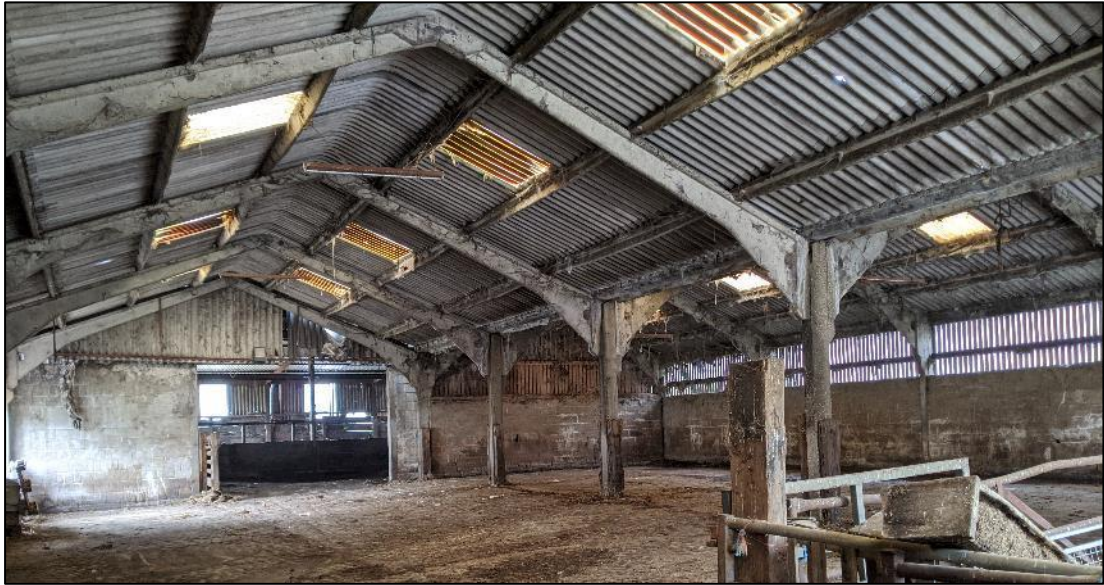
**Plate 7. Interior of BS6**

- 5.2.9 Building Section 6 comprises a concrete framed single storey barn with a multi-pitched roof covered in corrugated asbestos sheet (Plate 7). This structure is part open sided

with the walls partly comprising concrete block, with some corrugated asbestos sheet cladding. A single void in the exterior of the blockwork wall on southeast elevation was noted and subject to an endoscopic inspection, with no signs of bat presence noted. No other potential roost features were recorded from BS6.

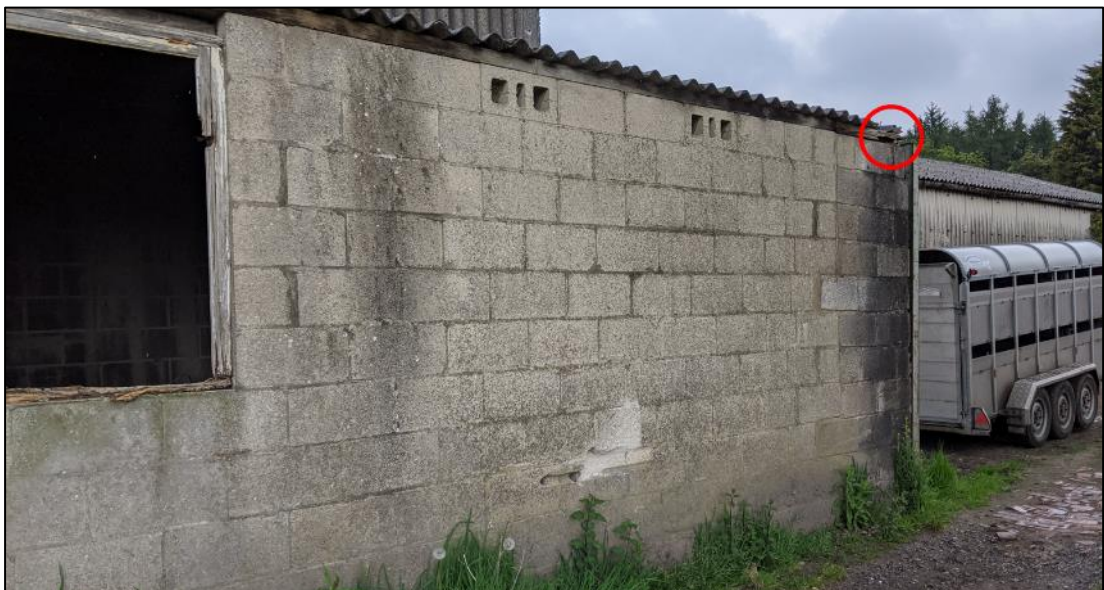
- 5.2.10 Building Section 7 comprises a small concrete single storey extension to the BS8 with a flat corrugated asbestos sheet roof (Plate 8). A historic swallow nest was recorded from an internal roof beam and an active house sparrow nest was recorded from a void within a concrete block, accessed from the top of the external wall (Plate 8). No potential bat roost features other than the house sparrow nest location, were recorded.

**Plate 8. Southeast elevation of BS7, with house sparrow nest location indicated by red circle**

- 6.3.3 Nesting house sparrow and swallow were confirmed from the surveyed building complex. It is recommended that two integrated sparrow nest boxes (i.e. Vivara Pro WoodStone House Sparrow Nest Box) are constructed into the northeast elevations of new dwellings.
- 6.3.4 It is also recommended that mitigation for nesting swallows is incorporated within the development. Suitable mitigation may include the provision of two swallow nest cups within either a newly constructed open sided structure (i.e. car port or log store) or within a retained barn.
- 6.3.5 Demolition of site buildings will either need to be undertaken outside the bird nesting period (March to September inclusive) or the works will need to be preceded by a nesting bird check undertaken by an experienced ecologist.

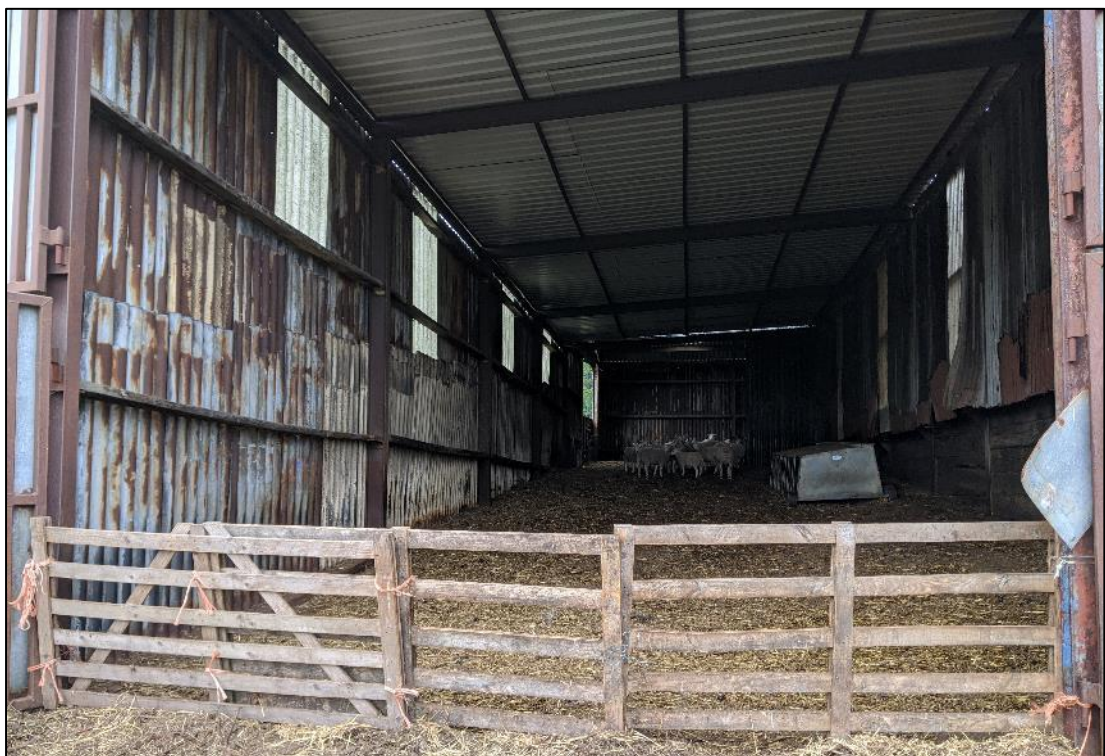
**Plate 9. Interior of BS10**

- 5.2.13 Building Section 10 comprises a metal framed single storey lean-to constructed against BS4. This structure has a single-pitched corrugated metal sheet covered roof and is part open-sided with some walls comprising stacked wood sleepers and corrugated asbestos sheet cladding (Plates 9 & 10). No potential bat roost features were recorded from BS10. This structure, together with BS11 and part of BS2 were being used to contain sheep at the time of survey.

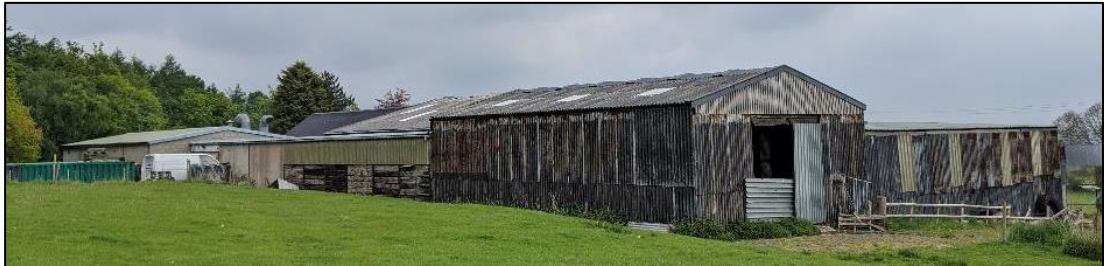
- 5.2.14 Building Section 11 comprises a metal framed single storey barn with a pitched corrugated asbestos sheet covered roof (Plate 10). This structure is part open sided with some walls comprising corrugated metal sheet and hit-and-miss timber cladding. No potential bat roost features were recorded from BS11.

**Plate 10. Building Sections 12 & 2 on left of image with BS11 in centre and BS10 on right**
