**347 DONCASTER ROAD.**

**BAT SURVEY.**

**Ref No: 190474/1.**

**Date: 7<sup>th</sup> May 2019.**

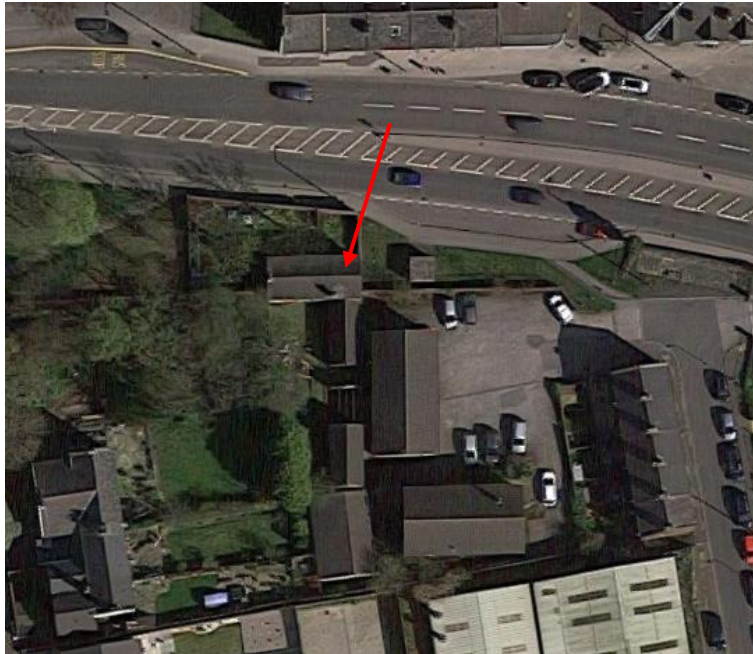
3.2.2. The aerial photograph below shows the buildings currently on the site. There is a two-storey house facing Doncaster Road with a further series of outbuilding at right angles behind the house.

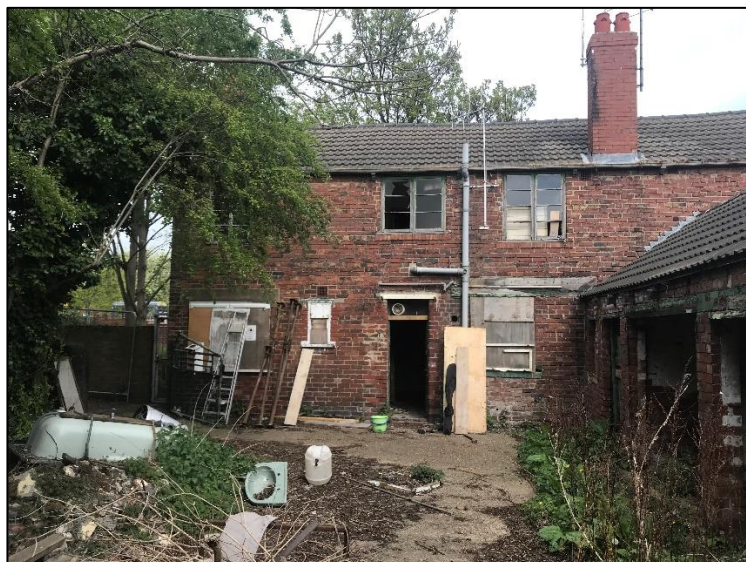
3.3.1.1. The house is a two-storey brick building with solid brick walls, as shown in the photograph below showing the rear of the building.

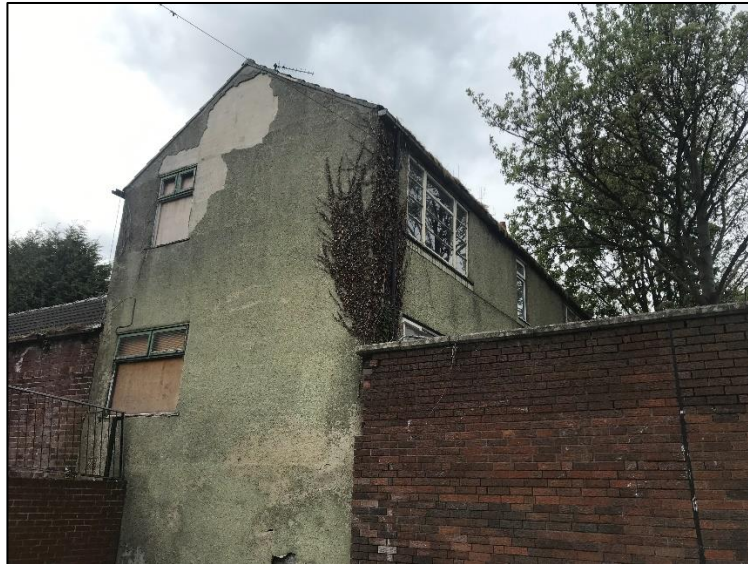
3.3.1.2. The photograph below shows the front on the building and the eastern gable end wall from Doncaster Road. This shows that these faces are rendered over the bricks.

3.3.1.3. The walls are generally in good condition although there are occasional small gaps between the brickwork towards the eaves.

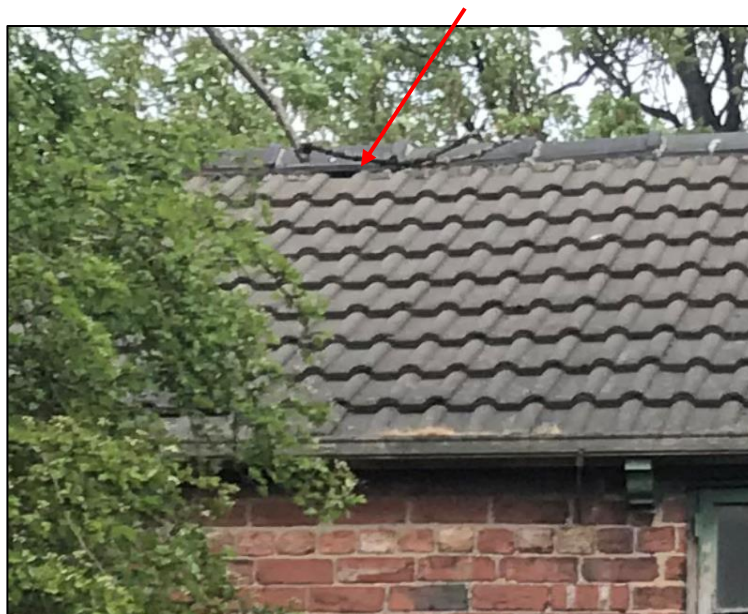
3.3.1.4. The pitched roof of the building is fairly modern and has been replaced with interlocking tiles. This is sound condition with all tiles in place and no gaps between. All ridge tiles are also in place although there are occasional gaps beneath them that provide some opportunity for roosting bats.

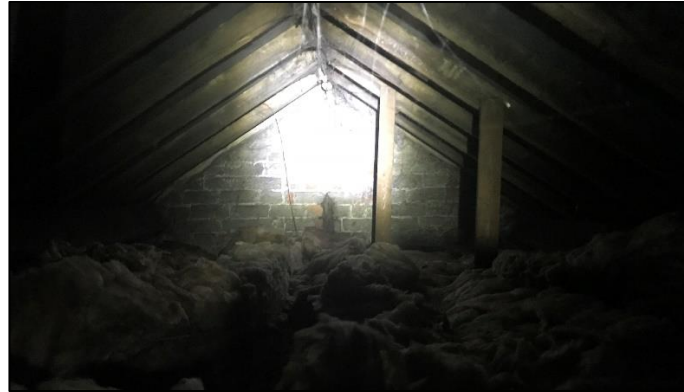
3.3.1.5. There are two loft spaces above the house, one accessible through the loft hatch and the other through a hole in the ceiling. The roof comprises a purlin and joist arrangement and the loft is shallow as the top floor rooms extend partly into the loft

space. There is a breathable membrane lining beneath the roof tiles inserted when the roof was replaced. There were no signs of daylight in the loft space.

3.3.1.6. No bats or bat field signs were identified in the loft spaces and both contained abundant cobwebs throughout.

3.3.1.7. This building was assessed to have a LOW potential for individual, crevice dwelling bats to roost.

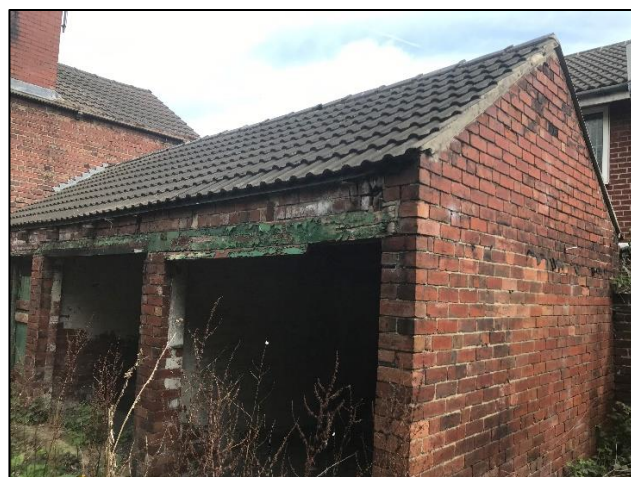
3.3.2.1. Immediately to the rear of the dwelling there is a block of single storey garages with solid stone walls and a pitched, interlocking tiled roof. The western aspect of the building contains two double door openings, each to a garage sized open room and one pedestrian door and window into an outside storage space. All are completely open to the underside of the roof, which has been replaced at the same time as the house roof and comprises interlocking tiles with a breathable membrane lining.

3.3.2.2. No bats or opportunities for roosting bats were identified anywhere within this block.

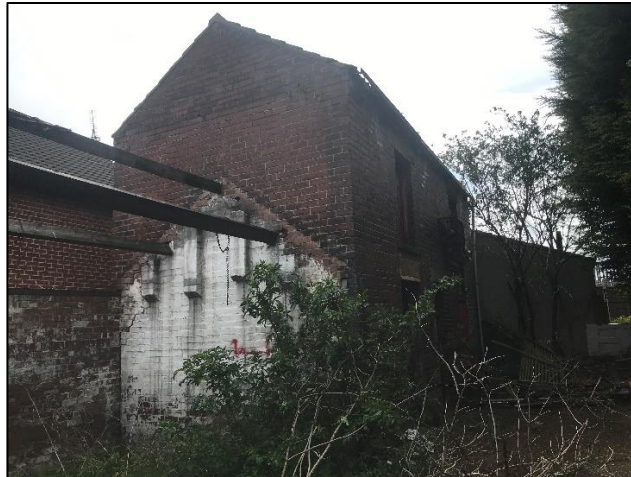
3.3.2.3. To the rear of the site there is a further single storey garage, but this is now devoid of the roof, which was burnt down by fire. This building is unsuitable for roosting bats and no bat field signs were found inside or outside this building.

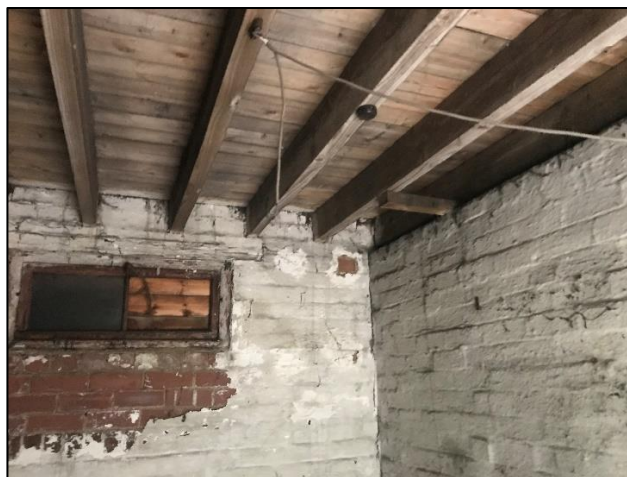
3.3.2.4. Beyond that, there is a two-storey outbuilding. This is constructed with solid brick walls, the same as the house.

3.3.2.5. The ground floor rooms have no doors and comprise open storage with a timber ceiling and whitewashed walls.

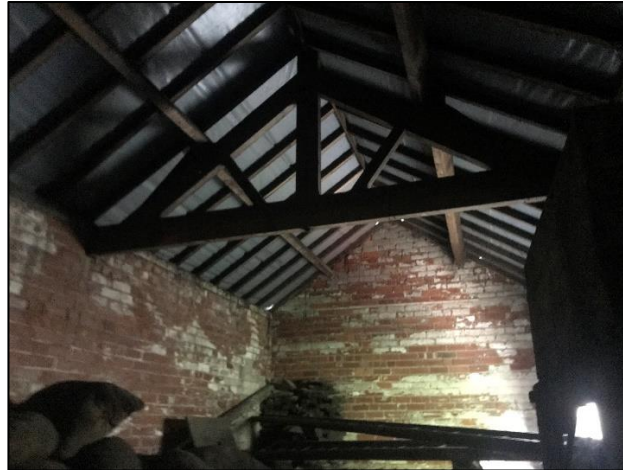
3.3.2.6. Upstairs there is open room with open windows to the outside. The walls are solid brick and have been whitewashed at some time in the past although much of this has fallen off.

3.3.2.7. The roof of this building is supported by a king post timber structure and the tiles above were replaced at the same time as the other roofs on the site. This building is covered with interlocking tiles with a breathable membrane lining.

3.3.2.8. No bats or bat field signs were identified in these buildings and this building was assessed to have negligible potential for roosting bats.

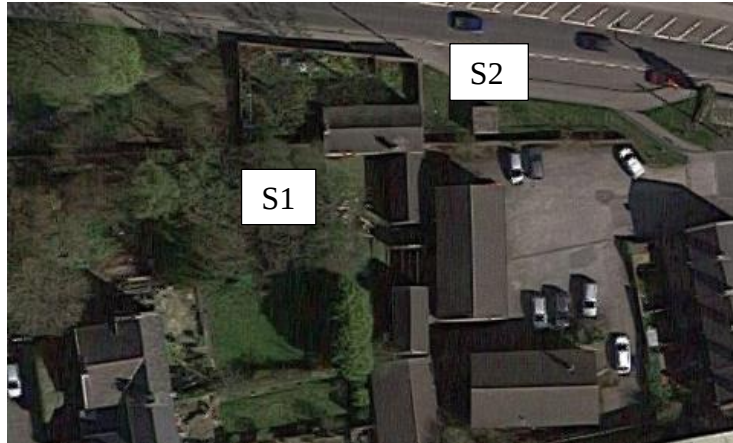
3.3.3.3. The two surveyors were positioned so that they could see all aspects of the house to be surveyed. The outbuildings had been assessed to have negligible potential for roosting bats and therefore did not require a dusk emergence survey. The position of each surveyor was as shown on the aerial photograph below.
