**WOOD NOOK FARM, STAINBOROUGH.**

**BAT SURVEY.**

**Ref No: 220207/1.**

1.1. There are plans for the conversion of a barn into living accommodation at Wood Nook Farm in Stainborough.

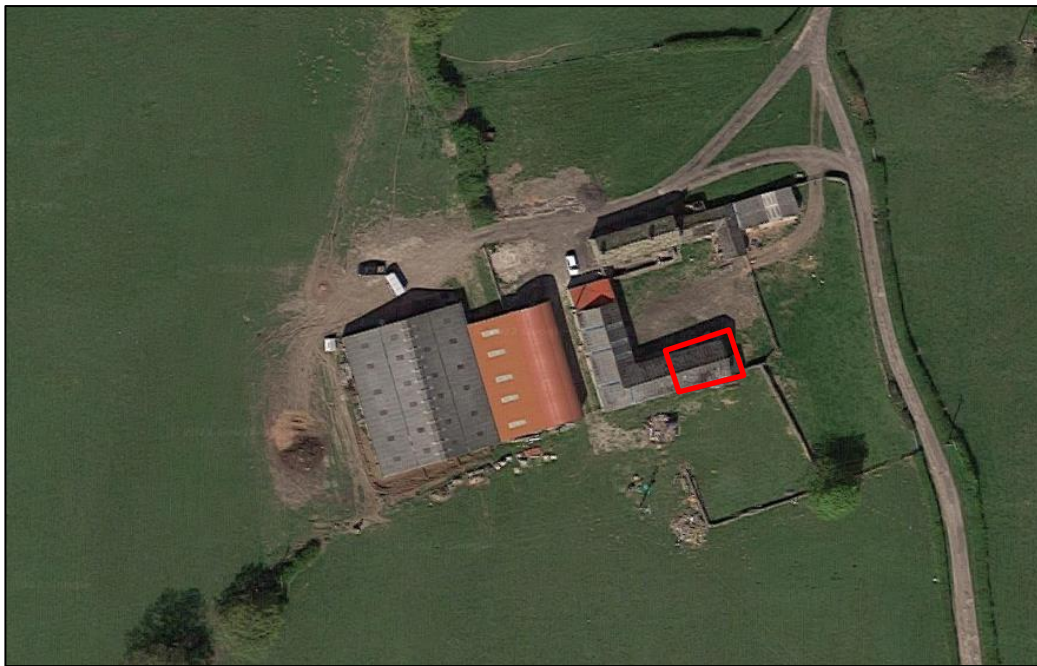
3.2.1. The survey area is the eastern end barn at Wood Nook Farm in Stainborough. The surveyed building is shown on the aerial map below.

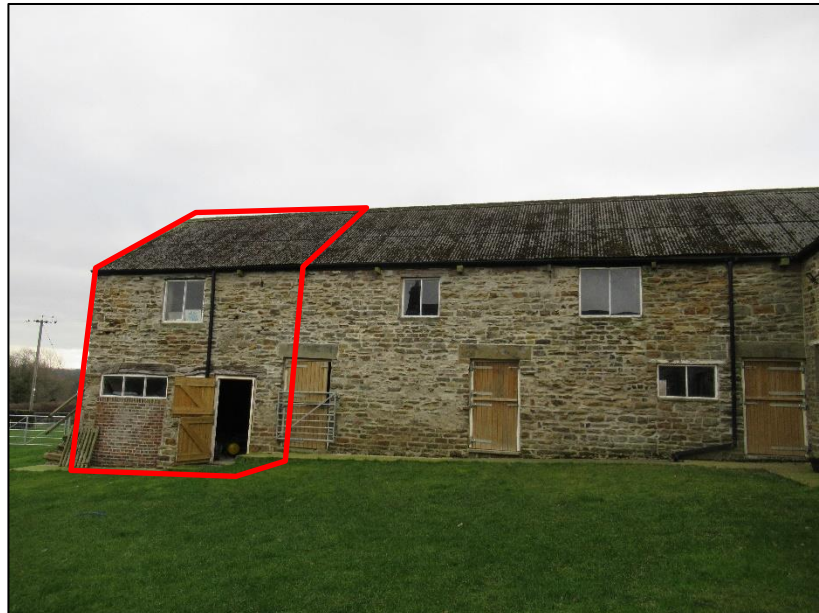
3.3.1. The survey area is a barn joined to the end of an existing building. The surveyed building is shown below.

3.3.2. The barn is two storey and constructed with rubble filled brick walls with a few small areas of solid brick wall where doorways and gaps have been bricked up in the past. The building is joined to the adjacent building at the western end.

3.3.3. The roof is pitched and covered with corrugated cement sheets and ridge. There are timber fascias around the building. All doors and windows are in place and well-sealed.

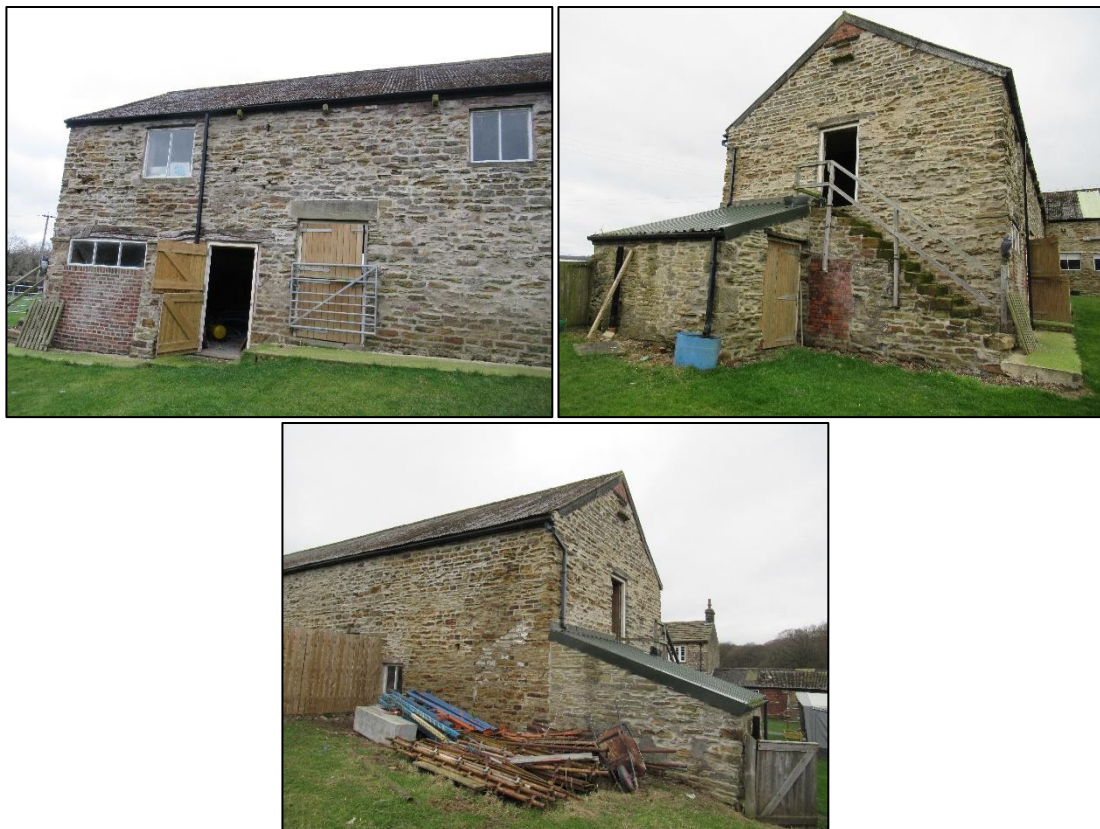
3.3.4. There is a small single storey lean to extension on the eastern end of the building with stone walls and a sloping roof covered with corrugated metal sheets.

3.3.5. Externally the roof is generally in good condition with all roof sheets in place and the ridge well fitted. However, there is some sign of water damage in the first floor room.

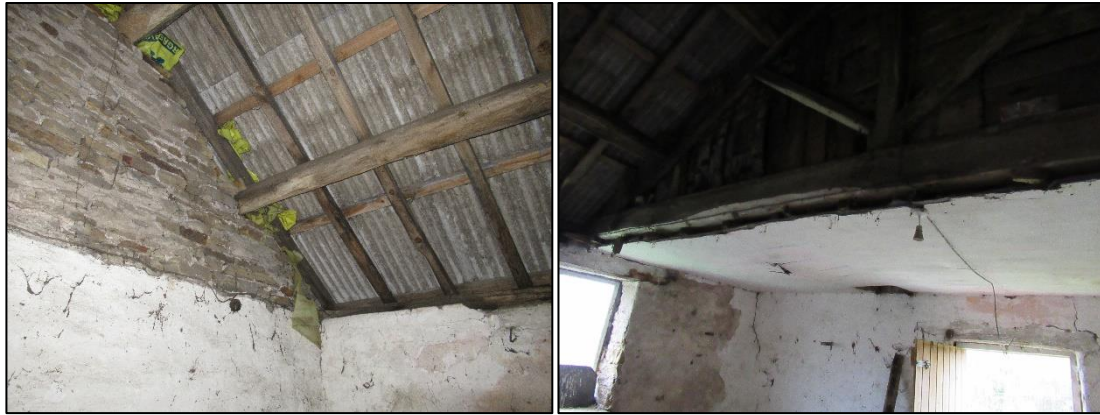
3.3.6. Internally there are two rooms. The first floor room is partly open to the underside of the roof, which has no lining under the corrugated roof sheets with timber beams. The other half of the room has a small loft space, which is boarded with no access into this area.

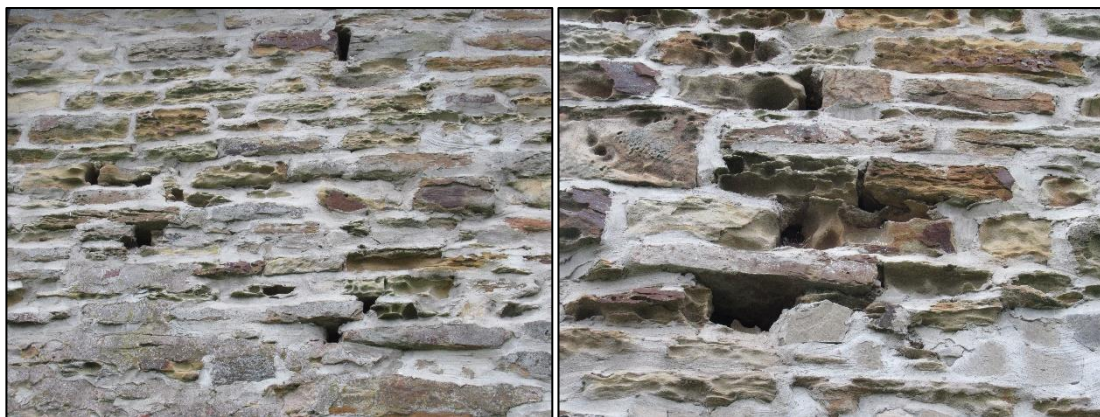
3.3.7. Externally there are numerous holes in the stonework on the northern side of the building. On the southern side of the building there is one hole in the wall, which is approximately 150mm square and leads through the wall into the ground floor room. These holes provide opportunities for roosting bats.

4.1. The building is generally in good condition and well-sealed. However, the holes in the stone walls and the gaps below the fascias of the building provide opportunities for roosting bats and the building has been assessed as providing low potential for roosting bats.

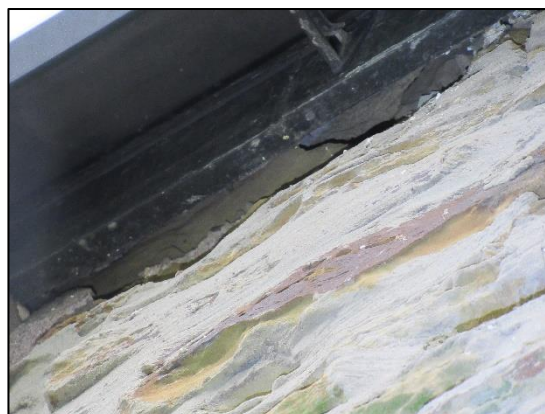
3.3.8. The fascias are in place but due to the uneven nature of the stonework there are some gaps below the fascia boards which could provide potential for roosting bats.

3.3.9. No bats or bat field signs were identified around the interior or the exterior of the building. However, due to the holes in the stone walls and the gaps below the fascias, the building has been assessed as providing **low** potential for roosting bats.

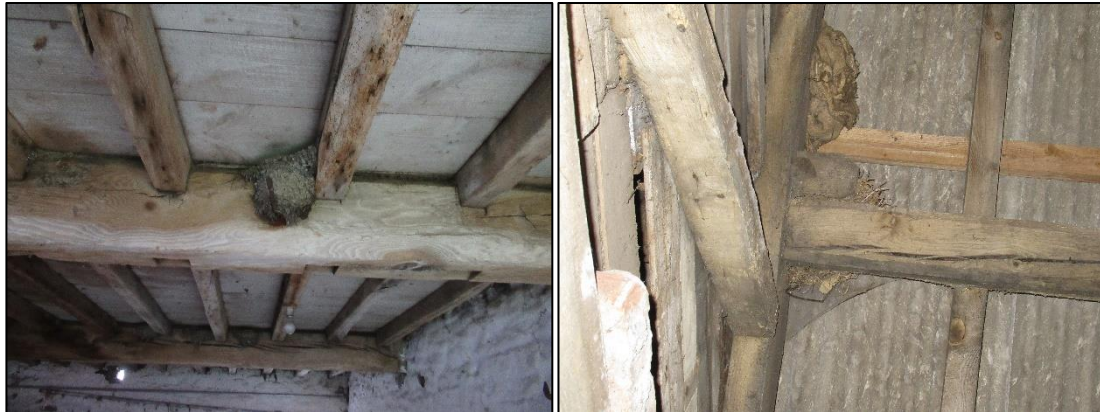
3.3.10. In the ground floor room, seven old swallow nests were identified on beams. In the first floor room a large nest was seen on a beam.

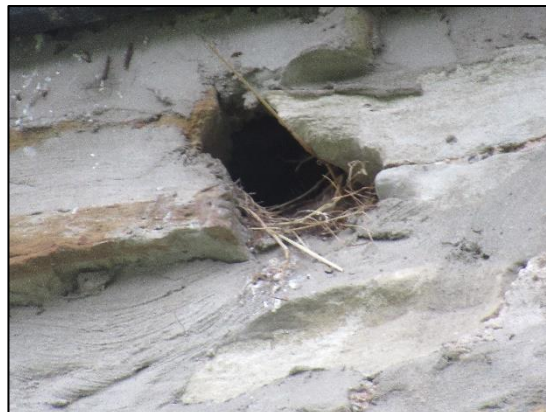
3.3.11. Externally sparrows were seen in two of the holes in the northern wall and signs of a nest were identified in another of the holes.

4.4. However, sparrows were seen in two of the external holes in the northern wall and a nest was seen in another of the holes showing that sparrow use these holes to nest. Therefore, works to the building will have a high impact on nesting birds if carried out during the nesting season, between March and September, but nesting can start earlier in the year if the weather is mild.

5.3. As birds are using the holes in the northern wall to nest it is recommended that no works are carried out that could disturb nesting birds during nesting season, which extends from March to September.

5.4. It is recommended that sparrow terrace nest boxes are put up on the building or an adjacent building to provide additional nesting opportunities for sparrows.

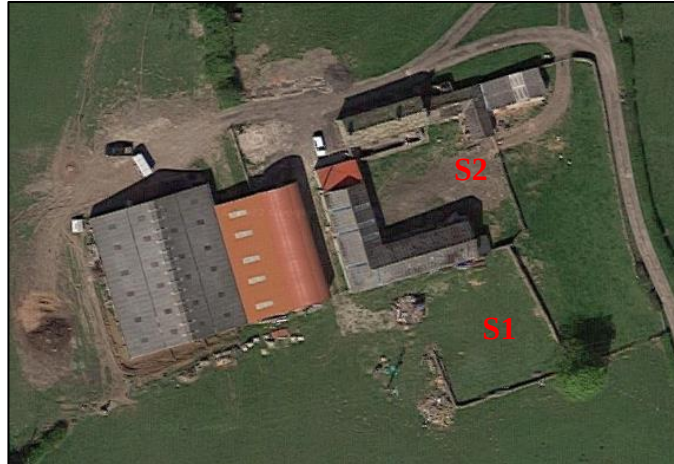
3.4.2. The two surveyors were positioned so that they could see all aspects of the building to be surveyed. The position of each surveyor (S) was as shown on the aerial photograph below. Each surveyor was equipped with a Batbox Duet detector and a two-way radio for communication and a static Anabat recorder was placed close by to record bat activity for subsequent computer analysis using Analook software.

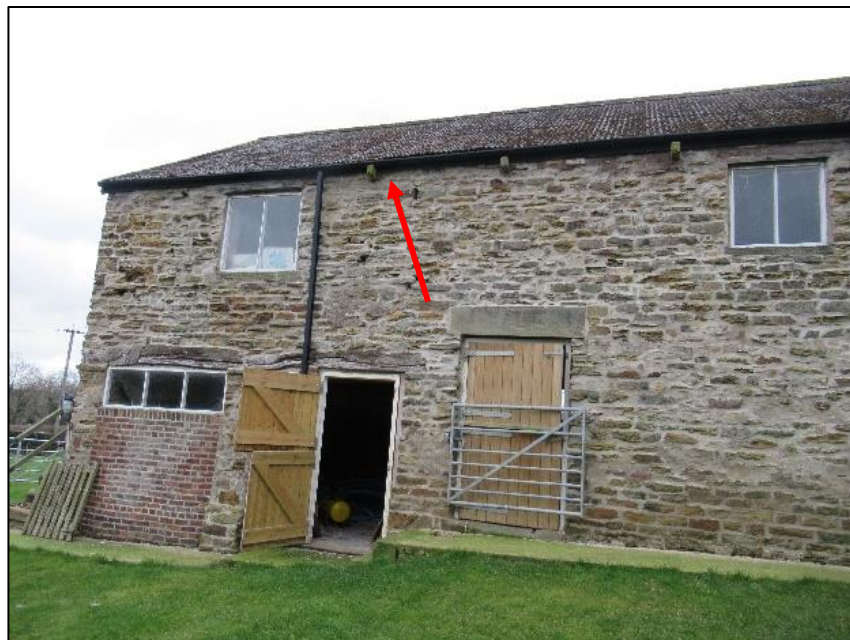
3.4.4. A low level of Common Pipistrelle activity was recorded. Over the site and a single Common Pipistrelle emerged from the building at eaves height at 21:42. The location the bat emerged from is shown below.

4.2. The subsequent dusk emergence survey found a single Common Pipistrelle emerge from the northern face of the building, as well as foraging within the survey area. Therefore, any works to the building will have a high impact on roosting bats.

5.1. A Common Pipistrelle was found to emerge from the building and therefore, there is a requirement to attain a Natural England EPS Licence prior to the commencement of works to the building. This requires two further surveys, one of which must be a dawn return survey. These surveys must be undertaken in the active bat season (May – August) and be at least two weeks apart.

5.2. On the completion of these surveys, once planning permission has been granted, a Natural England EPS Licence must be applied for and granted before works commence.
