## **Appendix B**

### **Photographs**

**BARNSLEY ROAD, DARTON.**

**PHASE 1 HABITAT SURVEY AND  
PROTECTED FAUNA SURVEY.**

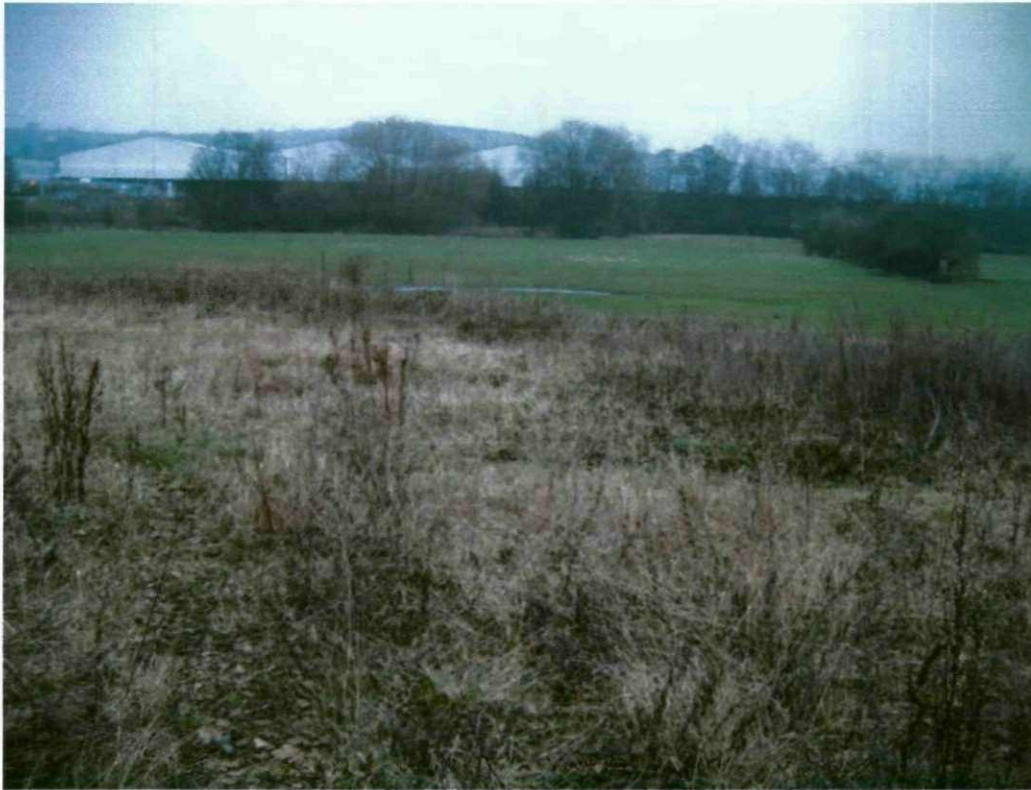
Photograph Number 1 showing the rough land and the paddock beyond the stream.

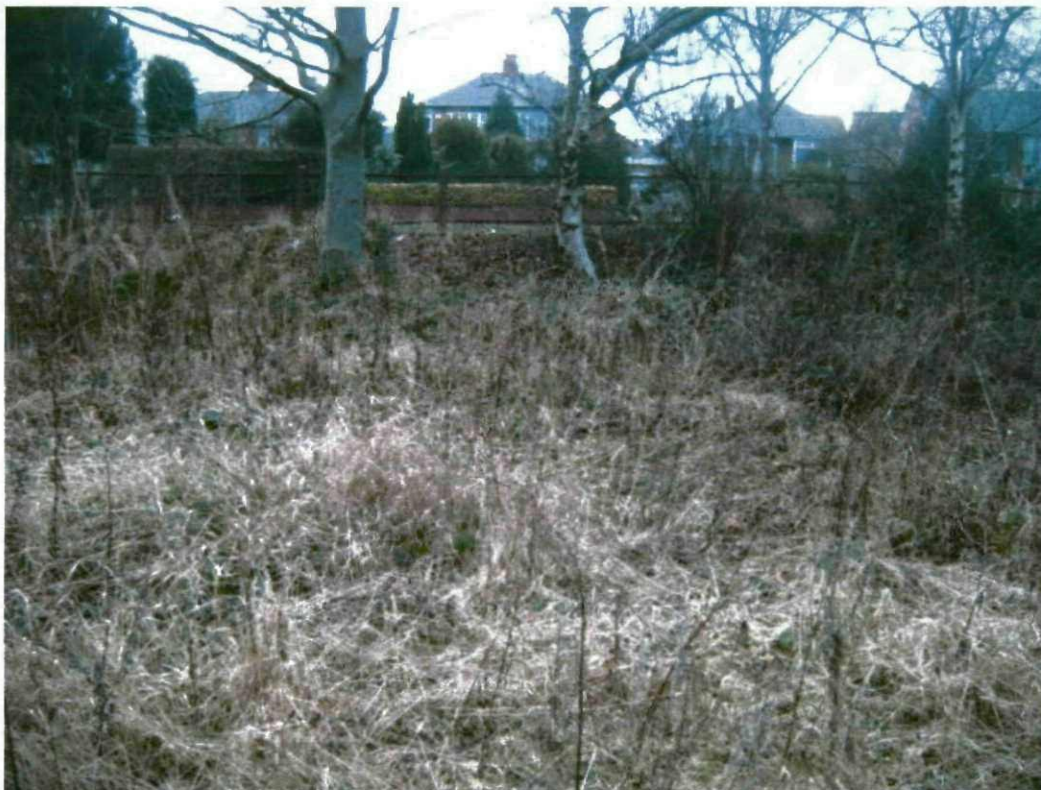
Photograph number 2 showing the hedge line with gaps in the tree line along Barnsley Rd.

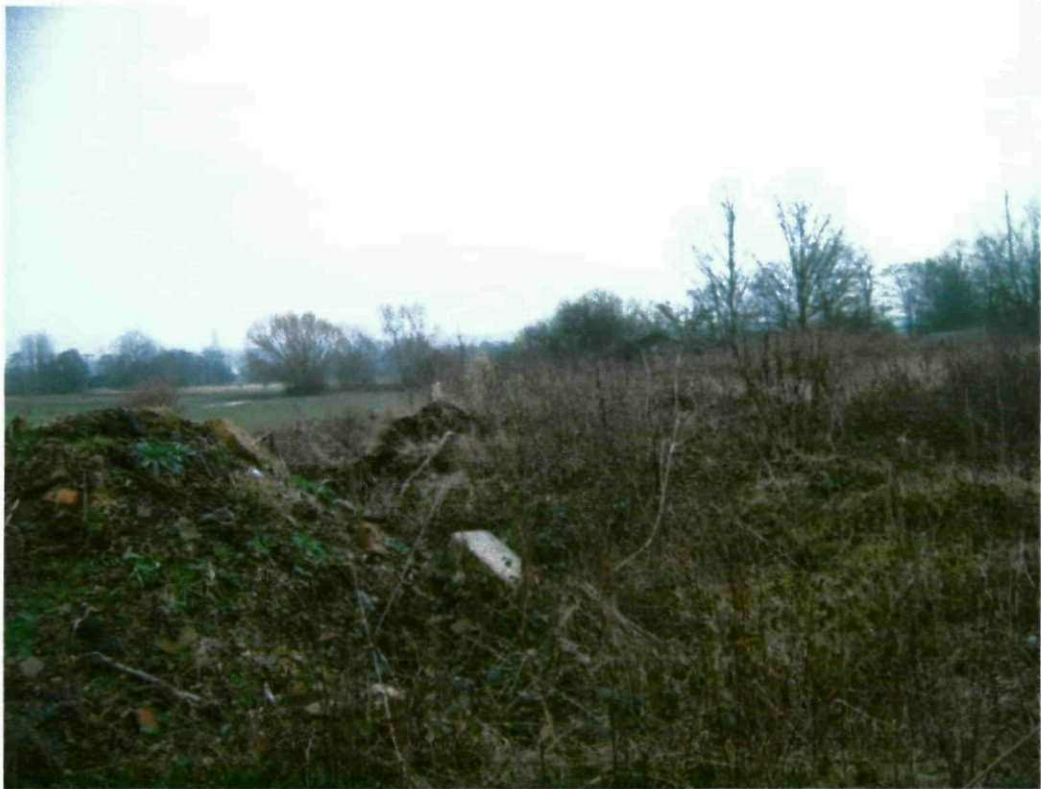
Photograph number 4 showing the hummocks and large blocks of concrete at the surface.

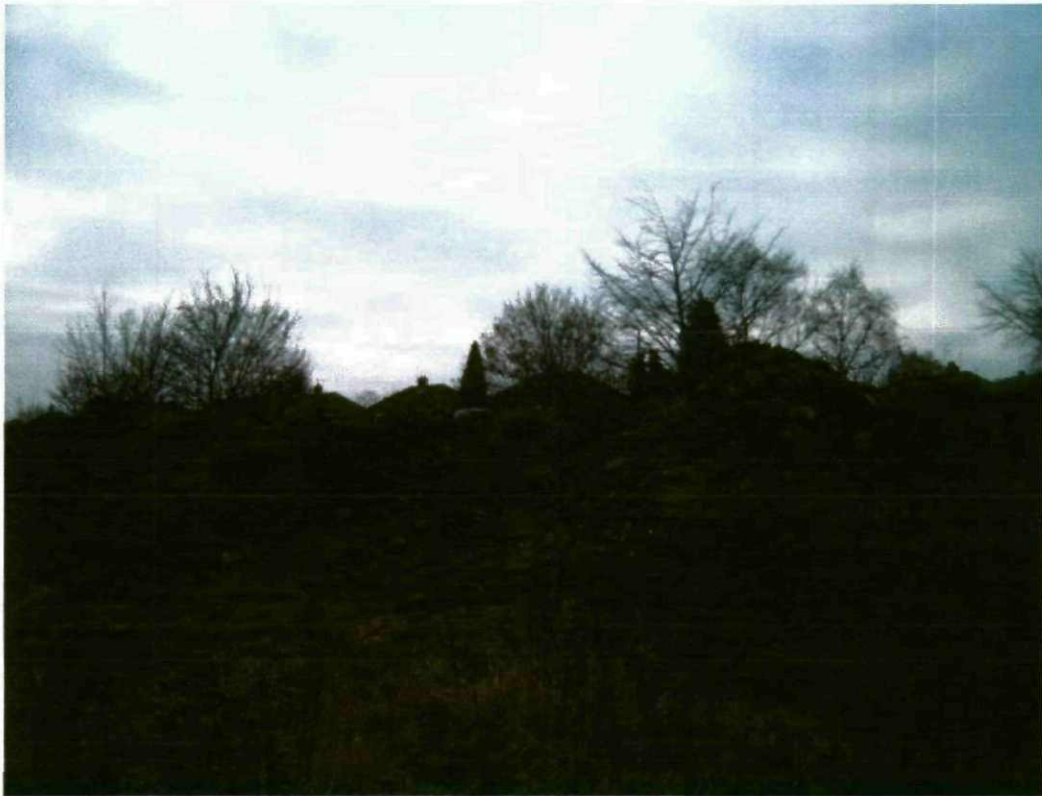
Photograph number 5 showing the bank side down to the stream with construction rubble and hummocks making the land unsuitable for any use.

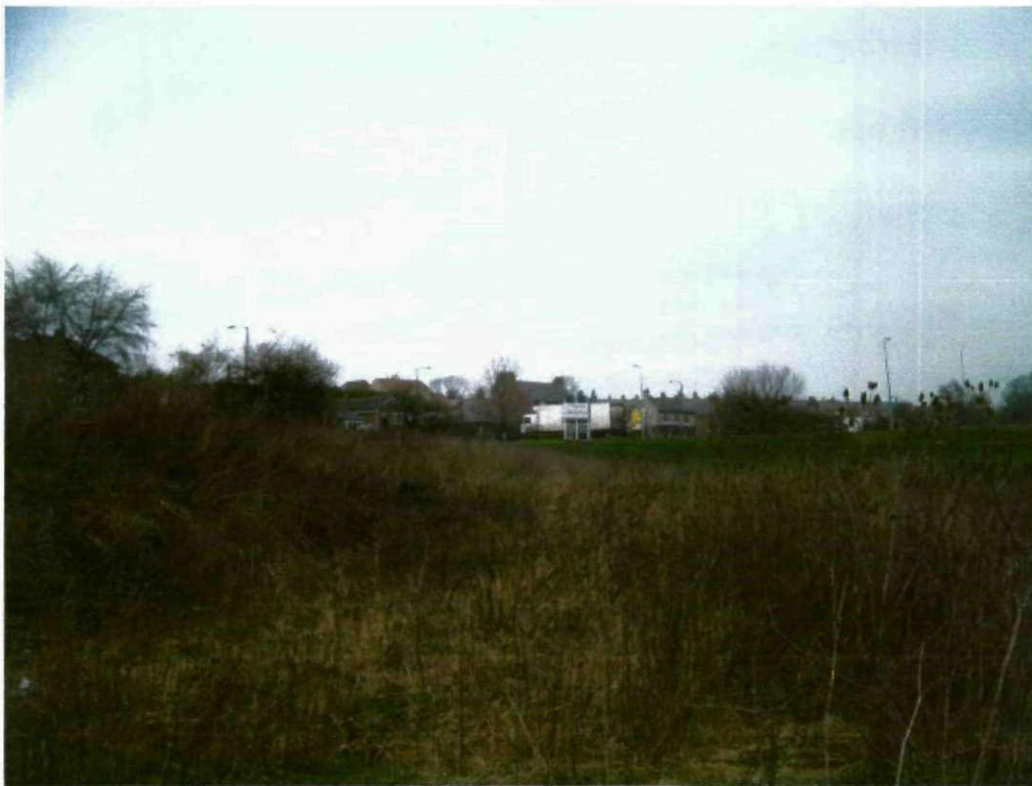
Photograph number 6 showing the lower part of the site near the watercourse and the slope down to the stream which renders the land unusable for anything.

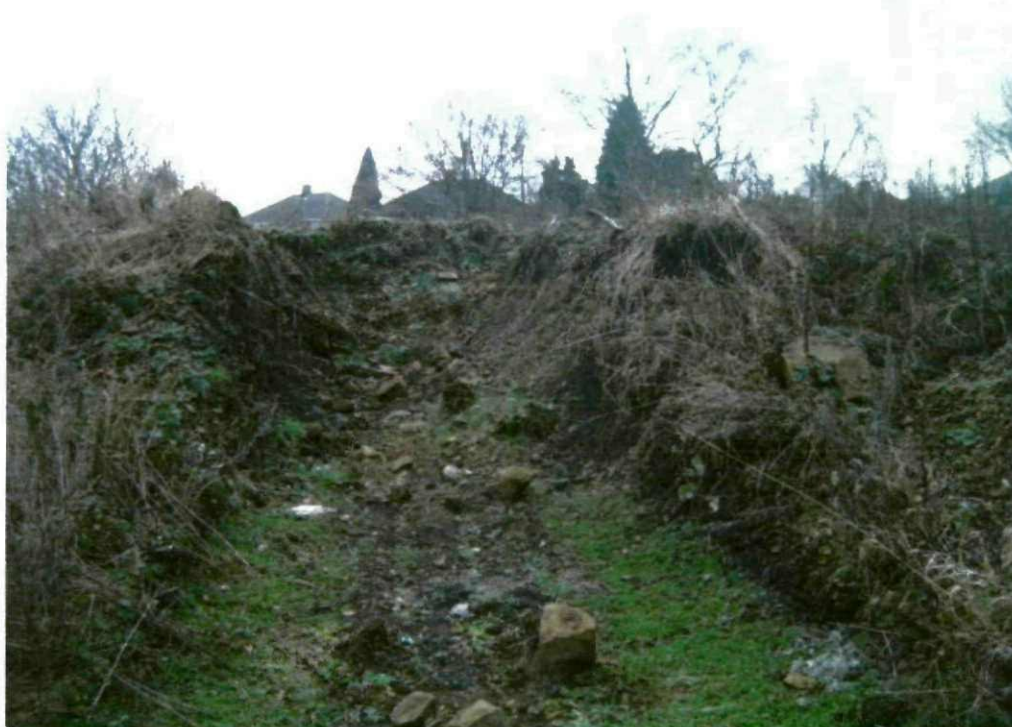
Photograph number 7 showing the excavations in the tip and illustrating the type of material tipped by the Council which is rubble, brick, concrete and sandstone kerbs and setts.

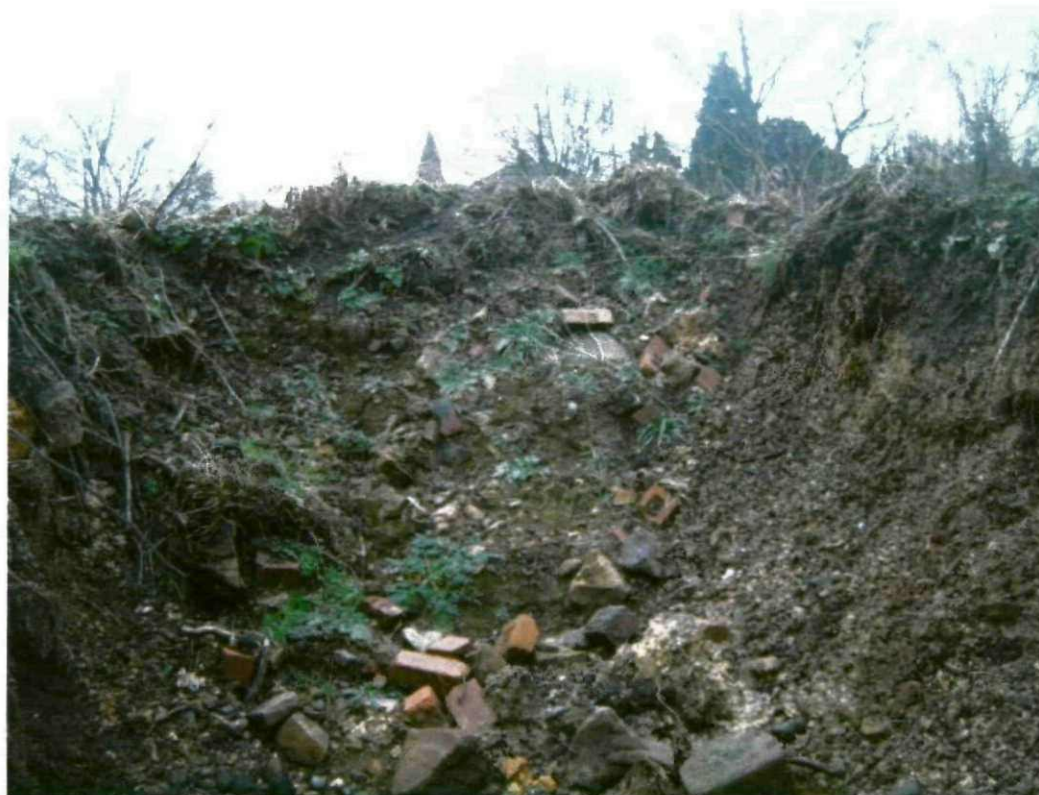
Photograph number 8 showing the soil making material and the coarse rubble which will be screened for the site roads and hard standing.

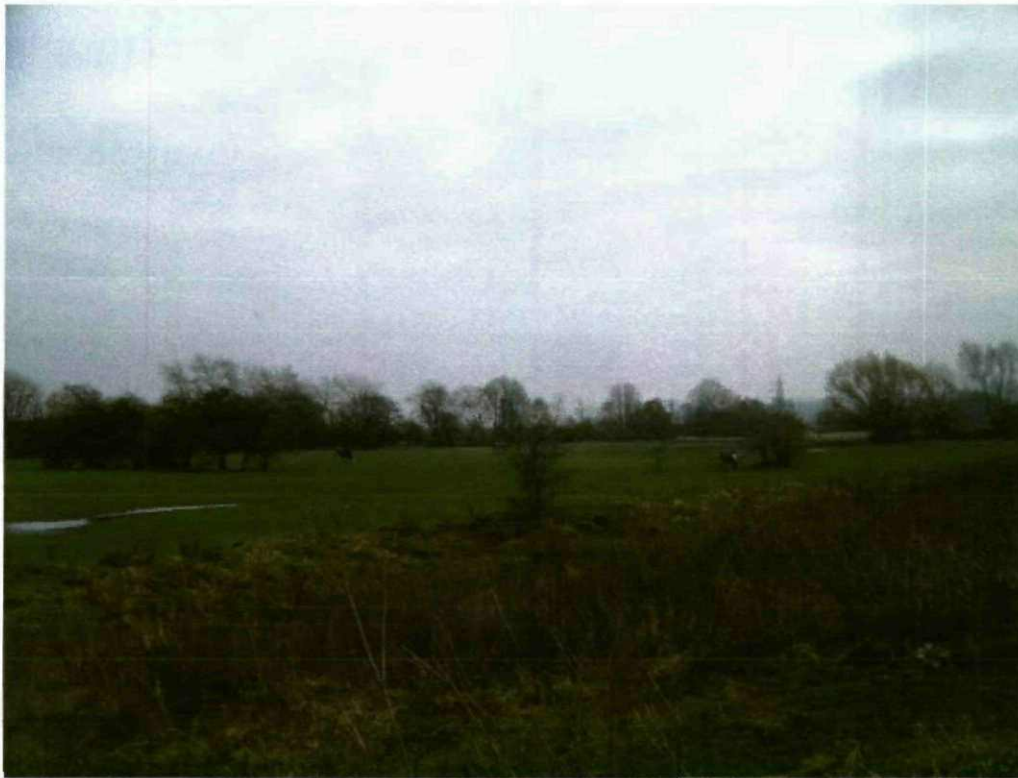
Photograph number 9 showing the tip in the foreground and the paddock on the other side of the stream at a lower level which attenuates the flooding from the river.

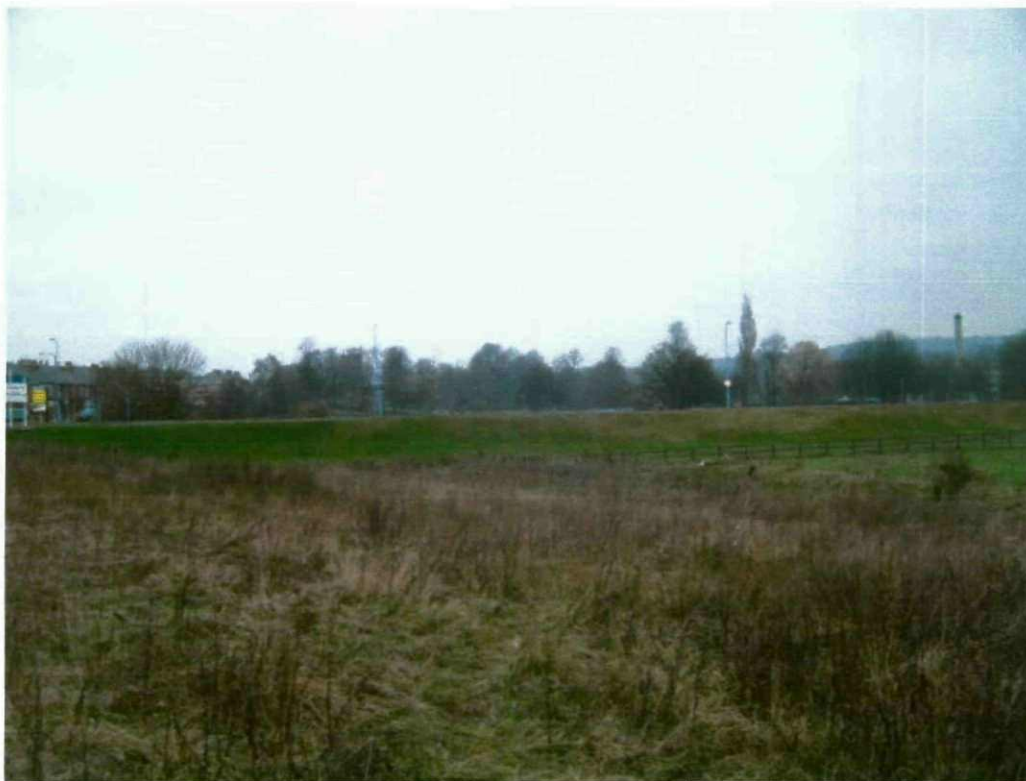
Photograph number 10 showing the tip and the paddock to the east of the stream. Note the land is undulating and rough so is not suitable for any use at the moment.

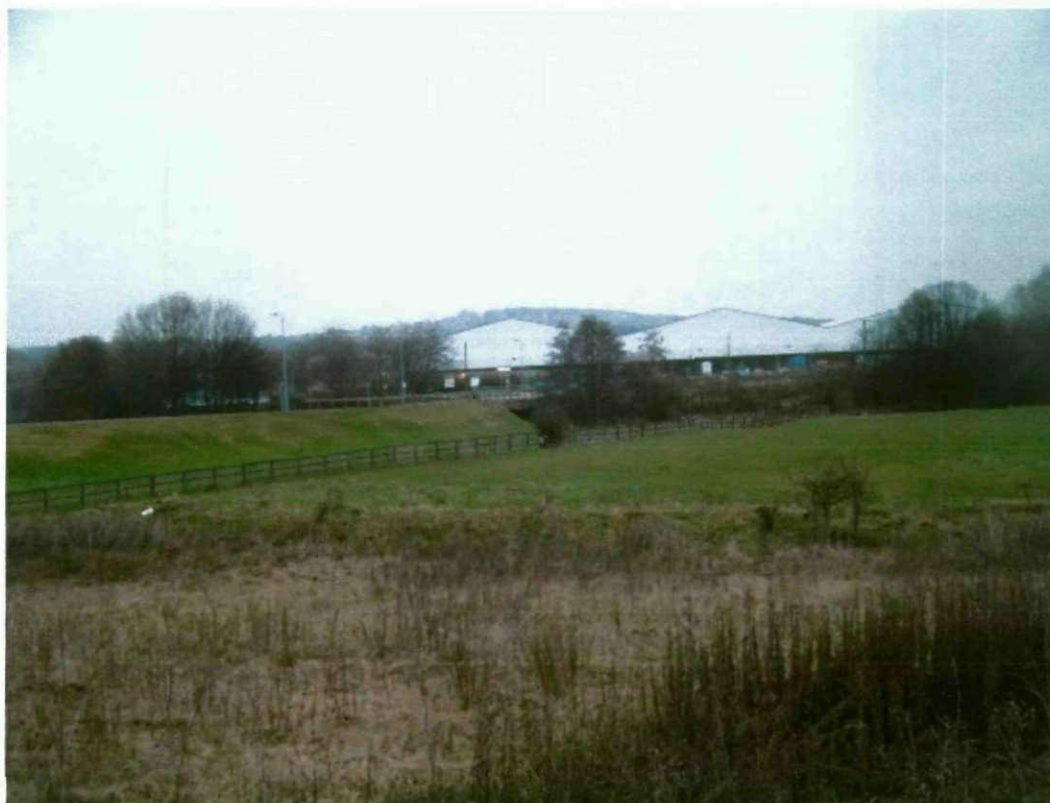
Photograph number 11 showing the extent of the green space and the access road to the carpet warehouse. Note the land slopes steeply for any livestock use and is rough which could damage horses or other livestock if not capped off.

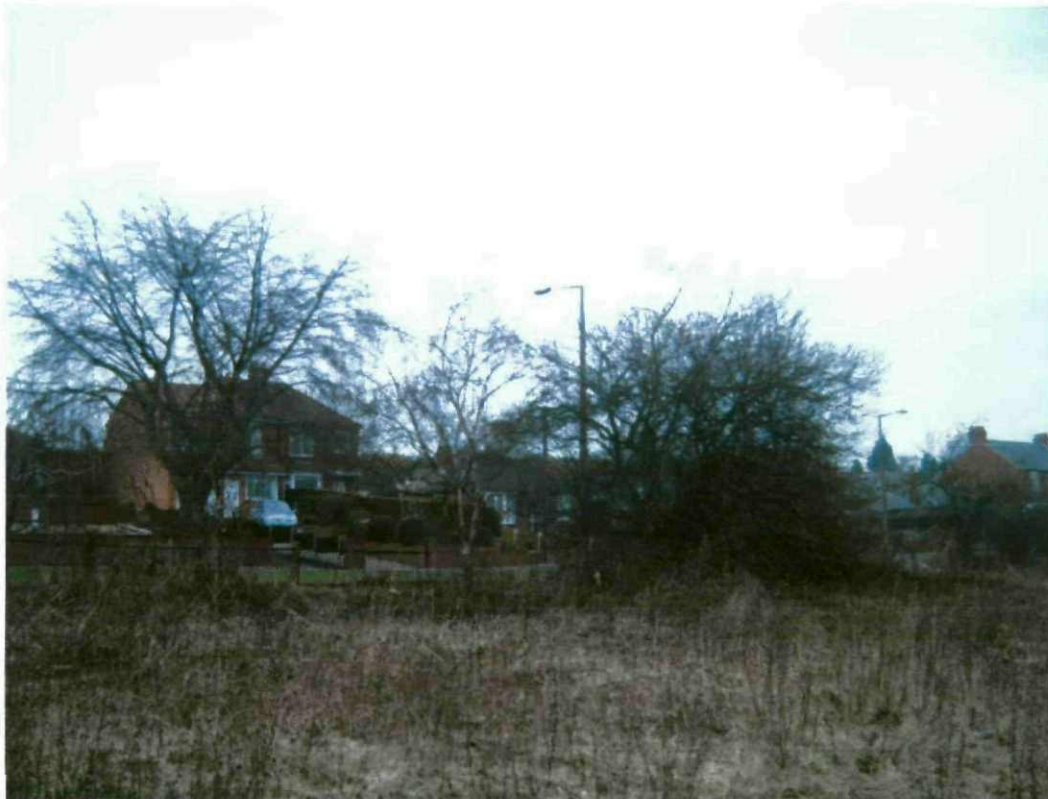
Photograph Number 13 showing the hedge line along Barnsley Road which will be planted up in the gaps once the material has been sloped down from the tree zone.

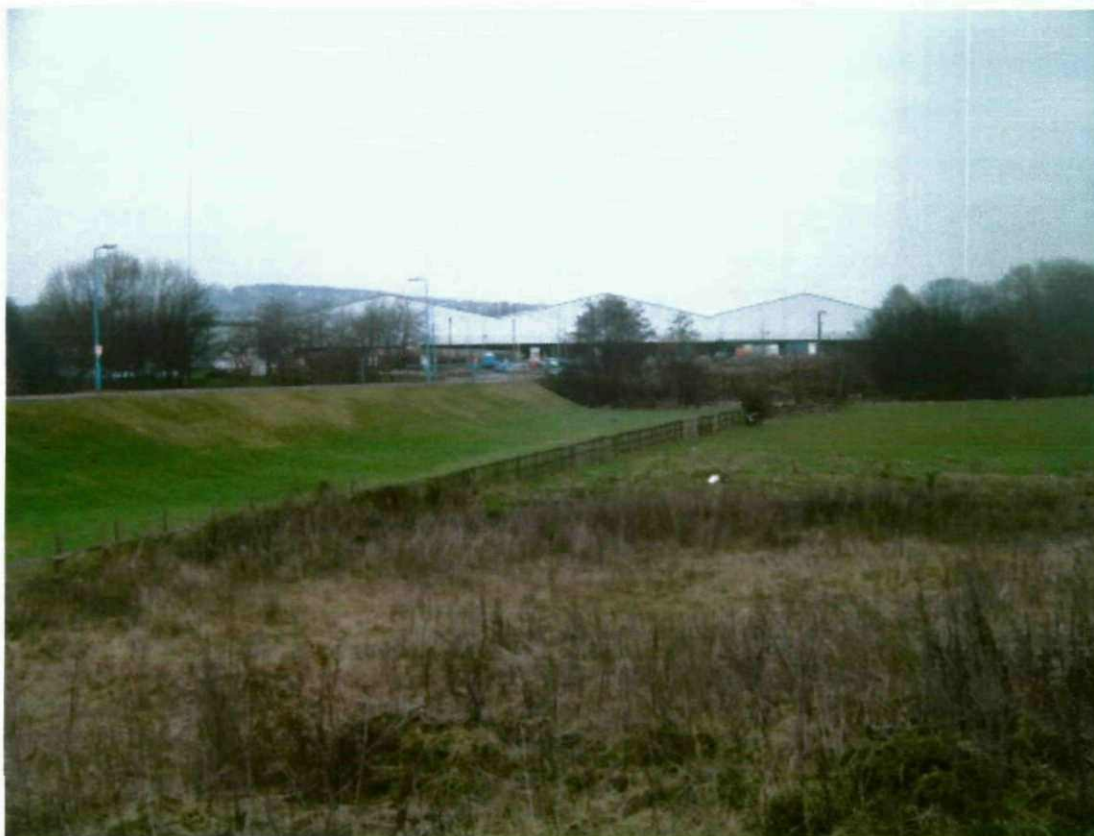
Photograph number 15 showing the edge of the tip against the access road to the carpet warehouse and the stream with the field in the background that floods on occasions.

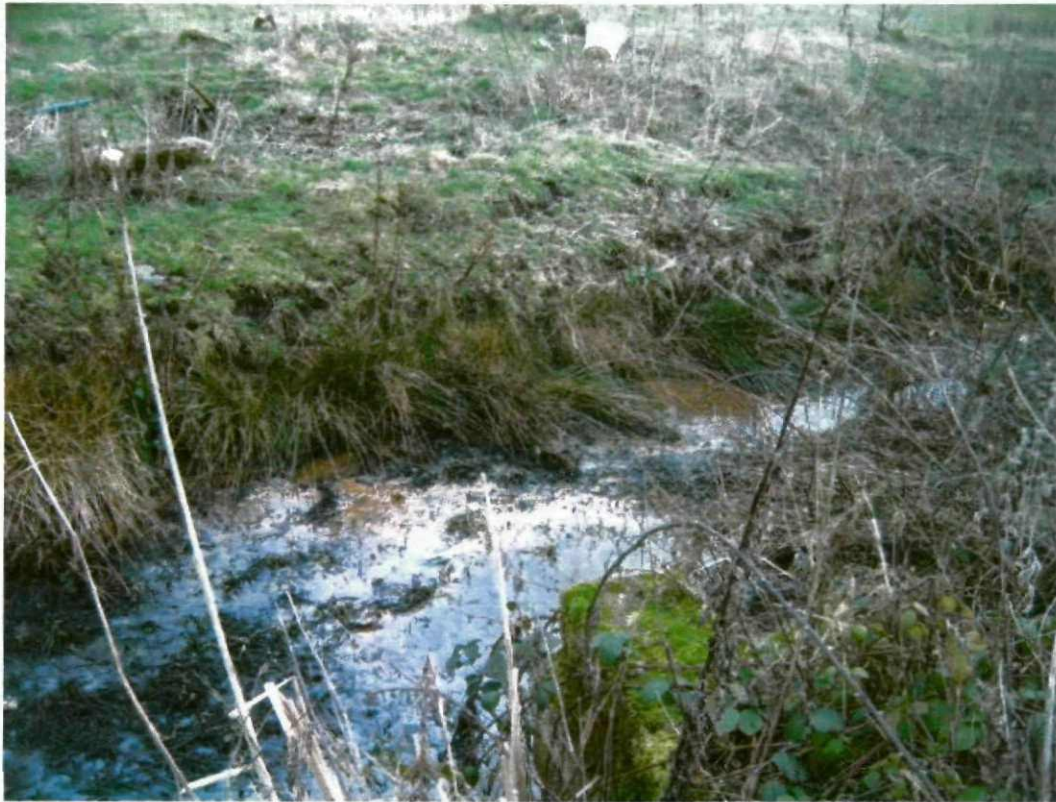
Photograph number 17 showing the stream with ochre water in it and heavily choked with vegetation, which will be cleaned out.

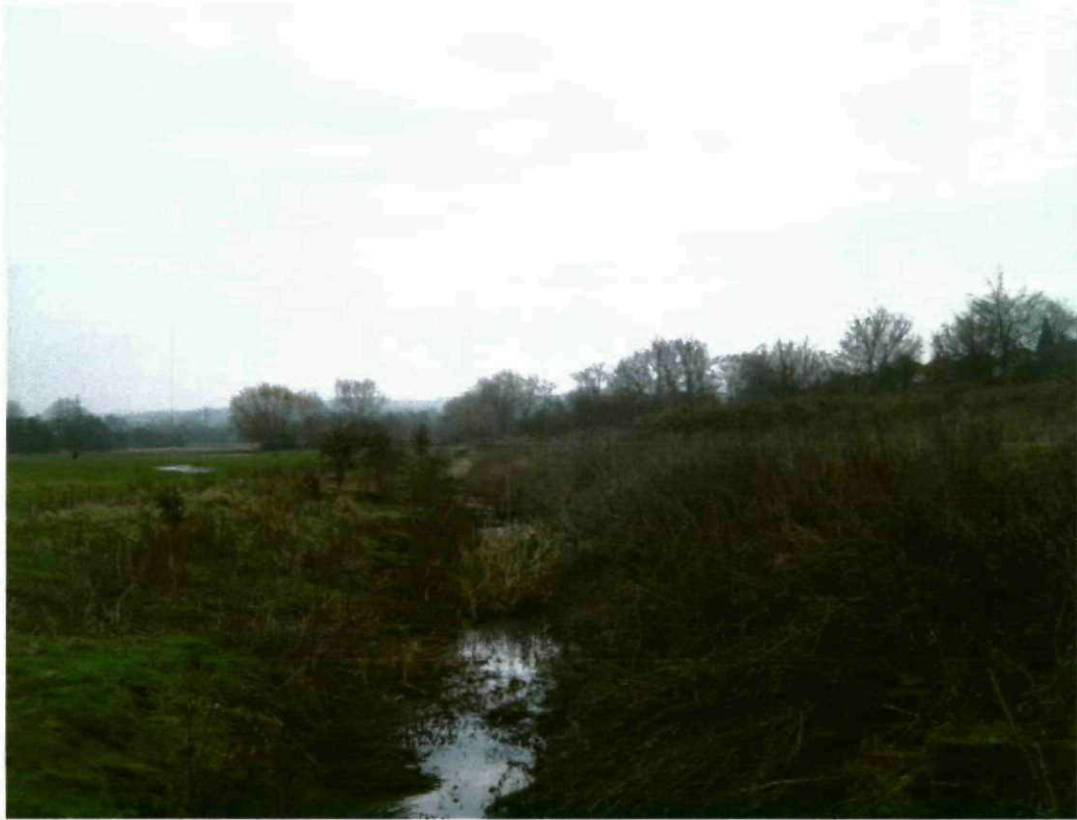
Photograph number 19 showing the stream choked with vegetation and the bank to the tip.

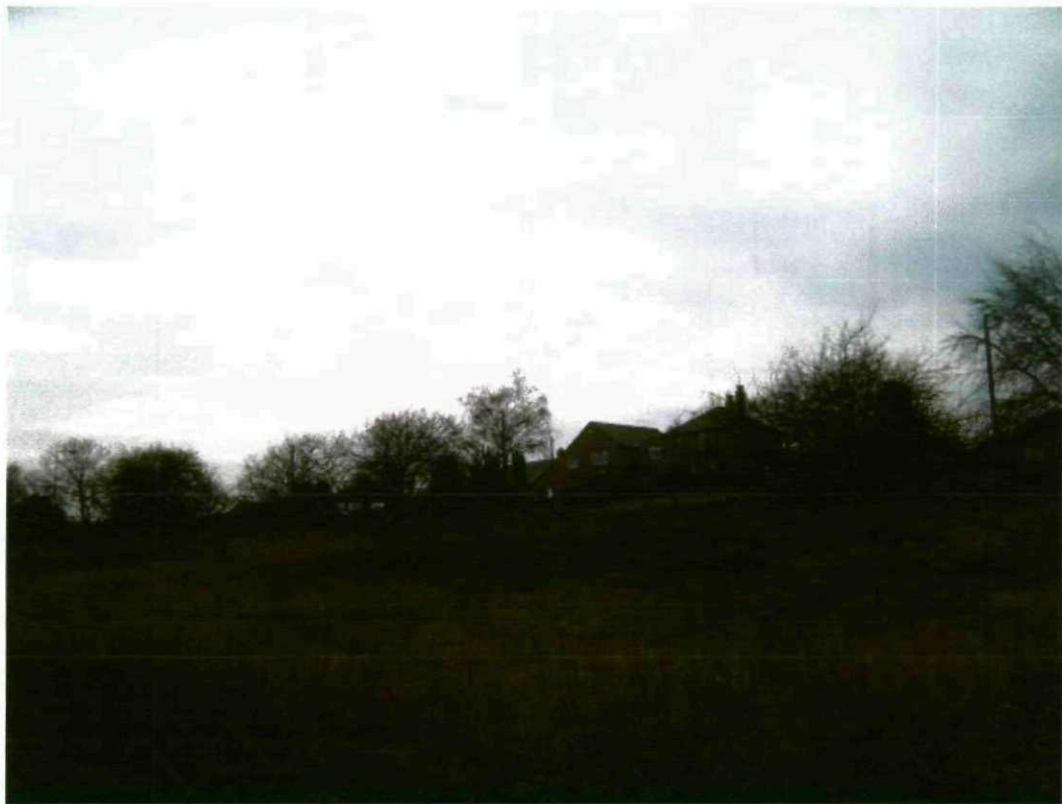
Photograph number 20 showing the gaps in the hedgerow and the houses beyond Barnsley Road. The land is undulating and rough with exposed lumps of rubble and concrete.

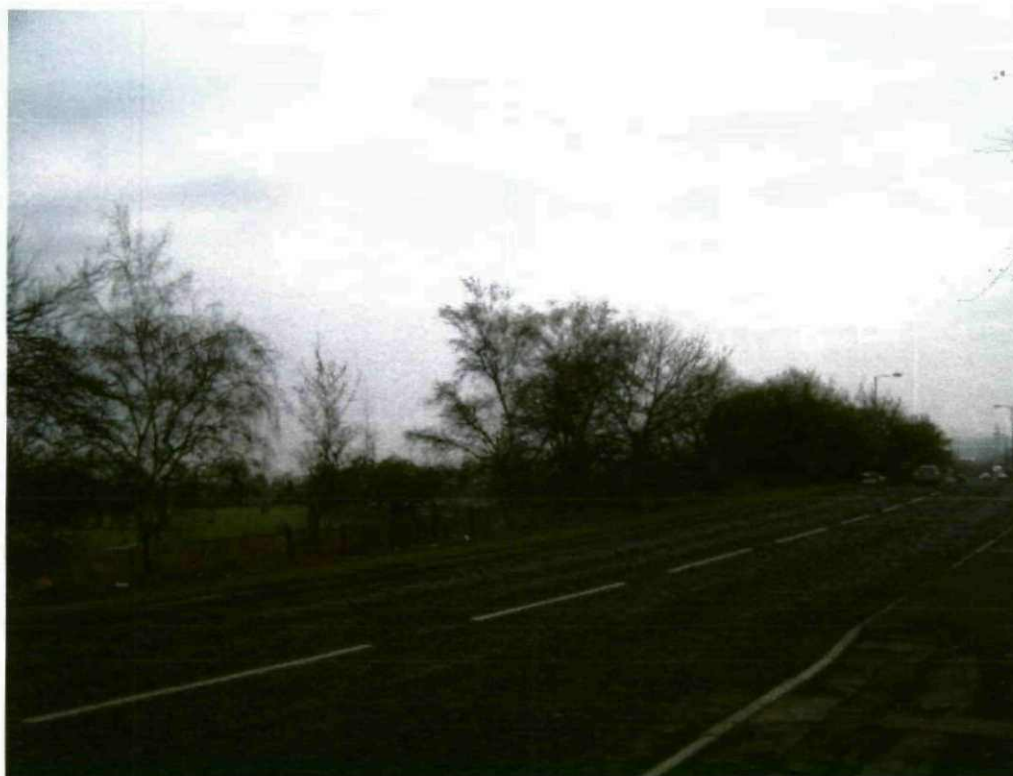
Photograph number 22 showing Barnsley Road looking south to the access and the gaps in the hedge row which will be planted up. Sight lines are adequate for the access onto the road.

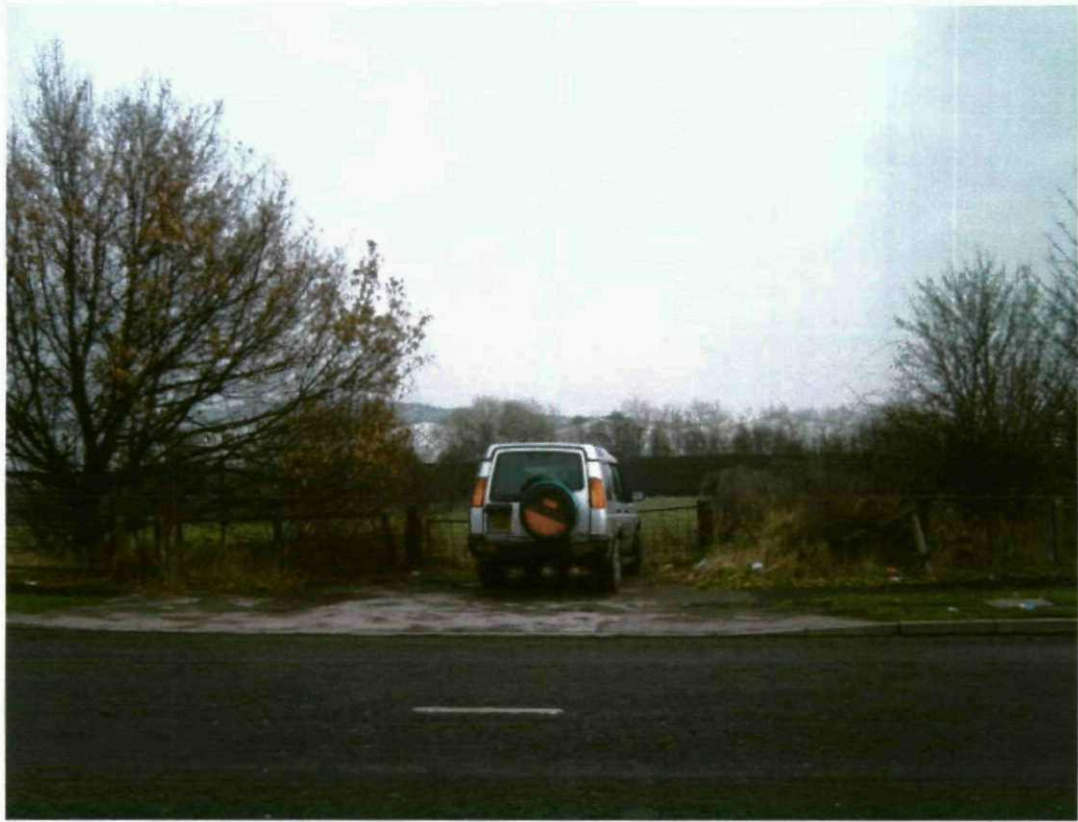
Photograph number 23 showing the access to the site and the drop kerbs.

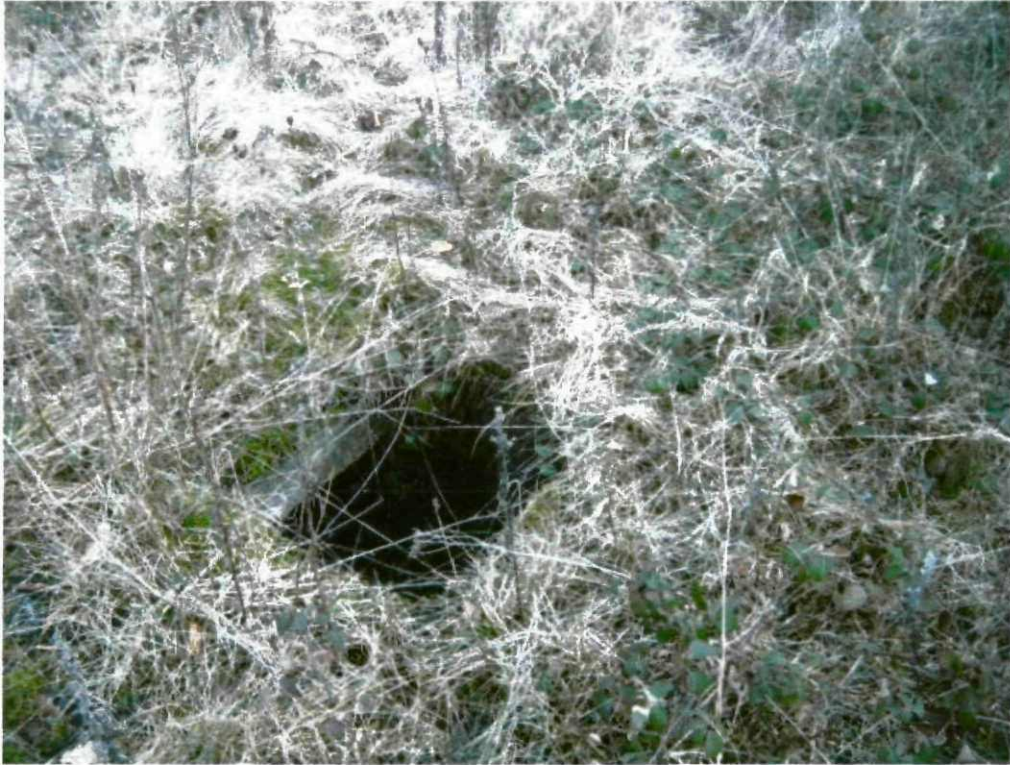
Photograph number 27 showing an old manhole which will be inspected and any pipe renewed if run off from the site.

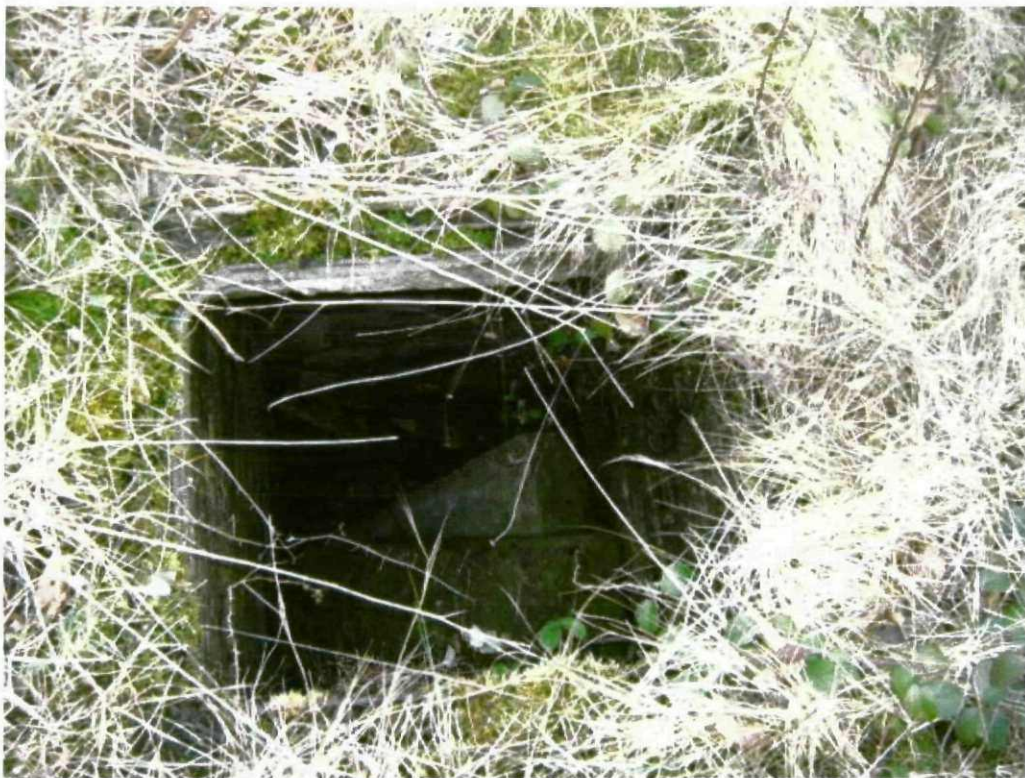
Photograph number 28 showing the same inspection chamber with debris inside.

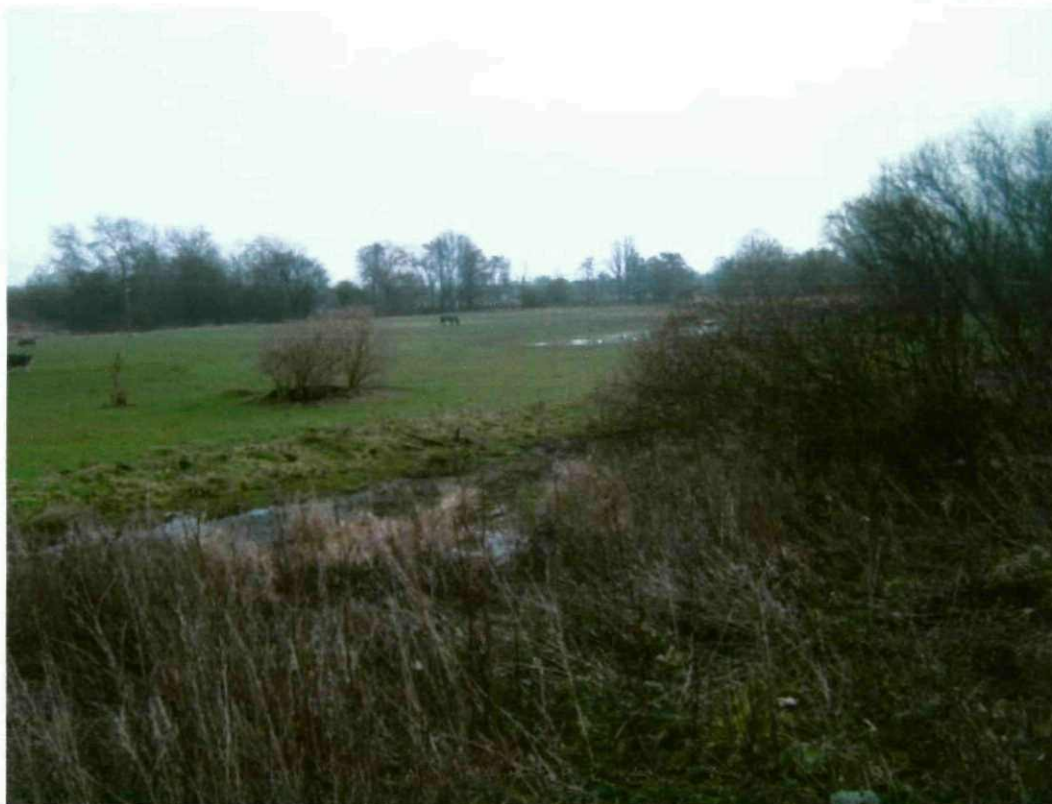
Photograph number 29 showing the stream on the side of the tip and flood area widened out at the field side and the base of the tip.

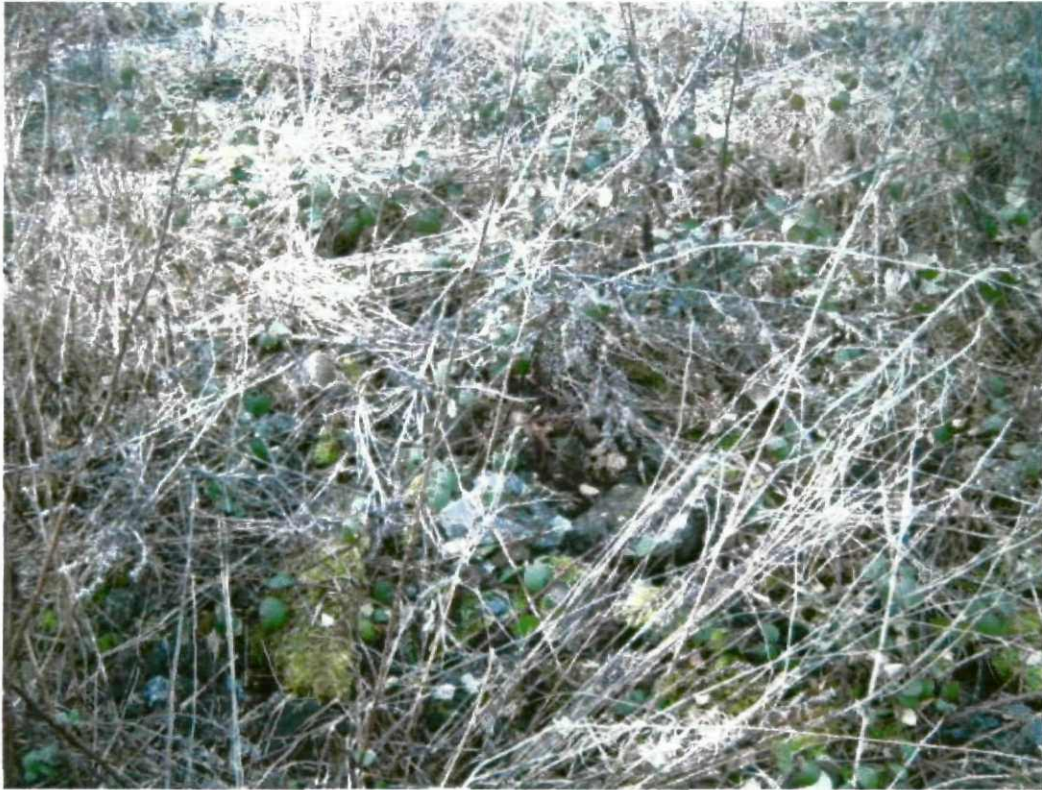
Photograph number 31 showing the rough ground and exposed rubble, tarmac and stones rendering the site unusable until reclaimed and covered with soil.

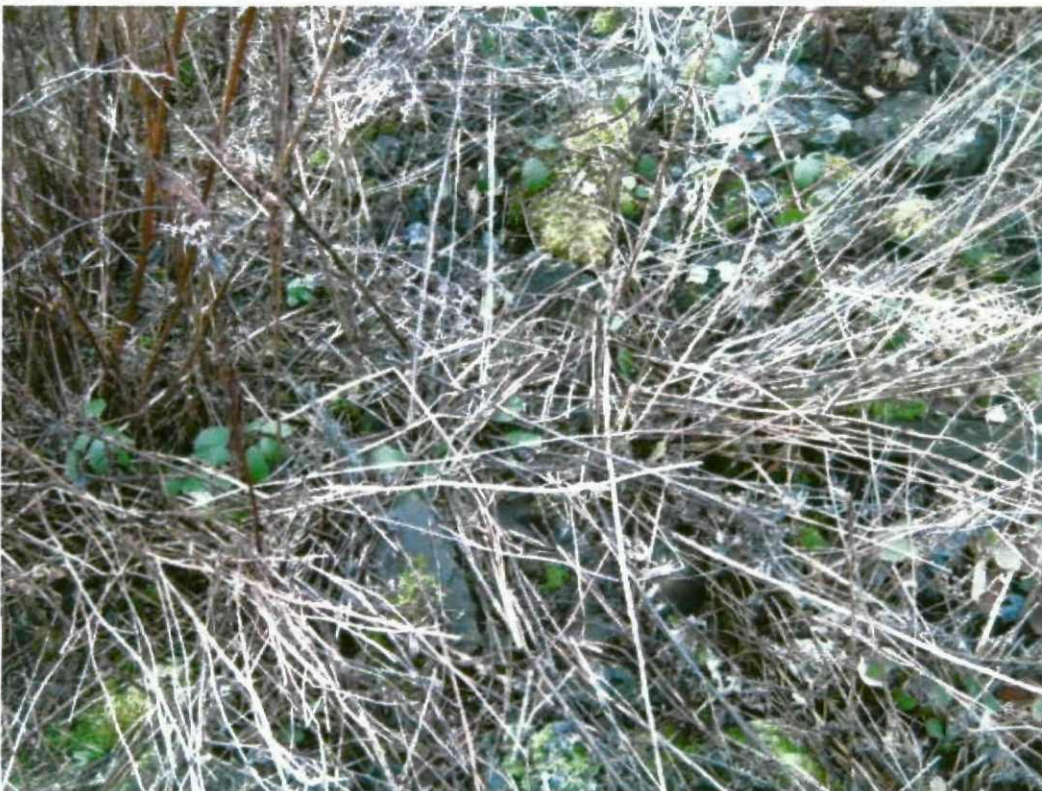
Photograph number 32 showing the rubble and stones at the surface of the tip.

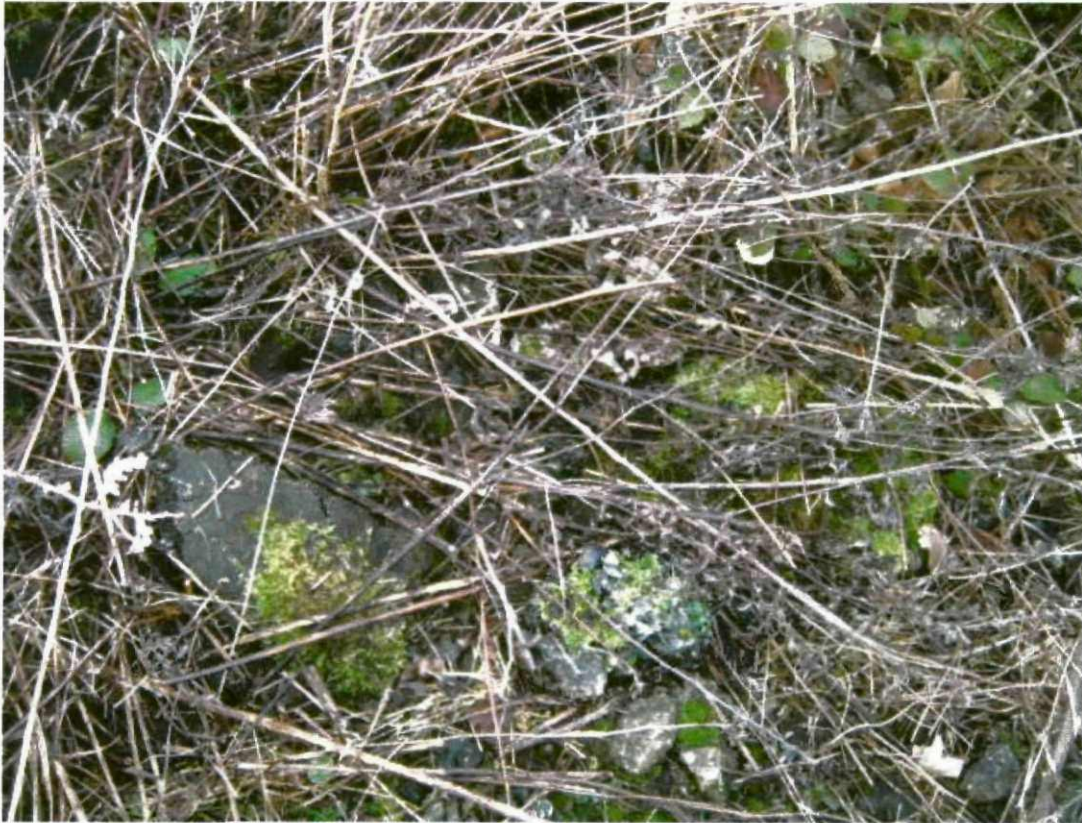
Photograph number 33 showing a close up of the rubble and tarmac on the site from the Council's highway works.

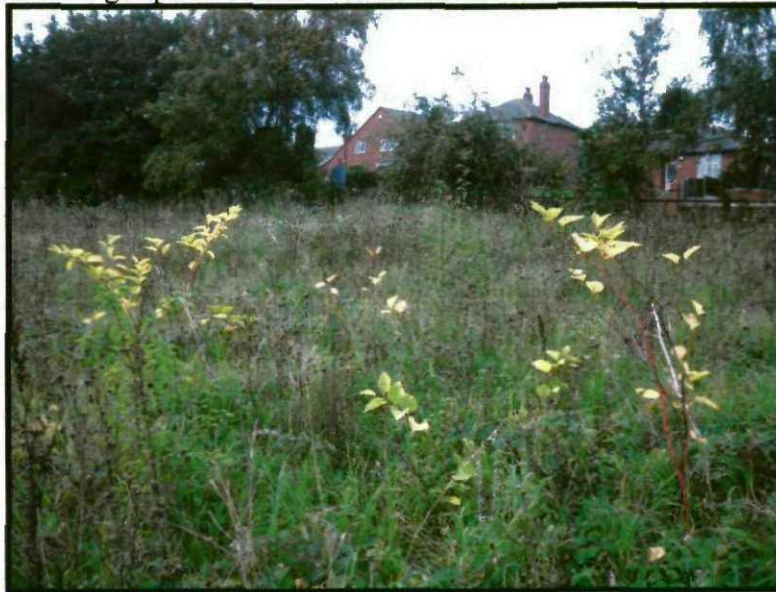
Photograph showing Japanese Knotweed on the site.

3.4.5. A small clump of Japanese Knotweed was identified on the site. This plant is listed under Schedule 9 of The Wildlife and Countryside Act 1989. Species listed under Schedule 9 are prohibited from release into the wild.

5.2. It is recommended that both of these plants are eradicated from the site.

5.3. Japanese Knotweed can be eradicated by excavation. An area of 7m around the clump must be excavated, treated as contaminated waste and disposed of in the correct manner.

5.4. The other option for the eradication of Japanese Knotweed is to spray with an approved herbicide.

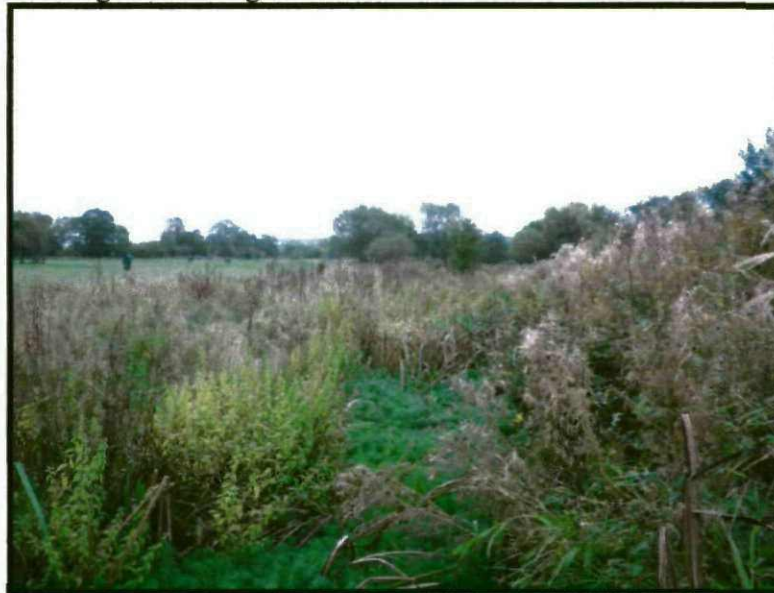
- **3.3.2.6. *Standing Water.*** The eastern site boundary is a ditch running the length of the site. This ditch contains shallow standing water and is overgrown with bulrush, sedge, water mint and parrots feather. Parrots feather is listed under Schedule 9 of The Wildlife and Countryside Act 1989. Species listed under Schedule 9 are prohibited from release into the wild. The full list of species is shown in Appendix IV of this report.

Photograph looking south along the ditch.

3.4.2. The ditch which runs along the eastern site boundary contains shallow static water with a deep layer of silt in the ditch. The water appeared to be polluted at the time of the survey. This ditch does not provide suitable habitat for water voles, otters or crayfish.

3.4.6. Parrots Feather, a type of water weed, was identified growing throughout the ditch on the eastern site boundary. This plant is listed under Schedule 9 of The Wildlife and Countryside Act 1989. Species listed under Schedule 9 are prohibited from release into the wild. This is a vigorous plant and it can choke ponds and waterways. This plant can reproduce from small fragment of the parent plants.

5.5. One method of eradicating Parrots Feather is to spray with Reglone to control infestations in the short-term. Action can be taken to reduce nutrient inputs to the water for long-term eradication.
