SF2653

March 2017

Preliminary Ecological Appraisal
McDonalds Barnsley
Barnsley
South Yorkshire

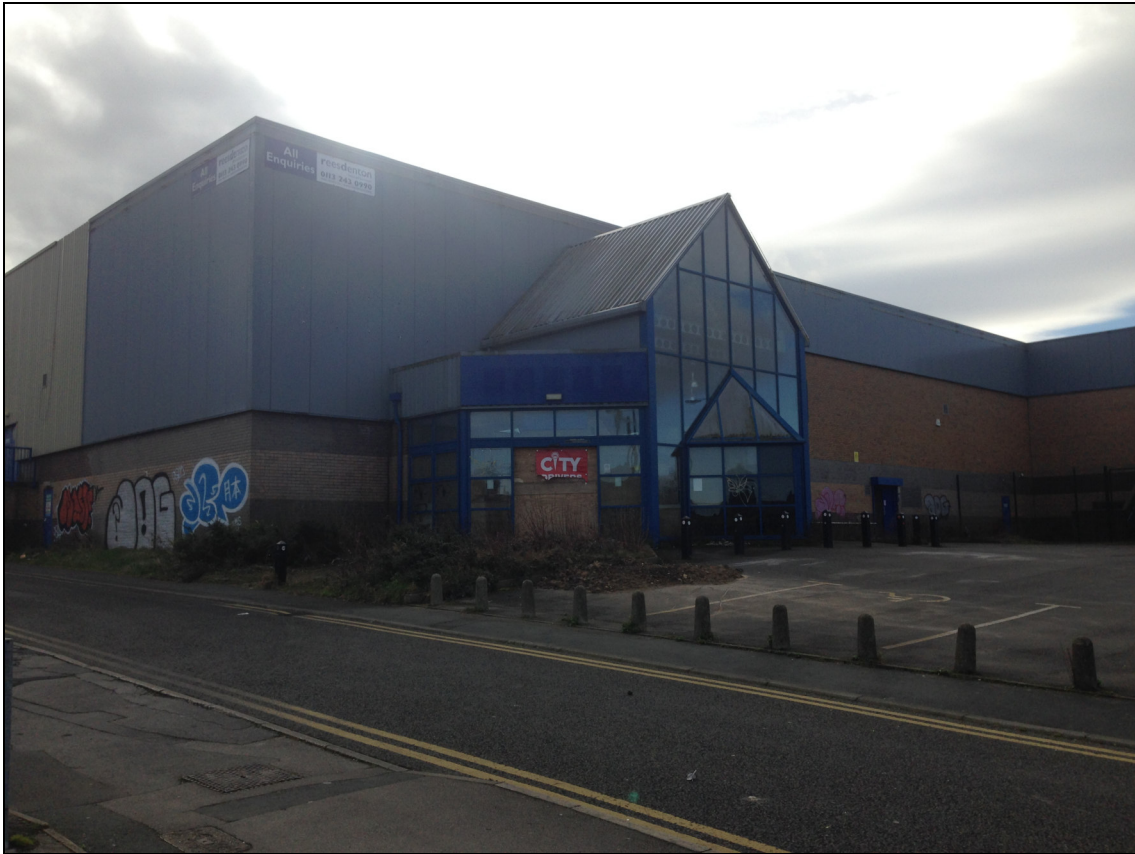
Building B1 covers the majority of the site. It is constructed from brick walls partially covered in metal sheeting, a glass fronted entrance, and a metal flat roof.

The external inspection of the building found it to be in good condition and well sealed with limited potential access points for use by bats. There were a number of vents around the building's exterior but these all had a metal mesh present that would not allow bats to pass through. There were a number of breather slits between bricks around the building at approximately 2m above ground, it is anticipated that these would allow access into a wall cavity. On the north-west elevation, at two separate locations, there were a total of three holes in the wall (refer to *Figure 03*), but it was not possible to discern if they would allow access into the wall cavity. There were some gaps under gutters and the metal sheeting on the walls but due to metal having a low specific heat capacity, which will heat up quickly during the day and cool down quickly at night, it is considered that that roosting bats would be unlikely to use such features.

Building B1

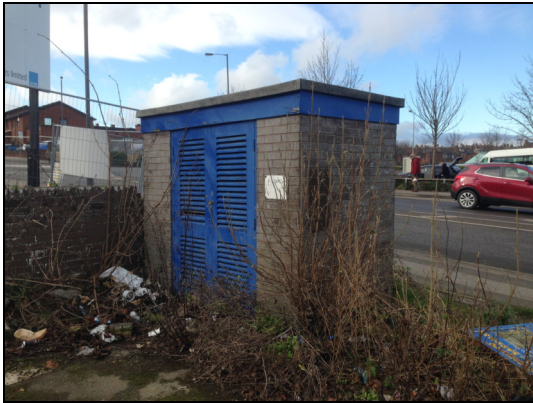
Building B2 is a gas governor building composed of brick walls, wooden doors and a flat bitumen felt roof. It is located in the north-west corner of the site. The internals of this building were not accessible.

There were some limited opportunities for roosting bats present, such as small gaps between vents on the wooden doors, otherwise the building was in good condition and well sealed. Based on the typical single skin wall and roof construction of a building of this type, and the good condition of the pointing it is considered unlikely that there would be any opportunities for roosting bats within the building internals.

Building B2

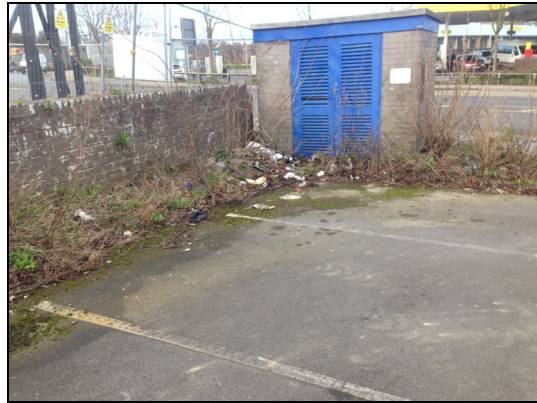
Surrounding the buildings at the site is hardstanding which is composed of concrete/tarmac with some scattered patches of sparse vegetation around the edges. Species present include buddleja, bramble *Rubus fruticosus*, creeping thistle *Cirsium arvense*, cleavers *Galium aparine*, Yorkshire-fog, cock's-foot, dandelion, broadleaved dock and moss species.

Hard standing with marginal vegetation

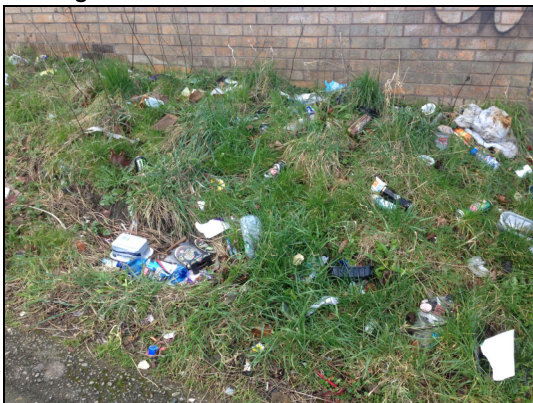
Along the north-east and south-east boundaries of the site are thin strips of amenity grassland characterised by: abundant and constant perennial ryegrass *Lolium perenne*; frequent and constant Yorkshire-fog *Holcus lanatus*, cock's-foot *Dactylis glomerata*, broadleaved dock *Rumex obtusifolius* and dandelion *Taraxacum agg.*; and, locally frequent common nettle *Urtica dioica*, ribwort plantain *Plantago lanceolata*, creeping buttercup *Ranunculus repens*, ragwort *Jacobaea vulgaris* and rosebay willowherb *Chamerion angustifolium*.

Amenity grassland

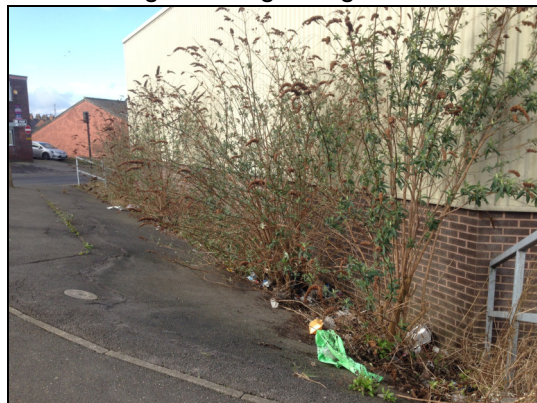
Trees and shrubs at the site are associated with the site boundaries. Species present include, cherry *Prunus sp.*, elder *Sambucus nigra*, Darwin's barberry *Berberis darwinii*, buddleja *buddleja davidii*, ash saplings *Fraxinus excelsior* and ornamentals.

Buddleja shrubs

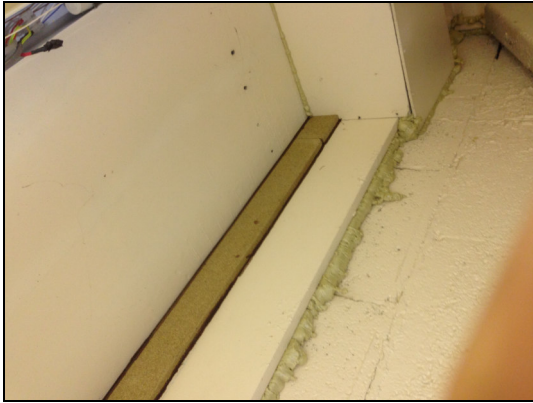
The internal inspection found each room to be generally very well sealed from the next, making access practically impossible for bats to either get into such rooms. On the first floor there is a large room which had a suspended ceiling with multiple tiles missing that allowed access between the roof space and the room below. However above this room the roof space appeared to be constructed entirely from metal materials, and the roof to be composed of a single skin of metal sheeting. Closer inspection of this area was not possible due to lack of access and health and safety reasons.

Well sealed internal rooms

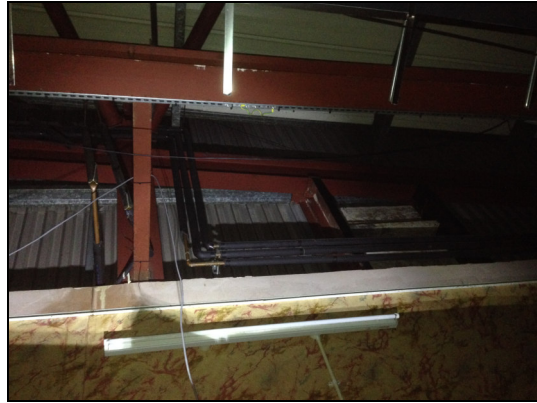
Due to the limited potential access points present, the well sealed internal structures, and materials used to construct the roof section of the building having a low specific heat capacity, which will heat up

quickly during the day and cool down quickly at night, the building bat potential is considered to be limited to the few low level holes and breather slits which may provide access into the wall cavity. None of which showed any evidence of being used by bats, such as grease stains, fur or droppings.

Metal construction of roof space

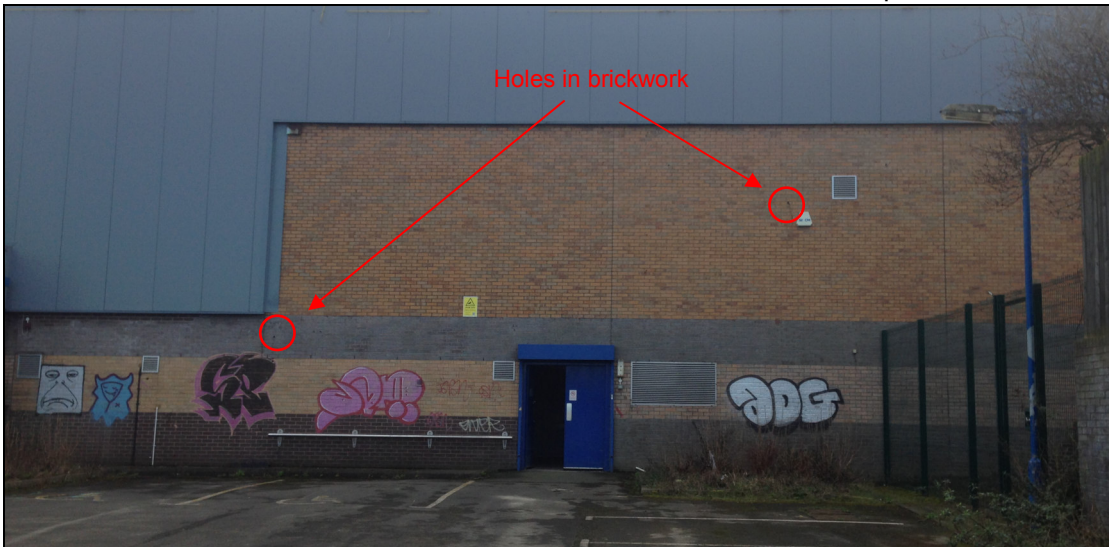
North-west elevation of building B1 showing potential access points

Building B1 was assessed as having *negligible to low bat potential*, and building B2 as having *negligible bat potential*. Concerning building B1 the potential access points identified were on its north-west elevation. Whilst surrounding habitats on that side of the building are unfavourable for bats and are likely to receive a high level of disturbance, and this in combination with the negligible to low bat potential of the building makes it unlikely that roosting bats would be present, due to the amount of local records for bats, and the presence of more favourable foraging habitat to the south and east, it is not possible to completely discount the presence of roosting bats within building B1. It is therefore as a precautionary measure recommended that one bat emergence/re-entry survey is carried out on building B1 during the appropriate survey season (May to September inclusive). In the event of bat roosts being found within trees or buildings to be affected by a development at the site, a licence from Natural England may be required, with appropriate mitigation and working methods.
