# Heritage Statement

| Site name | Shire Horse Stables (retrospective application) |
| Location: | Cannon Hall Farm, Bark House Lane, Cawthorne, Barnsley, South Yorkshire, S75 4AT<br><br>NGR: <b>SE 27477 08424</b> |

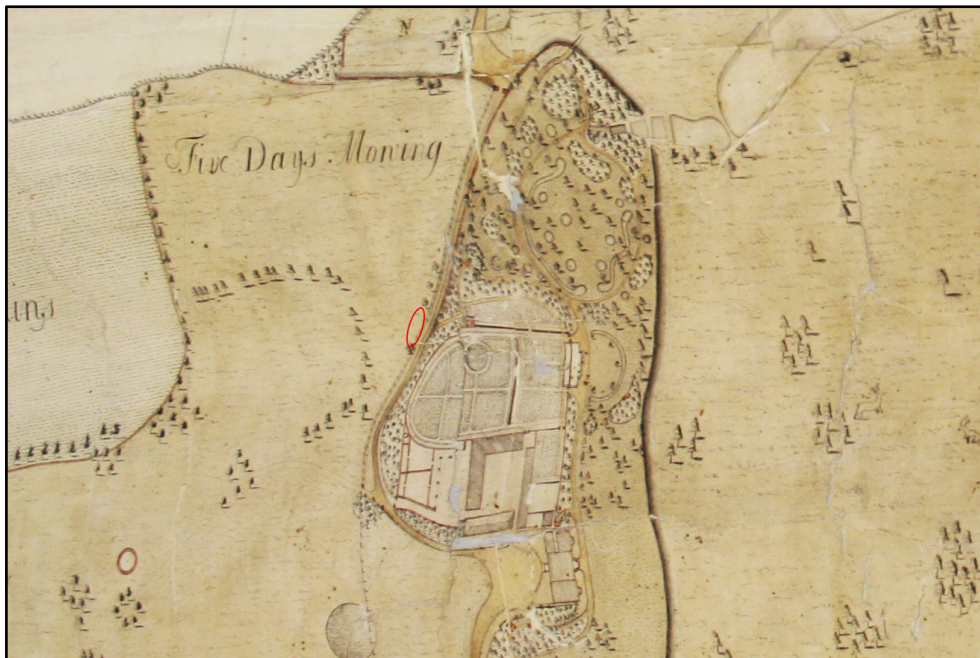
**Appendix I.4** – 1770 Plan by Richard Woods (site marked in red)

No historic vistas have been identified that are significant in-relation to the location of the stables, with the Hall and walled gardens being originally hidden behind a shelter belt along the north-eastern edge to pleasure grounds (see **Appendix 1.4**). The remnants of this planting survive as a mature shelter belt/shrubbery, including numerous trees as evidenced to the rear of the stables in **Appendix 2.3**.

The surviving historic landscape that surrounds Cannon Hall was a design by Richard Woods, a prominent landscape designer from the second half of the 18<sup>th</sup> Century (see **Appendices 1.3, 1.4**). The design created a pleasure ground to the south of the Hall, which was defined by a ha ha along the southern and northern boundaries (**Appendix 2.6**).

To the south of the walled garden is the route of a former access road leading up to the Hall (**Appendix 1.4**), which still retains a formal gateway with stone piers and iron gates (**Appendix 2.5**).

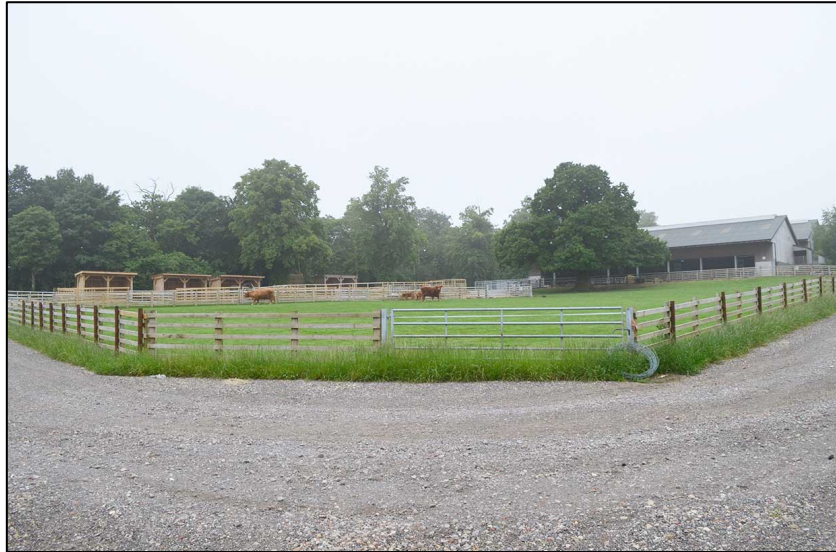
**Appendix 2.1:**

General view looking south-west across outer paddocks towards stables and Cannon Hall

The south-eastern part of the farm has a rural character with enclosed pastures with timber post and rail fencing (**Appendix 2.1**) and partial views out into the surrounding countryside to the north and east (**Appendix 2.6**). There are no views of Cannon Hall, the walled kitchen gardens, or stable yard from this secluded part of the farm (see **Appendices 2.1, 2.3**).

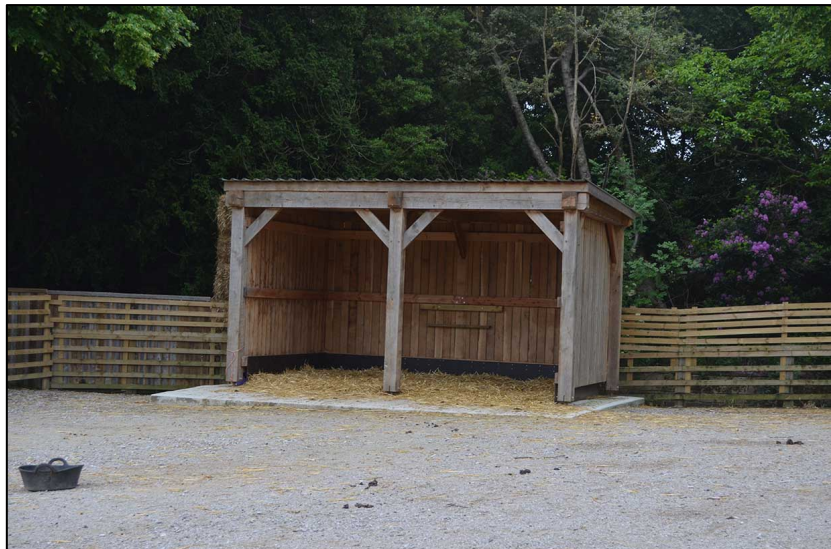
**Appendix 2.2:**

A group of four timber framed open fronted stables (**Appendix 2.3**) have been constructed adjacent to the former access road around the south-eastern boundary to Cannon Hall (**Figure 2; Appendix 2.4**). Whilst these structures are a modern design (**Appendix 2.2**) their form has been sensitively designed to respect traditional forms of stabling using traditional construction techniques.

Detail of shire horse stables on concrete base

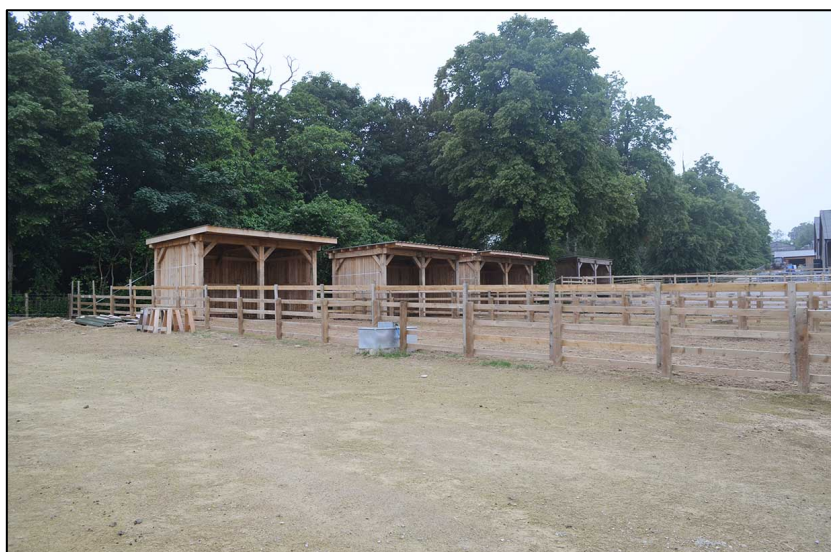
**Appendix 2.3:**

General view of shire horse stables following installation

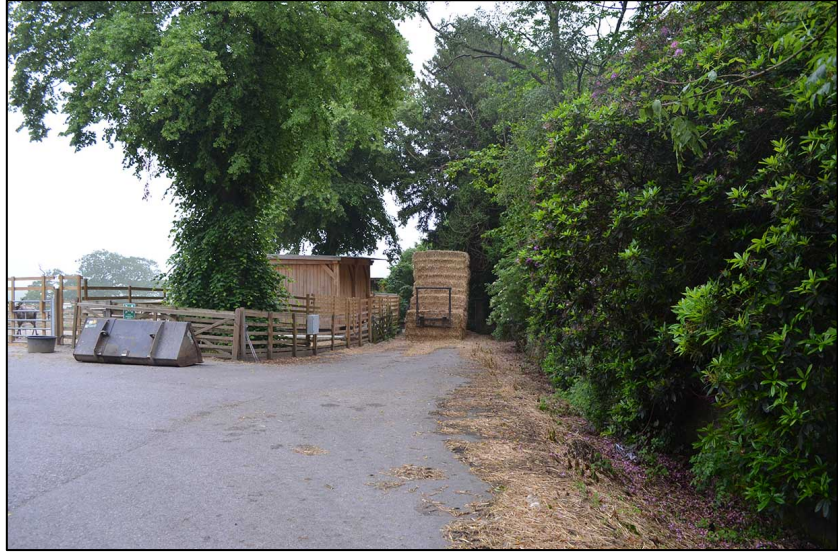
**Appendix 2.4:**

The former entrance road along the north-eastern boundary of the pleasure grounds is no-longer maintained as a means of access along this part of the site (**Appendix 2.4**) which has diminished its historic presence, however the survival of a formal gateway (**Appendix 2.5**) does provide clear evidence for its former location and route. The proximity of the stables to the gateway does constitute a degree of harm to its setting. This is however considered to be acceptable as the lightweight nature of construction is easily reversible, and there is no physical impact upon gate or gate piers and thus their historic integrity is maintained, having no impact upon their heritage significance

General view looking east  
along former access  
roadway into the parkland

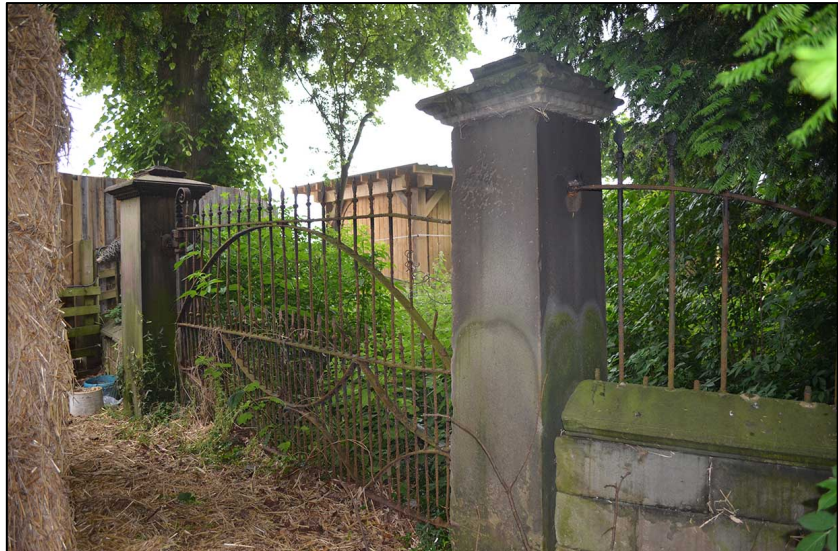
**Appendix 2.5:**

Detail of parkland gateway  
to former access roadway to  
the south of the stables

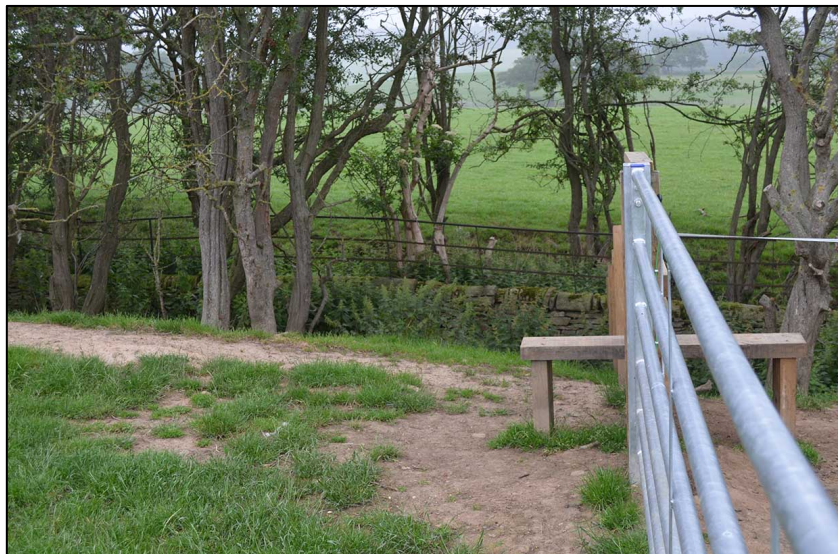
**Appendix 2.6:**

View of ha ha and estate  
boundary wall to the east of  
the site
