# **Longsight Design Consultancy Ltd**

**Carr Head Farm, Hunshelf Road S36 2BS**

**LDC23-028-SR-01**

The objective of this report is to establish if the buildings noted above are suitable for “Class Q” Planning Application to be submitted.

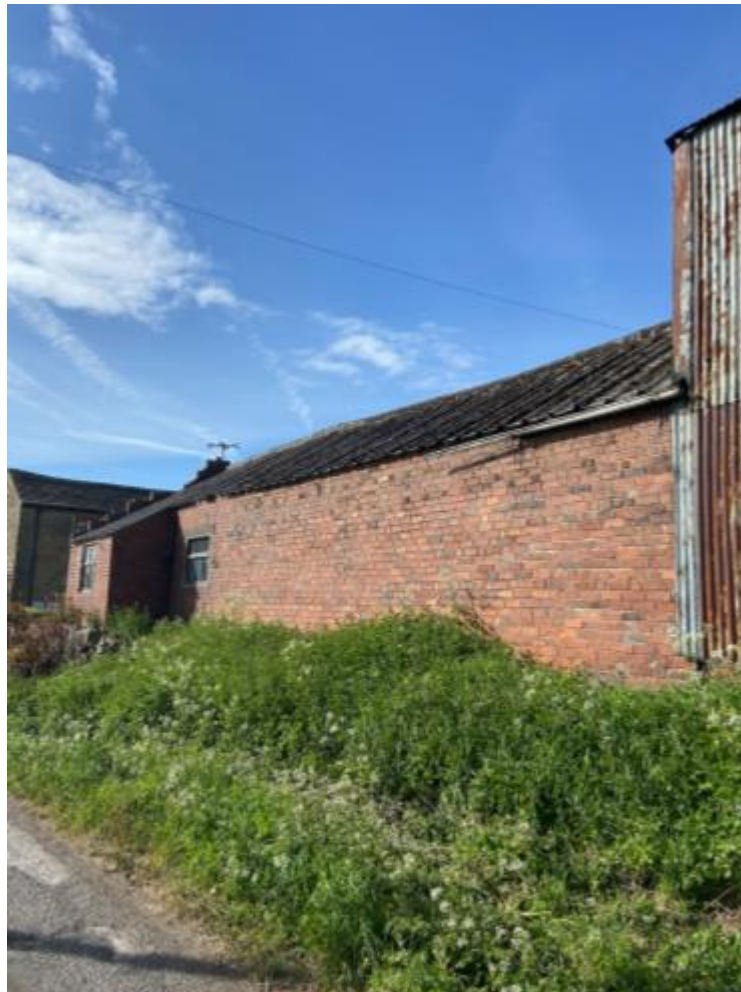
*Photo P1A – Pony Stable Walls to Hunshelf Road Elevation*

This elevation is constructed in red brickwork. At the Western end of the stables there is a small projection which is a later addition (approximately 1980). The wall to this elevation appears to be in good structural condition. See Photograph P1

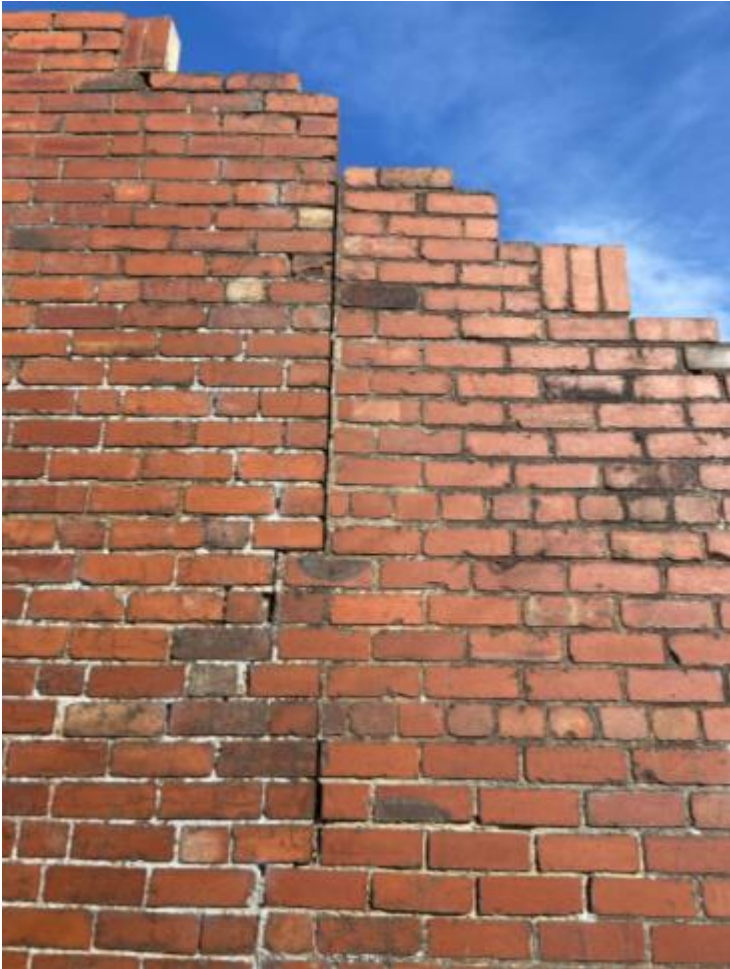
*Photo P1B – Cracking to Gable End*

This is a gable elevation with a stepped profile above the roof line acting as a parapet. The roof is flashed into the wall. Where the later projection (noted on South Elevation) has been constructed there is straight joint which has opened slightly. The movement is due to a lack of bonding between the original gable and the gable to the projection. See Photograph P1A and P3. It is understood that the projection may be removed, and the original external wall reinstated. The movement is between 1-5mm and considered to be stable. If the projection is to be retained, then the straight joint should be remediated. The projection gable should be partially taken down and brick jointed into the original gable.

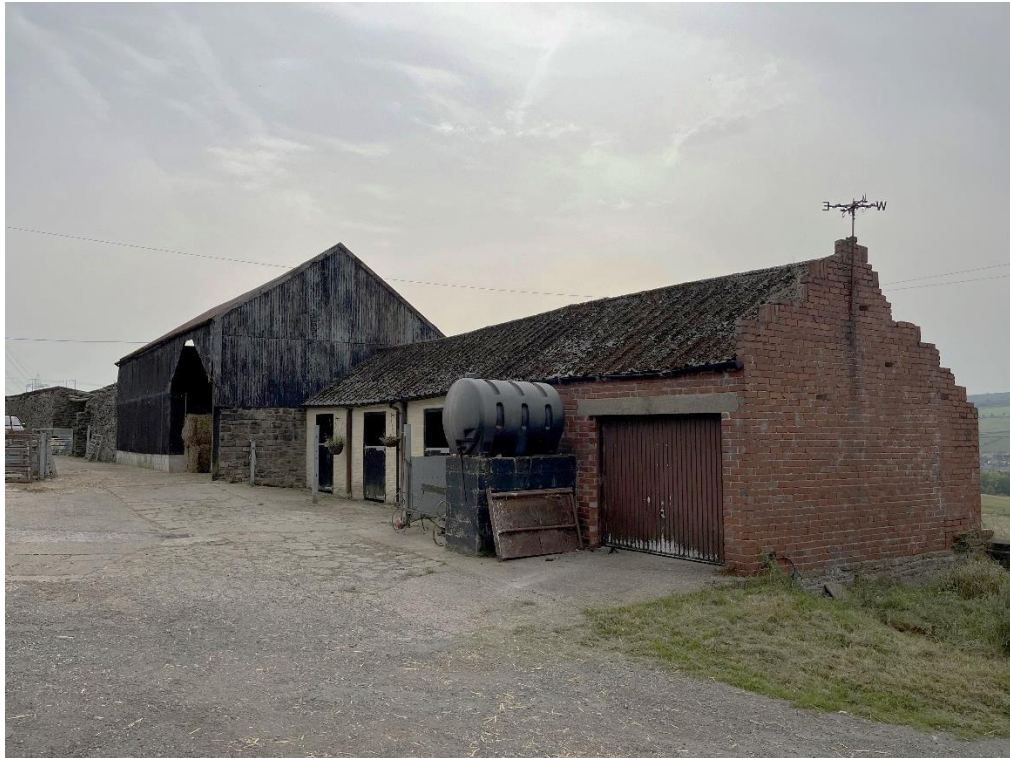
*Photo P2 – Courtyard Elevation*

This elevation is constructed in a combination of blockwork (on the Eastern Half) and red brickwork (on the Western Half). There is an up-and-over garage style door and three stable doors in this elevation. There is no sign of cracking or movement along this section. See Photograph P2

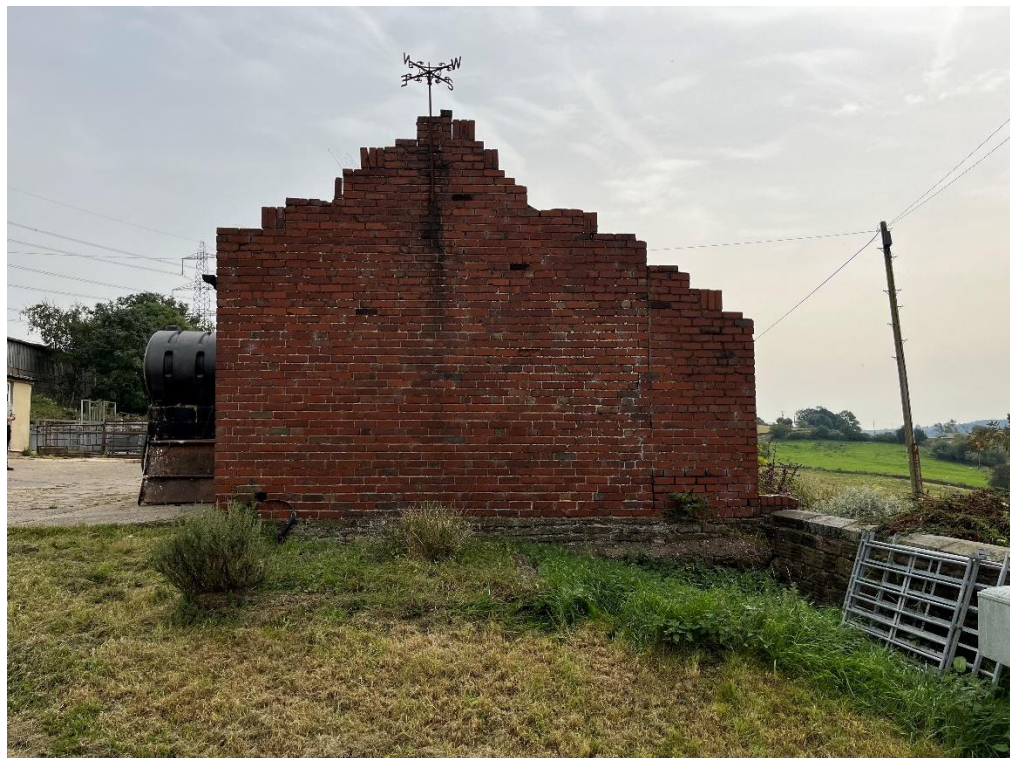
*Photo P3 – Pony Stable Gable End*

The remainder of the original gable wall is in good condition with no signs of cracking or settlement.

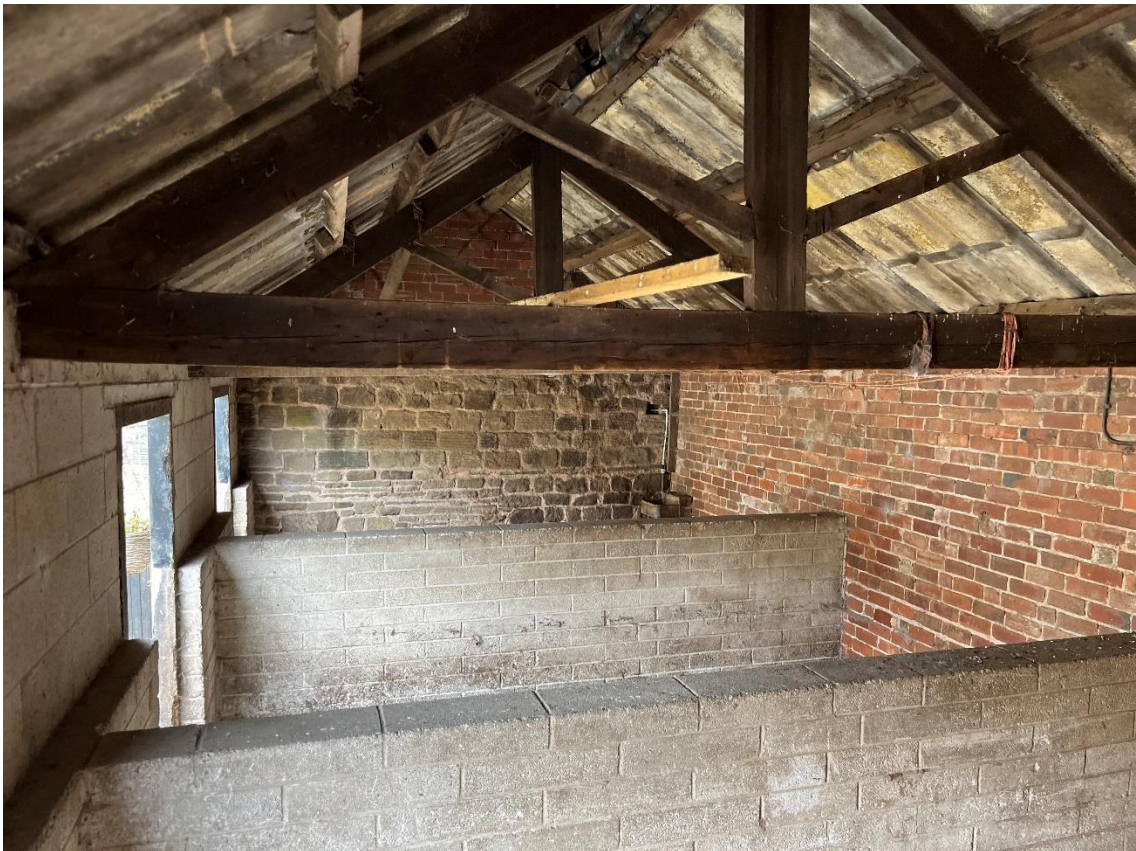
*Photo P4 – Gable Separating Cow Shed/Stables and Roof Timbers*

This gable is a joint gable of both the Pony Shed and The Old Cow Shed. It is constructed in random coursed stone masonry for its lower section and red brickwork for the upper section, it follows the profile of the Pony Shed roof. This elevation is in good condition with no signs of cracking or settlement. See Photograph P4

The roof is a dupitch span North-South. The structure is formed in king post trusses at third points supporting purlins spanning between the trusses and gable walls. In turn the purlins support rafters spanning between walls, purlins and ridge beam. The timbers forming the king post trusses are formed from substantial timber sections. The roof covering is of profiled asbestos sheeting.

All roof timbers are in good condition showing no signs of rot or infestation. See Photograph P4

Note – the roof sheeting is to be removed as part of the conversion by an approved asbestos removal and disposal contractor.

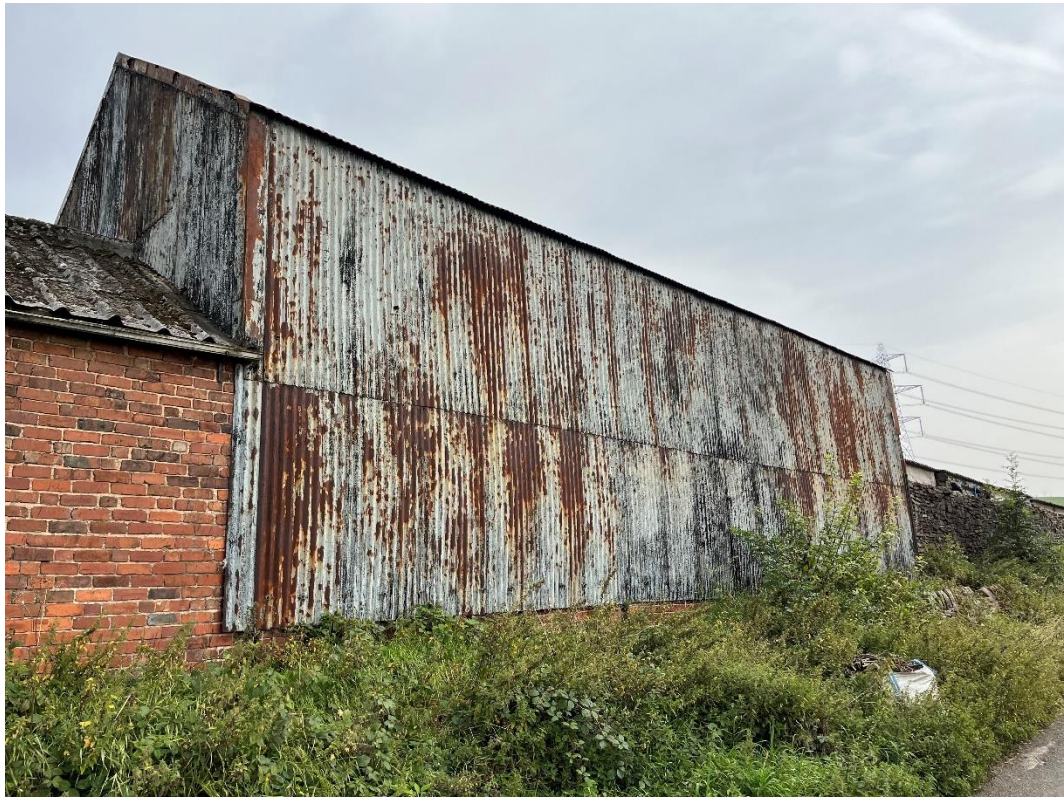
*Photo P5 – The Old Cow Shed, Hunshelf Road Elevation*

This elevation is formed in red Brickwork external leaf with a combination of concrete panels/stonework/Blockwork inner leaf. There is a cavity between the two leafs which could not be viewed.

Externally the brickwork external leaf is clad in metal profiled sheeting which extend from eaves down to approximately 600mm above internal floor level. Due to the metal cladding, it is not possible to assess the condition of the outer brickwork wall behind.

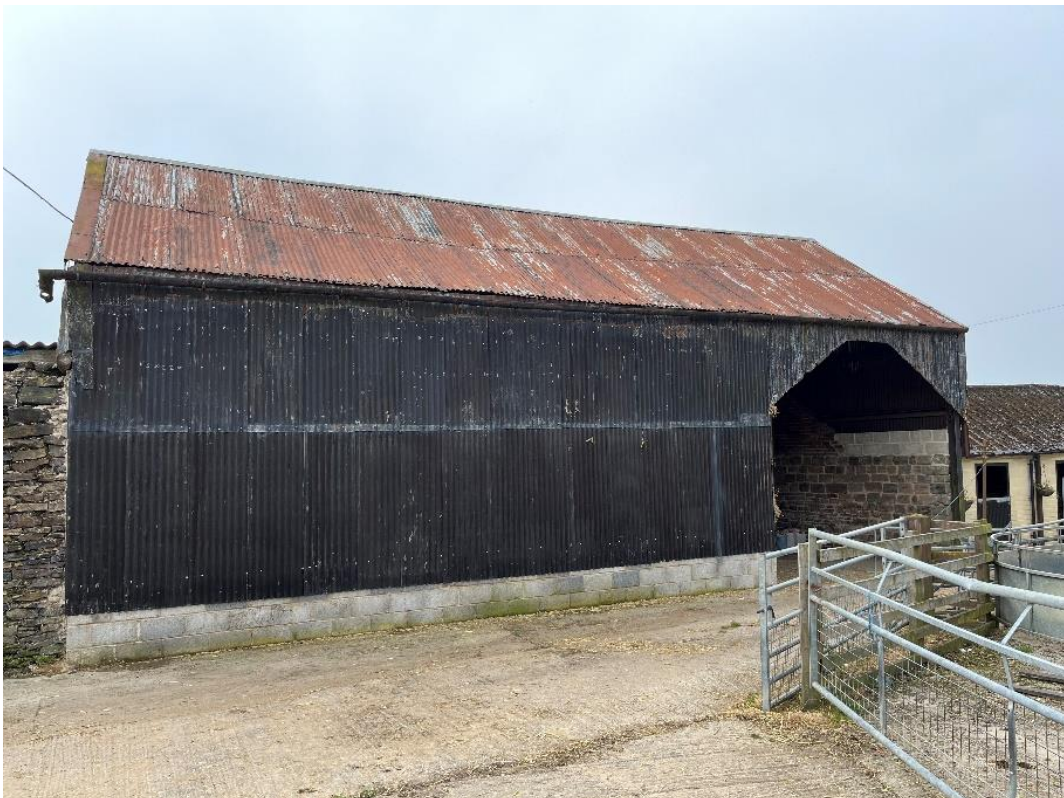
*Photo P6 – The Old Cow Shed, Courtyard Elevation*

The internal leaf is constructed in a combination of concrete panels / blockwork. The external leaf is constructed in blockwork. There is a cavity between the two leaves. As on the South Elevation profiled metal cladding extends from eaves to approximately 600 mm above the internal floor level.

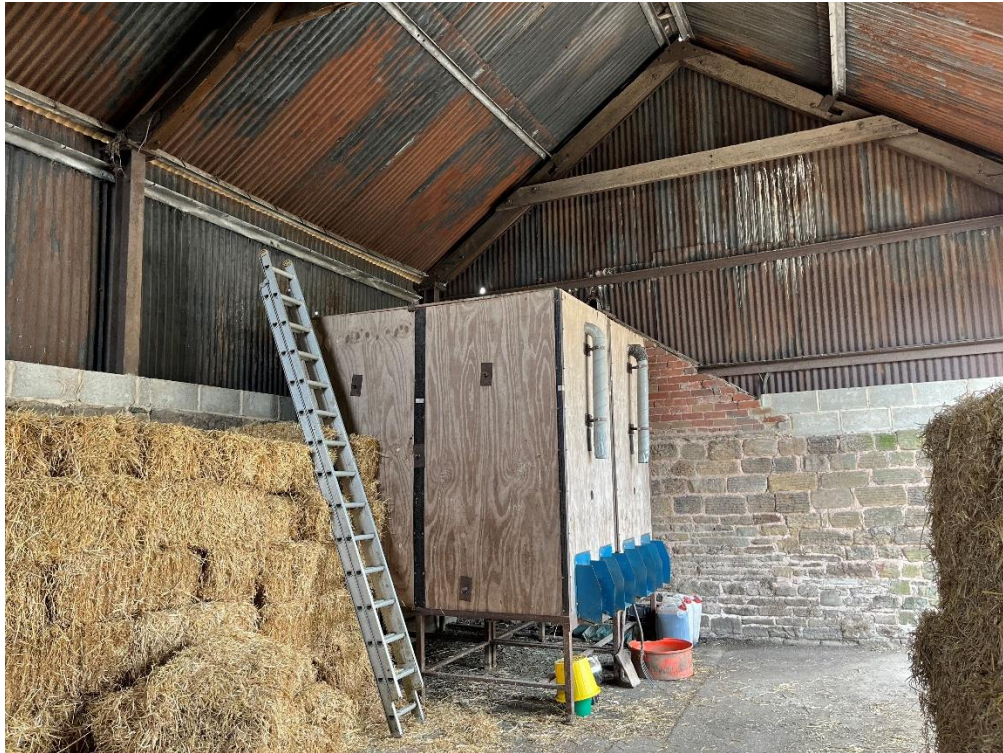
*Photo P7 – The Old Cow Shed Adjoining Gable to Stables*

This elevation is shared with Pony Stable and is constructed in red brickwork within The Old Cow Shed. The wall is in good condition with no signs of cracking or movement.

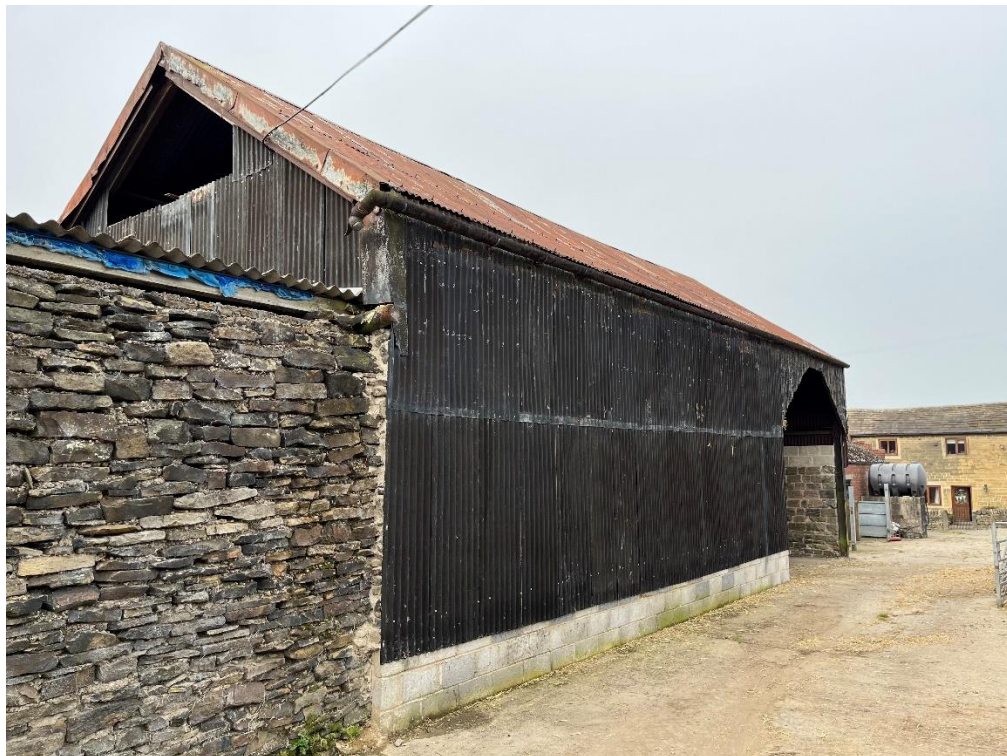
*Photo P8 – The Old Cow Shed, Adjoining Wall to Storage Barn*

External skin of this elevation is constructed in blockwork. There are no signs of settlement or cracking on this wall.

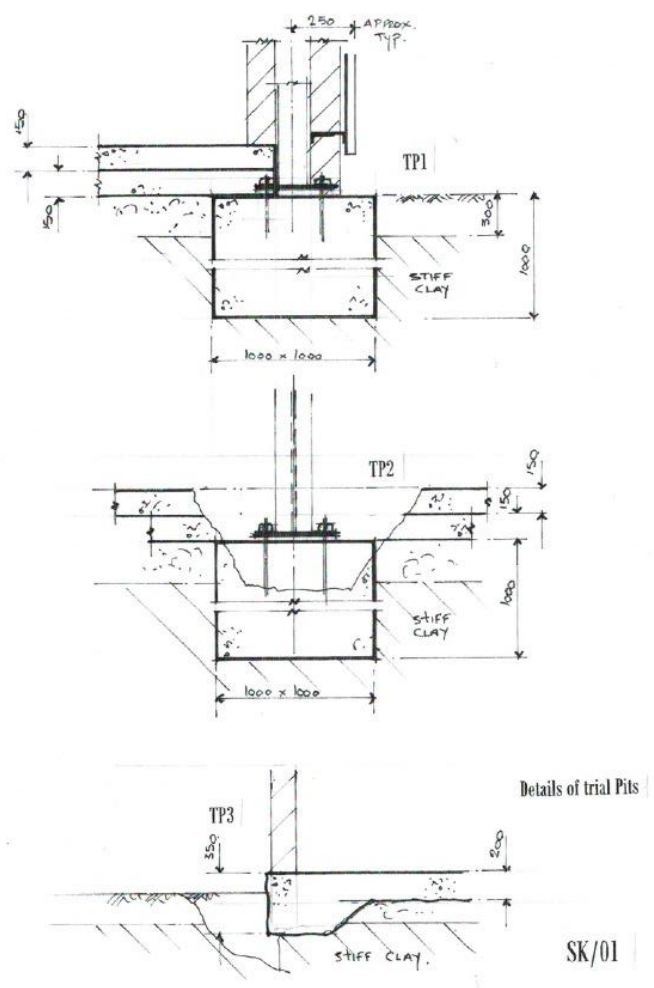
Details of trial pits please refer to drawing **SK/01** below.

- Old Cow Shed main steel frame column/wall foundations **TP1**.
- The Old Cow Shed floor slab details **TP2**.
- Pony Shed floor slab/foundation **TP3**.
- Ground conditions at all locations.
- Check for any ground contamination.

From the excavated trial pits, the existing ground was consistent throughout.

All indicate approximately 300mm minimum compacted hardcore on virgin "stiff clay".

The ground bearing capacity is in the category of 100 – 150 KNm<sup>2</sup>.
