**LOWER COATES FARM, BLACKERGREEN  
LANE, SILKSTONE COMMON, BARNSELY.**

**BAT SURVEY.**

**Ref No: 210503.**

**Date: 2<sup>nd</sup> June 2021.**

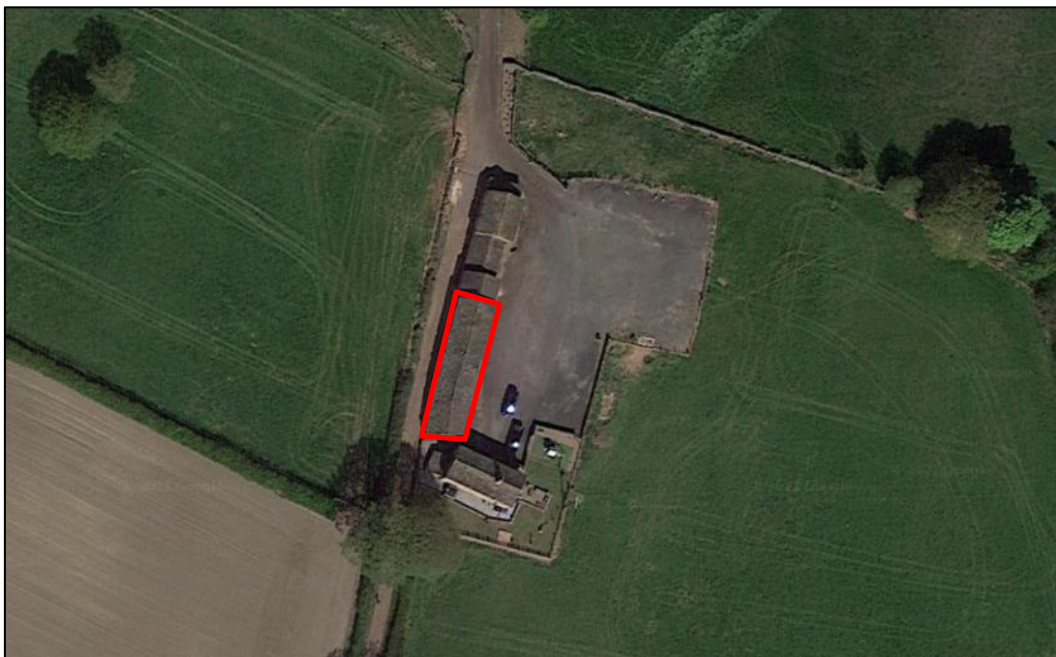
3.2.1. The survey area is two attached stone barns at the south end of Lower Coates Farm off Blackergreen Lane, Silkstone (outlined in red below). The aerial photograph below shows the survey.

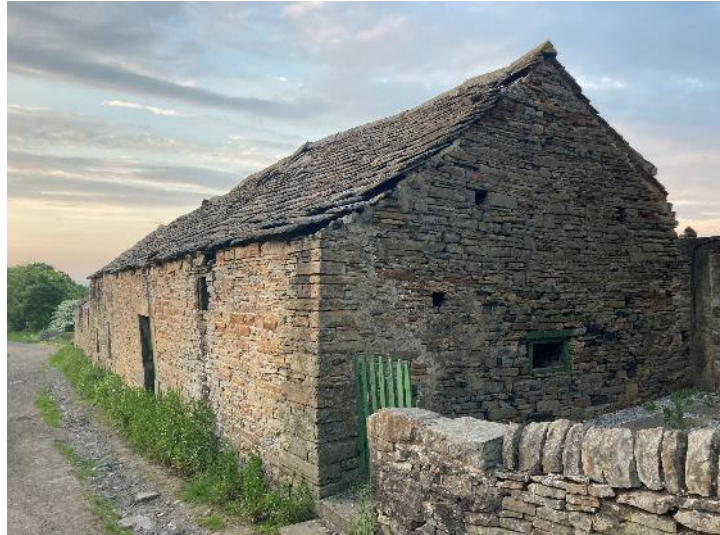
3.3.1. The walls of the building are in poor condition with cracks and crevices between the stone bricks on both the west and east facing walls. There were multiple holes, likely used for timber beams, allowing for potential access points in and out of the building for bats.

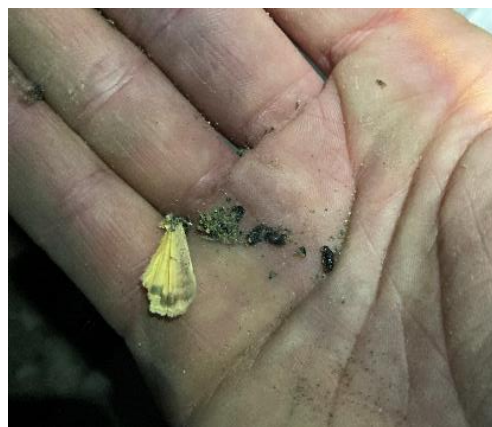
3.3.6. A small number of bat droppings and an insect wing were found on the floor of the barn closets to the farmhouse. The size and shape of these droppings indicated they were from a pipistrelle bat and the insect wing suggests the presence of a feeding roost present within the barn, see right photograph.

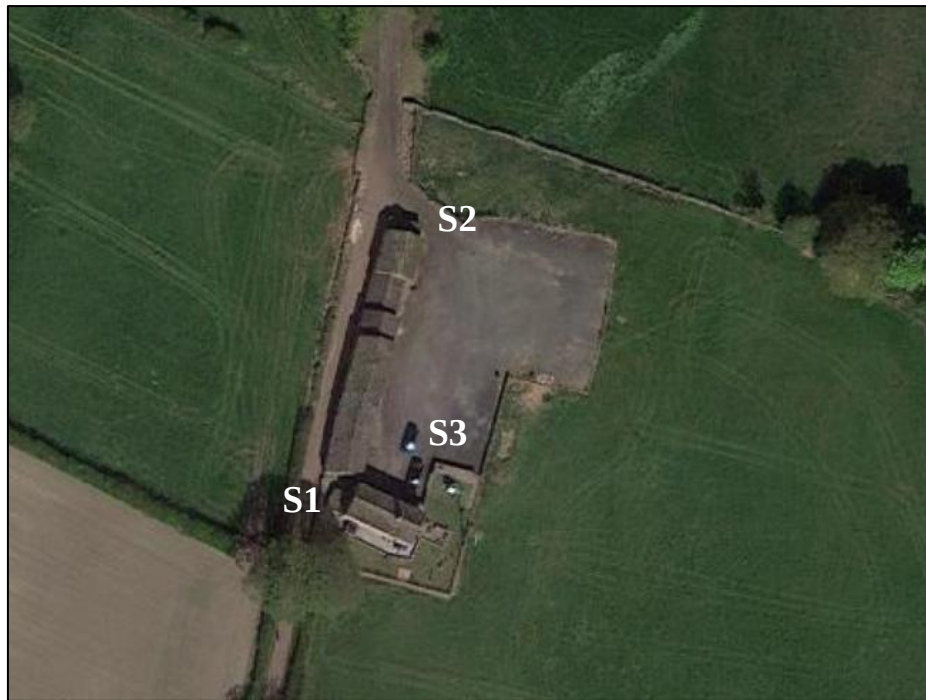
3.4.2. The surveyors were positioned in a manner which allowed for clear and unhindered views of the three exterior walls. The position of each surveyor (S) was as shown on the aerial photograph below. Each surveyor was equipped with a Batbox Duet detector and a two-way radio for communication. A static Anabat recorder was

also placed close by to record bat activity for subsequent computer analysis using Analook software.

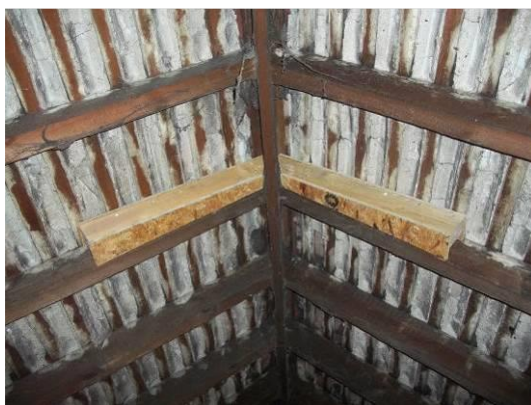
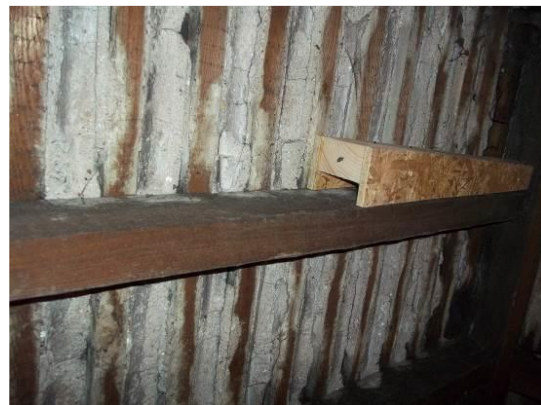
5.5. Additional roosting features will also be provided by fixing small sections of rafters approximately 600mm long to the side of the false rafters with spacers forming a narrow slot butted up to the ridge board at the top end and with the upper half bridged over with 75mm x 15mm untreated sawn timbers, or equivalent, to form a long narrow cavity. Six such features (three pairs) will be provided in the new loft. Examples of these features are shown in the photograph below.

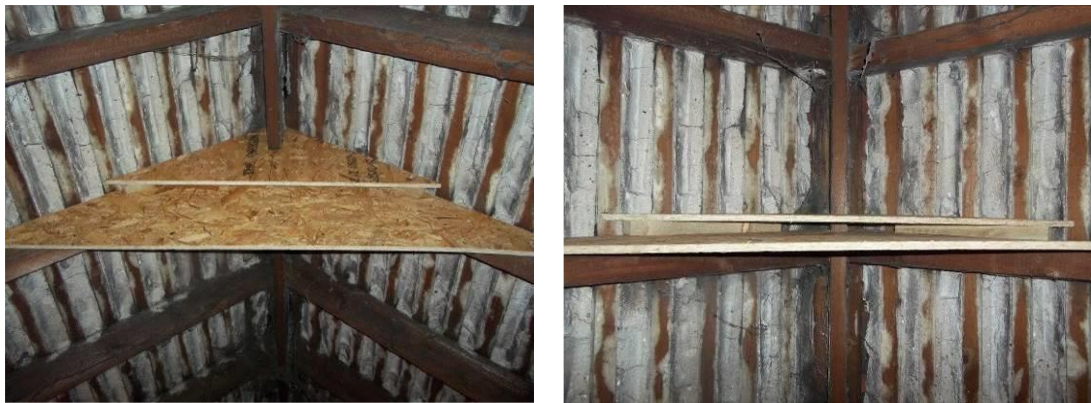
5.6. Internal partitioning of the loft apex will be provided with triangular shaped pieces of rough faced ply boards, fastened to the rafters and hanging down 500mm below the ridge. A second piece of ply board will be fixed onto this hanging down 300mm below the ridge, to provide a cavity between the two boards and an area for the bats to land on before crawling up into the cavity. These will be fixed on using 25mm spacers between the boards. These will be provided at three locations in the loft between the false rafter features. Examples of these features are shown in the photograph below.

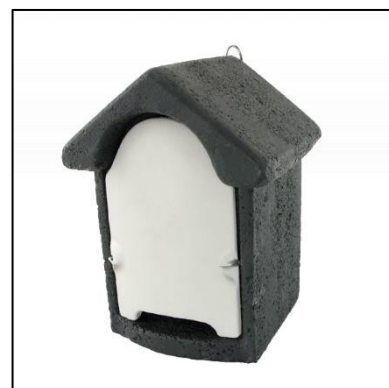
5.9. One Vivara Pro WoodStone Bat Box (see picture adjacent) will be installed on the western or southern aspect of the main farmhouse by the following March to provide a roost location for bats to use until replacement bat roosts are incorporated into the new houses on the site.
